# National Transportation Safety Board

WPR22LA313

## **FOLLOW-UP EXAMINATION**

Location: St. Ignatius, Montana  
Date: August 23, 2022  
Time: 1150 Mountain daylight time  
Airplane: N4009Y Piper PA-30 Comanche

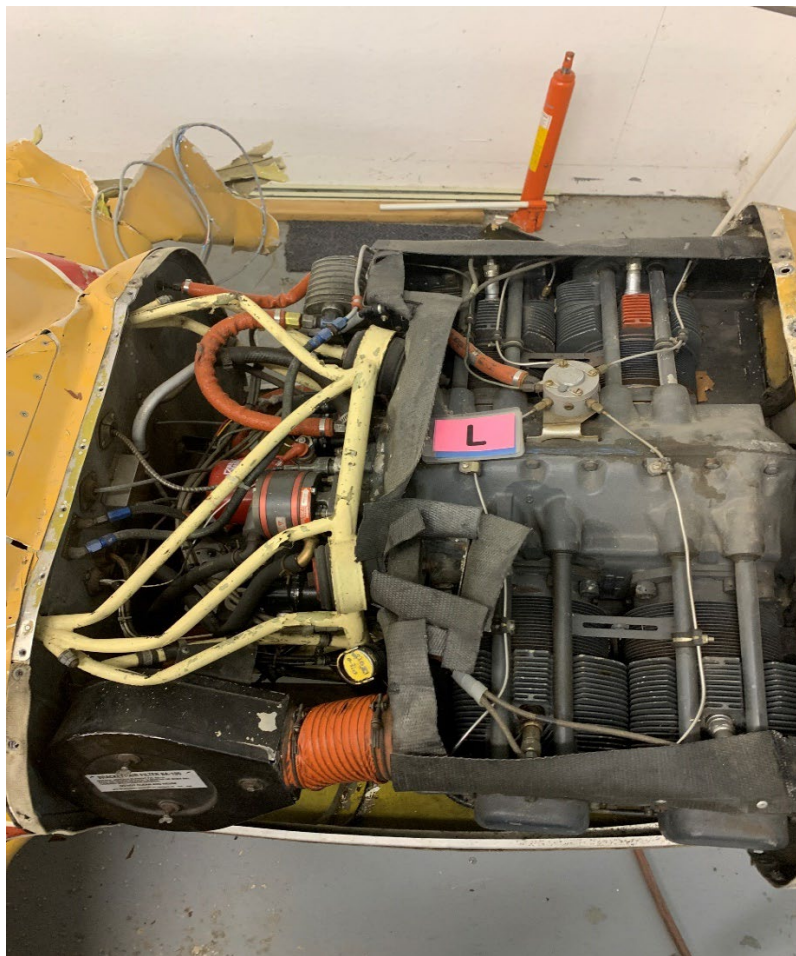
**Figure 1. Top view of left engine**

The installed left engine was Lycoming IO-320-B1A, serial no. L-938-55 (figure 1) appeared free from impact damage. The crankshaft was manually rotated, and appropriate movement of the valve rocker arms was observed. The crankshaft and camshaft freely rotated, and both impulse couplings were heard engaging.

Thumb compression and suction to all four cylinders were established. The spark plugs electrodes displayed normal wear, with no mechanical damage. The throttle and mixture control cables remained attached to the fuel servo. The fuel servo inlet screen was removed and free from blockage. The fuel flow divider was free of obstructions and the diaphragm was intact. The outlet elbow on the mechanical fuel pump was loose however no fuel leakage from the elbow or attached fuel line was evident. The mechanical pump was removed and found unremarkable.

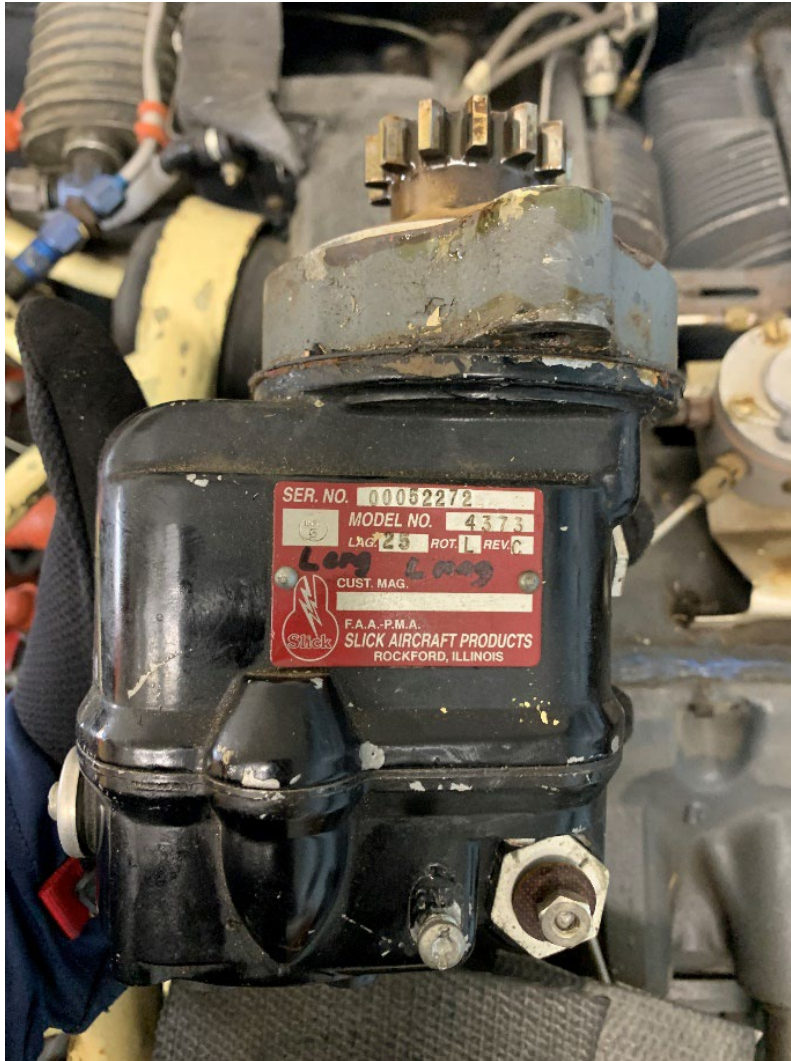
**Figure 2. View of the left magneto from the left engine**

The left and right magnetos installed on the left engine were manufactured by Bendix, model no. 4373, serial nos. 00052272 and 00052347, respectively (figure 2 & 3). The magnetos were secured on its respective mounting pad. Both magnetos were removed and revealed that each were free of impact damage. All drive gears were found unremarkable. Each terminal produced sparks when the drive gear was manually rotated by hand. According to the engine logbooks, the last 500-hour inspection was completed on April 5, 2004, with which the magneto to engine timing was set to 25 degrees.
