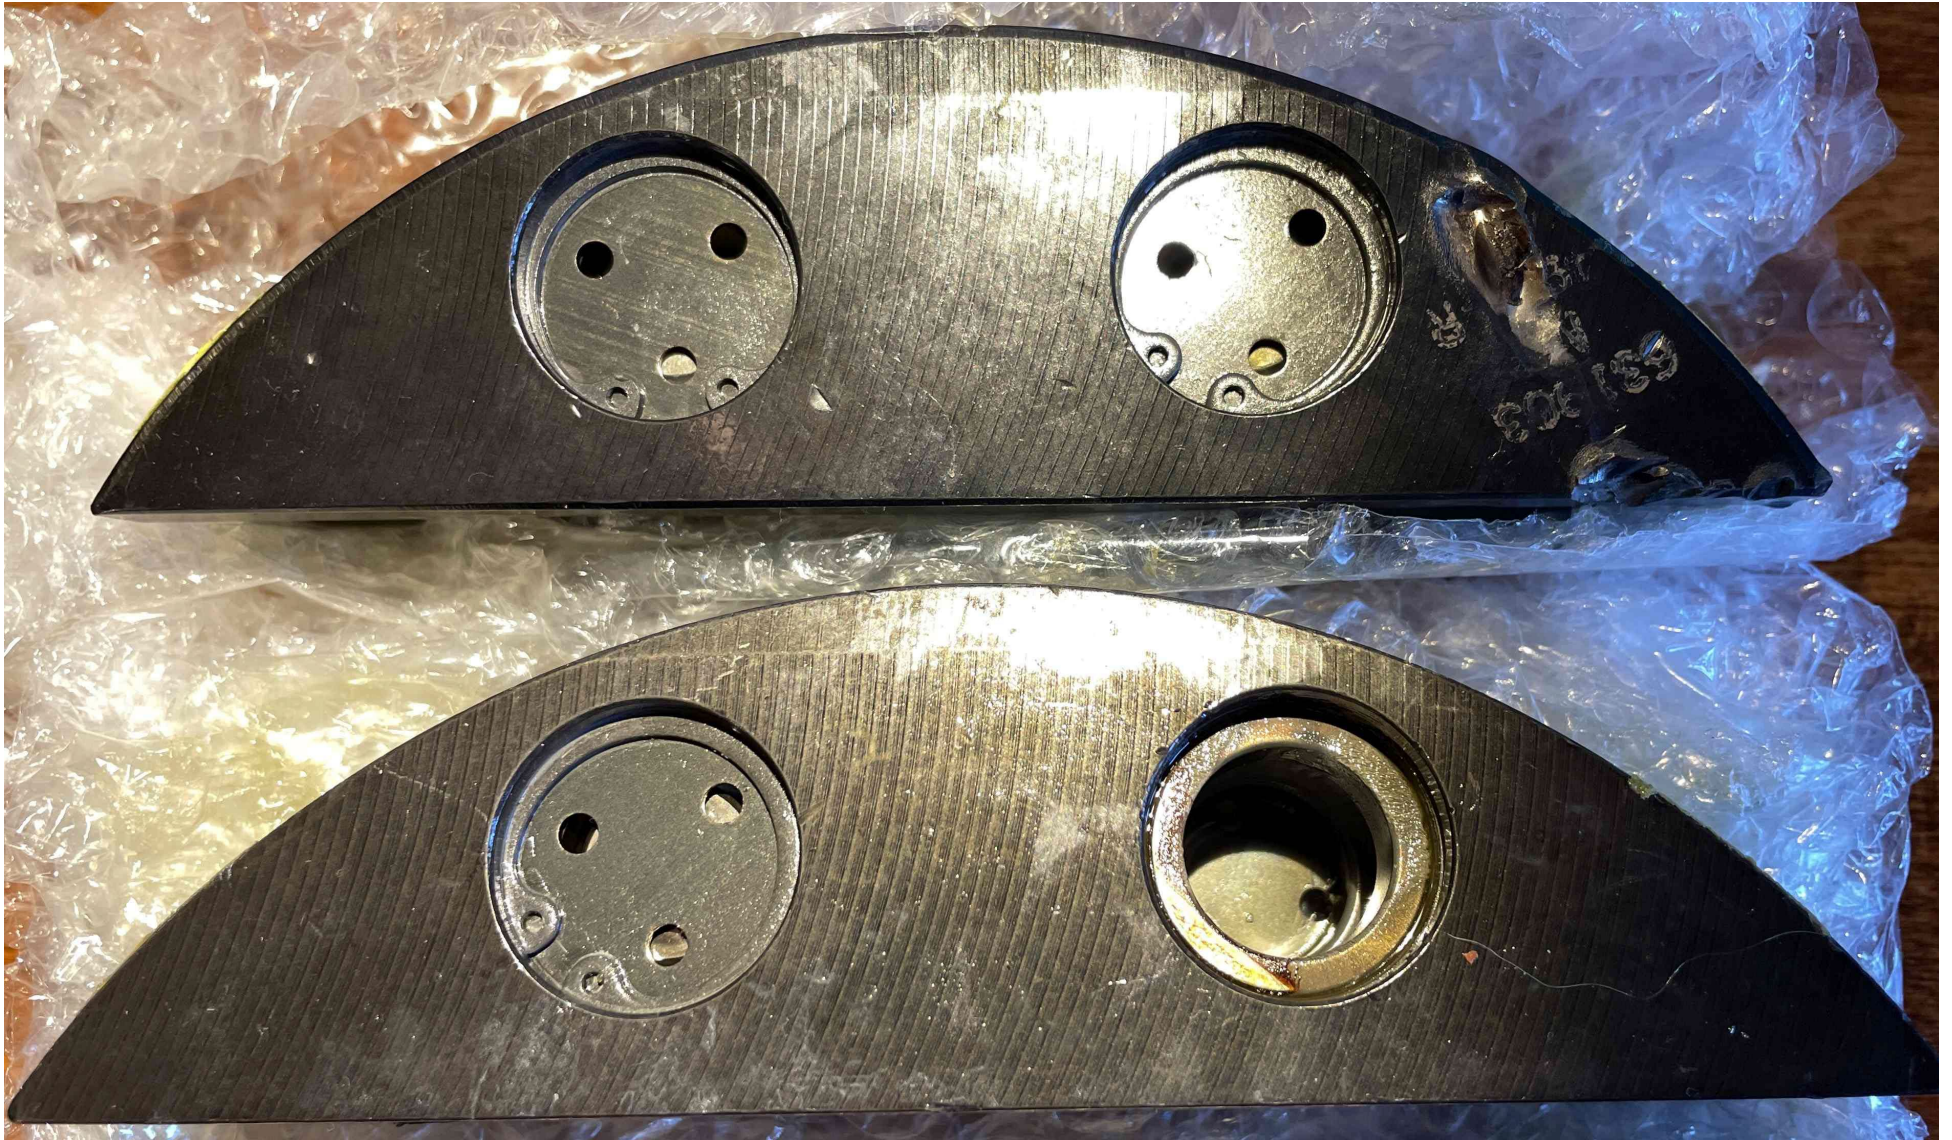
**Photo 1 – Cylinder number 1 and 2 counterweight with two incorrectly installed retaining clips (top right, bottom left).**

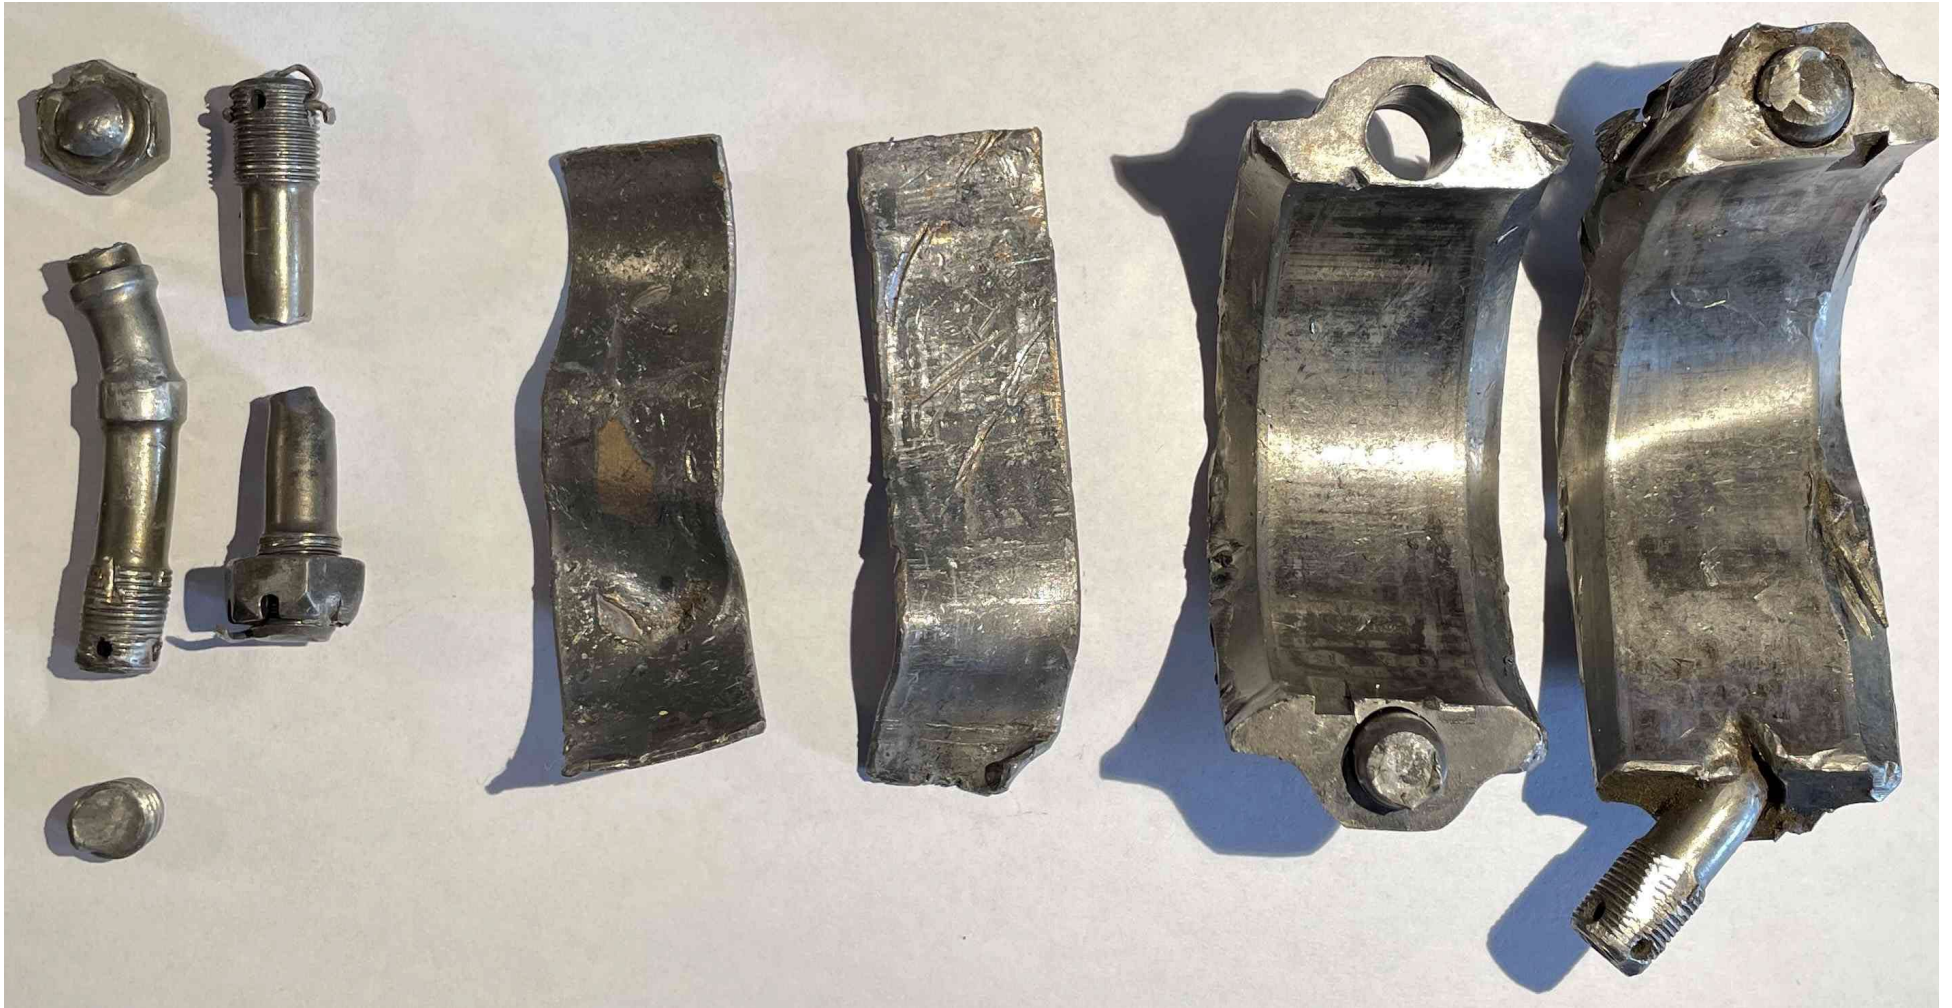
**Photo 2 – Cylinder number 1 and 2 rod caps, bearing and bolt remnants**

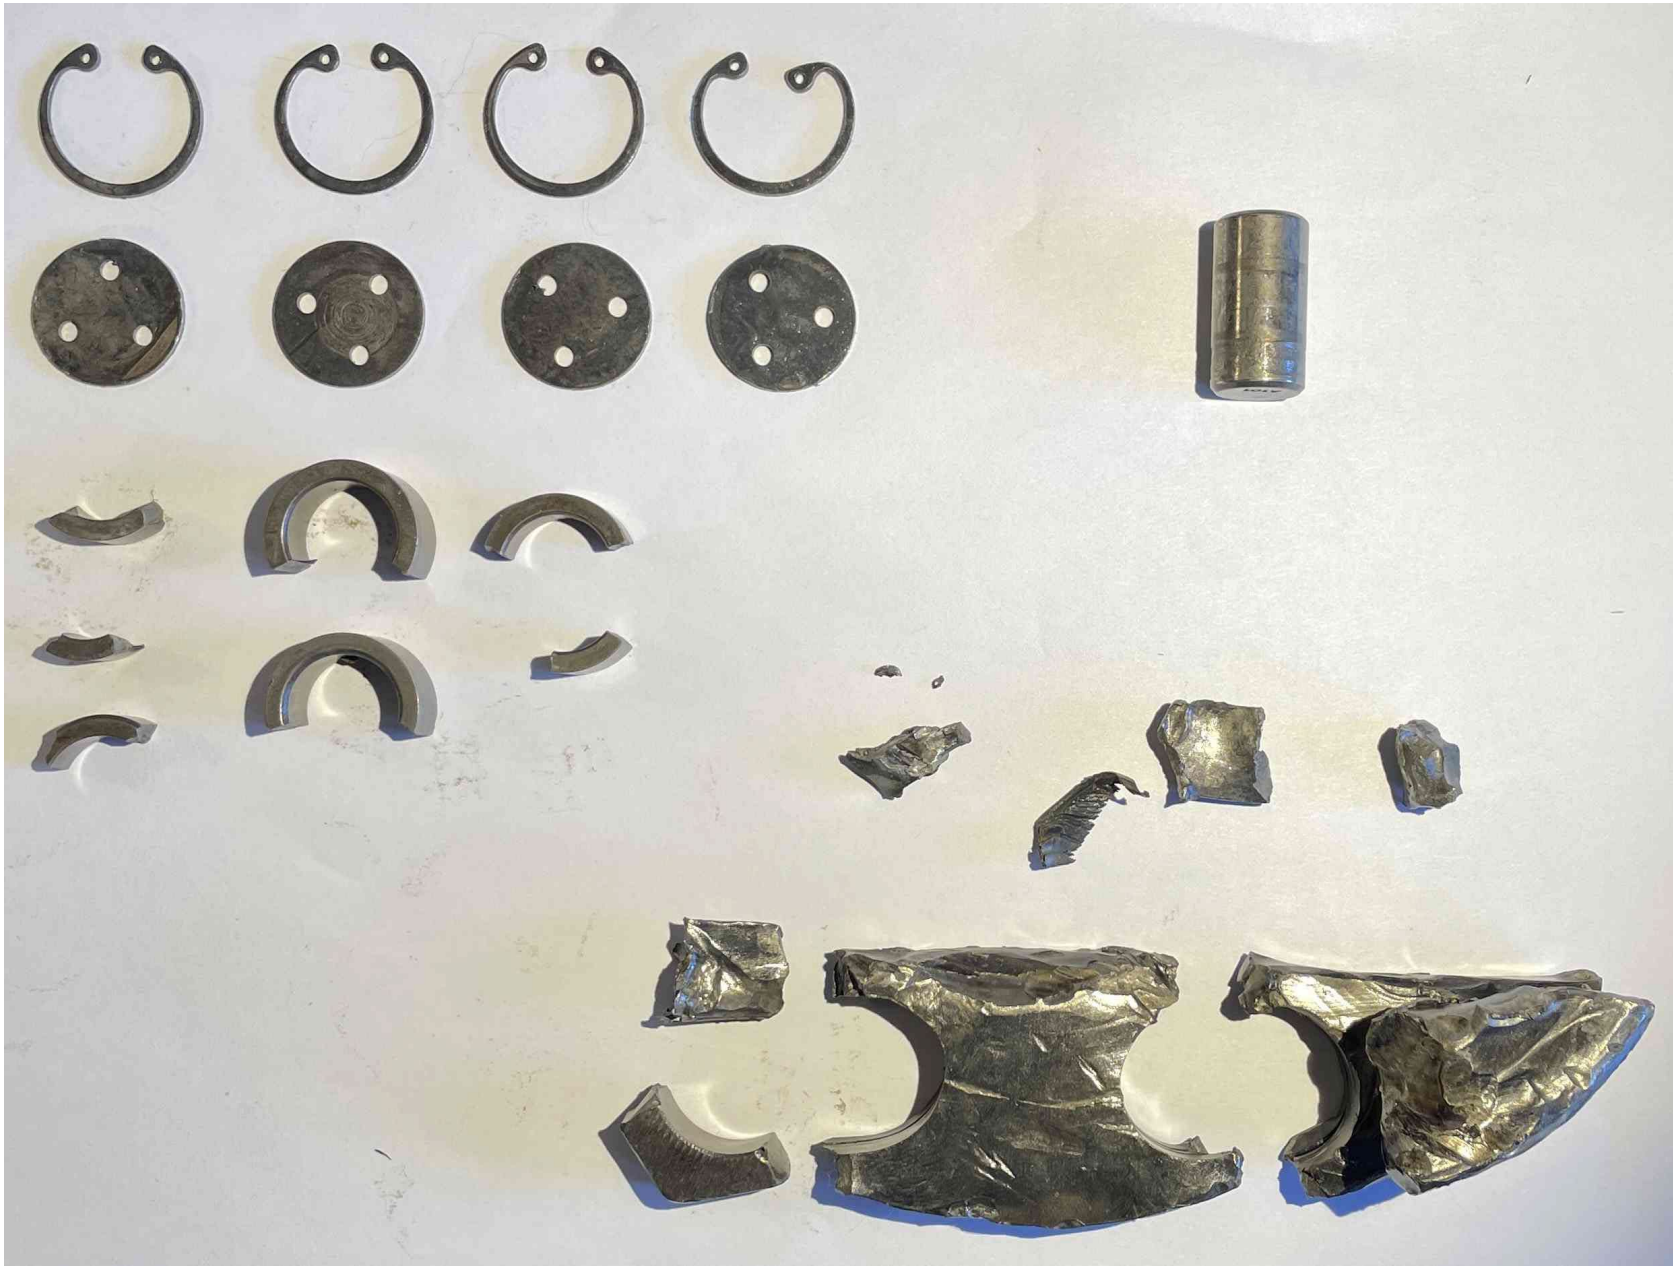
**Photo 3 – Fragments of counterweight, bushings, a single counterweight pin, and four retaining rings and plates**
