# National Transportation Safety Board

WPR22L316

## **AIRFRAME AND ENGINE EXAMINATION**

Location: Vacaville, California  
Date: August 24, 2022  
Time: 1118 Pacific daylight time  
Airplane: Cessna 150, N22507

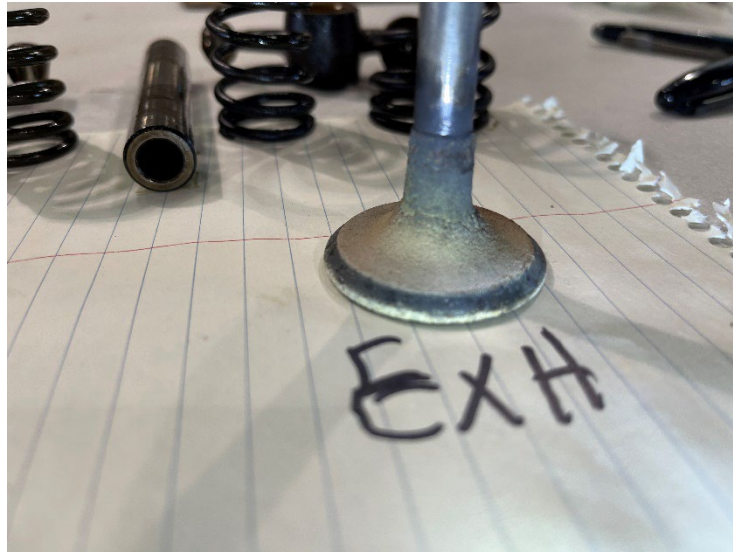
Cylinder no. 2 was intact and undamaged. The exhaust and intake valve springs were intact and oil coated. The intake and exhaust valve rocker arms were intact oil coated. The valve springs and keepers were removed. The intake valve slid out of the valve guide freely. The exhaust valve slid out of the valve guide with a significant amount of force.

The exhaust valve stem exhibited some amount of carbon build up along with the valve neck. Some white deposits were observed around the rim of the valve.

The valve seat exhibited some carbon build up.

**Figure 1: No. 2 Cylinder Exhaust Valve - Removed.**
