## **NATIONAL TRANSPORTATION SAFETY BOARD**

# **DRAFT AIRFRAME EXAMINATION SUMMARY REPORT**

**WPR22LA317**

Location: Boulder City, Nevada  
Date: August 26, 2022  
Aircraft: N916CA  
NTSB IIC: Andrew Swick

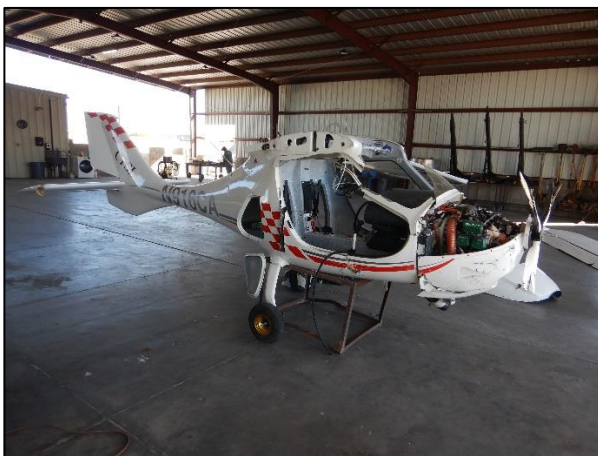
The wings were removed from the airplane to facilitate the relocation of the wreckage. The left wing had impact damage near the tip and the left wing had substantial damage to its lower side as a result of impacting a chain link fence. The fuselage and landing gear had substantial damage. The engine and propeller assembly remained attached to the fuselage. The engine cowling was crushed on the right side. The propeller spinner separated and the propeller blades were damaged.

Figure 1-Right forward side of airplane.

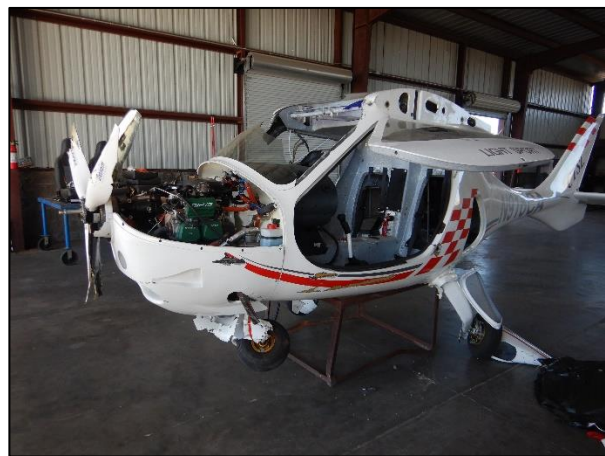
Figure 2-Left forward side of airplane.

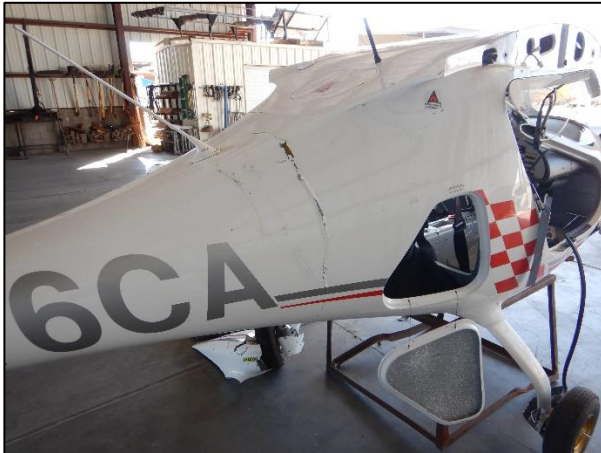
The fuselage had buckling on both sides of the fuselage aft of the cabin area. The windshield was mostly separated. The right door was found in multiple sections. The right windshield pillar separated near the top wing attachment. Both metal fuel lines within the pillar were bent forward. The instrument panel right side panels were cracked.

Figure 3-Right side of aft fuselage.

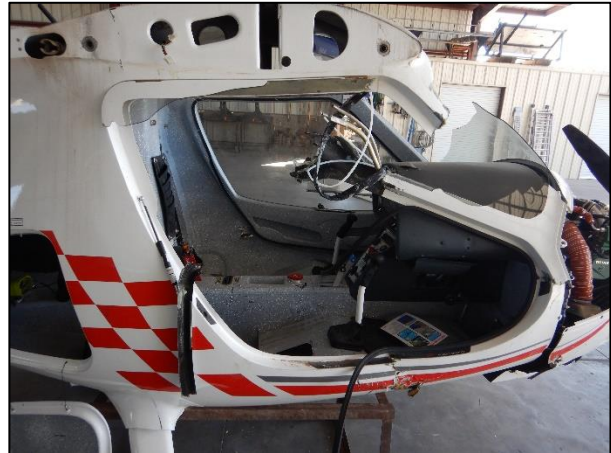
Figure 4-Right side of airplane cabin area.

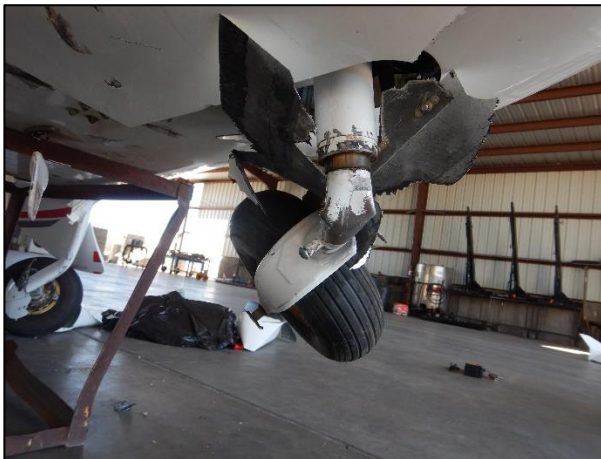
The nose gear was bent rearward and remained attached to the steering linkage. The left main gear remained attached to the airframe and was bent and twisted aft. The brake system was actuated and brake pressure was established and consistent at both main wheel brake assemblies.

Figure 5-Nose landing gear.

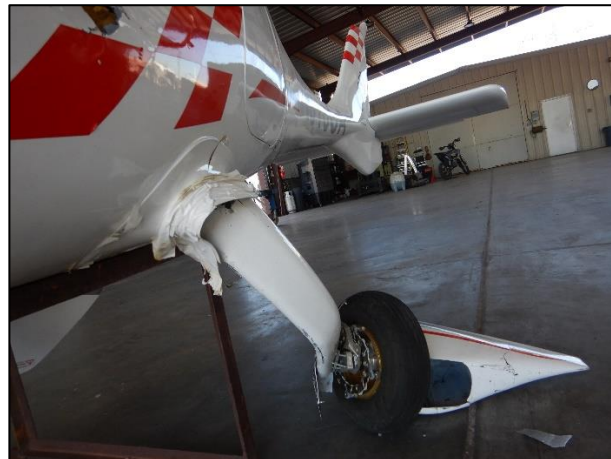
Figure 6-Left main gear.

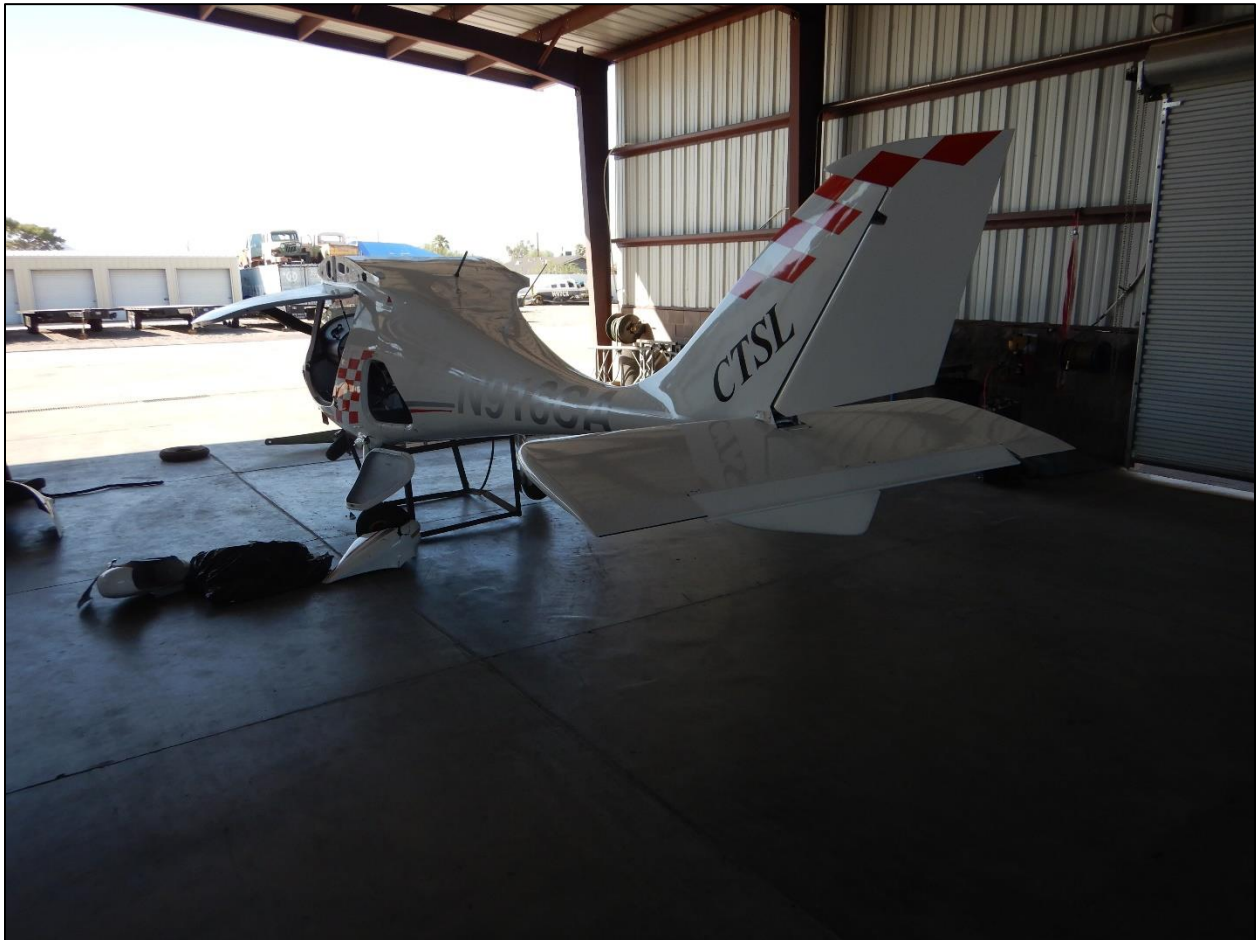
Flight control continuity was established through both wings. The aileron bellcranks at both wing root areas were undamaged and aileron movement was normal. The aileron control linkage located in the airframe was undamaged and moved normally during control stick movement. Flap control linkage at the wing root areas were undamaged and moved normally. The elevator moved freely from each control stick. The rudder moved freely from the foot controls. Rudder and aileron manual trim worked normally. The electric elevator trim was activated and worked normally. The flap system was activated from the instrument panel and the control linkage moved normally in all positions.

Figure 7-View of the left aft side of the airframe.

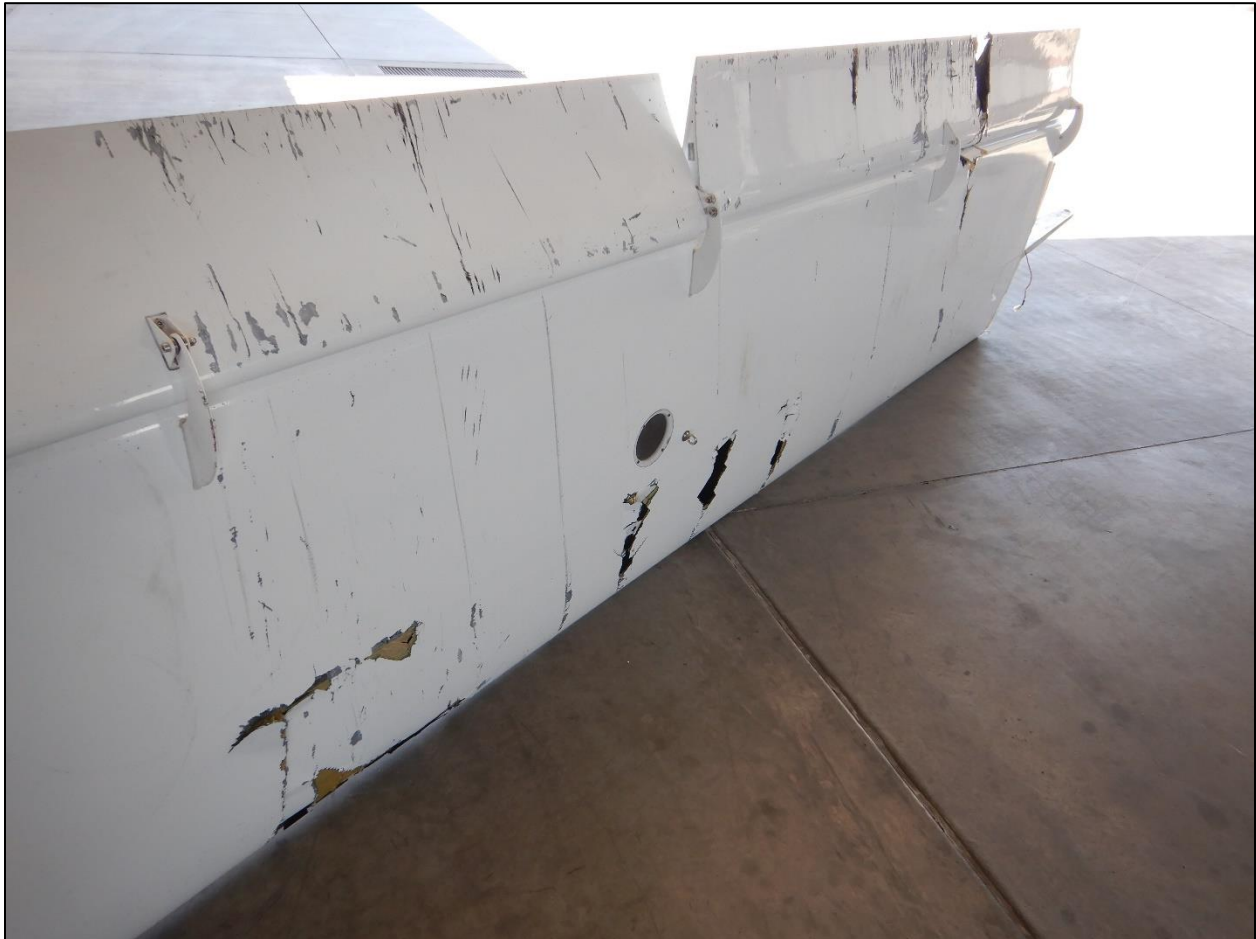
The left wing lower surface including the aileron and flap were damaged. The lower plexiglass inspection panel revealed the undamaged aileron linkage assembly.

**Figure 8-Left wing, view of the lower surface.**
