## **NATIONAL TRANSPORTATION SAFETY BOARD**

# **ENGINE EXAMINATION SUMMARY REPORT**

**WPR22LA317**

Location: Boulder City, Nevada  
Date: August 26, 2022  
Aircraft: N916CA  
NTSB IIC: Andrew Swick

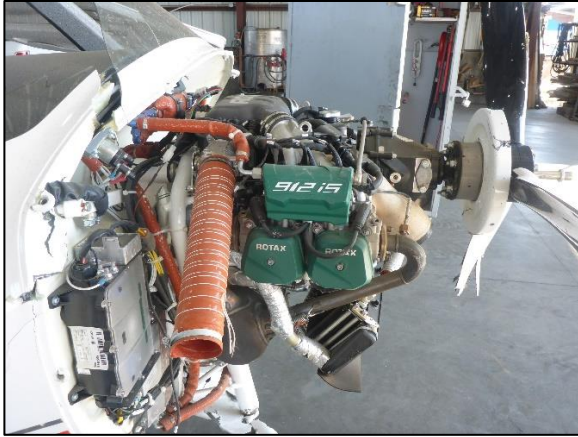
The Rotax 912iS Sport engine remained attached to the airframe during the examination. The Neuform CR3-65-(IP)-47-101.6, three-bladed propeller assembly remained attached to the crankshaft propeller flange. The engine cowling was crushed on the right side. The propeller spinner separated, and the propeller blades had impact damage. The upper and lower cowlings were removed, and damage was noted to the upper right side of the firewall area near the upper right engine mounting tube. The right exhaust stack separated from the exhaust muffler inlet flange. The muffler stack attachment springs remained attached and were stretched. Engine control continuity was established from the cabin area to the engine.

Figure 1-Right forward side view of the airplane.

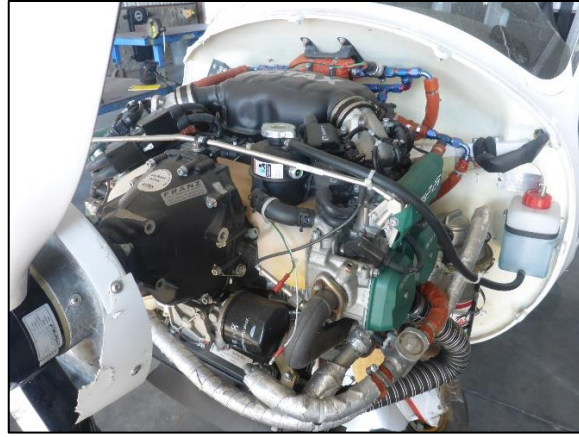
Figure 2-Forward side view of the propeller and airplane.

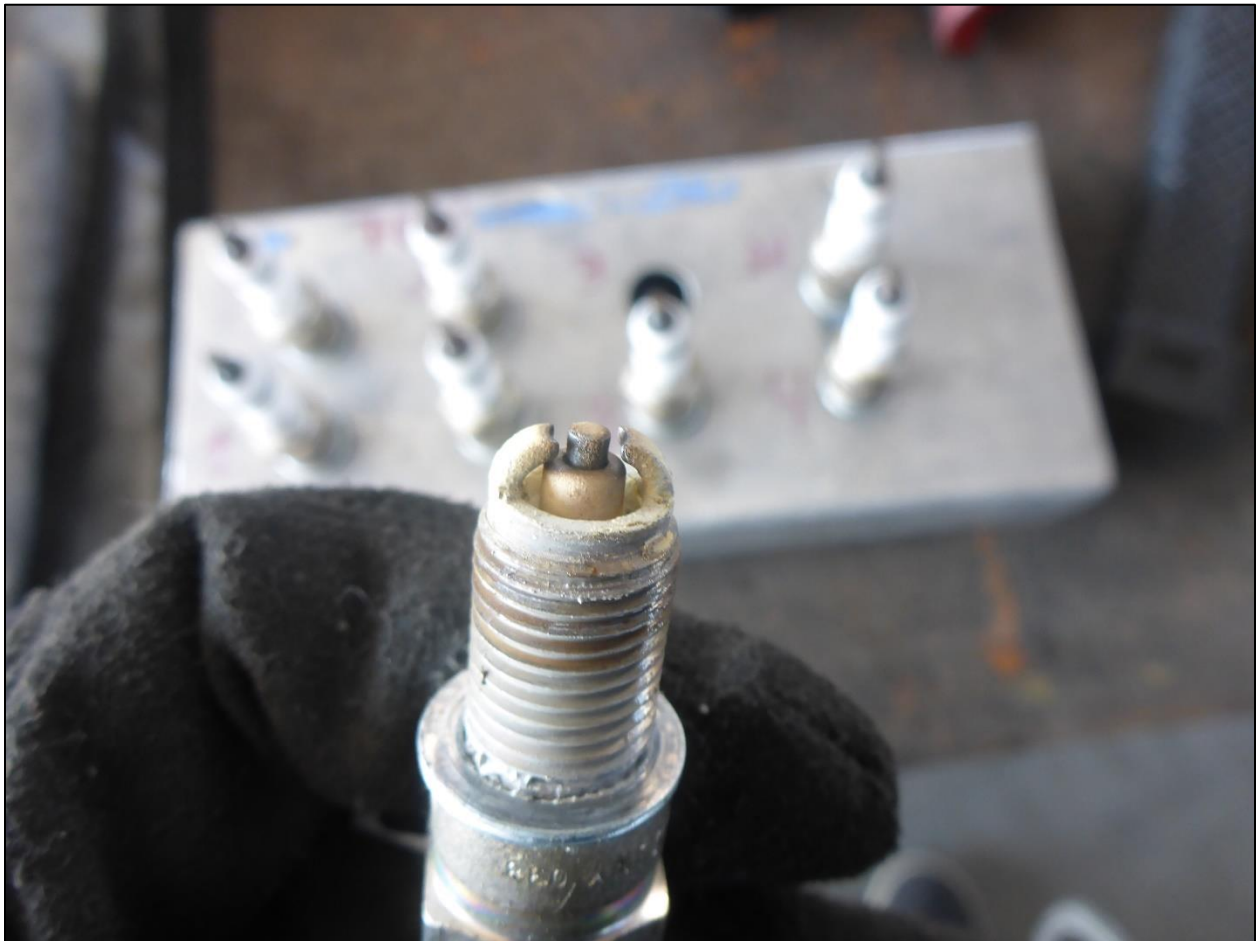
The BRP spark plugs (297-656) were removed from the engine. The spark plugs electrodes had minimal wear and the electrode areas had white combustion deposits. According to Rotax, the white deposits were consistent with the engine operating Avgas 100LL fuel.

Figure 3-No. 3 spark plug electrode area.

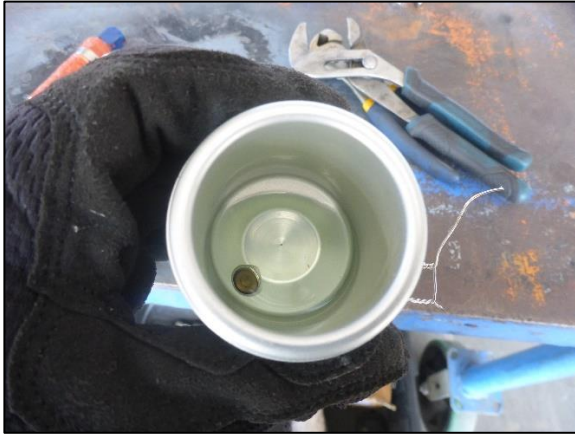
The fuel pumps were removed from the firewall area and tested. The fuel pumps operated normally, and fuel flowed freely. The gascolator was removed and disassembled and contained a couple ounces of fuel. The fuel selector valve was opened from the Left to Right position, and fuel flowed from the gascolator. The fuel captured had a light green appearance.

Figure 4-Gascolator bowl removed.

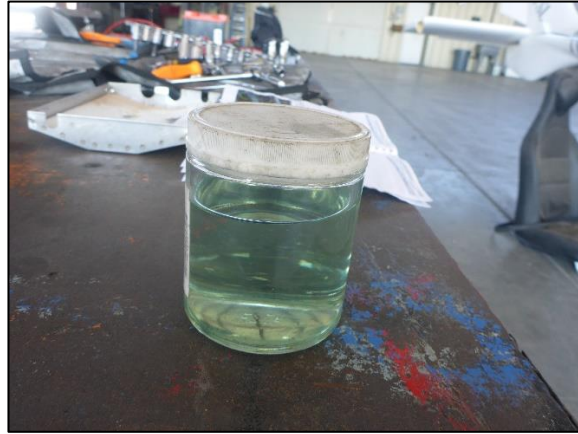
Figure 5-Fuel captured.

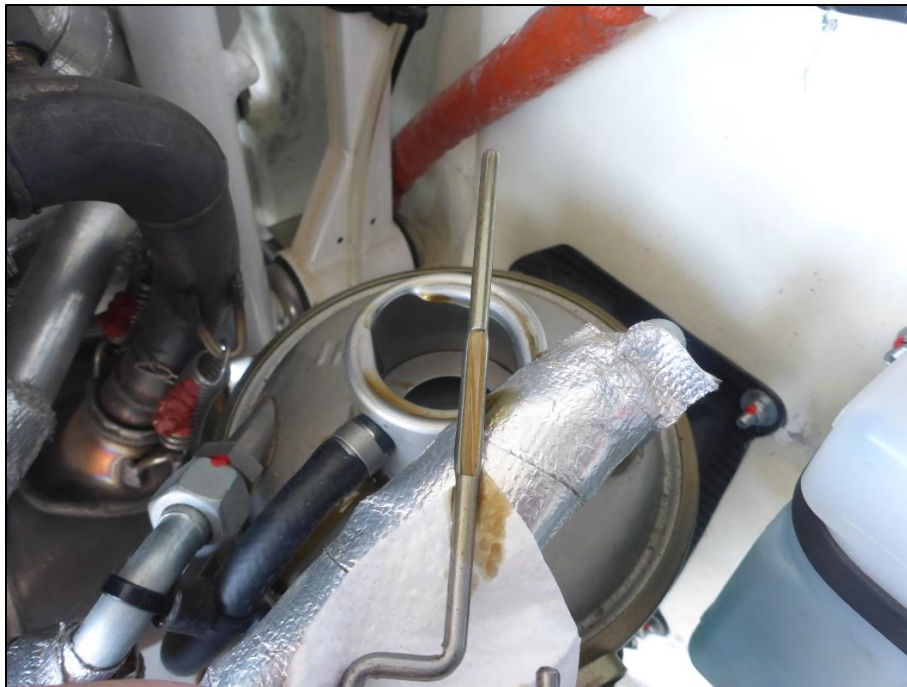
The oil dip stick was checked and contained a quantity that was overfull and beyond the mix limit indication. The propeller assembly was rotated by hand and returning oil flow was confirmed back to the tank. The oil system had an aftermarket oil thermostat installed.

Figure 6-Oil tank dip stick.
