**NATIONAL TRANSPORTATION SAFETY BOARD**  
Office of Aviation Safety

**Wreckage Examination Group Field Notes**

**A. ACCIDENT      WPR22FA320**

Location:      Ione, California  
Date:      May 26, 2022  
Time:      1227 PDT  
Operator:      Private  
Aircraft:      Cessna 152  
Registration:      N49430

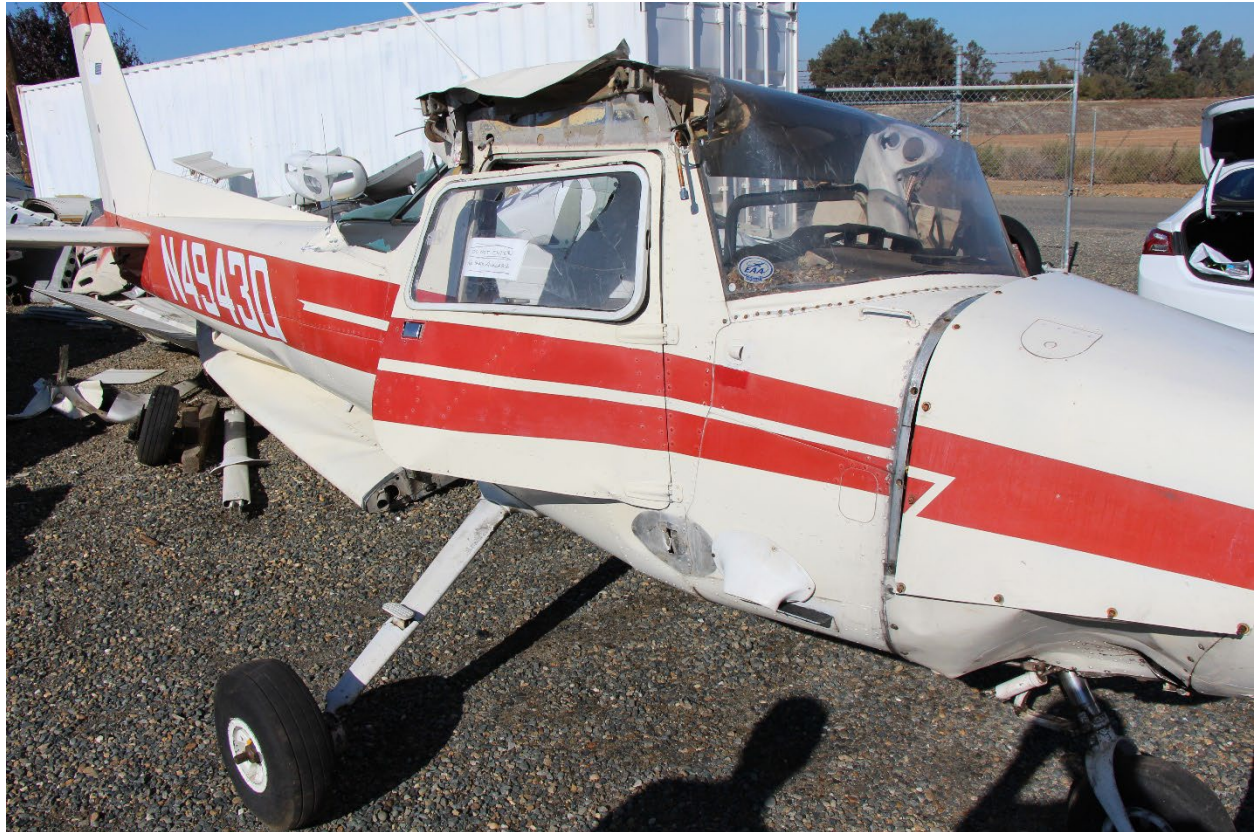
*Photograph 1: Accident airplane and prior to examination*

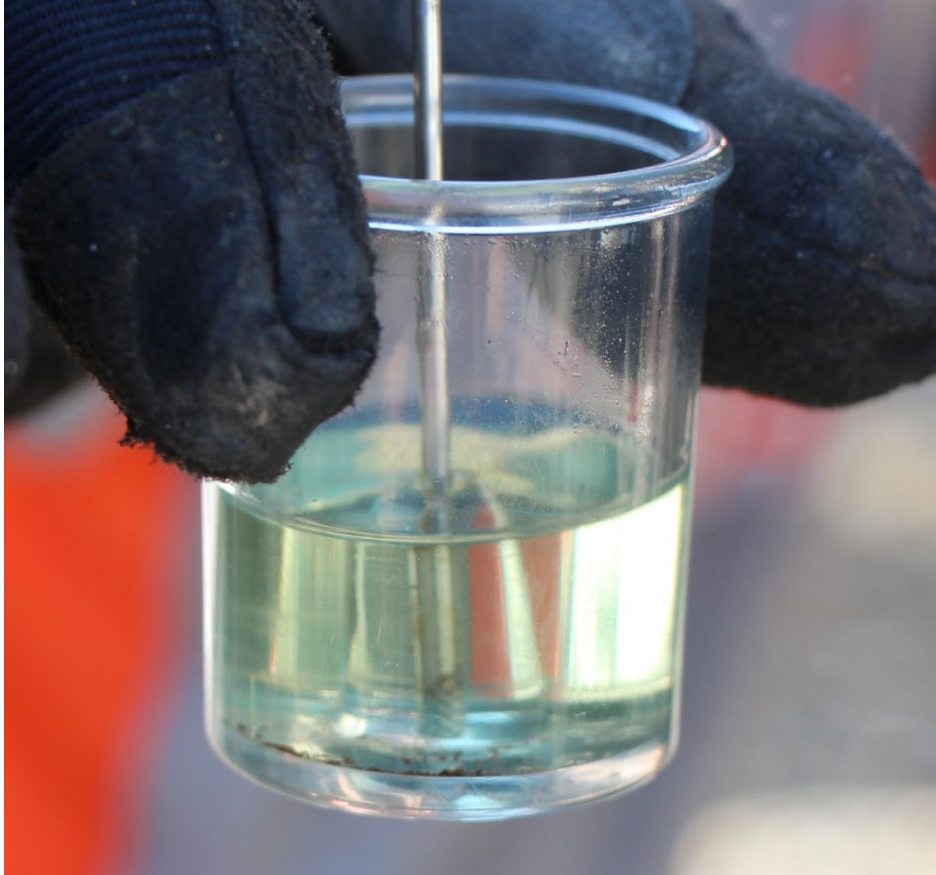
A fuel sample taken from the fuel strainer exhibited a blue hue and consisted of an odor that was consistent with 100 low lead aviation grade gasoline. The fuel strainer bowl contained a trace amount of debris and the strainer screen was free of foreign contaminants.

*Photograph 2: Sample from fuel strainer bowl*

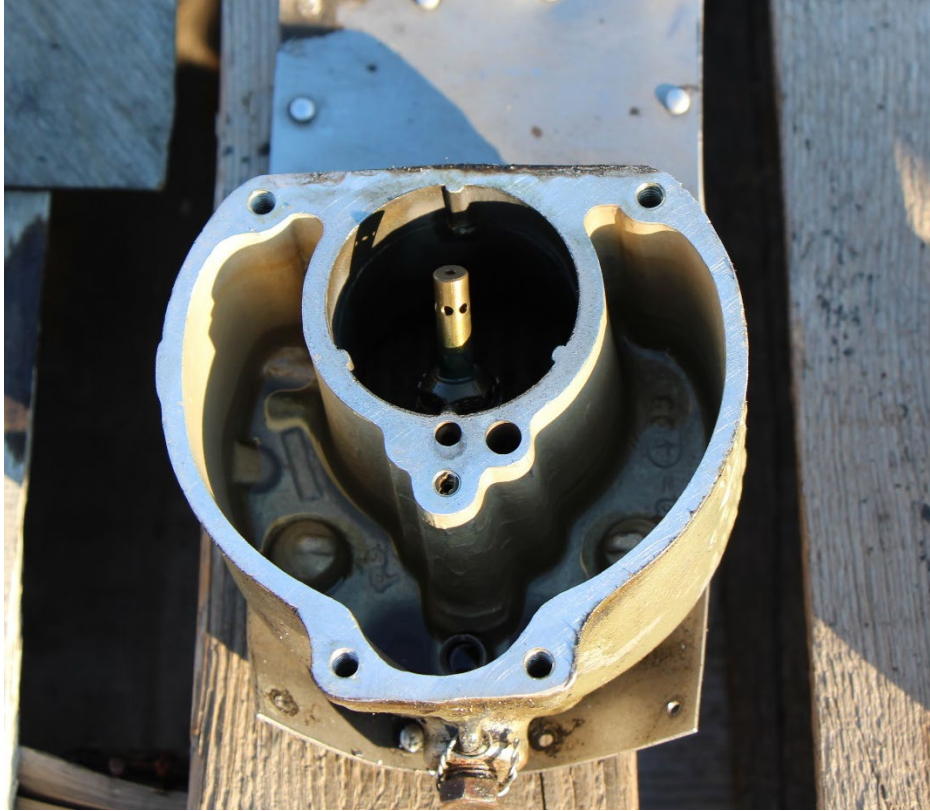
The carburetor was manufactured by Marvel-Schebler and was a model 3A. Disassembly of the carburetor revealed several ounces of fuel in the carburetor bowl, which was free of debris. The fuel delivery channel did not display any foreign contaminants and the carburetor floats were unremarkable.

*Photograph 3: Carburetor bowl*

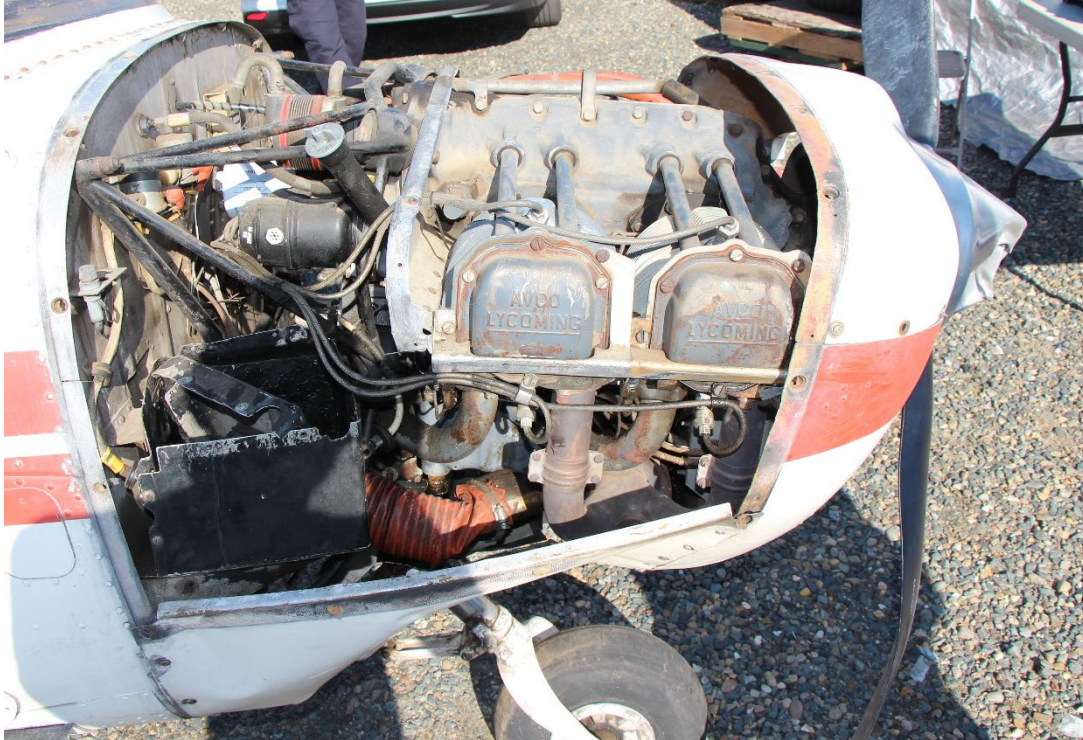
The airplane was equipped with a Lycoming Engines O-235-L2C, a 118 hp, horizontally opposed, air cooled, carbureted, normally aspirated, reciprocating engine. The engine sustained minimal damage with exception of the airbox, which was partially crushed.

*Photograph 4: Engine from right side prior to examination*

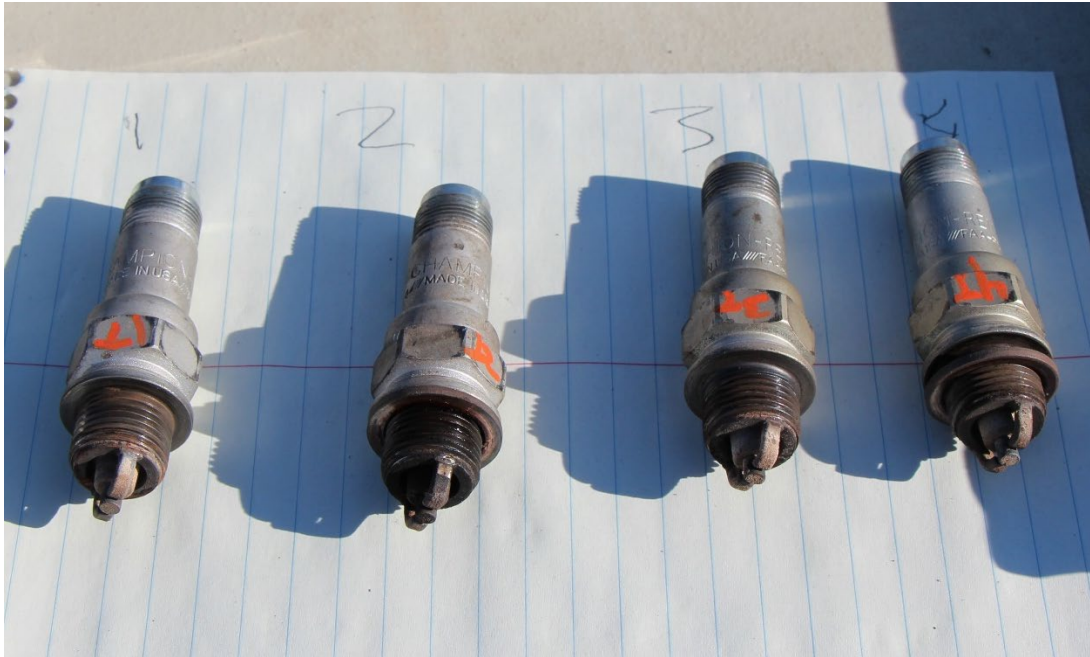
All eight massive electrode spark plugs were secure at their respective ports with each ignition lead securely attached. The top spark plugs to cylinders 1, 3 and 4 were lead fouled and the cylinder 2 plug was dark in appearance. The center electrodes to spark plugs 2 and 3 were worn. The right and left magnetos were timed at 20° below top dead center, consistent with the timing listed on the engine data plate. Spark was achieved at each of the four top ignition leads in the proper firing order.

*Photograph 5: Top spark plugs*
