Michael Hicks  
Air Safety Investigator  
OAS-WPR

**Date:** 9/26/2022

**Subject:** WPR22LA321

Below is a synopsis of communication between the Investigator-in-charge (IIC) and the Principal Maintenance Inspector regarding accident airplane N3268B.

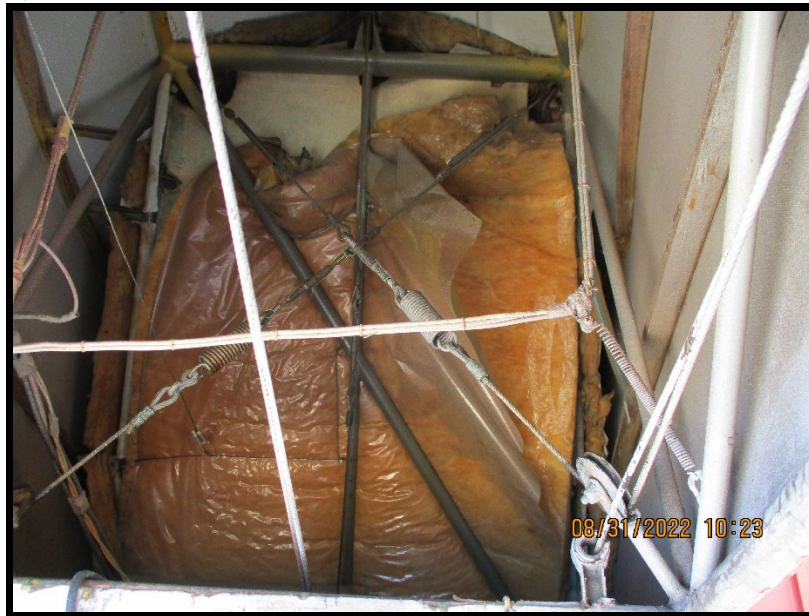
The rest of the flight controls (when disconnected from the steering linkage and damaged L/H aileron) moved smoothly and without any binding or restriction. The first picture I sent you is of the interconnect between the aileron and the rudder (Figure 1). It worked as advertised (when damaged components were disconnected from the system).

*Figure 1: Interconnect between the aileron and the rudder (Source: FAA)*
