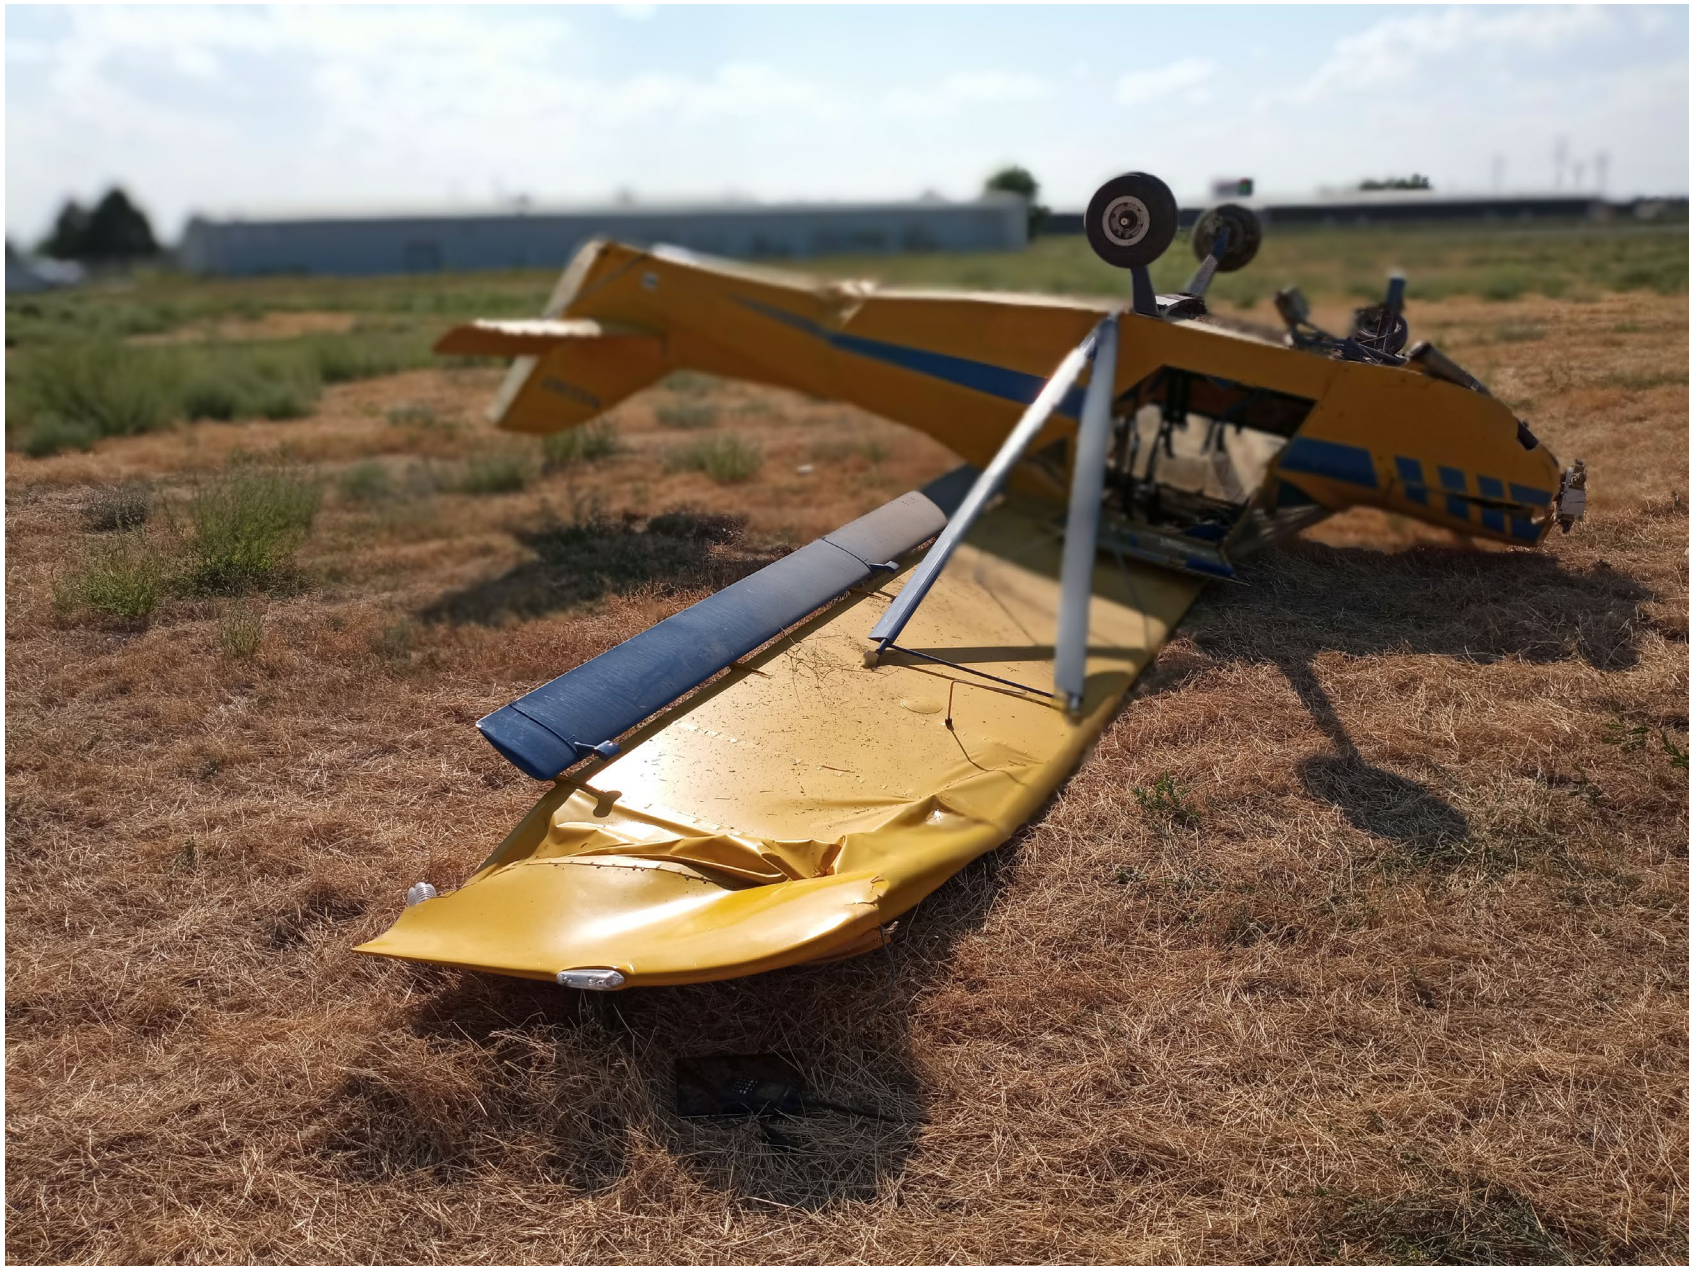
**Photo 1 – N52367 showing substantial damage to the left wing and strut. Photo courtesy of the pilot**

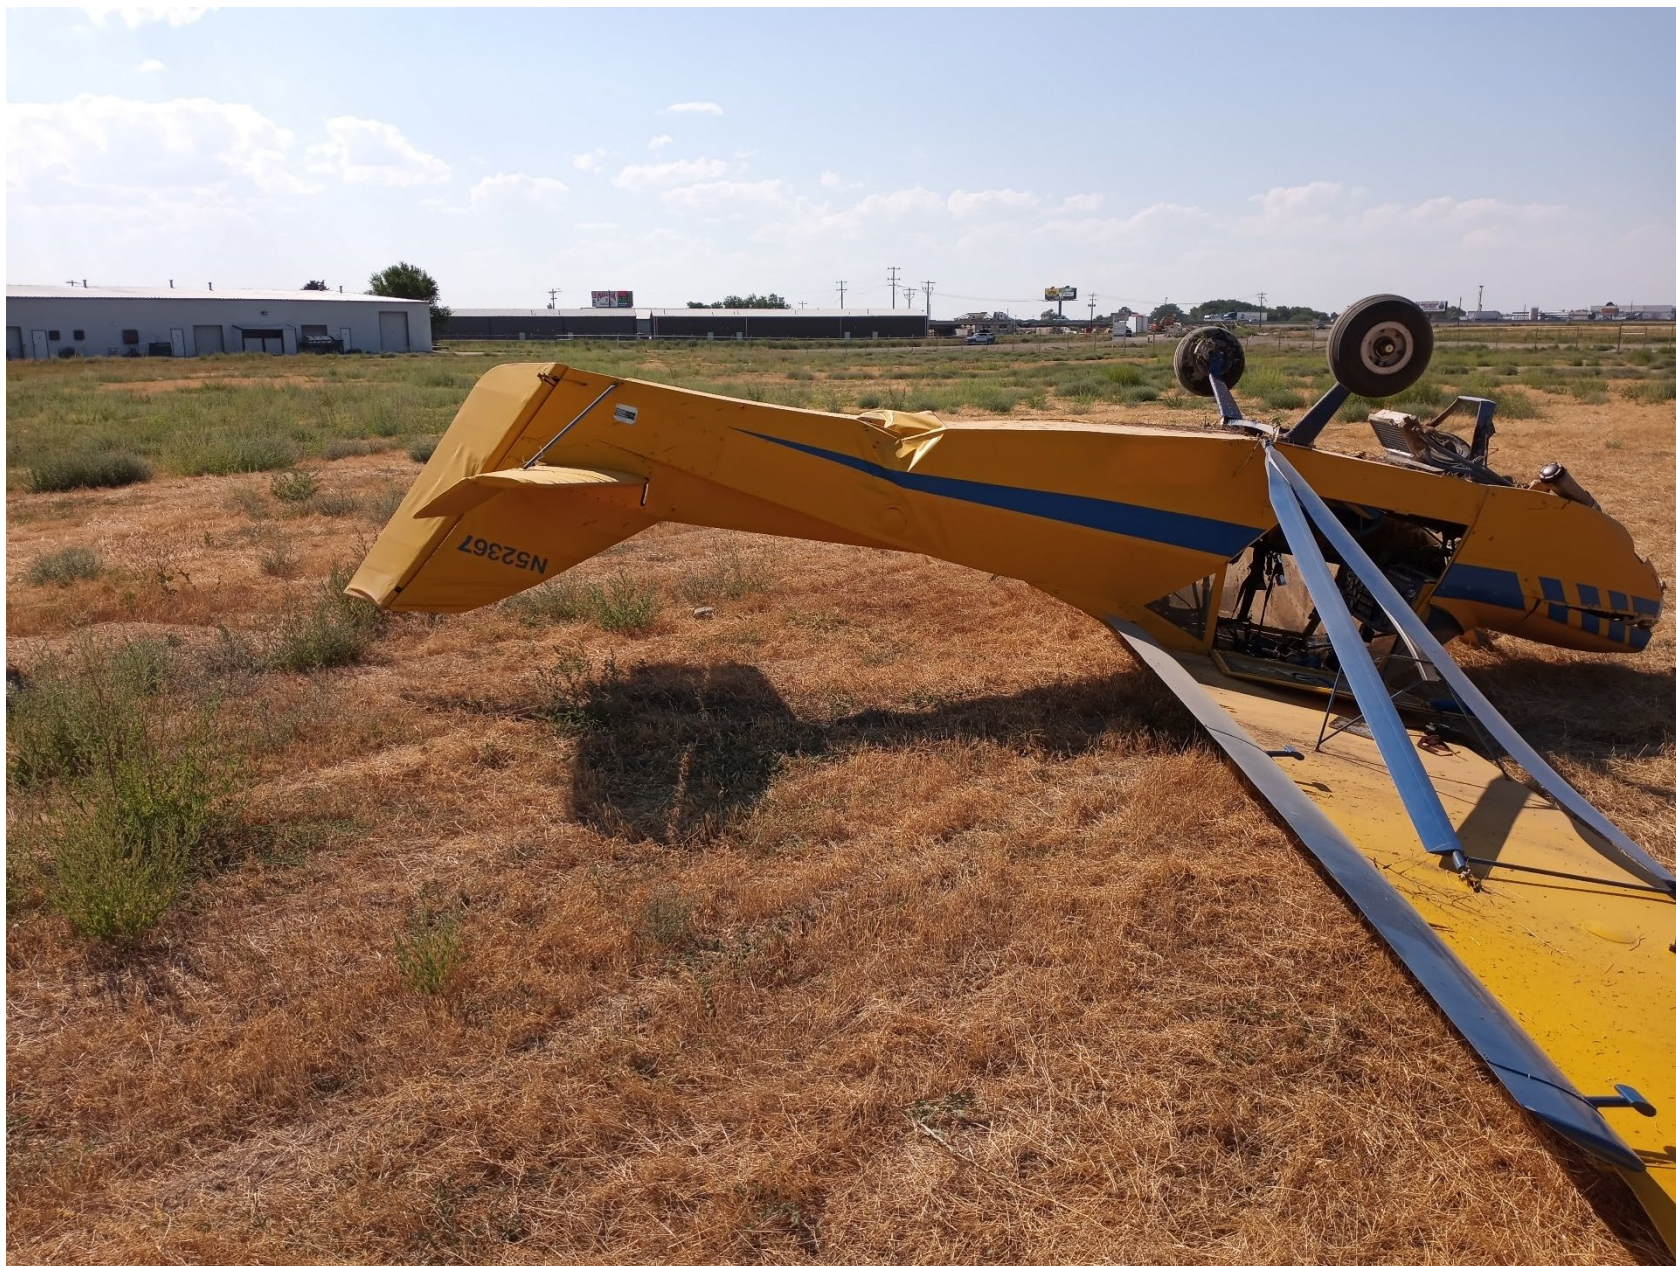
**Photo 2 – Left view (Photo courtesy of the pilot)**

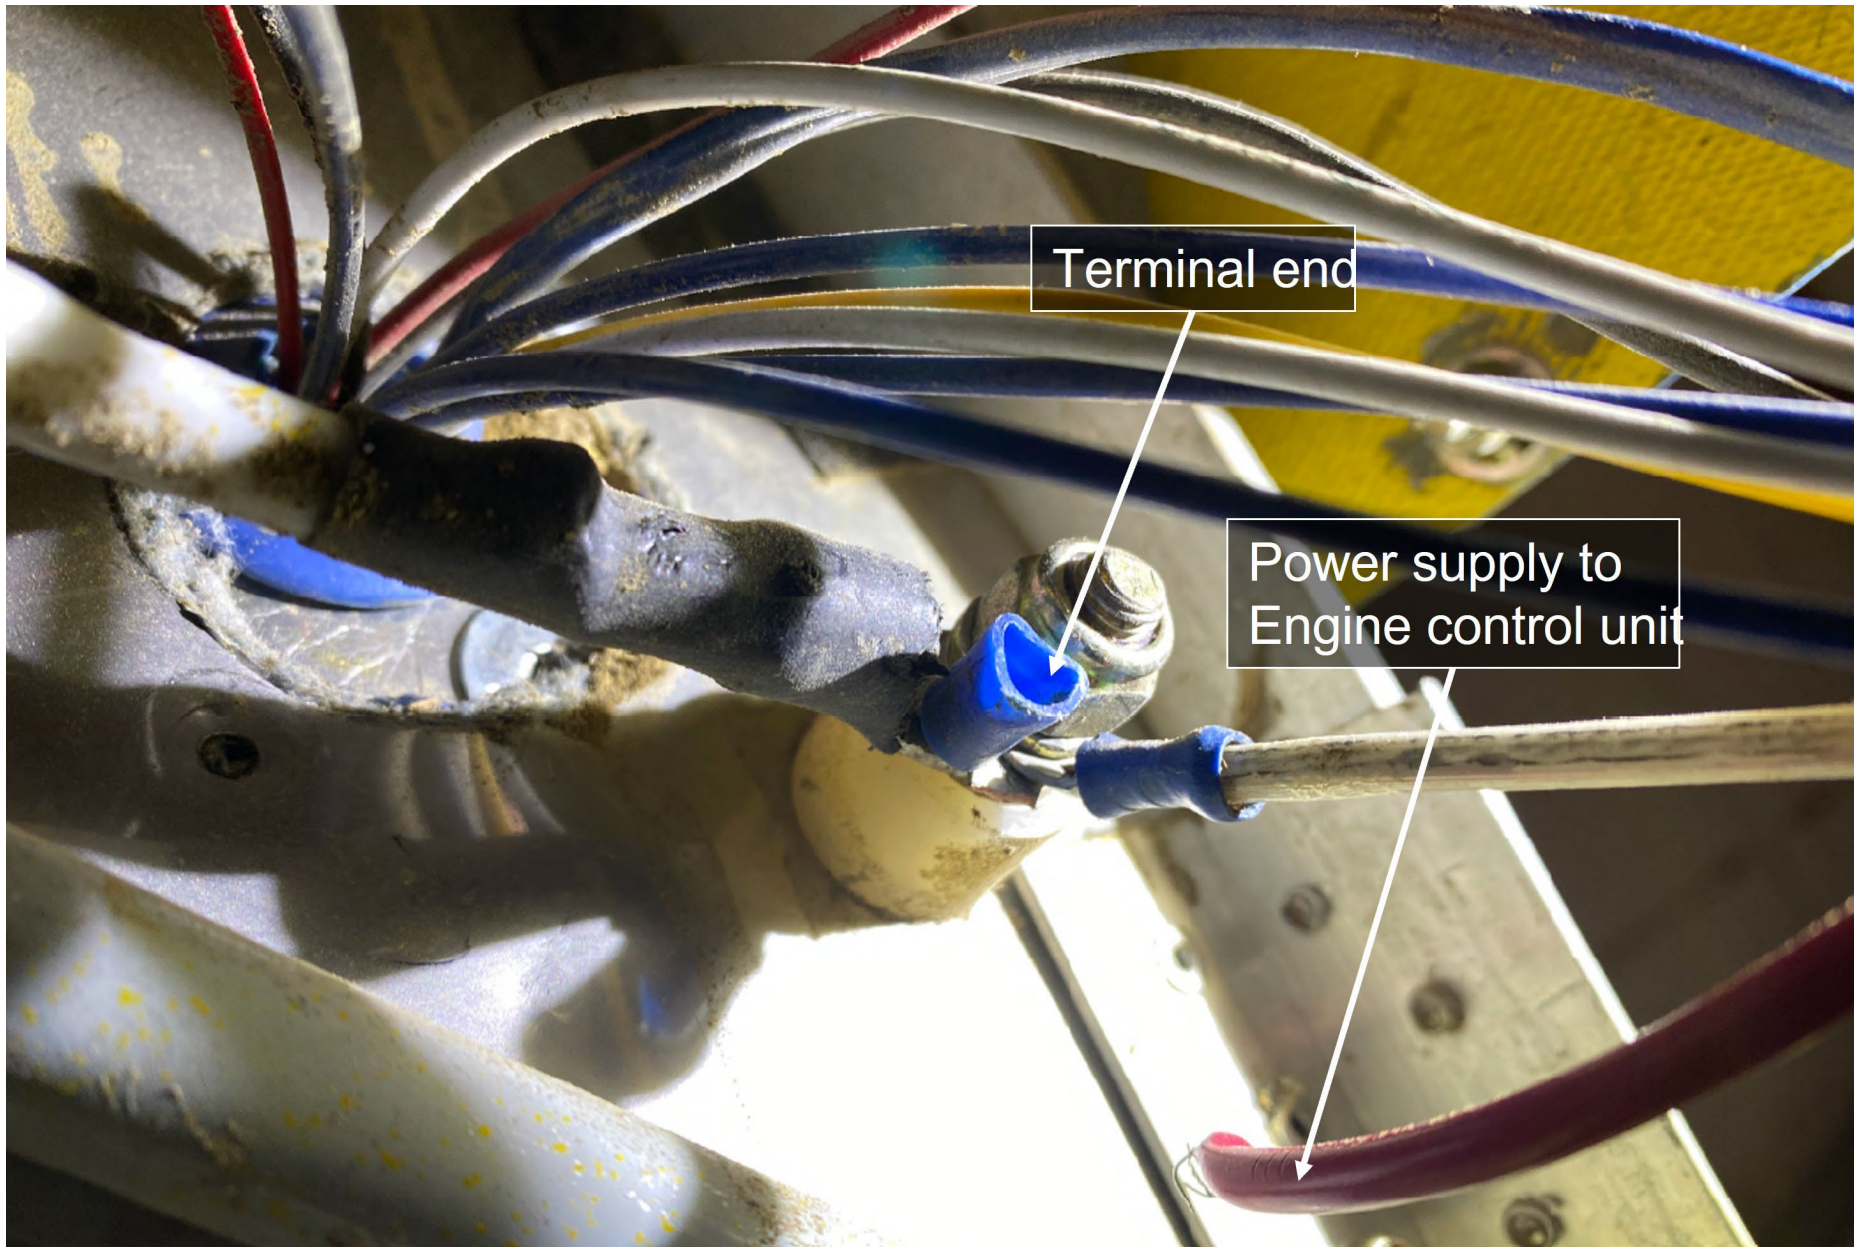
**Photo 3 – Electrical terminal showing the loose electronic control unit power supply wire (photo courtesy of the FAA)**
