## SUMMARY OF FINDINGS

**Date: September 21, 2022**  
**Person Contacted: Huy Bui (A&P)**  
**NTSB Accident Number: WPR22LA323**

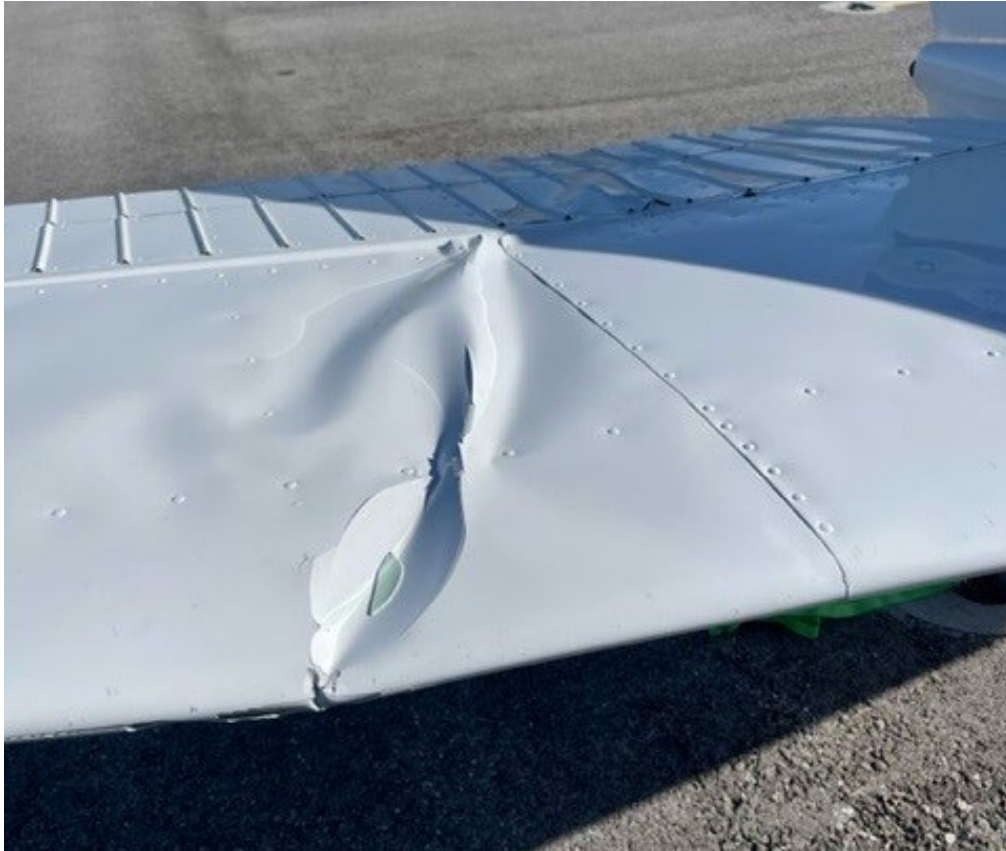
Examination of N3094Q, a Cessna 182K, revealed that bending was observed from the leading edge to the trailing edge of the right horizontal stabilizer about mid span. Bending was also observed on the right elevator from the leading edge to the trailing edge about mid span as seen in figure 1.

*Figure 1: View of right horizontal stabilizer and elevator damage (photo courtesy of A&P)*

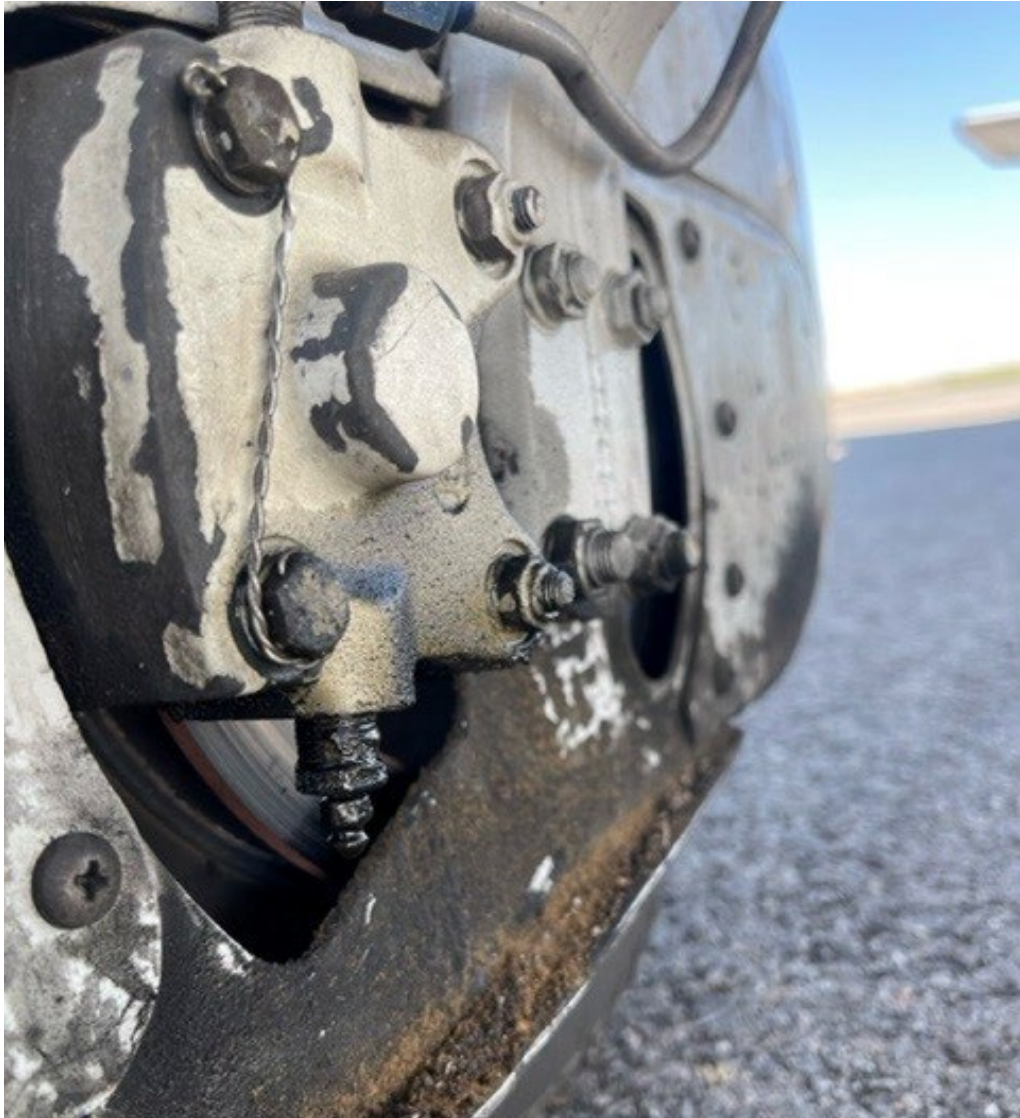
Examination of the airplane's brake system revealed that when the airplane's brakes were activated using the rudder pedals, no resistance or pressure was felt on both sets of rudder pedals. Both brake master cylinders are empty. No breaks or leaks were observed in the brake lines. A liquid consistent with brake fluid was observed leaking from both main landing gear brake caliper O-ring seals as seen in figure 2 & 3. Both brake calipers were disassembled and both O-ring seals were flattened, consistent with excessive use/wear. The flattened O-ring seals prevented the proper seal within the brake calipers, resulting in leaking brake fluid.

*Figure 2: View of right main landing gear brake caliper (photo courtesy of A&P)*

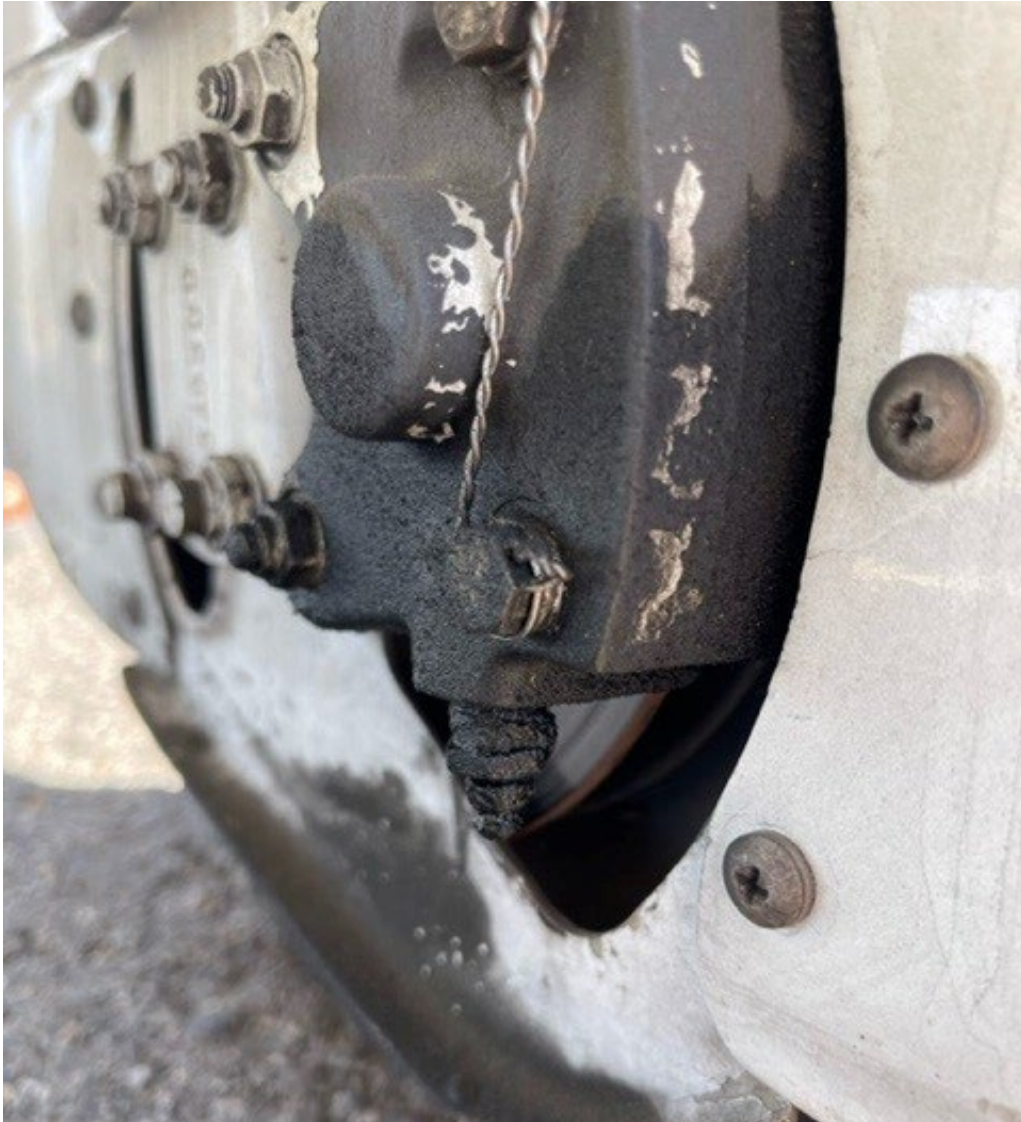
*Figure 3: View of left main landing gear brake caliper (photo courtesy of A&P)*
