## **Engine Investigation Report**

**Rolls-Royce Corporation  
Model M250-C47B  
Engine CAE-848351**

**Operator: Air Methods Corporation  
Location: Mount Baldy, LA County, California**

**Accident date: 4 September 2022  
Wreckage exam date: 22 September 2022  
Engine exam date: 2 November 2022  
Report date: 13 December 2022  
NTSB Case: WPR22LA33**

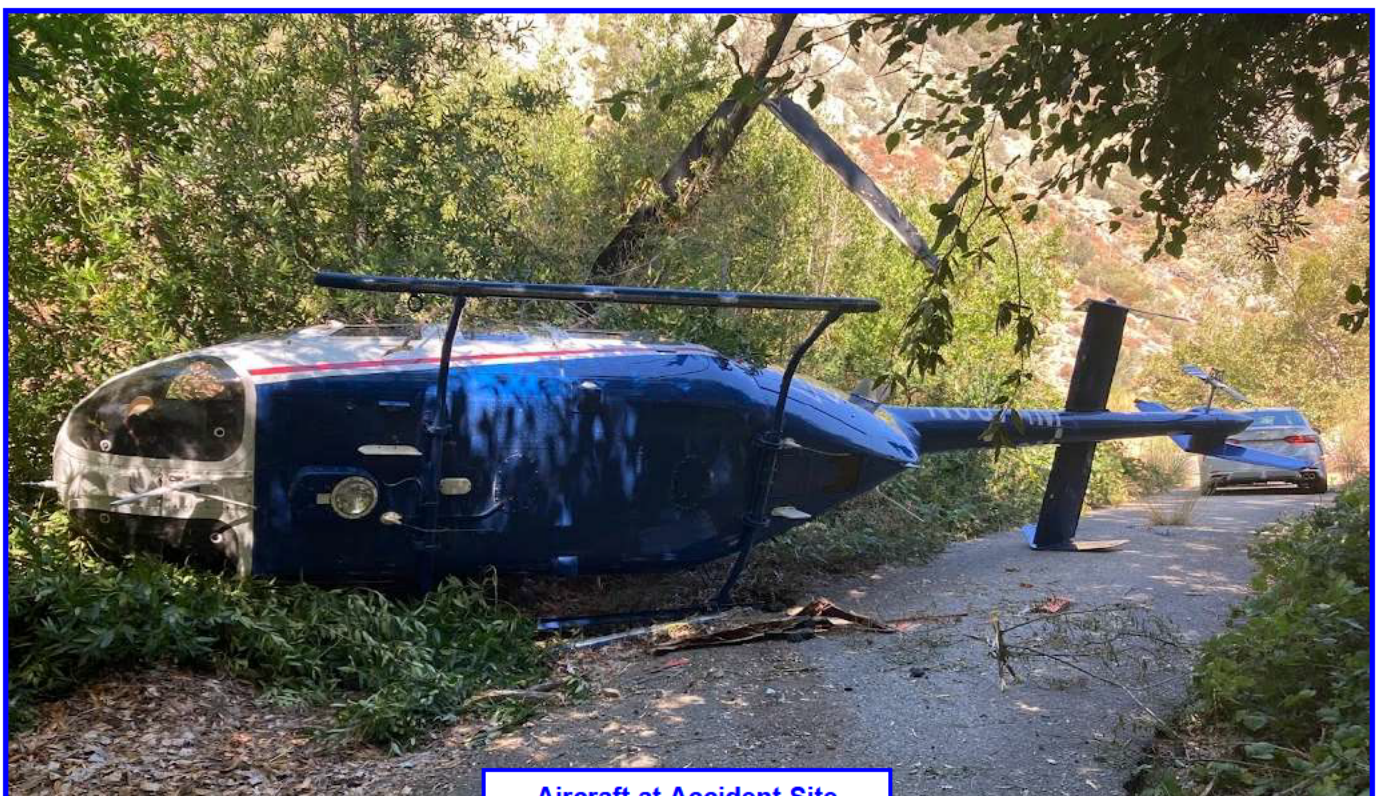
Aircraft at Accident Site

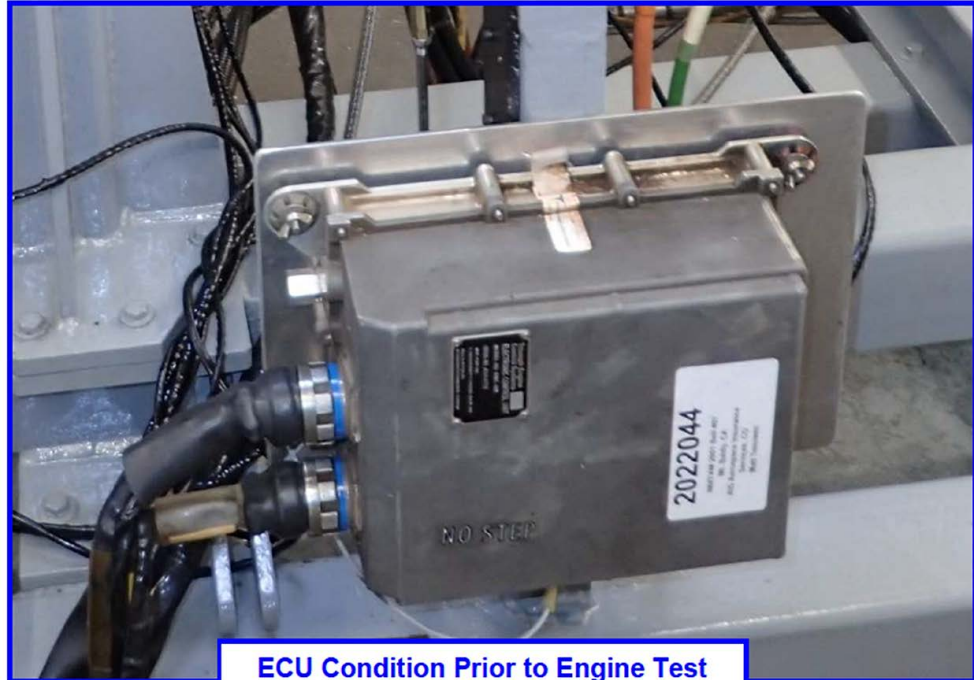
of the ECU, which captured 3 “snapshot” lines of data as well as an additional 51 complete IR lines of data.

The IR data indicated PLA readings between 48-50 degrees. The normal PLA reading when the throttle is in the FLY position is 70 degrees.

The data further showed that the engine was performing normally, in accordance with the lower PLA position, and was responding to throttle inputs as expected during the accident sequence.

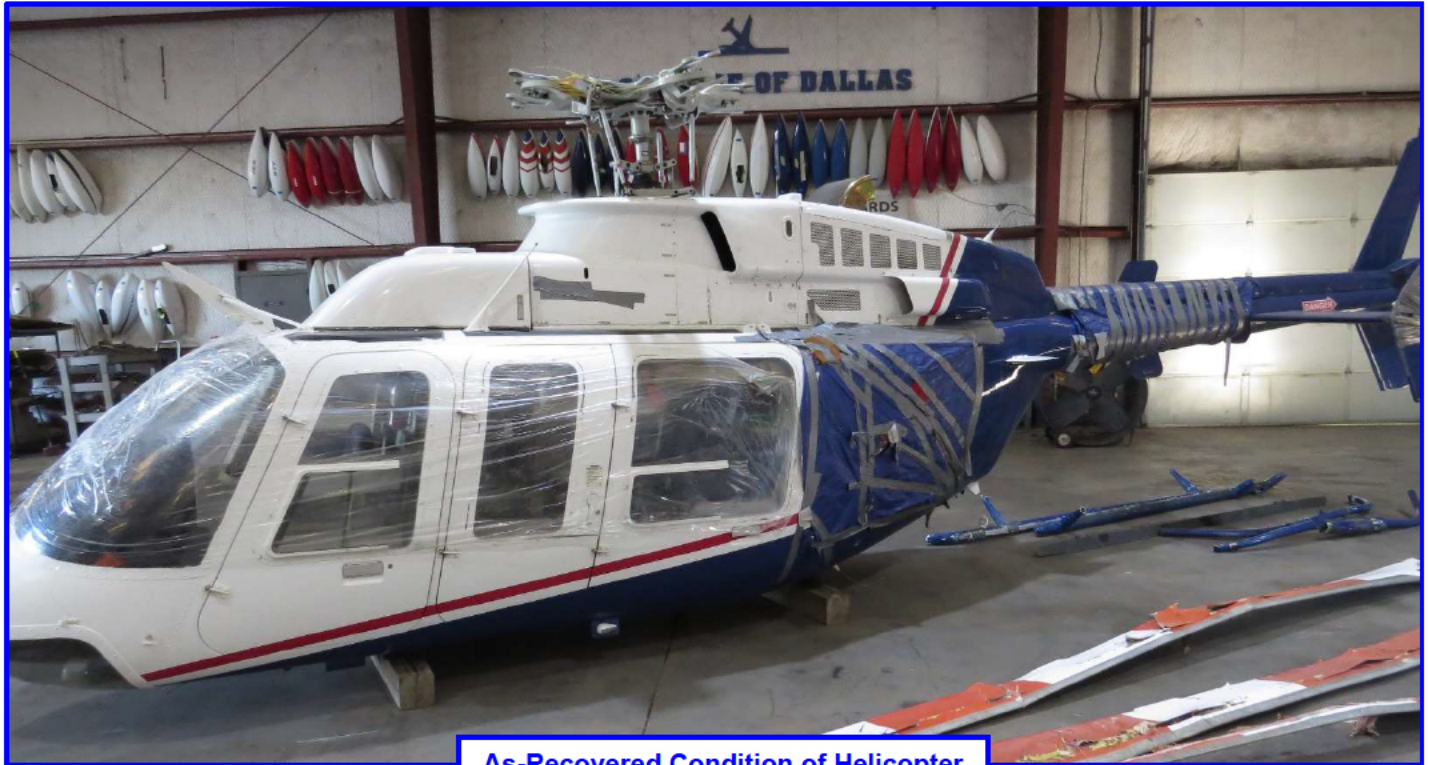
**As-Recovered Condition of Helicopter**

Visual examination of the airframe & engine revealed no evidence of any pre-existing mechanical damage or malfunction. The engine was removed for ease of further examination and testing.

The aircraft sustained damage consistent with vertical impact and rollover. The right-hand skid was fractured from the support struts. The left-hand skid was mechanically severed, and the struts were removed to facilitate wreckage transportation.

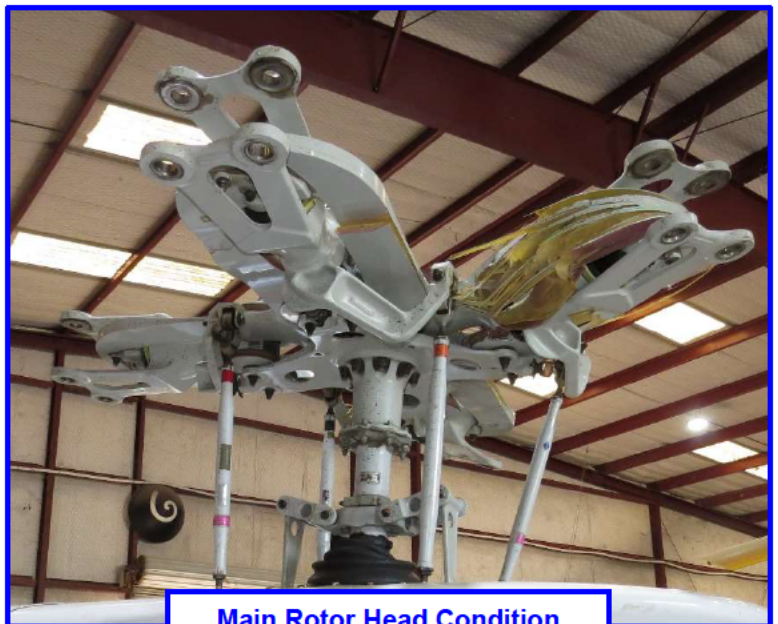
The main rotor showed signs of low rotational inertia as indicated by the vertical fracture damage at the rotor head as well as the spanwise bending/buckling damage to the main rotor blades. All 4 main rotor blades remained securely attached to their respective blade grips but were removed prior to ground transportation.

**Main Rotor Head Condition**

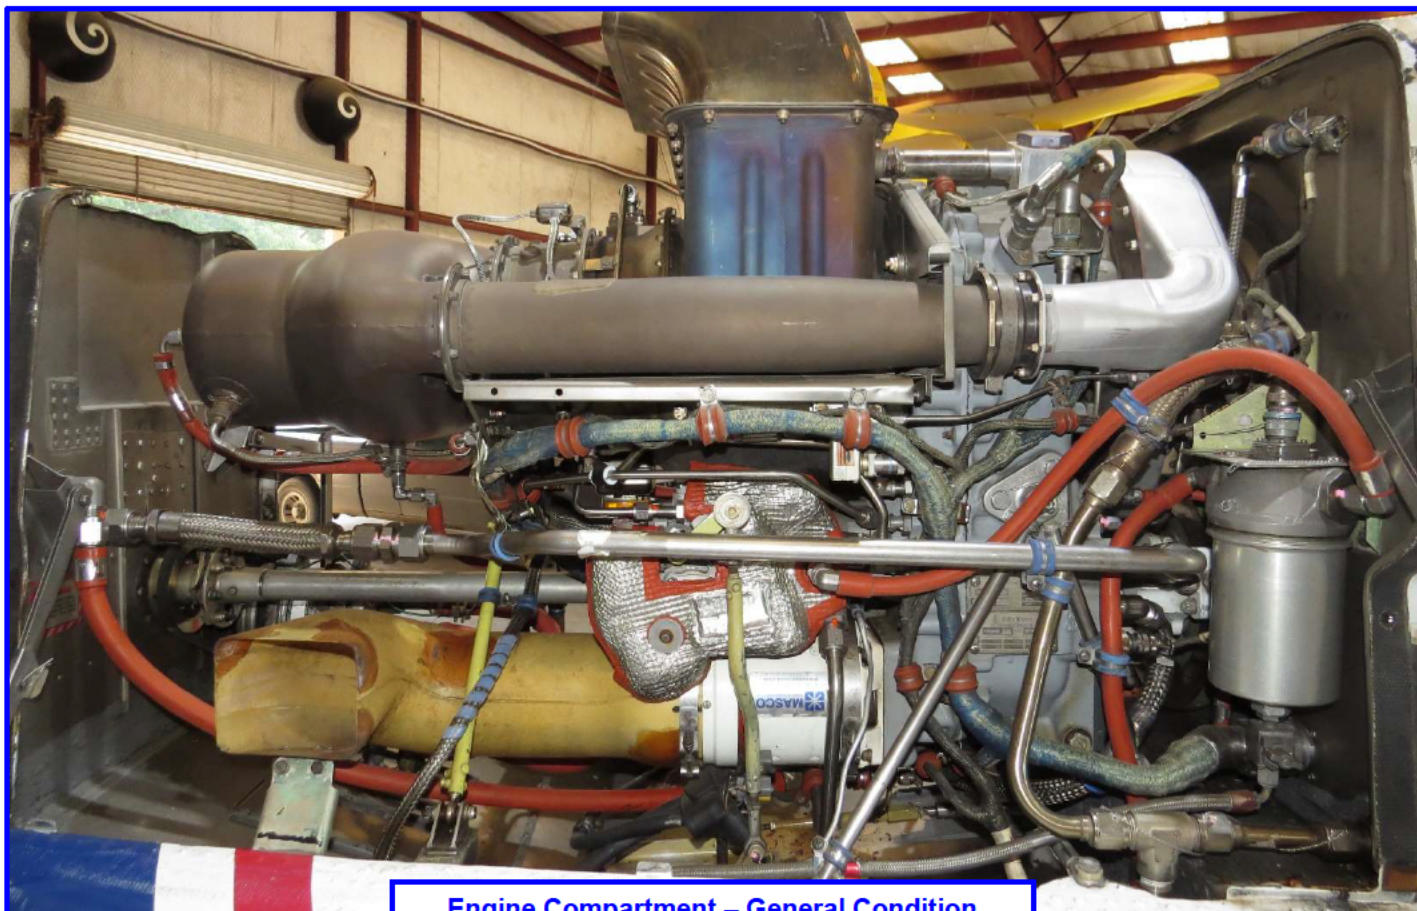
The engine remained securely attached at all 3 mount points as well as their respective connections on the airframe in the engine bay. There was no visual indication of axial or lateral displacement of the engine as a result of the accident sequence.

**Engine Compartment – General Condition**

General visual inspection of the engine's various fuel, oil, air, and electrical connections including B-nuts were found hand tight and painted with torque stripe. The engine did not reveal any obvious signs of damage from impact forces, internal engine failure, fluid leakage, or evidence of fire.

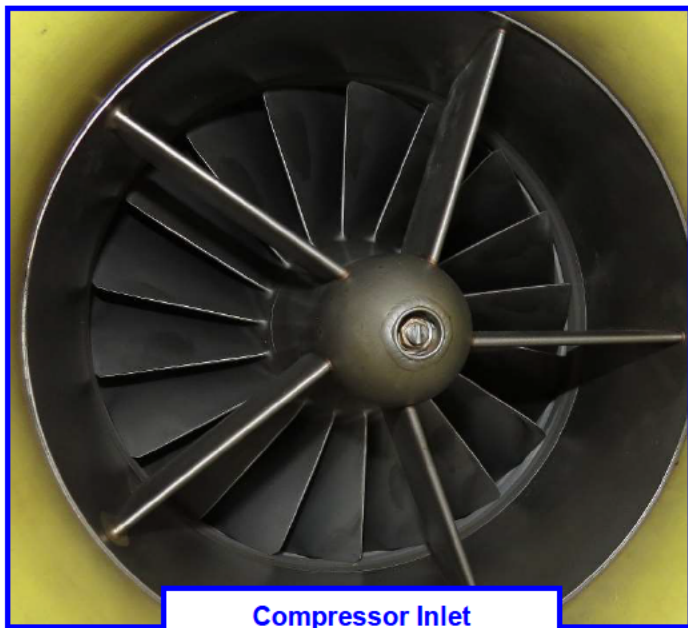
The aircraft was equipped with an inlet barrier filter. The compressor front support, guide vanes (struts), and impeller vanes were void of any noticeable impact damage or FOD.

**Compressor Inlet**

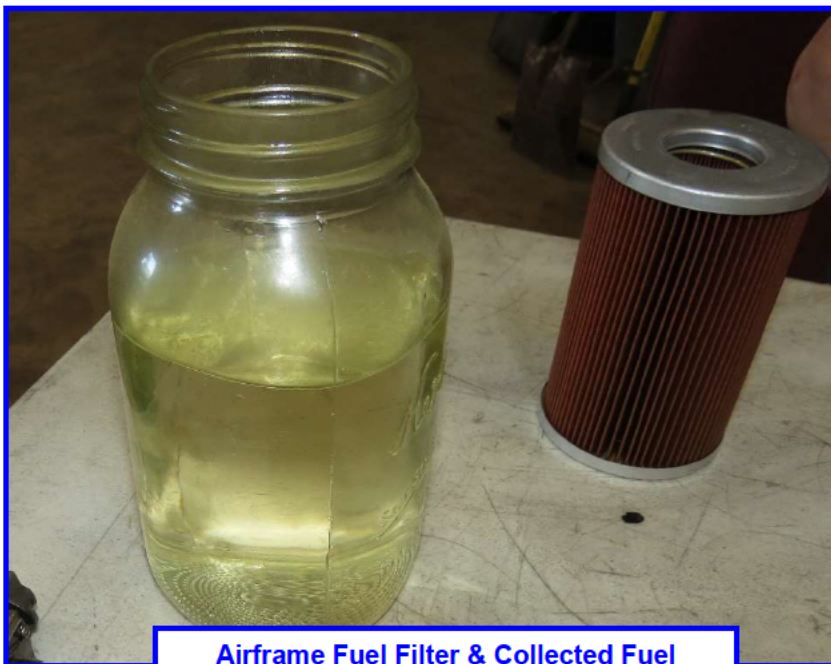
The airframe fuel filter canister was removed for examination & to facilitate engine removal. The bypass indicator on the top of the filter body housing was not extended. The canister was full of clean, clear fuel. Fuel was drained from the canister revealing no evidence of residual debris in the bottom. The internal fuel filter was clean and void of any captured debris within the pleats.

**Airframe Fuel Filter & Collected Fuel**

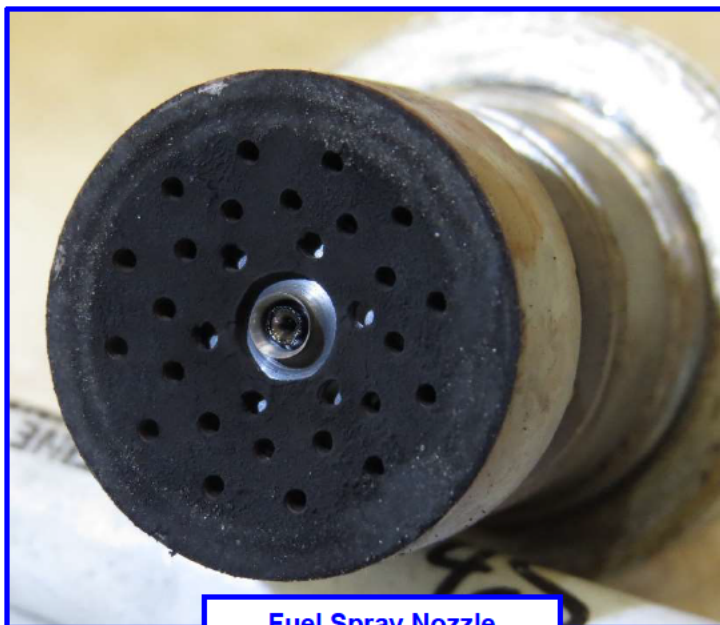
The fuel spray nozzle was removed and inspected. There was no evidence of obstruction in the fuel spray nozzle inlet. The fuel nozzle contained a uniform carbon layer across the air shroud. The nozzle was otherwise visually normal in appearance and not disassembled further.

**Fuel Spray Nozzle**

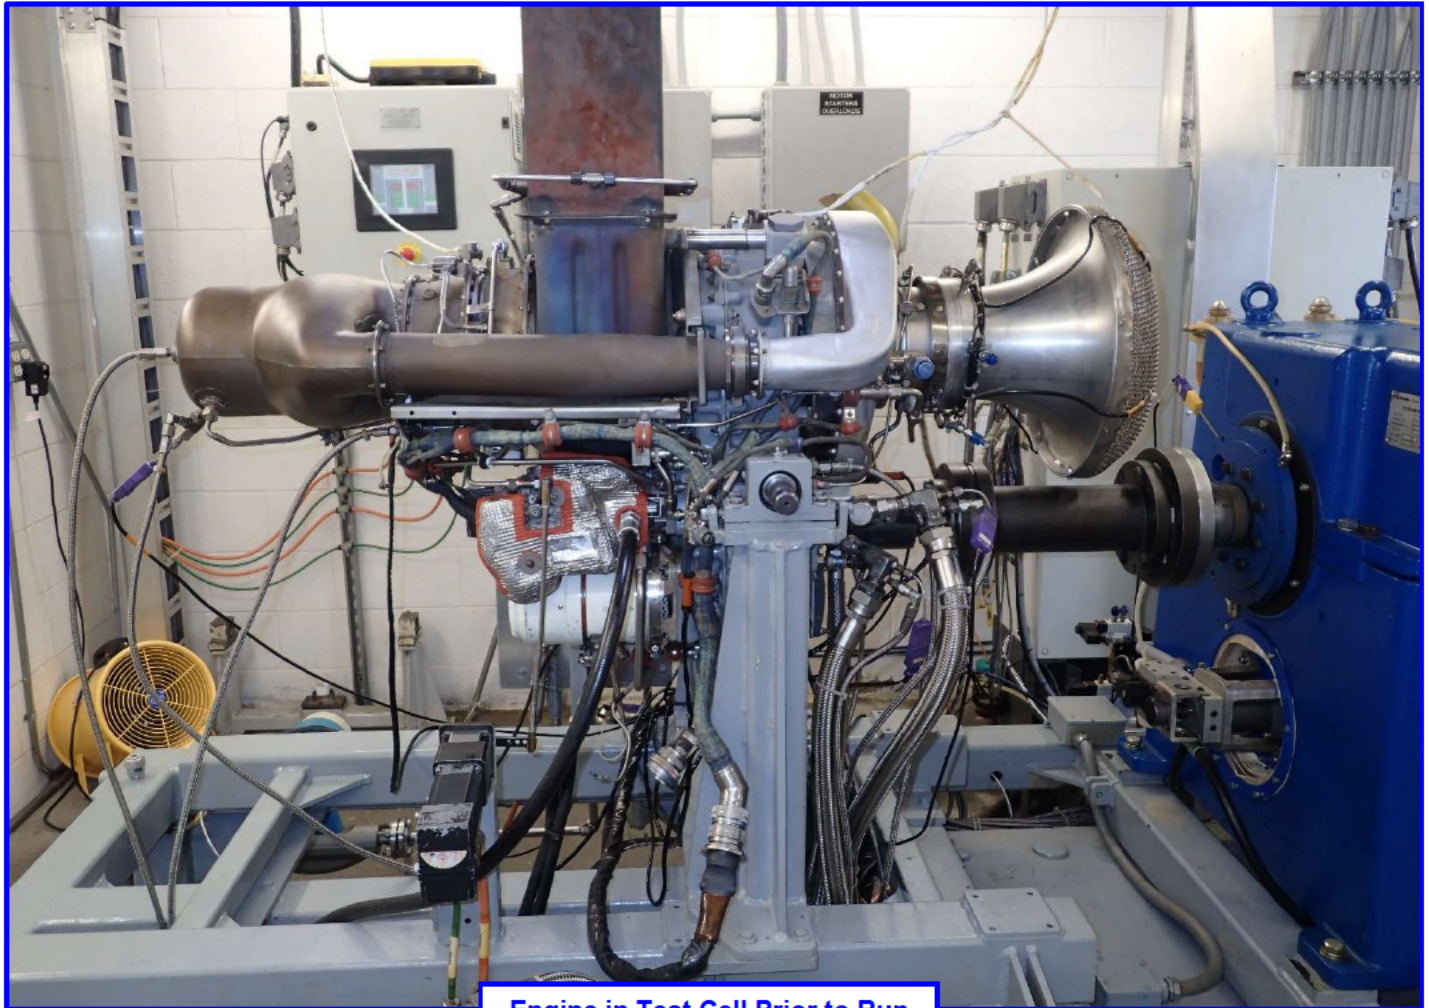
**Engine in Test Cell Prior to Run**

The engine successfully started, ran, and shut down. The engine successfully completed ground idle, flight-idle, max-continuous-power and take-off power runs. When corrected for standard atmospheric conditions, the engine yielded performance +6.9% above new-production standards at "low cruise" (450 horsepower), +5.0% above new-production standards at "high cruise" (540 horsepower), +5.0% above new-production standards at max continuous (600 horsepower), and +4.6% above new-production standards at maximum (Take-Off) power (650 horsepower).

The engine then completed "wave-off" max-power transients where the power was reduced to flight idle and then rapidly increased to take-off power. The engine responded normally and responded with maximum power without surging or hesitation. The testing was terminated following successful completion of the wave-off test and power calibration activities.
