WPR22LA333

## INVESTIGATION PHOTOGRAPHS

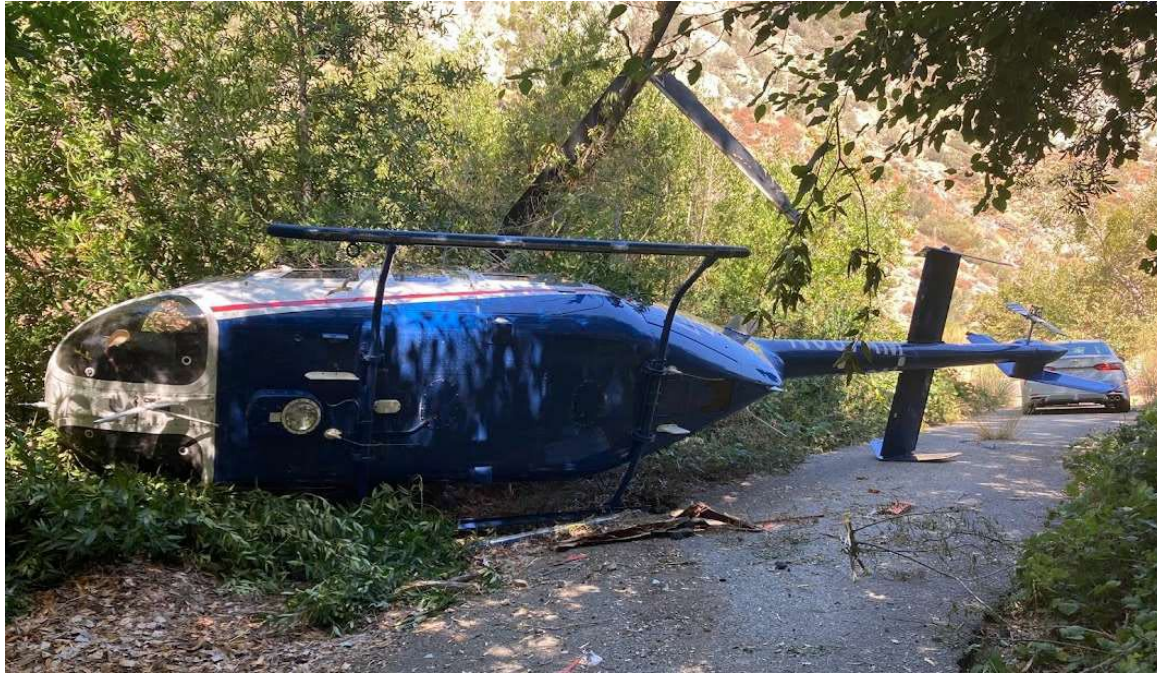
**Photograph 1 - Accident Site (Courtesy of Unknown Photographer)**

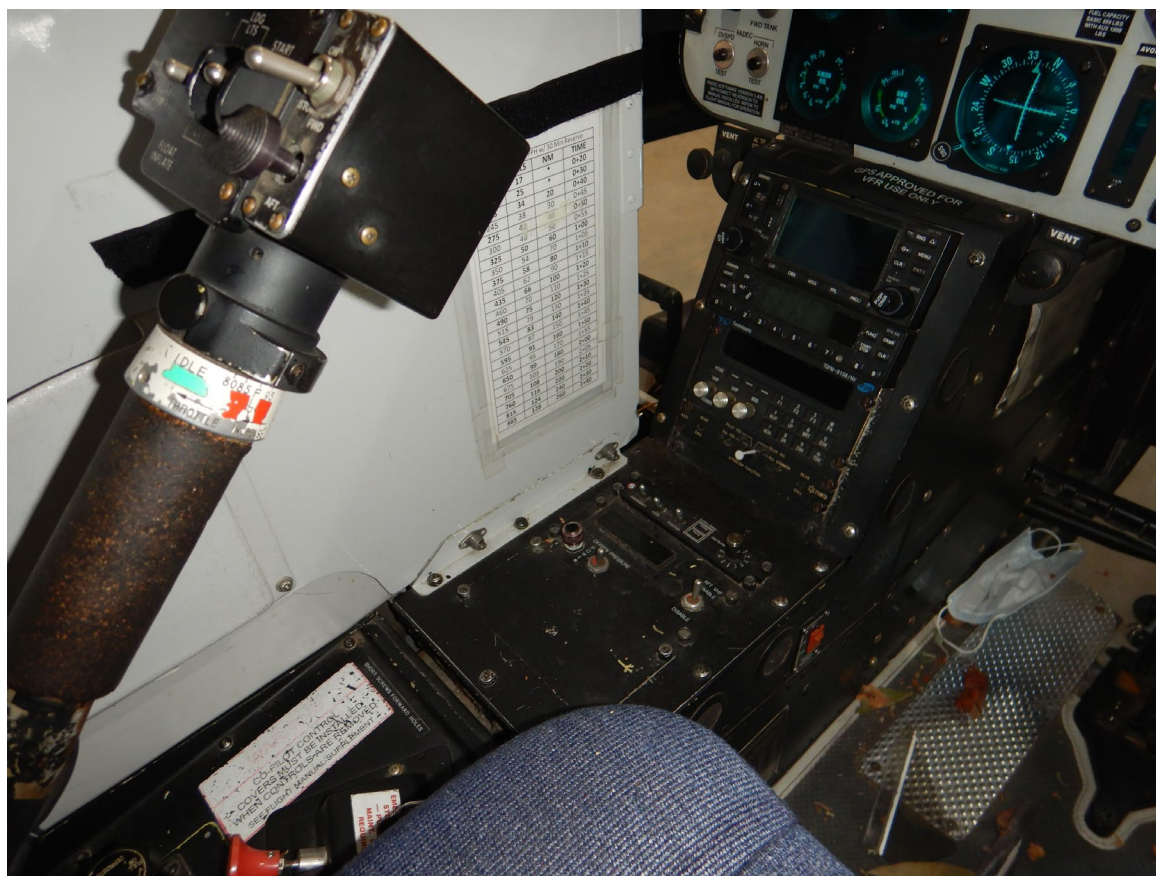
**Photograph 2 - Collective Grip Twist Throttle Installed (Courtesy of NTSB)**

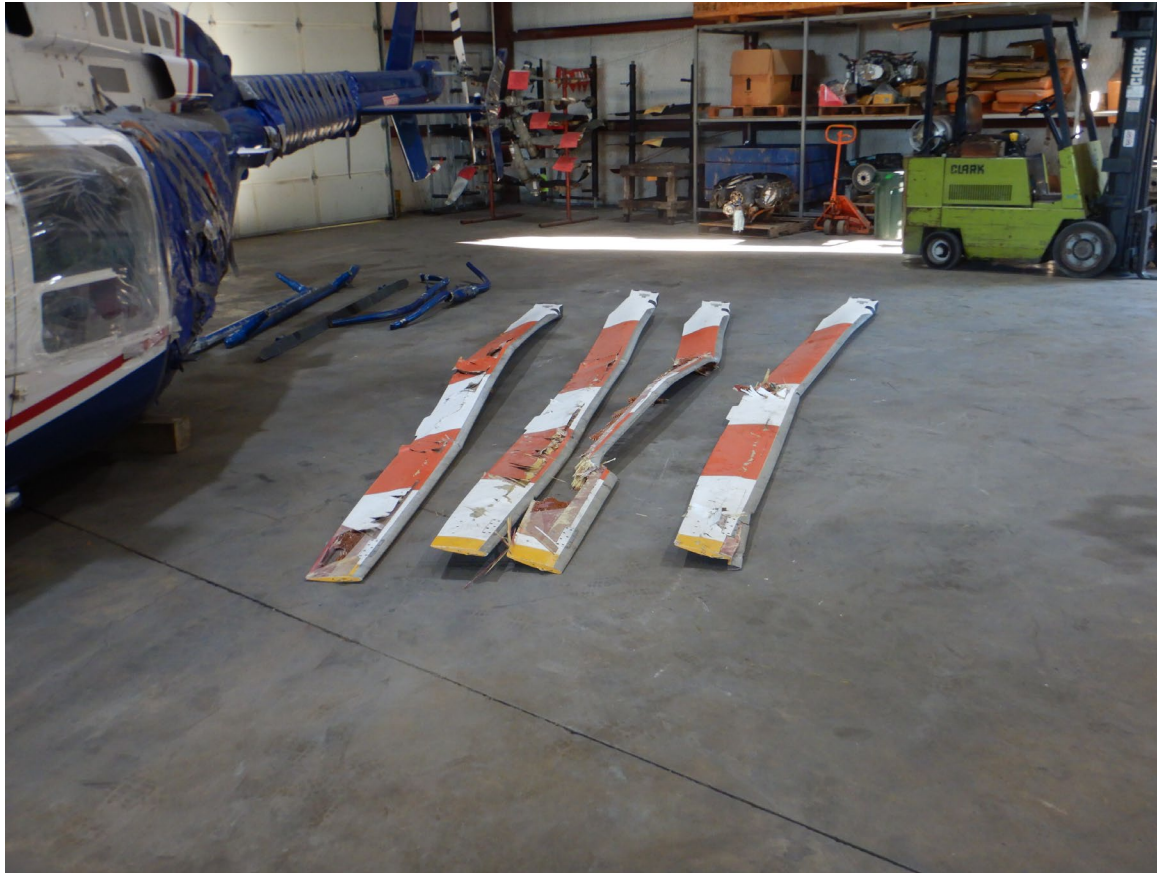
**Photograph 3 - Main Rotor Blades (Courtesy of NTSB)**

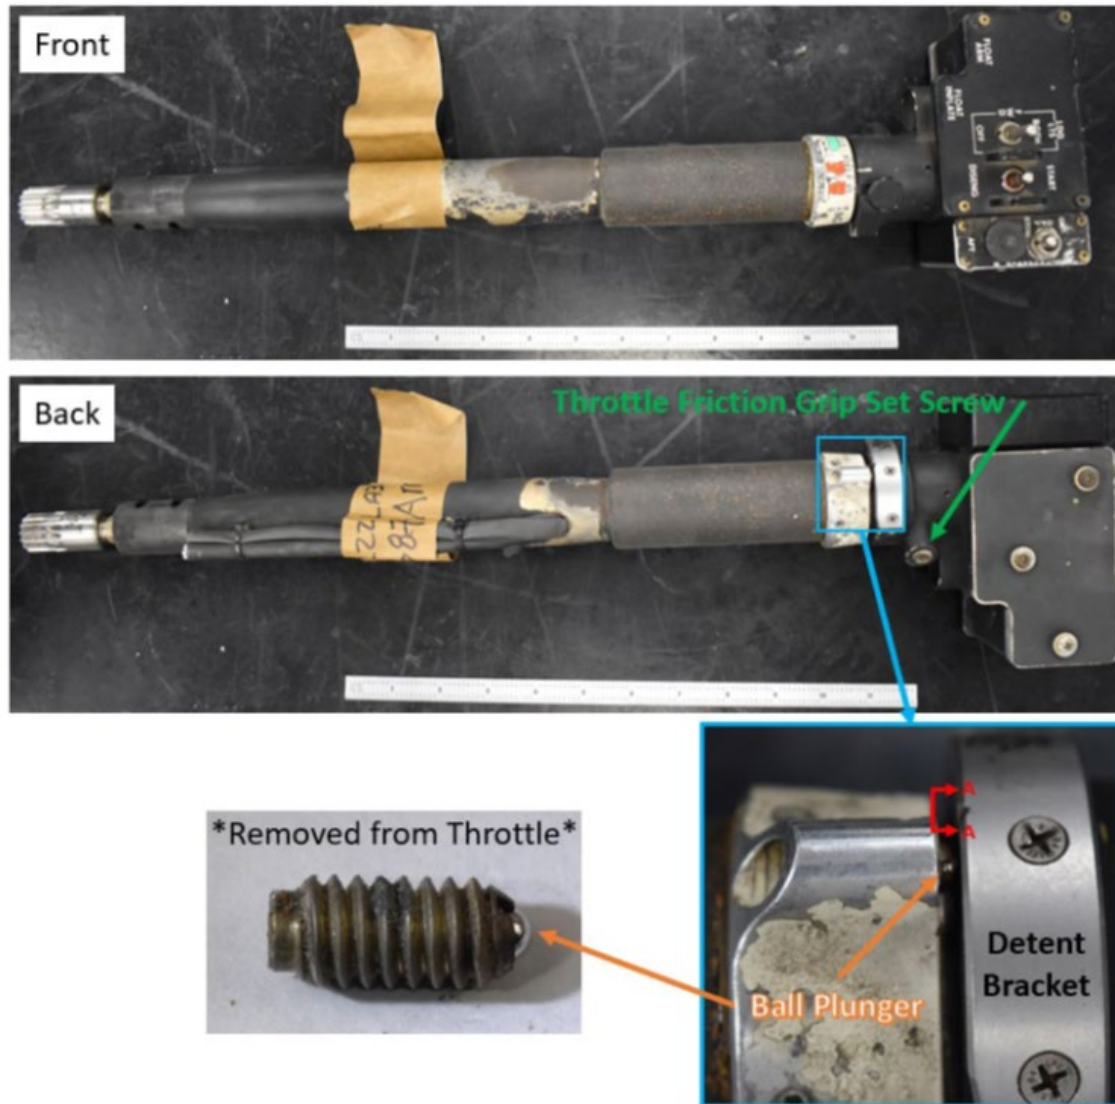
**Photograph 4 - Collective Assembly and Throttle Components (Courtesy of Bell Helicopters)**

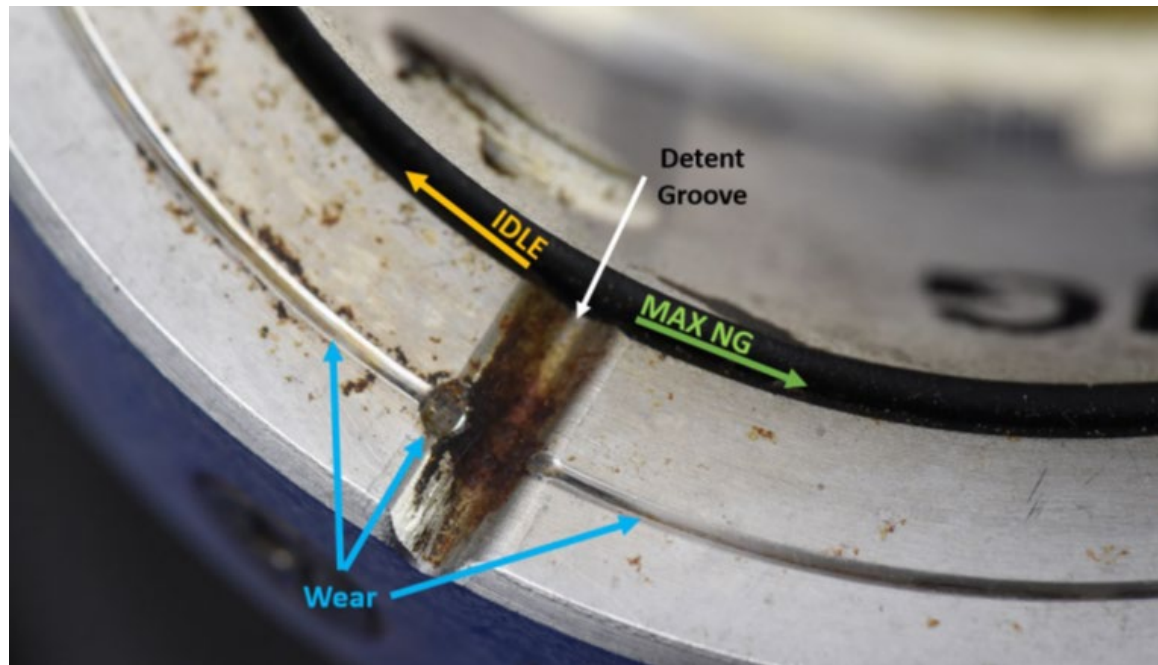
**Photograph 5 - Throttle Detent Wear (Courtesy of Bell Helicopters)**
