# National Transportation Safety Board

WPR22LA334

## **ENGINE EXAMINATION PARTICIPANTS**

Location: Medicine Bow, Montana  
Date: September 5, 2022  
Time: 1030 Mountain daylight time  
Airplane: N444MR Long EZ

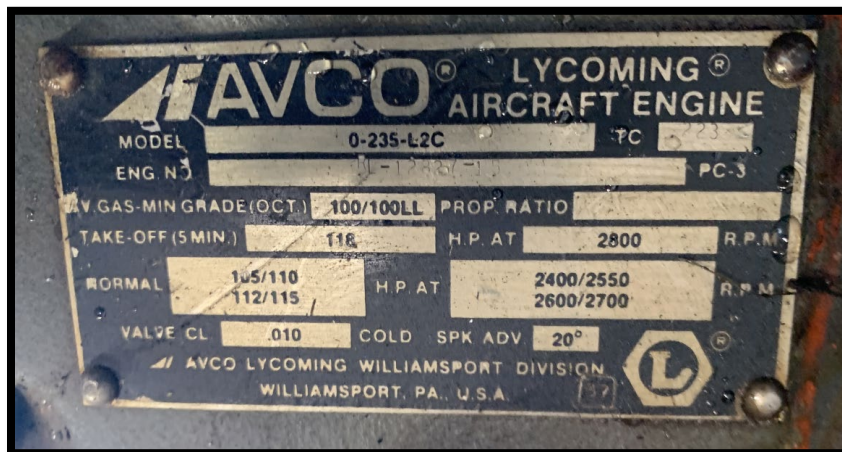
**Figure 2. View of engine data plate**

The installed engine, a Lycoming O-235-L2C, serial no. RL-12827-15, was remanufactured and zero timed by AVCO Lycoming Factory Service Department Engine on November 24, 1981 (figure 2). According to the pilot, the engine had not been overhauled, with only cylinder no. 1 being replaced due to low compression. Engine logbook records revealed that no. 1 cylinder was installed on 6/27/2017.

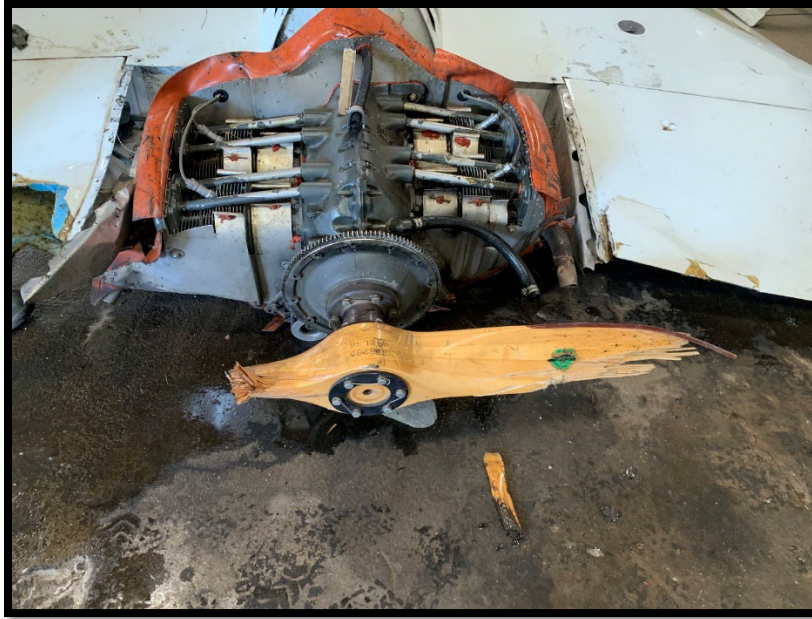
**Figure 3. View of engine and propeller**

The engine remained attached to all 4 engine mounts (figure 3). Continuity of the throttle, mixture, propeller control cables were confirmed from the engine back to the cockpit area.

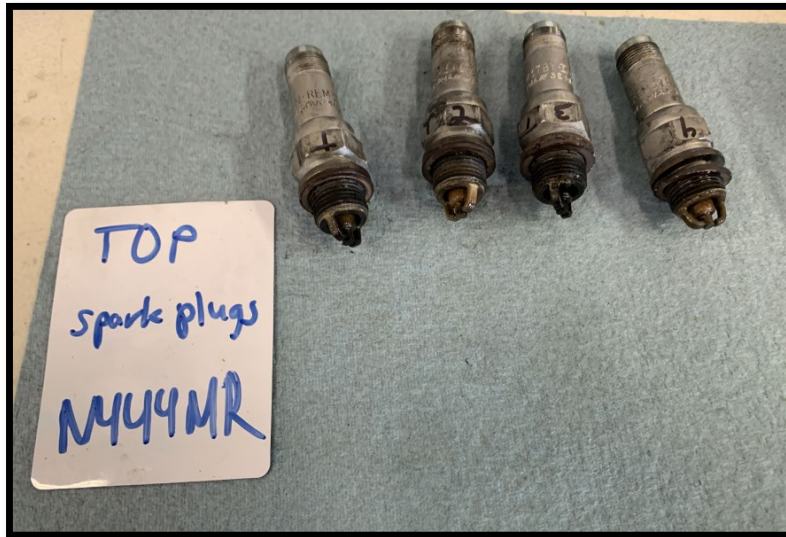
All top spark plugs were removed (figure 4) and revealed that all spark plugs had each of its ground and central electrodes intact; all electrodes had oil carbon residue.

**Figure 4. View of all top spark plugs from accident engine**

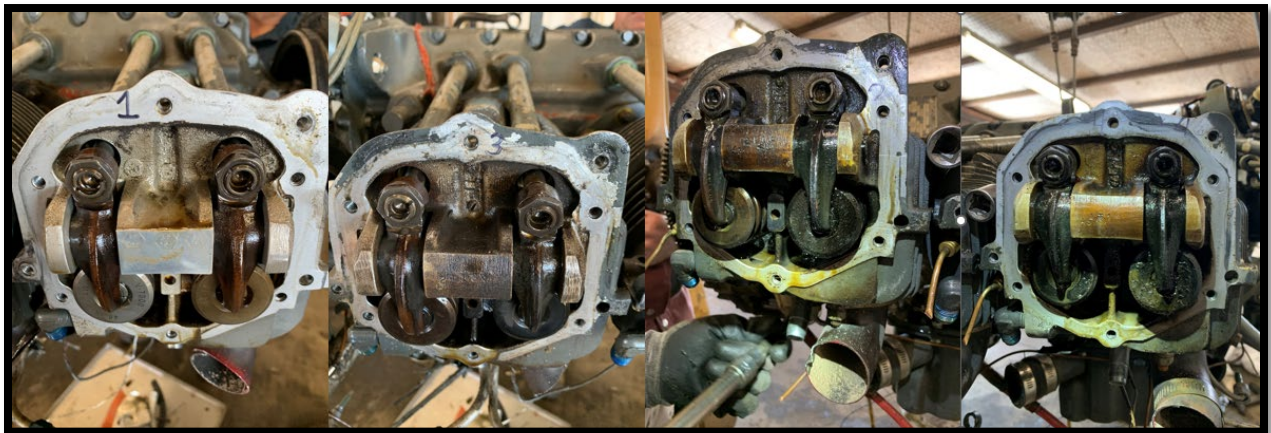
After all top spark plugs were removed, the cylinder wall and pistons were visually examined and revealed that the no. 4 cylinder had mechanical gouges to the piston and cylinder. All rocker box covers were removed and revealed that cylinders no. 2, 3, and 4 had severe oil and carbon residue on its valve springs, consistent with exhaust blow-by (figure 5). Each cylinder was removed for further examination.

**Figure 5. View of valve rockers and springs after rocker box cover removal (4 total views)**

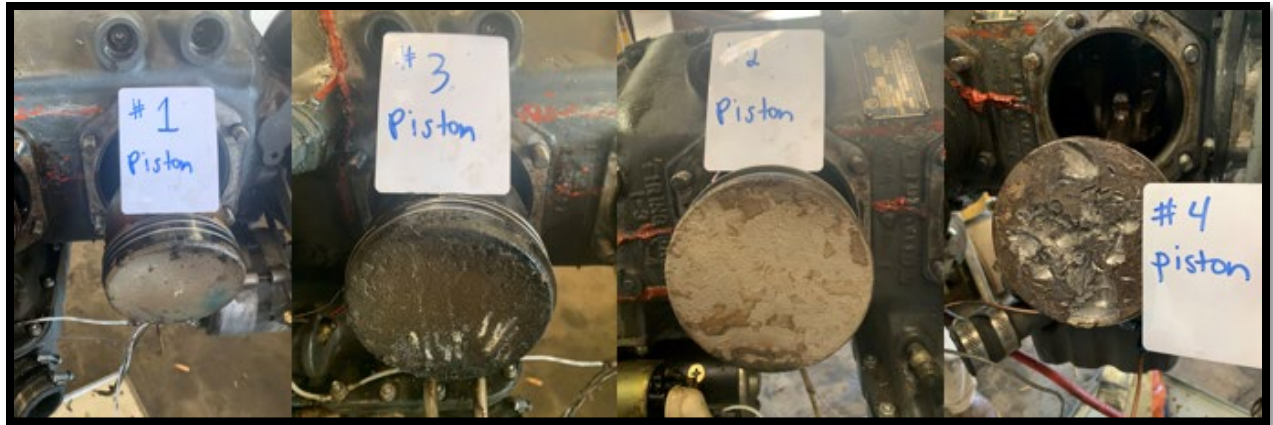
Removal of piston no. 1 and 2 revealed no mechanical anomalies; pistons no. 3 revealed no mechanical anomalies but had an excess of oily carbon buildup; and piston no. 4 revealed mechanical damage on its face (figure 6).

**Figure 6. View of piston faces with mechanical damage to piston no. 4 (4 total view)**

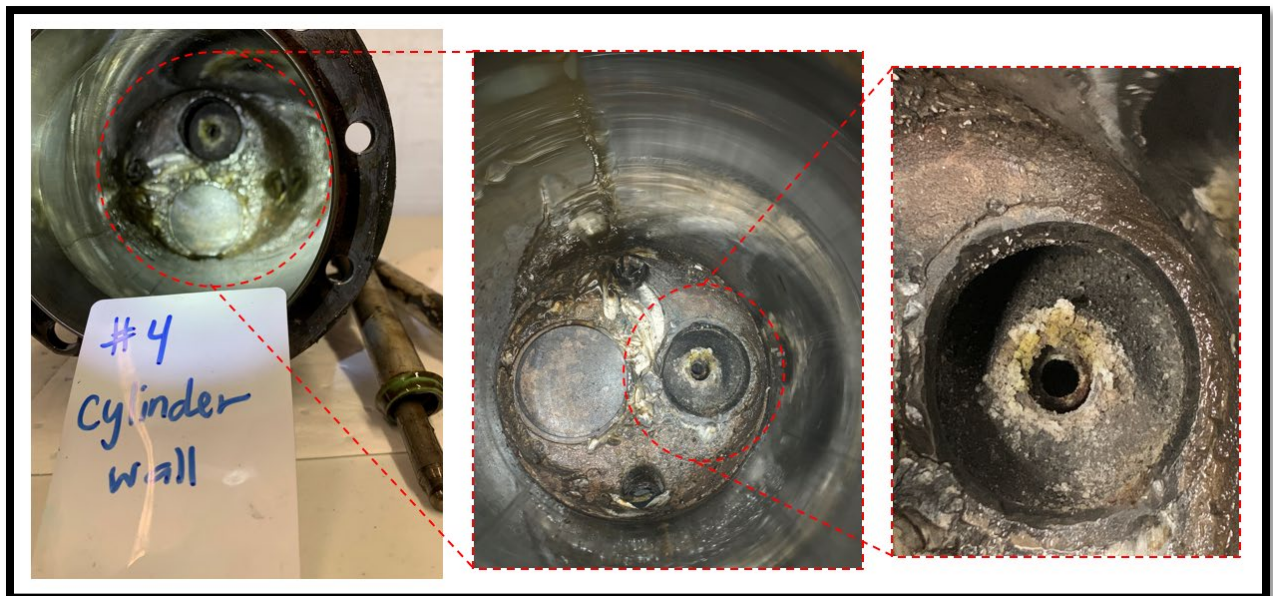
Examination of cylinder no. 4 revealed that the no. 4 valve face. A section of the exhaust valve stem and the valve head was separated and not found within the engine; the intake valve and head remained intact (figure 7). Gouging and scoring was found on the cylinder wall adjacent the valve seats consistent with mechanical damage from the broken valve face and stem.

**Figure 7. Left photo: View of no. 4 cylinder wall; center photo: close-up view of intake and exhaust valve heads; right photo: close-up view of damage to exhaust valve stem and seat**

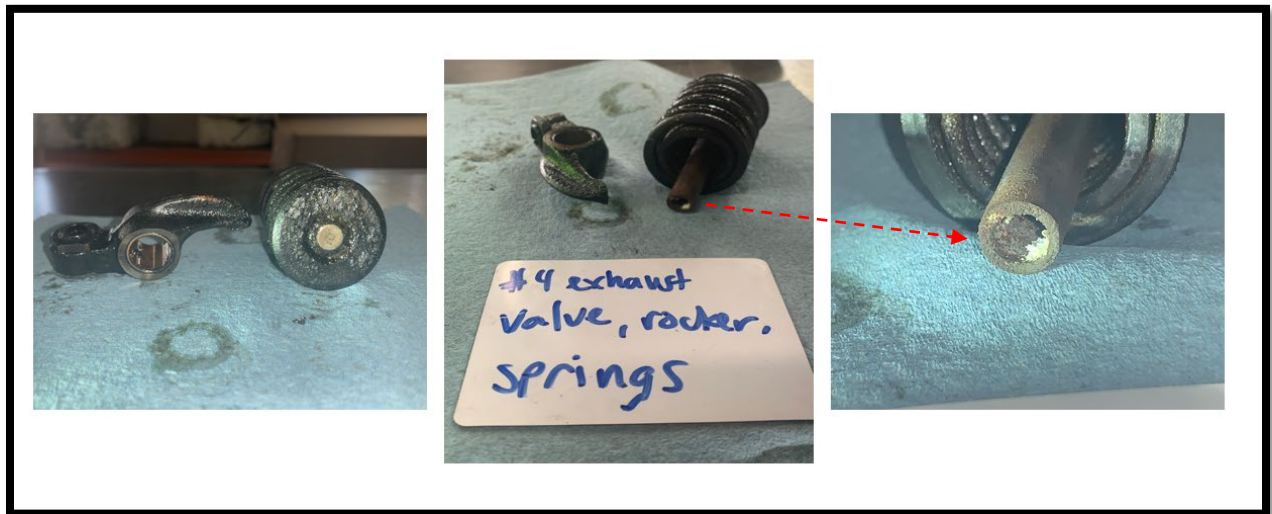
The exhaust valve stem had excessive play within the valve guide. It was manually forced out of the valve guide and revealed excessive oily carbon buildup around and within the exhaust valve guide and seat (figure 8). According to the manufacturer, the exhaust valve should measure about 4.3 inches in length contrasting the remaining exhaust valve stem which measured about 3.5 inches (figure 9).

**Figure 8. Left and center photos: view of fore and aft section of no. 4 exhaust valve spring, stem, and rocker; right photo: closeup view of damaged no.4 exhaust valve stem**

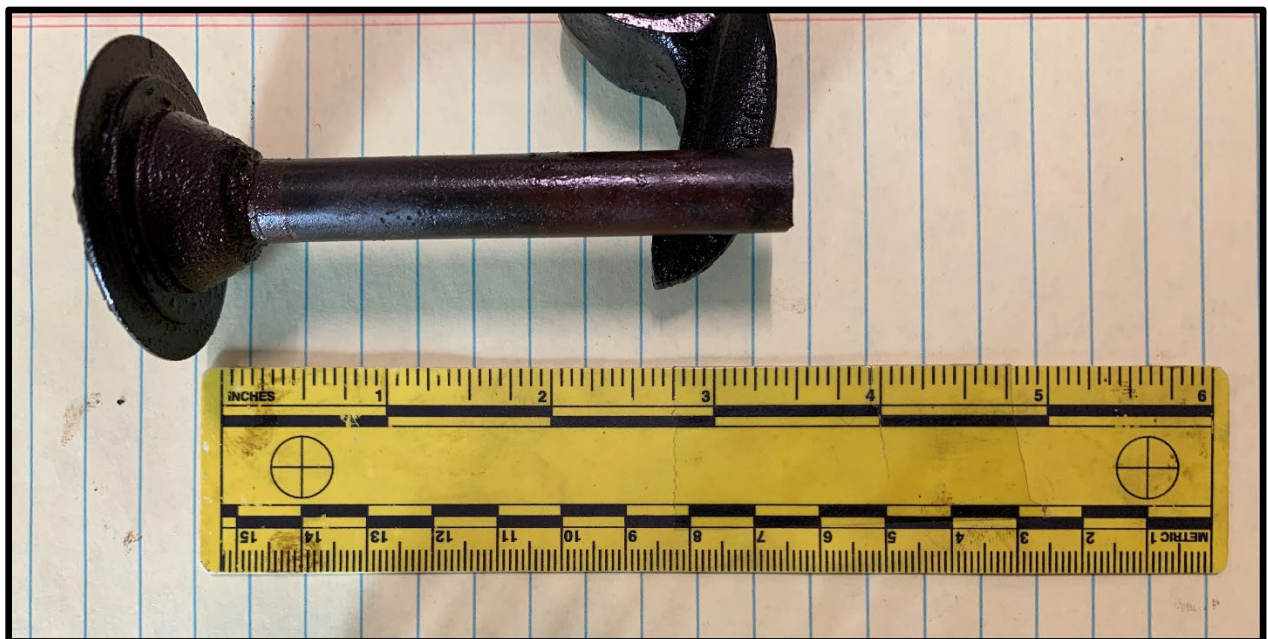
**Figure 9. View of No. 4 cylinder exhaust valve measurement**
