# National Transportation Safety Board

WPR22LA334

## **MATERIALS LABORATORY**

Factual Report 23-106

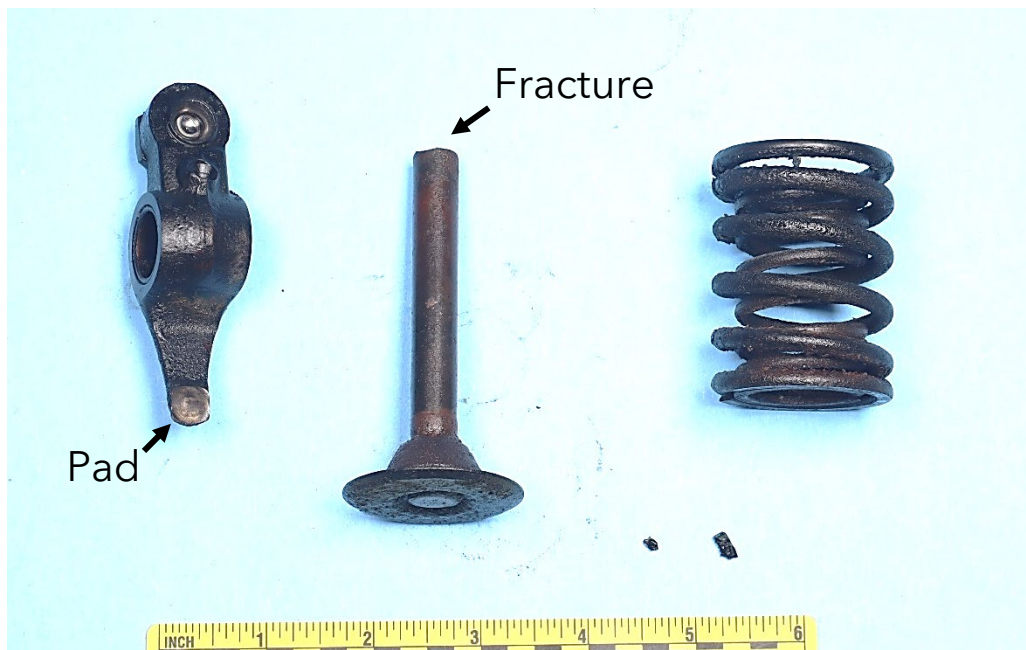
Figure 1 shows an overall view of the as-received exhaust valve that fractured at the stem, rocker arm, two particles that were not labeled, and inner and outer valve springs. The fractured stem segment at the rocker arm end was not submitted. The as-received parts were covered with oil and at the NTSB Materials Laboratory were ultrasonic cleaned with a solution of Alconox, a commercial detergent. The rocker arm contained evidence of contact wear at the pad and the valve springs showed no evidence of mechanical damage or a crack.

**Figure 1.** As-received rocker arm, exhaust valve that fractured at the stem, two particles that were not labeled, inner and outer valve springs (left to right).

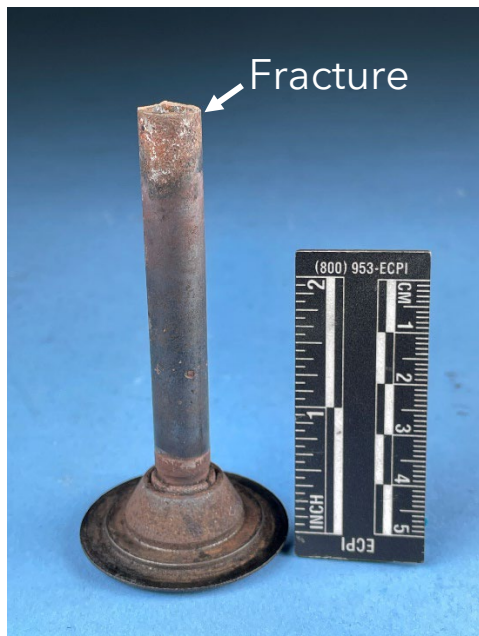
Bench binocular microscope examination of the exhaust valve revealed the outer surface of the stem in the area that extended between the fracture and an area located approximately 0.3 inch from the fracture contained corrosion damage (see figure 2). The corrosion extended round the circumference of the stem. Detailed examination of the fracture face revealed evidence of severe oxidation damage that obliterated the fine fracture features. However, the fracture face in several isolated areas showed evidence of fatigue striations that emanated from severe corrosion pits at the outer surface of the stem in the area indicated by a bracket "O" in figures 3 through 5. The arrows in figures 3 through 5 indicate the general direction of fracture propagation. The terminus of the fatigue crack was not determined because of the severe oxidation damage on the fracture face.

**Figure 2.** Side view of the fractured valve stem, after cleaning.

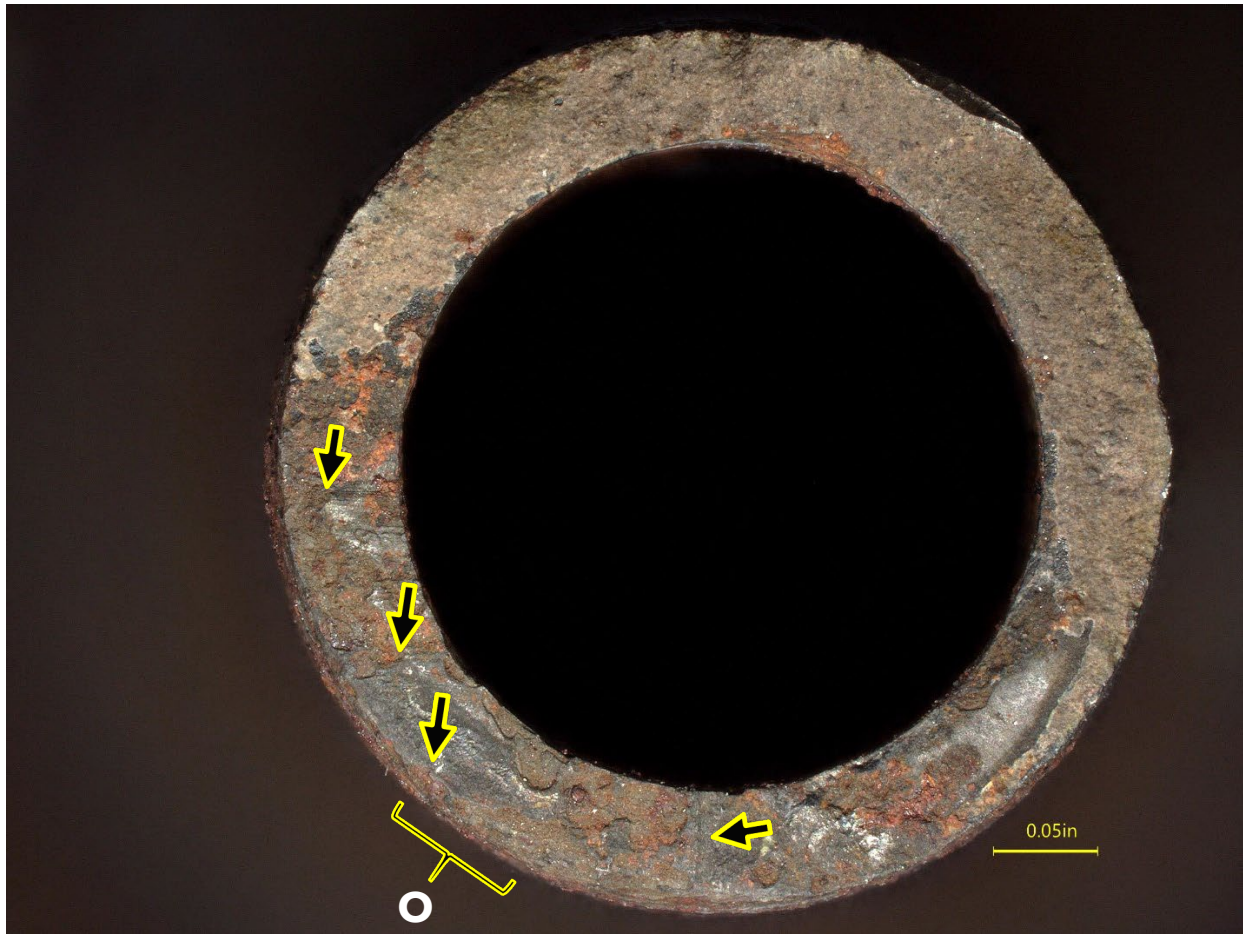
**Figure 3.** Optical image of the fracture face from the fractured valve stem, showing the origin of the fatigue crack, indicated by bracket "O", after cleaning.

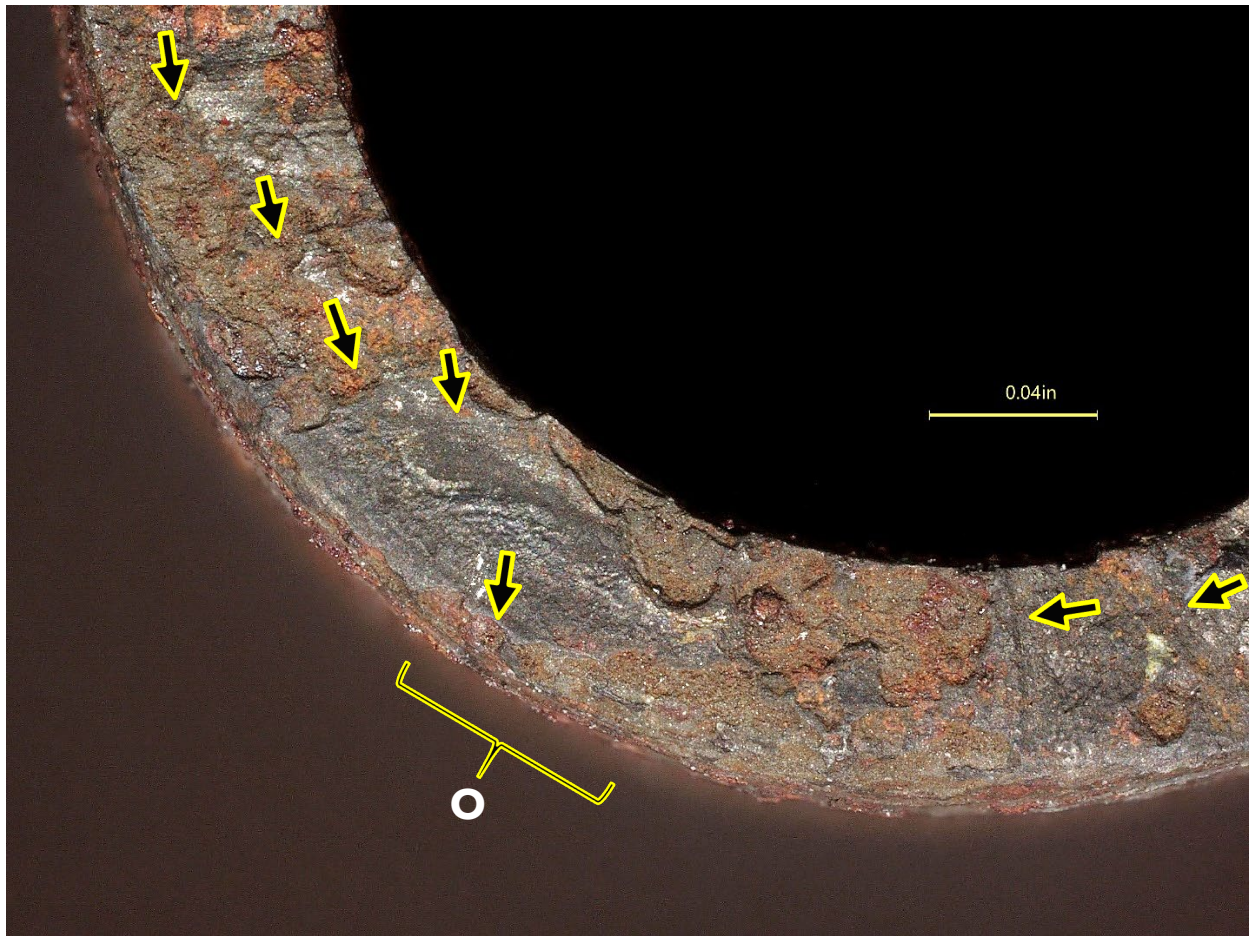
**Figure 4.** Higher magnification view of the fracture face from the fractured valve stem showing the origin of the fatigue crack, indicated by bracket "O", after cleaning.

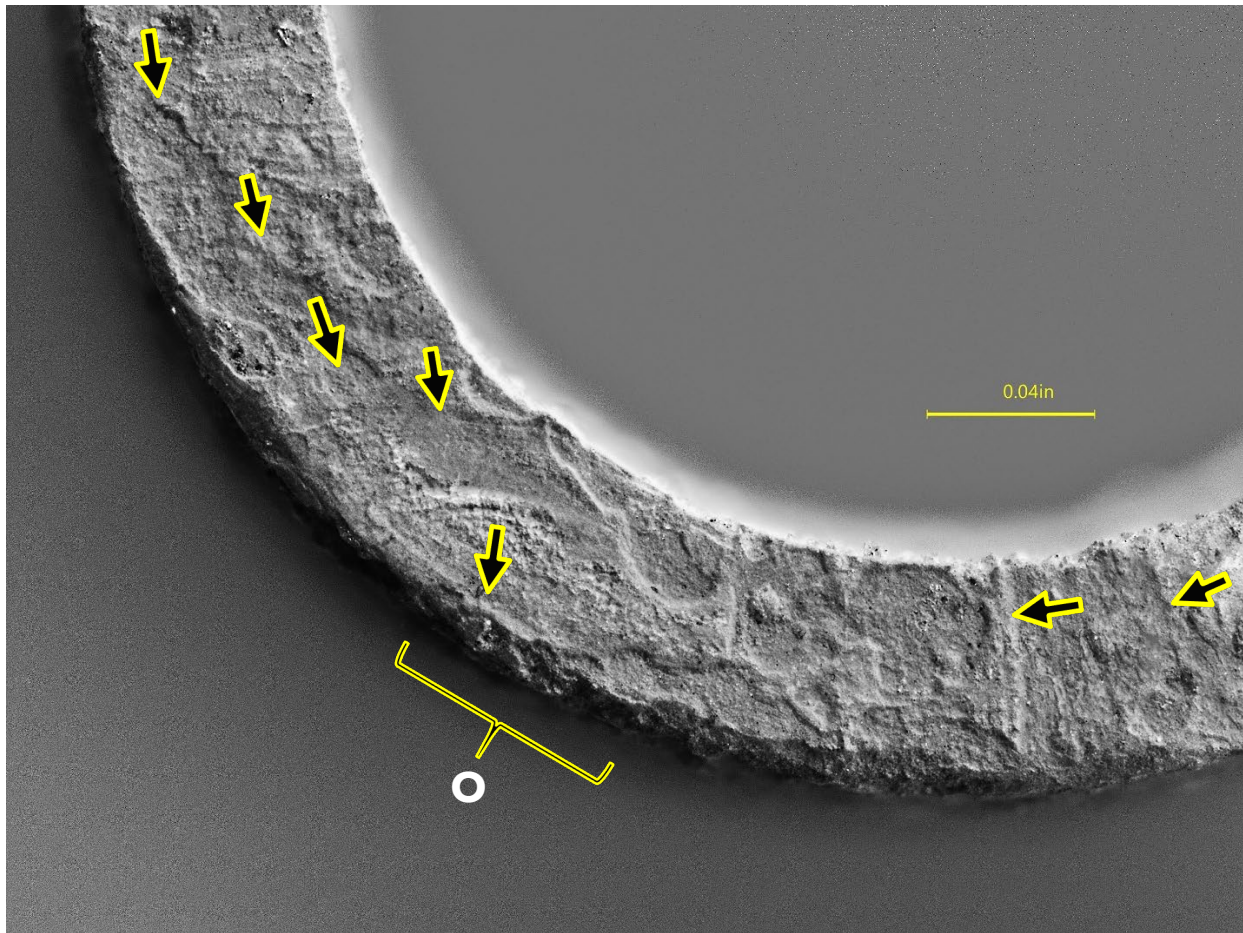
**Figure 5.** Same location as in figure 4 except using side lighting to make uneven contours stand out (increases elevational contrasts). The image is presented in grey scale.
