# National Transportation Safety Board

WPR22LA340

## **MATERIALS LABORATORY**

Factual Report 23-007

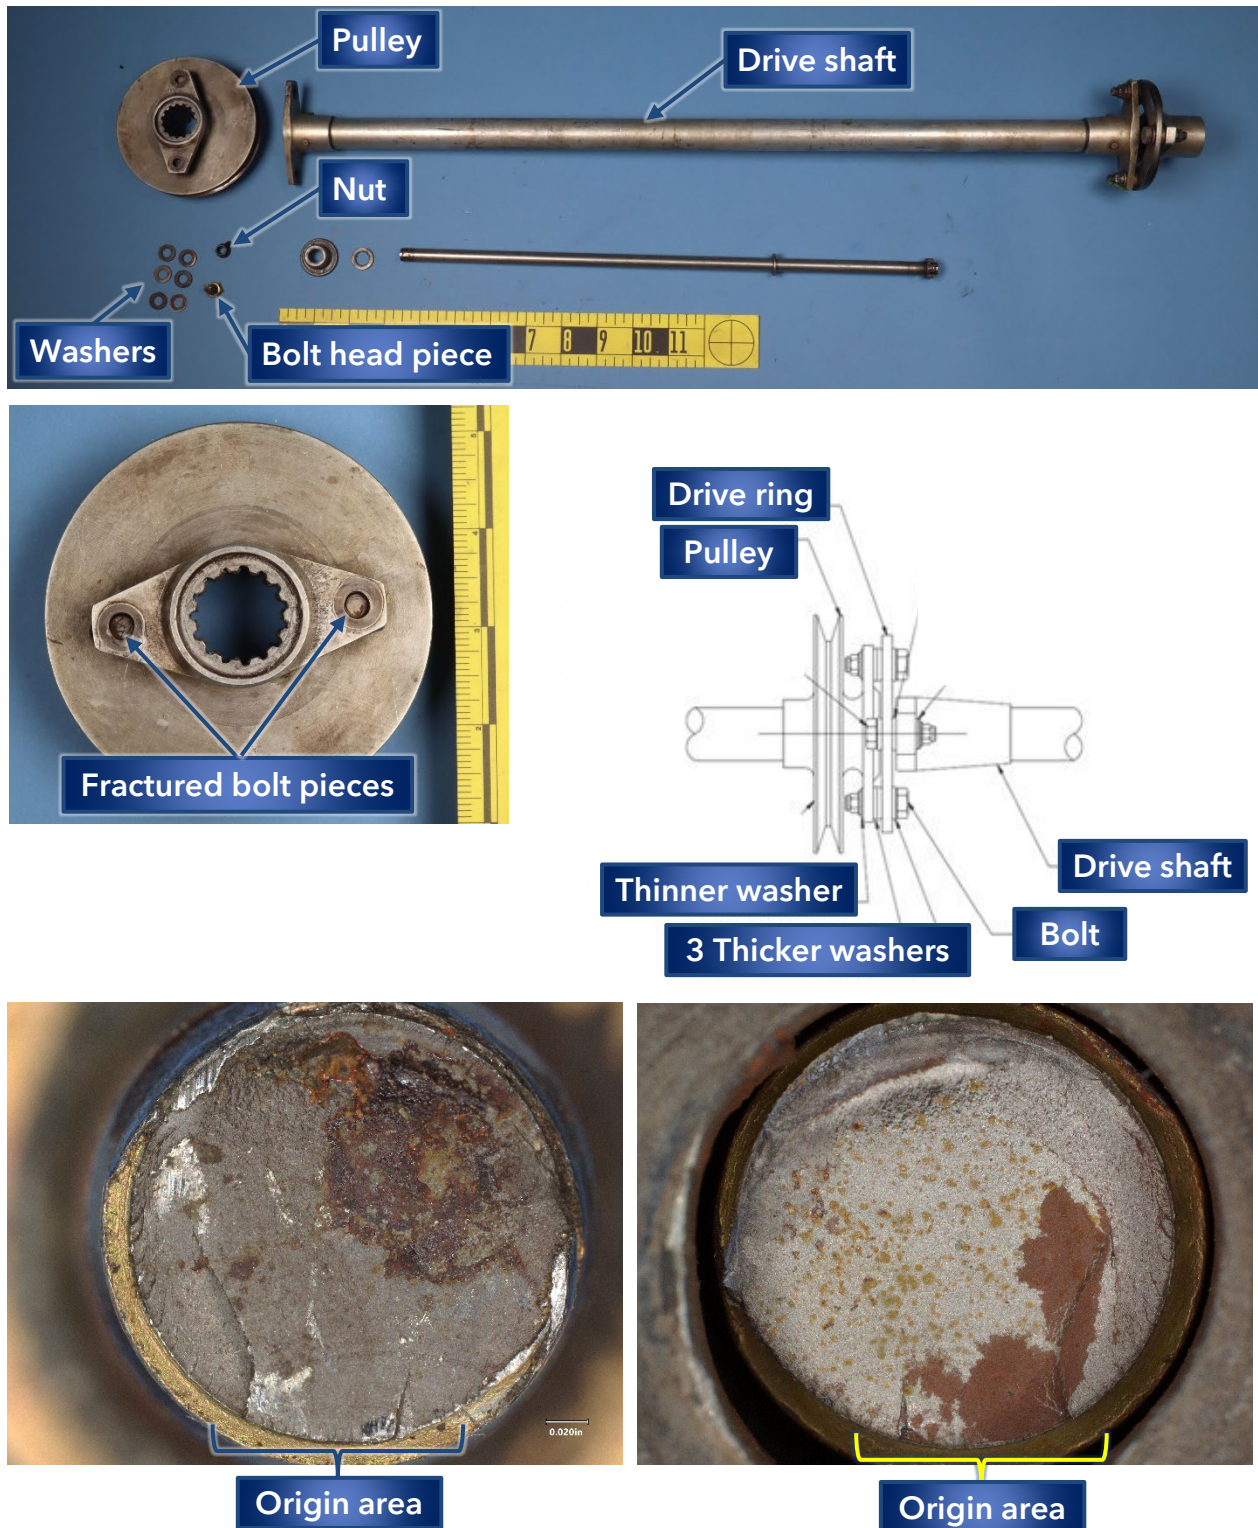
An overall view of the submitted components are shown in the upper image in figure 1. The components included tail rotor drive components including a driveshaft assembly with an intact flex coupling at one end and a separated coupling at the other end. A diagram showing the properly assembled components of the separated coupling is shown at the middle right in figure 1. Two fractured bolt pieces with attached nuts remained trapped within the flange on the pulley side of the coupling as shown in the middle left image in figure 1. No washers were installed between the nuts and the flange at either location. Six washers, a bolt piece, and a nut recovered from the helicopter tail boom were also included as shown in figure 1.

The fracture surfaces of the bolt pieces trapped in the pulley flanges had relatively flat features with curving crack arrest lines across most of the fracture surfaces, features consistent with fatigue fracture. A close view of one of the bolt fracture surfaces is shown in the lower right image in figure 1. Ratchet marks consistent with multiple fatigue origins were located on one side of the bolt as indicated with a bracket. A mating fracture surface was observed on the recovered bolt head piece as shown in the lower left image in figure 1 as evidenced by the corresponding shapes of the ratchet marks and crack arrest lines. Although orange and dark red oxides formed in different locations on each fracture, these oxides were consistent with post-fracture oxidation.

One flange of the pulley was cut using a handheld bandsaw to liberate the nut end of the bolt piece that mated to the recovered head piece. The length of the shank from the nut clamping face to the fracture origin was 0.097 inch. On the head side, the shank length from the underside of the head to the fracture origin was 0.397 inch, for a total bolt shank length of 0.494 inch between the clamping faces of

the head and the nut. The thickness of the pulley flange was 0.164 inch, and the thickness of the flange on the drive shaft assembly was 0.161 inch. For reference, the total thickness of the drive ring adjacent to one of the bolts on the intact coupling was 0.119 inch.

The six recovered washers shown in the upper image in figure 1 consisted of 4 washers that were relatively thicker than the remaining 2 washers. The thicker washers were approximately 0.058 inch thick, and the thinner washers were approximately 0.029 inch thick.

Four washers are specified for use on each bolt attaching the pulley flanges to the drive ring on the coupling as shown in the diagram in figure 1. The specified washers have two thicknesses; the thinner washer has a specified nominal thickness of 0.032 inch, and the three thicker washers have a specified nominal thickness of 0.063 inch.

**Figure 1.** Overall view of the submitted components (upper image). The middle left image shows the bolt fractures trapped in the pulley flange, and the middle right image shows an assembly diagram. Mating fractures on the recovered bolt head piece and one of the bolt pieces trapped in the pulley flange are shown in the lower left and right images, respectively.
