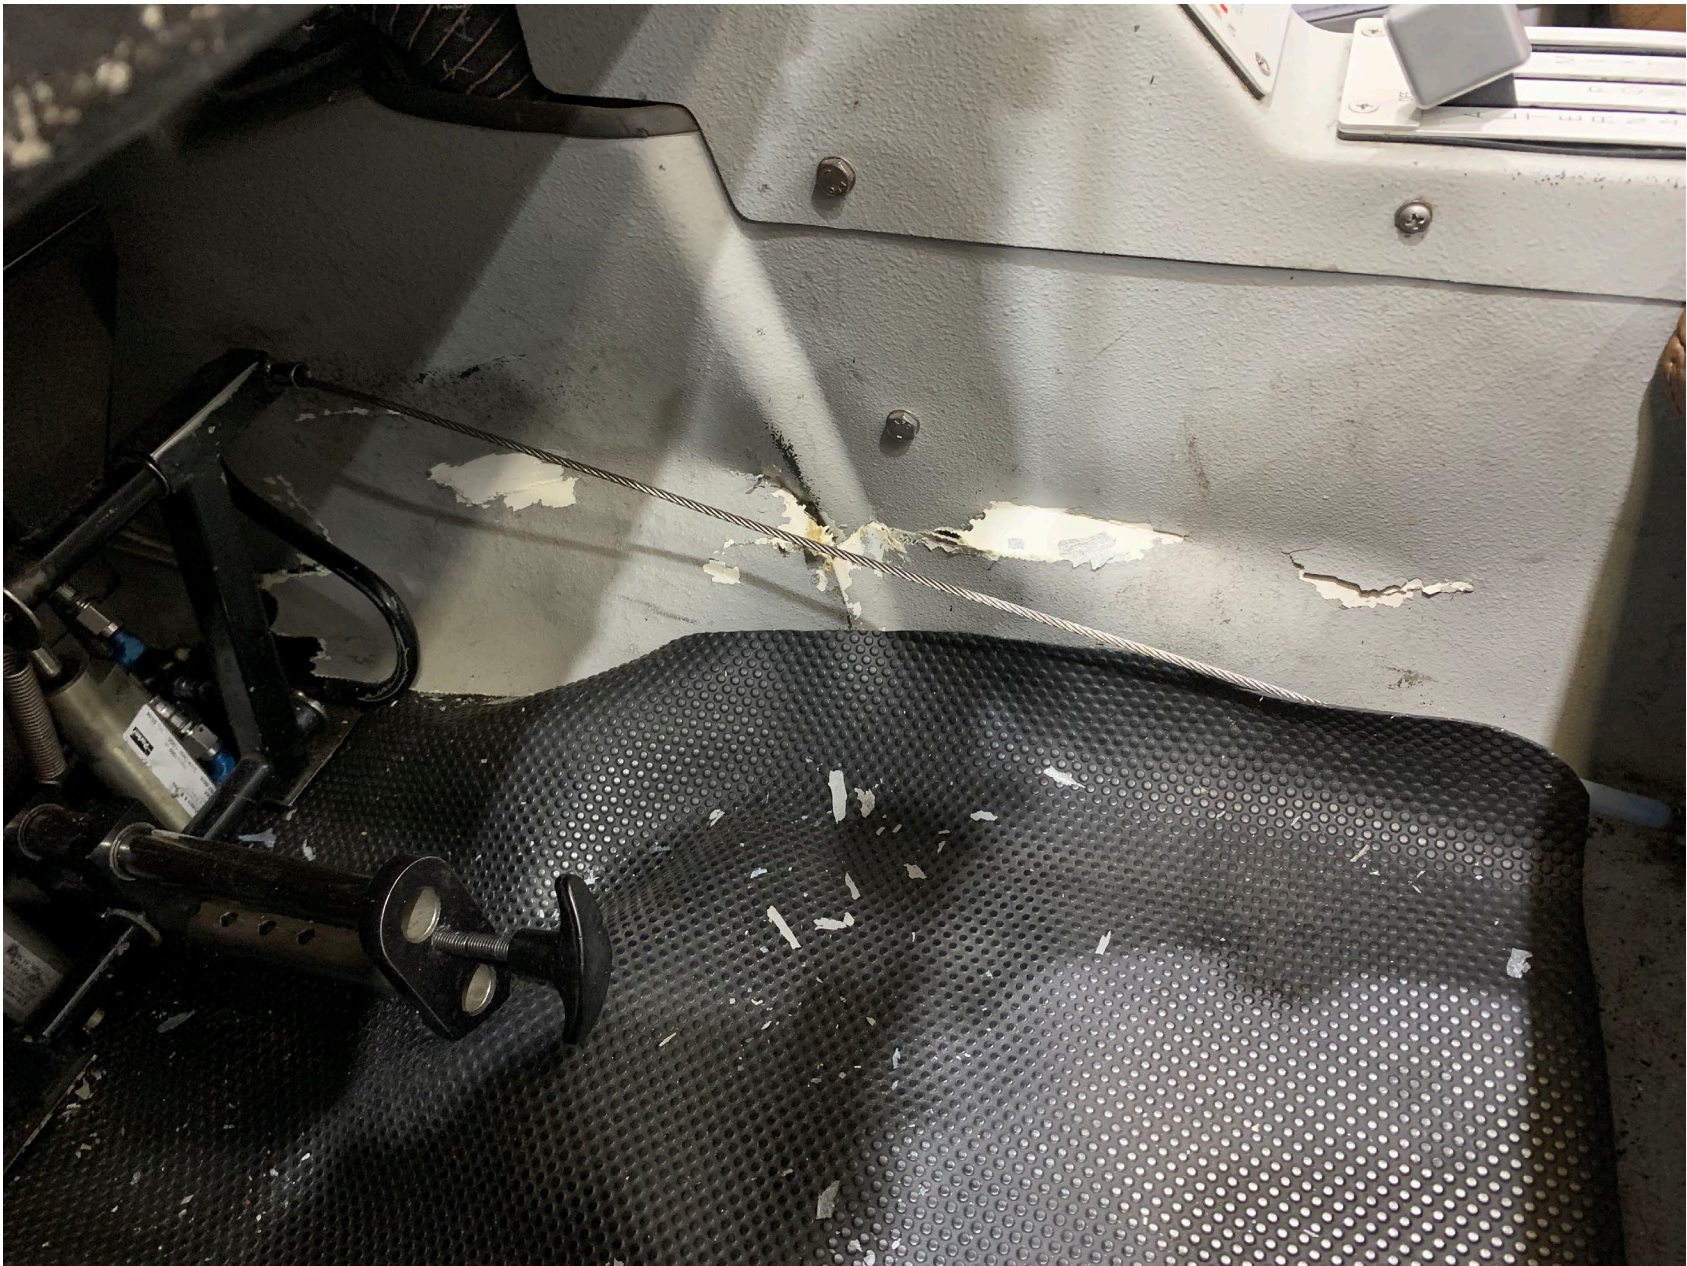
**Photo 1 – View of pilot side center pedestal / floorboard damage (Photo courtesy of Clark County DOA)**

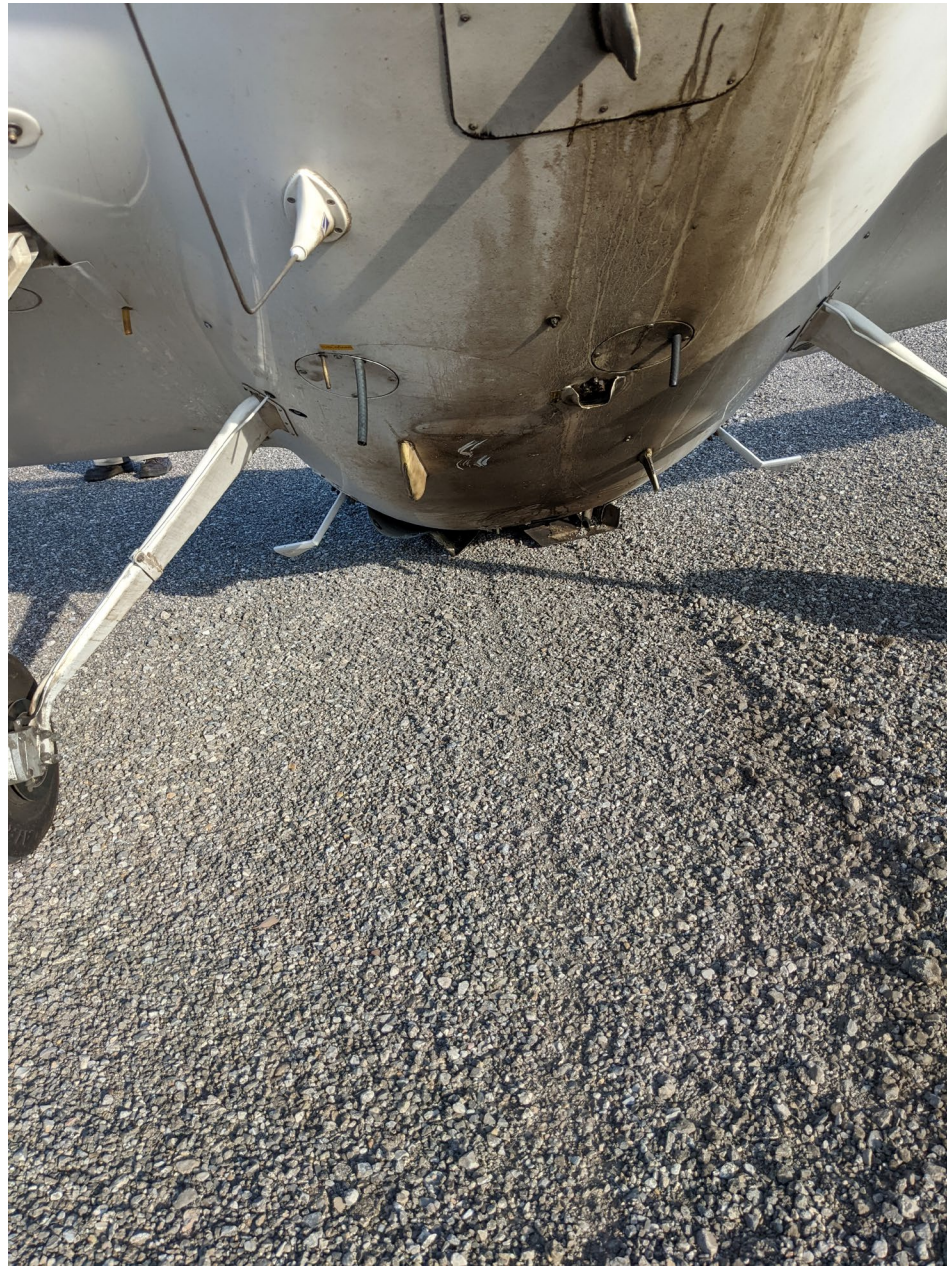
**Photo 2 – View of underside of airplane damage (Photos courtesy of Clark County DOA)**
