# National Transportation Safety Board

WPR22LA351

## **MATERIALS LABORATORY**

Factual Report 23-044

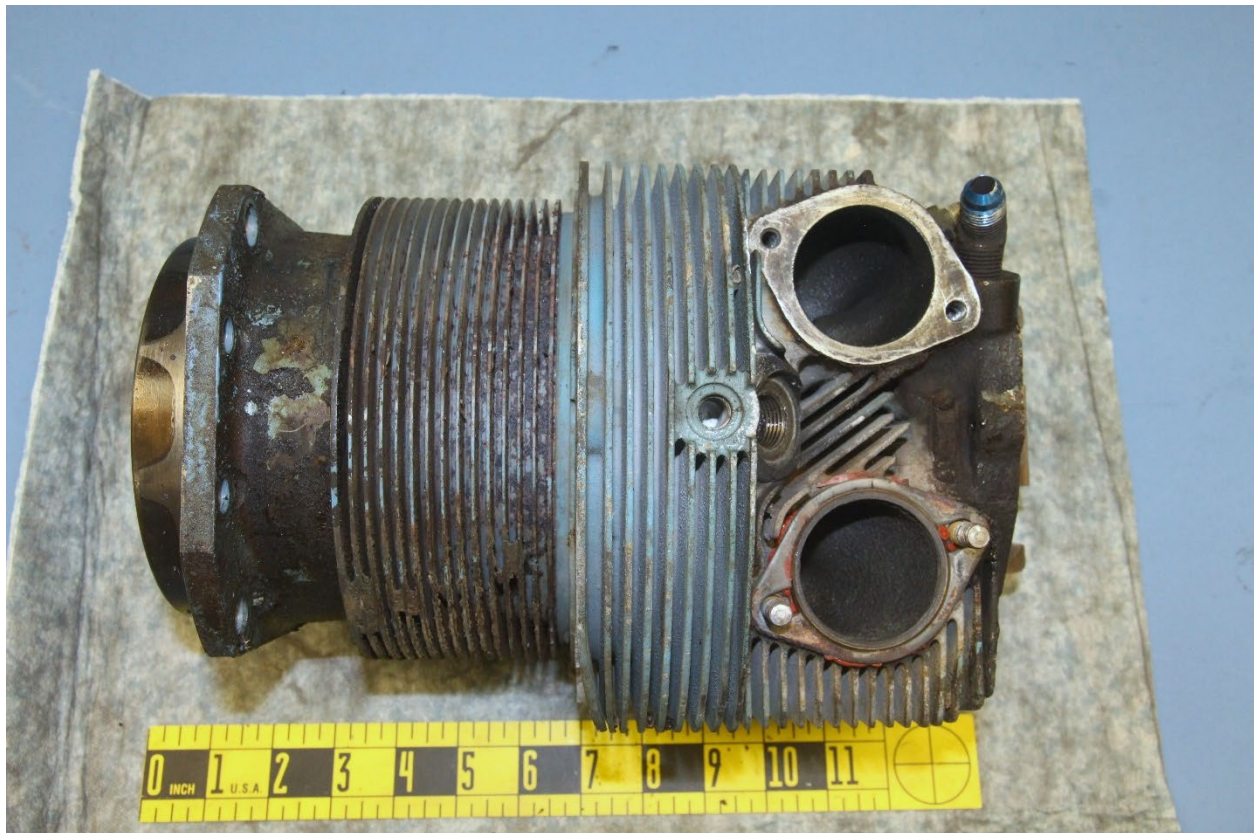
Figure 1 shows the #4 cylinder from the engine, as received. The cylinder had been disassembled, with the piston assembly removed and the valve housing detached along with the valves and rockers. The intake and exhaust ports are shown in the figure, with the nonmetallic deposits present, particularly along the interior surfaces of the exhaust port.

**Figure 1.** View of the cylinder from the side with the intake and exhaust ports.

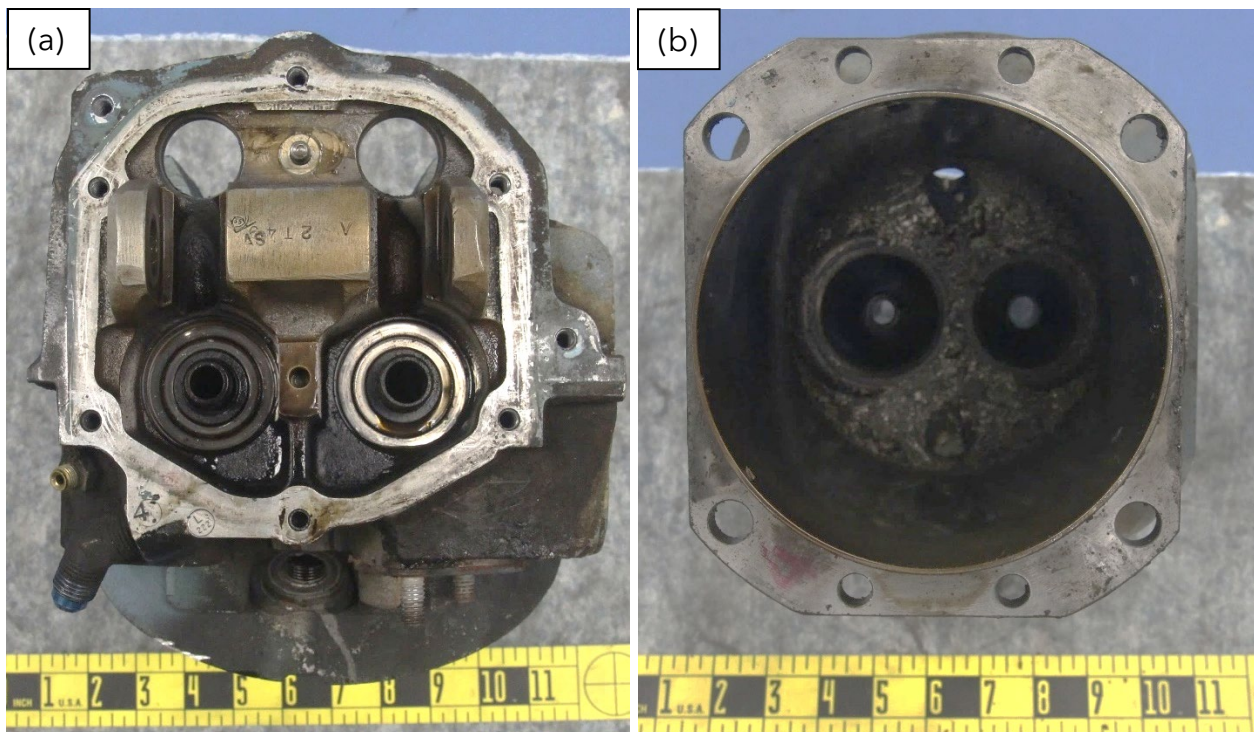
Figure 2 shows the cylinder interior from the rocker and upper valve stem area—these components had been removed prior to receipt. The cylinder surfaces located near the stem and rocker positions exhibited a darker contrast, consistent with exposure to

oil lubrication during engine service. The intake valve stem opening (right in Figure 2a) revealed a brighter metallic luster than the darker exhaust valve side, consistent with lower temperature exposure.

While there were no indications of physical damage on the stem and rocker side of the cylinder assembly (Figure 2a), the interior combustion side had been gouged and battered, as illustrated in Figure 2b and Figure 3. The damage was more concentrated on the exhaust valve side (right side of Figure 3), as the impact damage was present on the corner of the valve seat and the face of the valve stem bore.

**Figure 2.** Views of the cylinder from (a) the rocker and valve stem area with housing removed and (b) the piston end, as received.

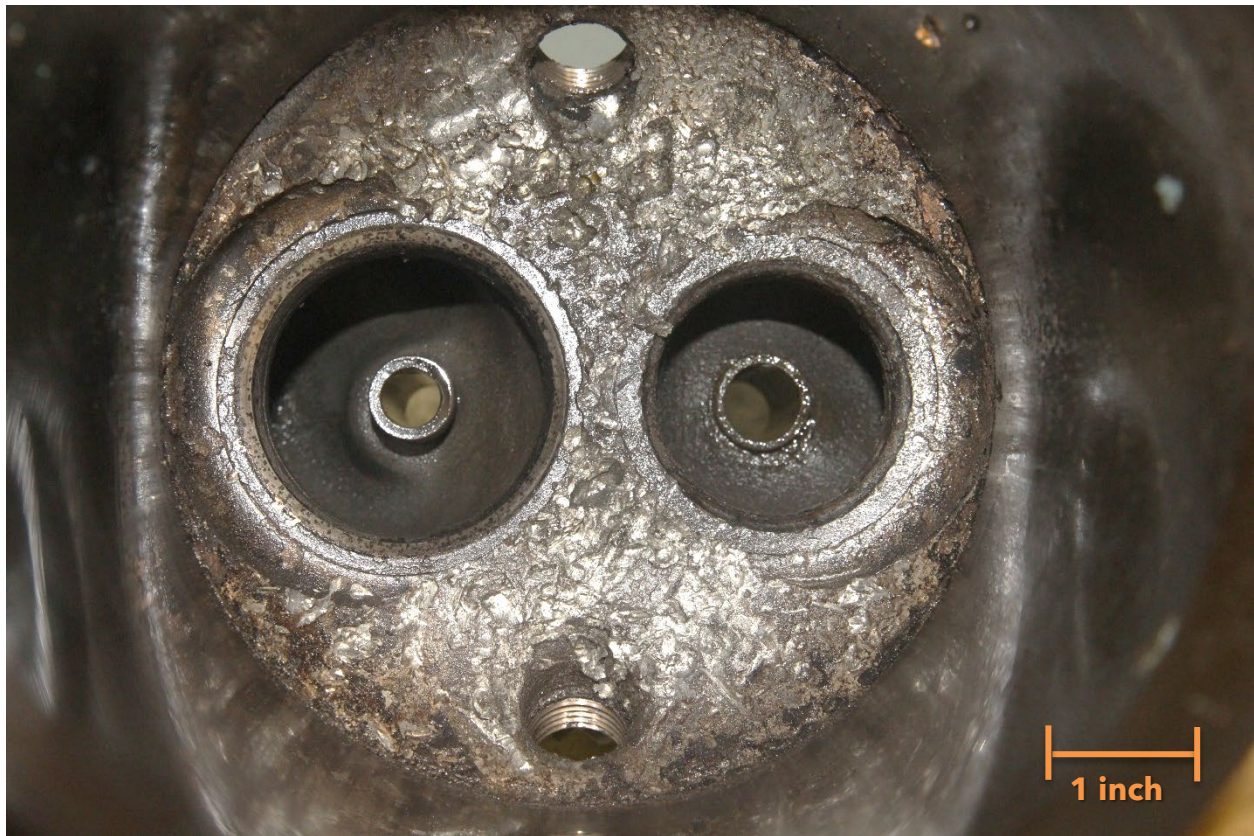
**Figure 3.** Closer view of the interior of the cylinder, showing impact damage to the cylinder and valve seat surfaces.

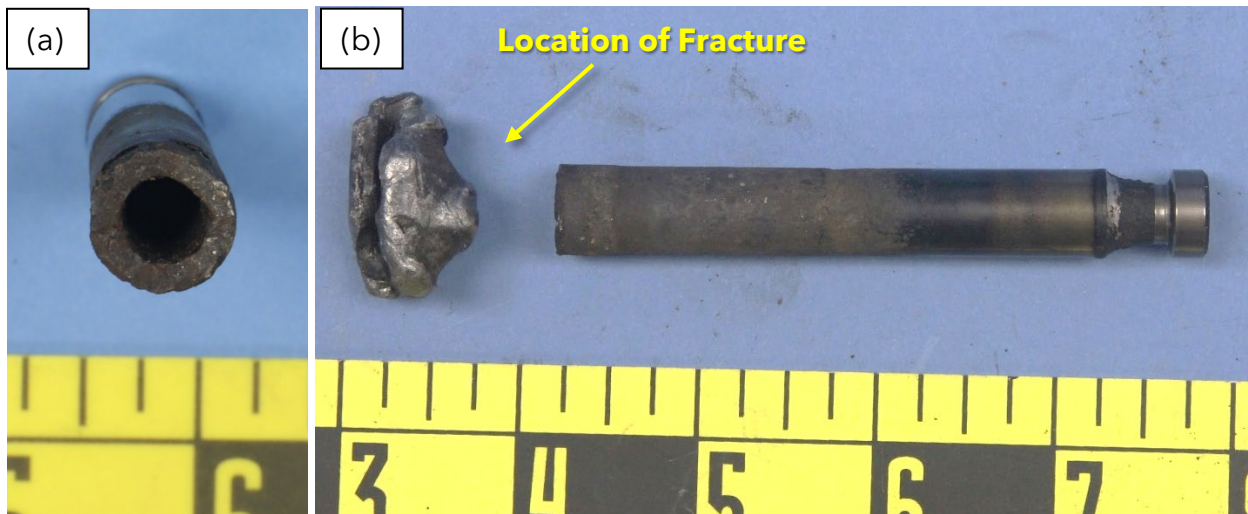
Figure 4 shows the exhaust valve as received. The exhaust valve had fractured at the shoulder transition of the stem and the head, identified in Figure 4b. The head fragment exhibited a rounded, globule shape, consistent with plastic deformation from repeated batter against adjacent metallic components. The stem fragment showed less damage, with the stem fracture illustrated in Figure 4a.

The stem fragment measured 3.164 inches long, with an outer diameter of 0.498 to 0.506 inches. The stem was hollow, and the inner diameter ranged between 0.281 and 0.307 inches.

**Figure 4.** View of the fractured exhaust valve from (a) the stem fracture and (b) side showing the stem side and liberated valve head remnant.

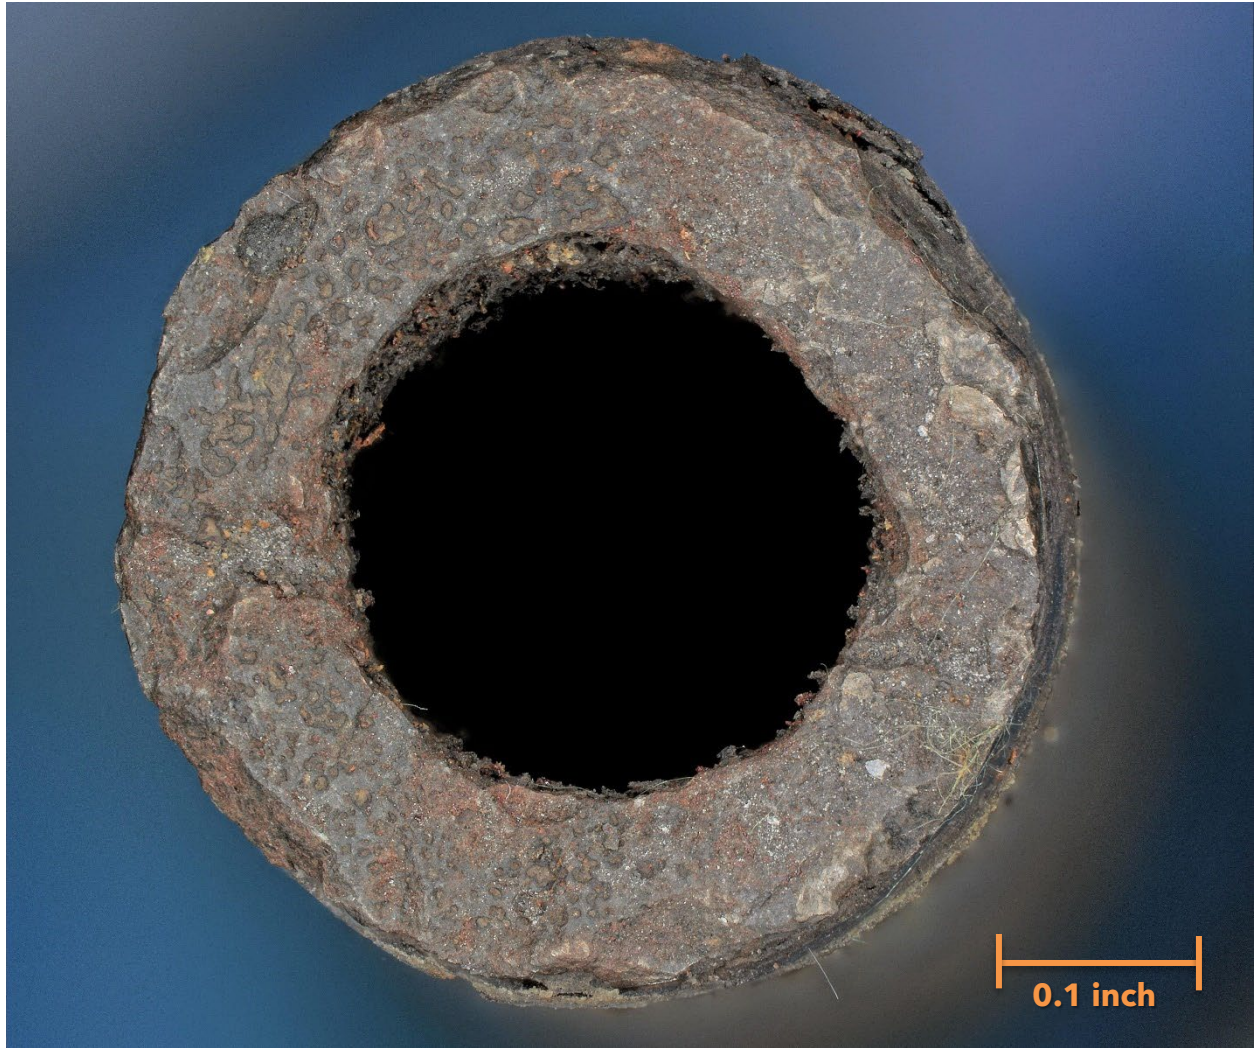
Figures 5 and 6 show closer views of the valve stem fracture surface after degreasing and then after cleaning with an aqueous solution of Alconox.<sup>2</sup> A side view of the stem's lower (fractured) end is illustrated in Figure 7 after cleaning. The innermost 0.75 inches of the valve stem surface contained surface deposits, which exhibited a variety of colors, from brighter white to dull brown, orange, and gray. These deposits were consistent with combustion products typical of reciprocating engines expending avgas fuel.

The fracture surface, shown in Figures 5 and 6, exhibited a rough but flat orientation with a dull luster. The surface was alternately light black and orange-brown, consistent with post-fracture oxidation.

**Figure 5.** View of the exhaust valve stem fracture surface after degreasing.

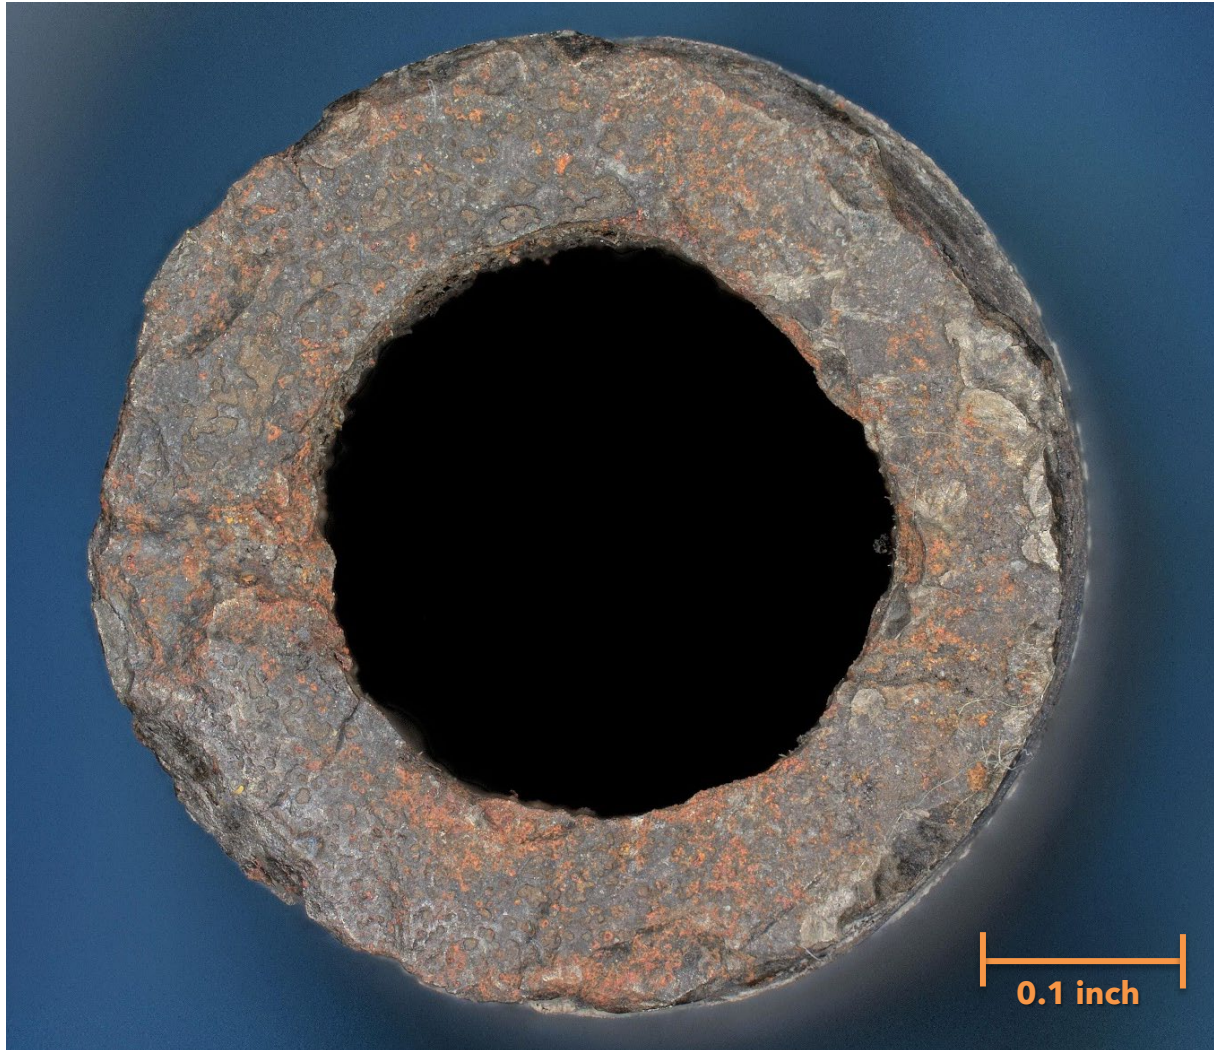
**Figure 6.** View of the exhaust valve stem fracture surface after cleaning with Evaporust.

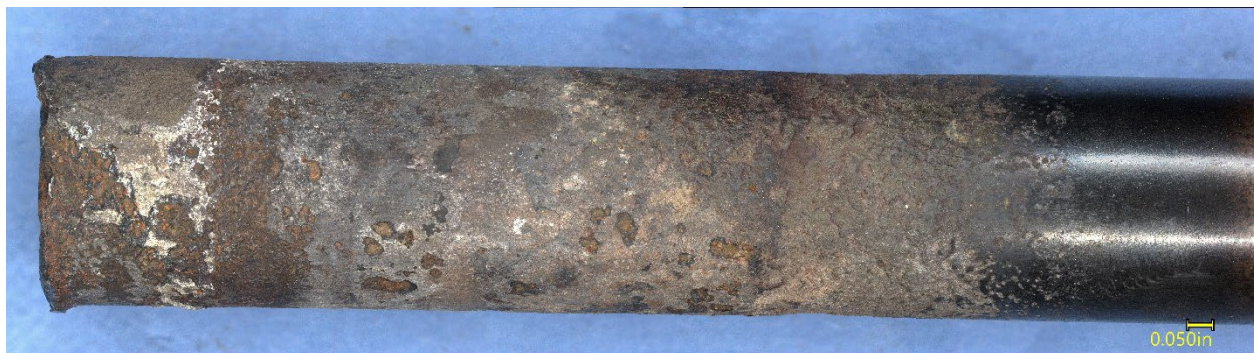
Measurements of the fractured valve stem's outer diameter revealed that the valve's thickness increased closer to the fracture surface. Near the face of the stem, the outer diameter was 0.4980 inches wide, but it increased to 0.5060 near the fracture surface. The increase was consistent with layering of combustion deposits on the valve stem exterior.

**Figure 7.** Side view of the exhaust valve stem remnant, after cleaning.

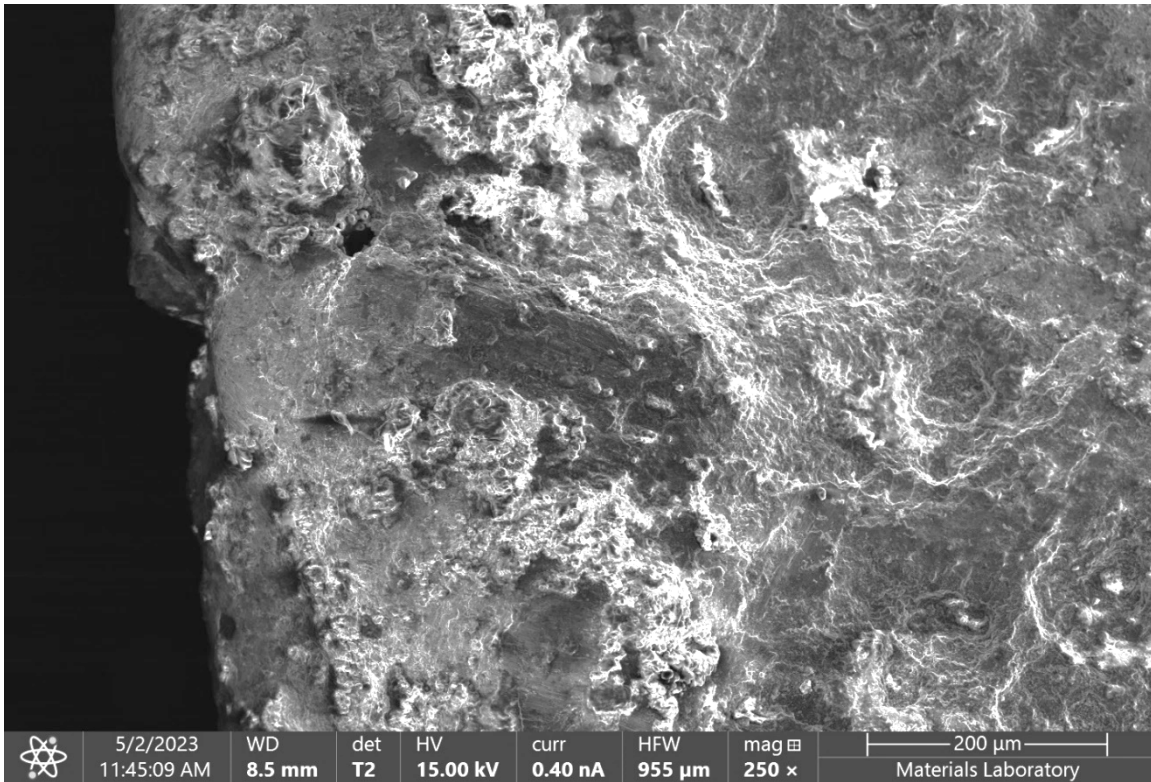
The fracture surface was examined using a field emission scanning electron microscope (SEM). Figure 8 depicts a typical area of the stem fracture surface near the exterior edge. The surface was partially concealed by nonconductive material,

**Figure 8.** Secondary electron (SE) micrograph of an edge of the exhaust valve stem fracture surface.

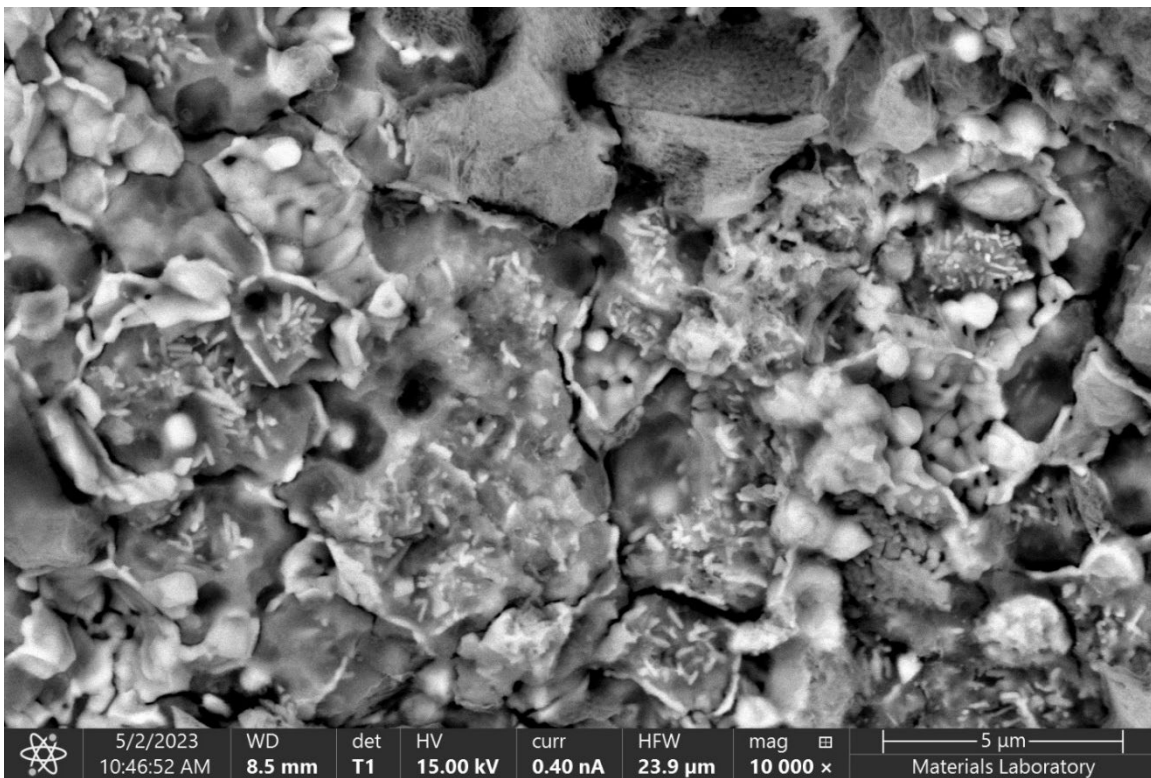
consistent with the post-fracture oxide seen visually. Figure 9 and Figure 10 show closer views of the surface compounds, which exhibited either a rounded blocky morphology or more platelike structures. The cleaning processes removed some surface compounds, revealing even parallel features.

bright in Figure 9 were consistent with high lead and bromine content, consistent with combustion deposits from tetraethyl lead additives in avgas fuel. The darker areas in Figure 9, as well as in Figure 13, were consistent mainly with iron oxide. This oxide also contained minor amounts of sodium, calcium, and chlorine—elements typical of exposure to salt or marine atmospheres.

**Figure 9.** BE micrograph of an area of thicker surface oxide on the fracture.

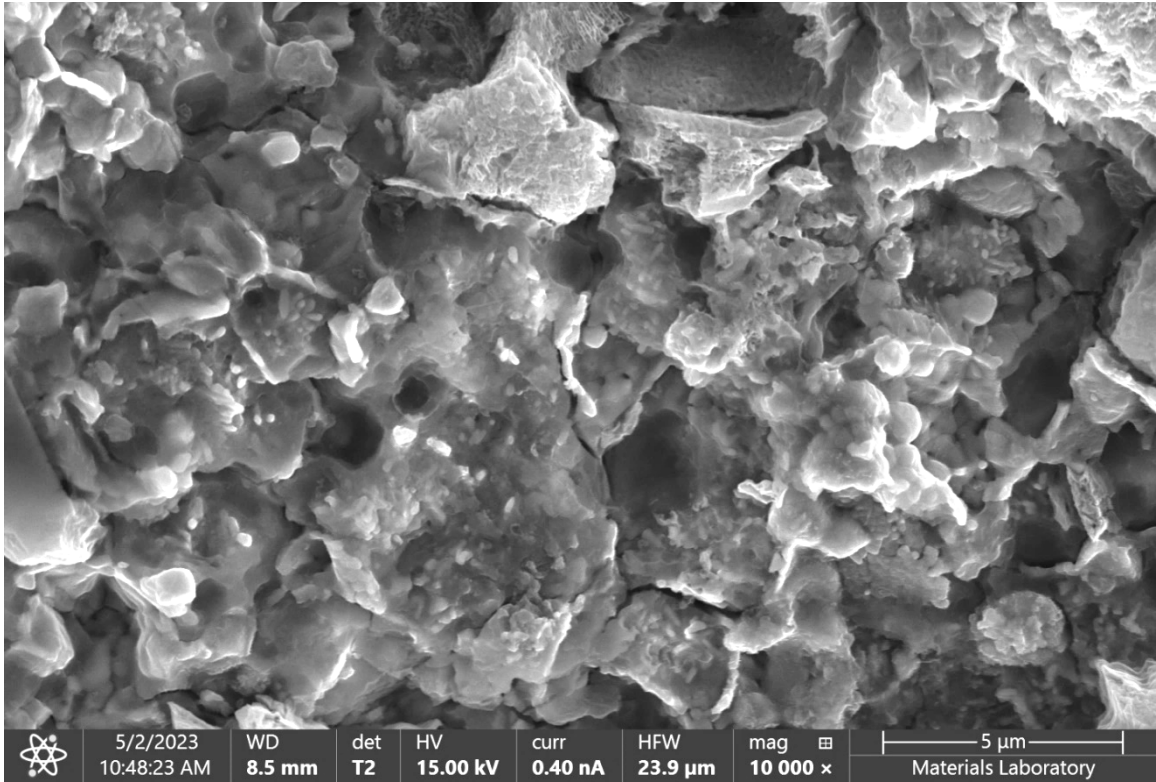
**Figure 10.** SE micrograph of an area of surface oxide in **Figure 9**.

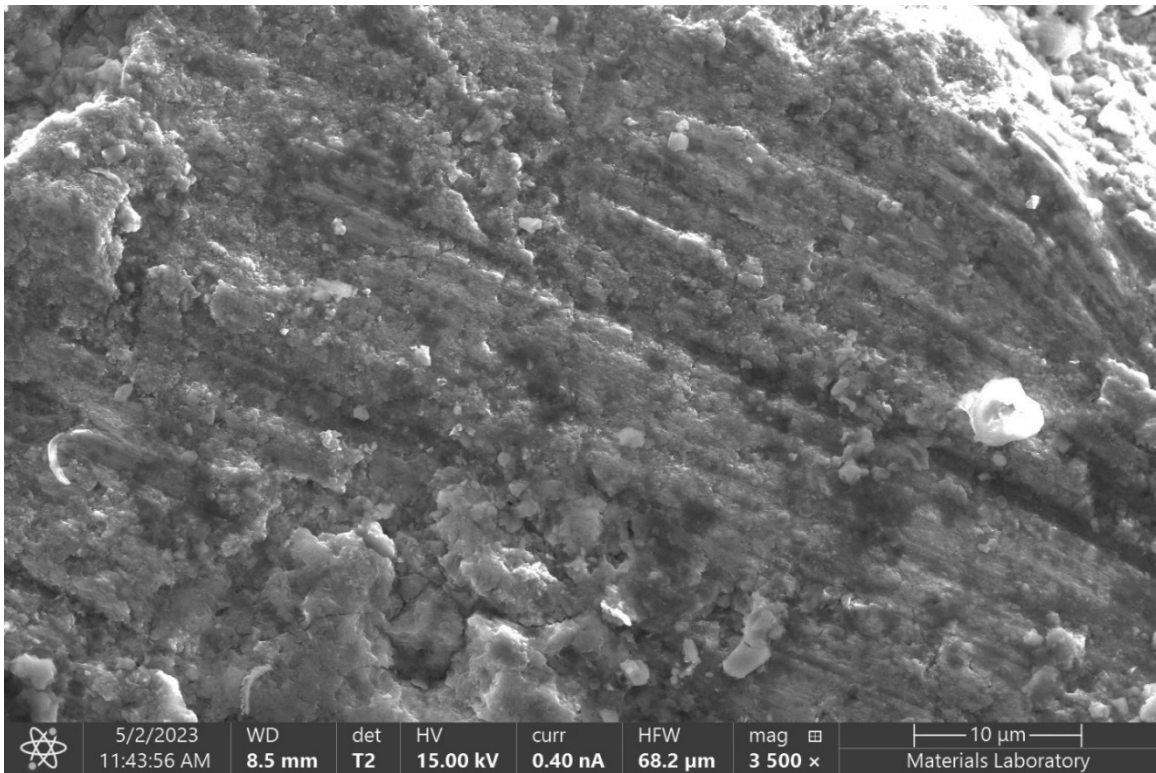
As demonstrated in Figure 11, these features were consistent with fatigue striations. Striations were observed on other parts of the valve stem fracture surface, as illustrated in Figure 12. While still covered in enough oxide to obscure much of the underlying features (Figure 13), selected areas did display striations, as shown in Figure 14 and Figure 15. The orientation of these fatigue striations was consistent with propagation from the outside surfaces inward and across the stem cross-section. Due to the amount of post-fracture surface oxidation and batter on the edges of the fractured valve stem, no features could be discerned on the edges of the fracture surface along the exterior. Streaking, plastic deformation, and batter were prevalent, consistent with impact against an adjacent metallic component. Therefore, no initiation sites were observed on this fracture. The liberated valve head was so damaged that no fracture features were present.

These features were consistent with fatigue cracking in the exhaust valve at the radius between the head and the stem. Once the fatigue crack had propagated through enough of the valve stem cross-section, the head separated and became battered by the reciprocating piston, leading to a loss of engine power and proper timing in the #5 cylinder.

**Figure 11.** SE micrograph of the boxed area in **Figure 8**, showing fatigue striations.

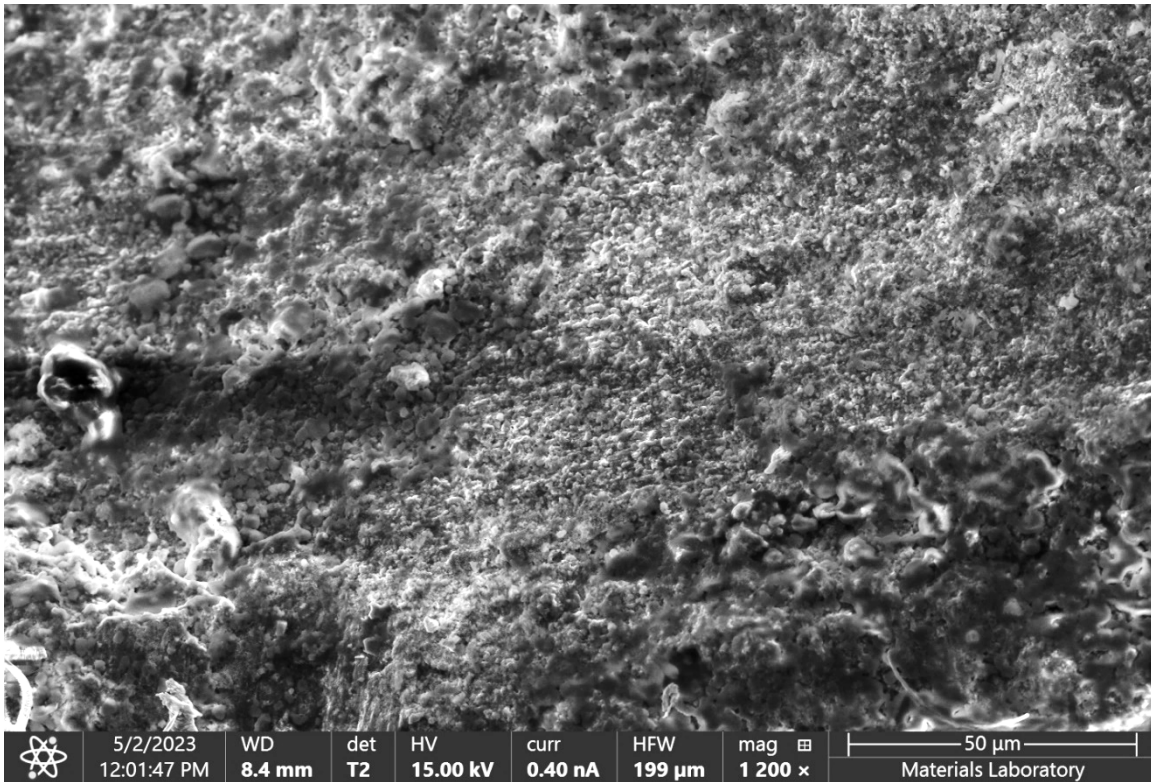
**Figure 12.** SE micrograph of a central area of the stem fracture.

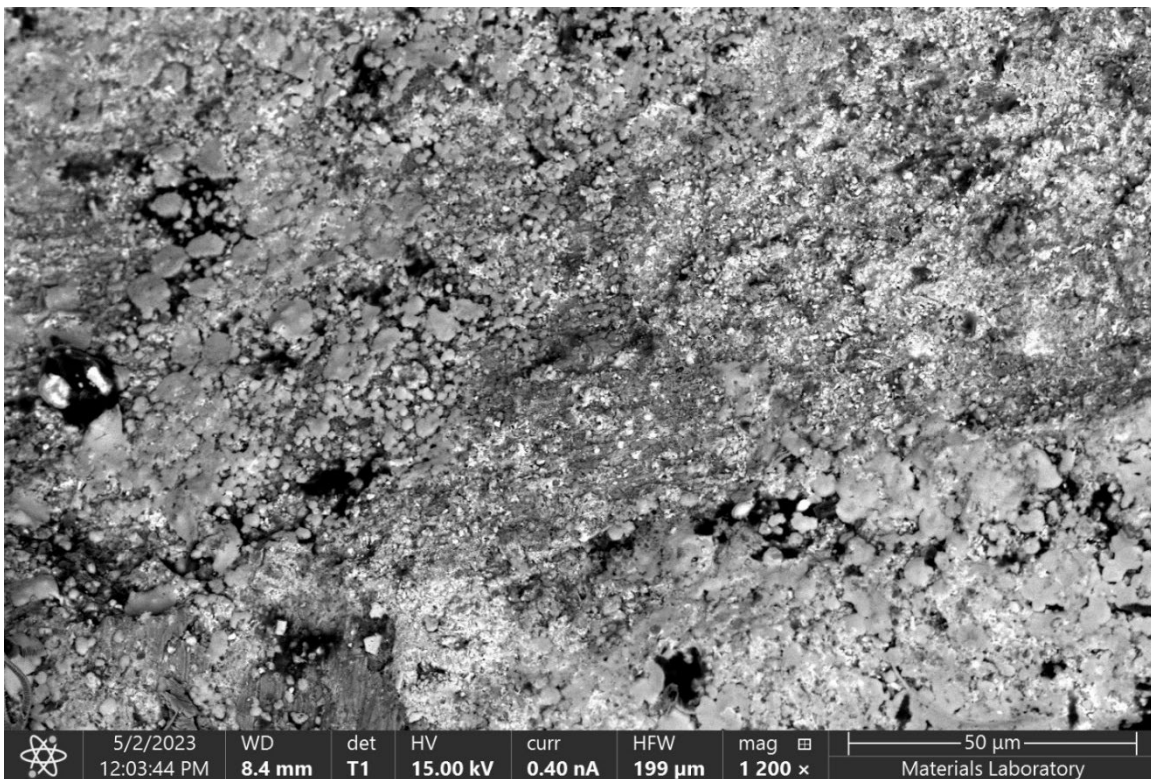
**Figure 13.** Backscattered electron (BE) micrograph of the central stem fracture area in **Figure 12**.

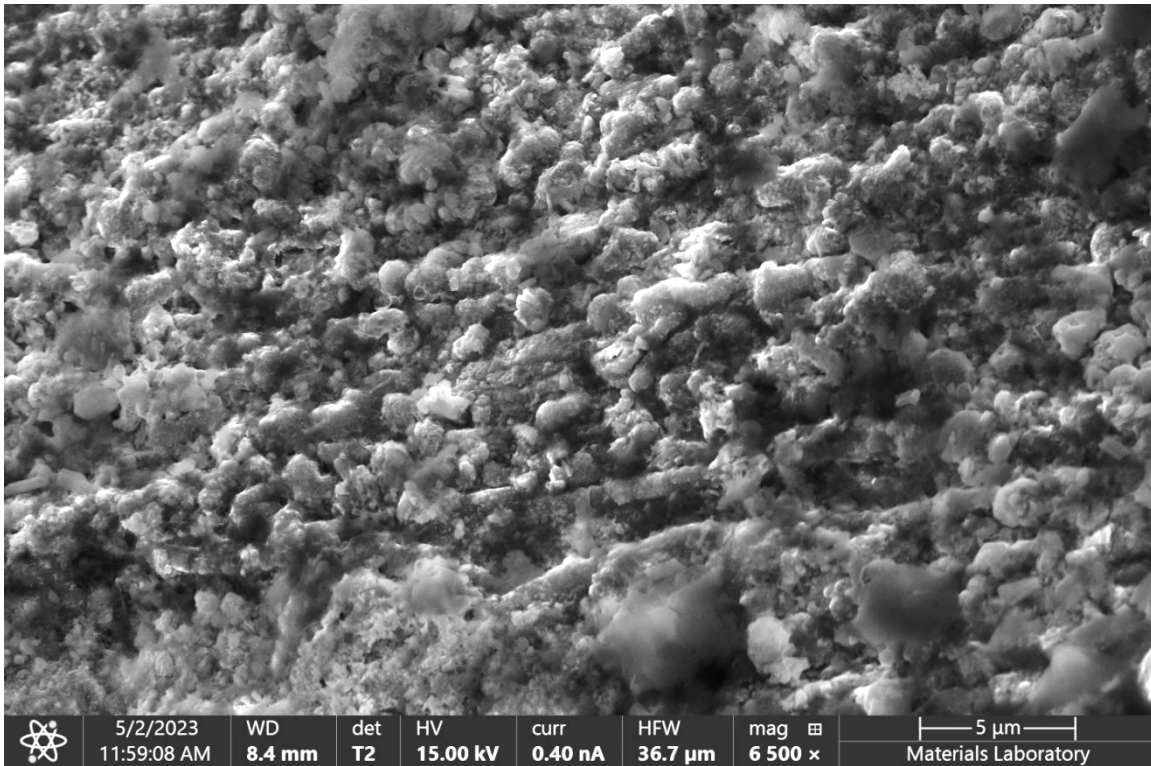
**Figure 14.** SE micrograph of a closer view of the area in **Figure 12**, showing striations underneath surface oxide globules and films.

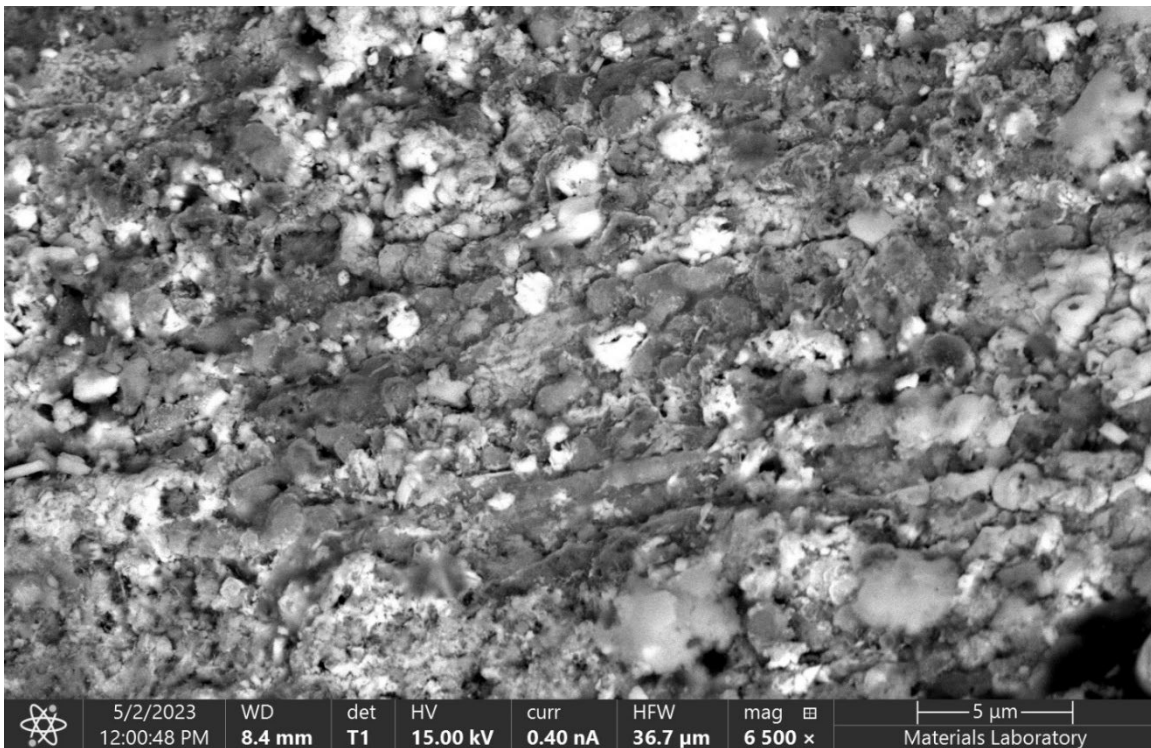
**Figure 15.** BE micrograph of a closer view of the area in **Figure 14**, showing striations underneath surface oxide globules and films.

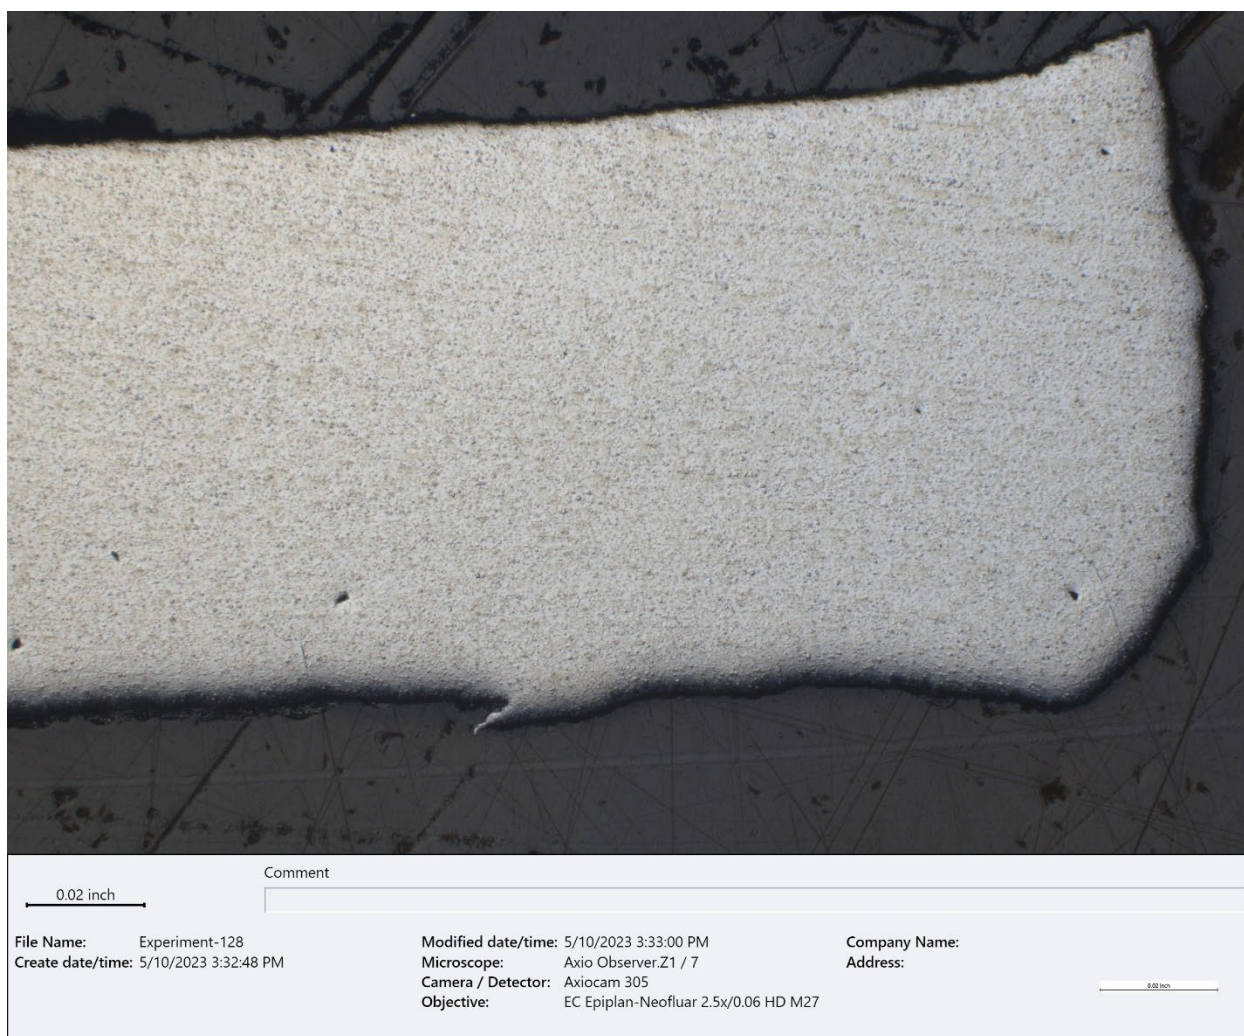
A portion of the valve stem fracture surface was excised, cross-sectioned, mounted, polished, and etched using a 2% Nital solution. Figure 16 shows a valve stem cross-section, with the fracture surface facing toward the right. The metallographic examination revealed external surface oxides and corrosion compounds, as typified by the darker gray material in Figure 17.

**Figure 16.** Bright-field (BF) optical micrograph of a cross section of part of the exhaust valve stem fracture surface (towards the right) (~25X, as polished)..

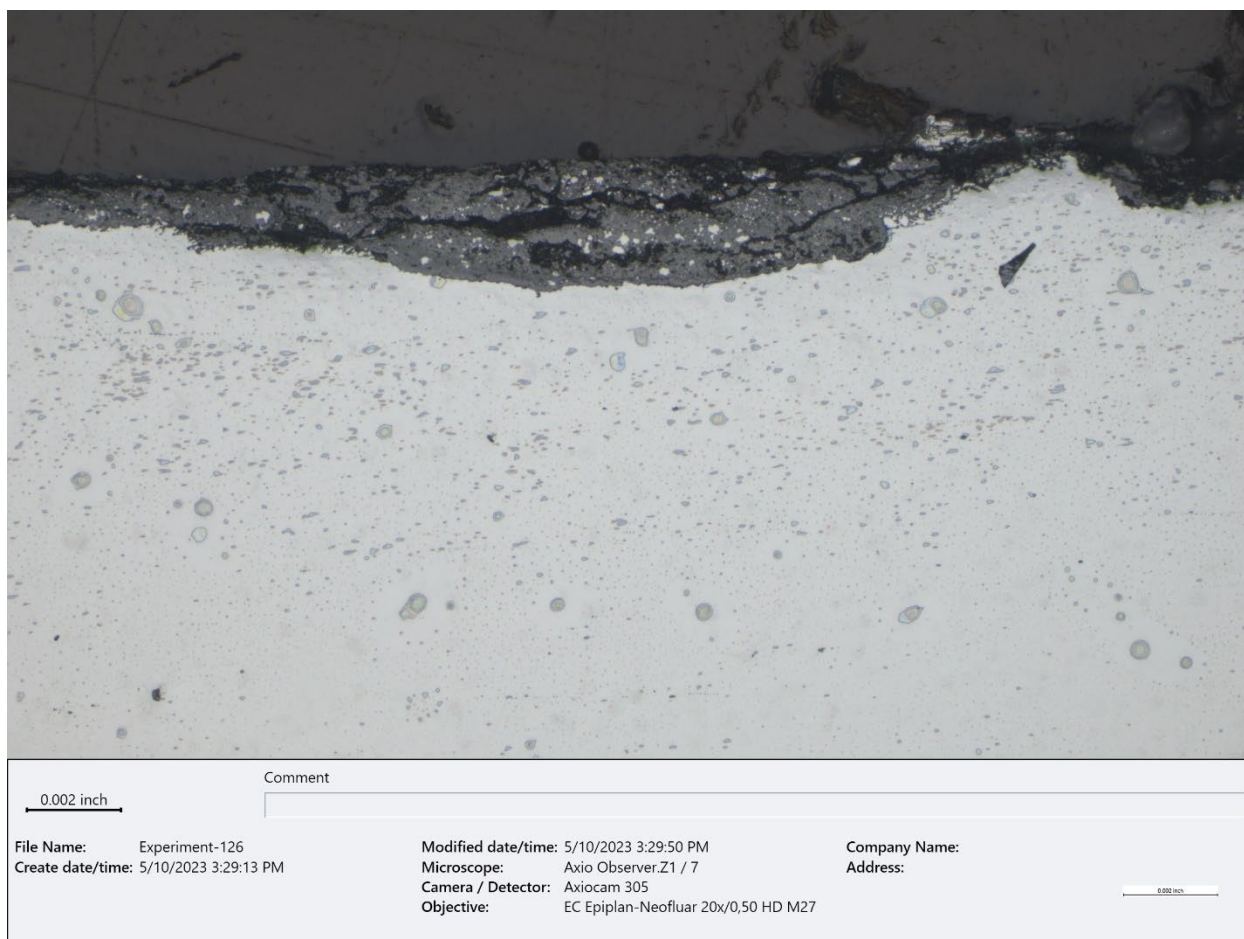
**Figure 17.** BF optical micrograph of nonmetallic surface compounds on the exterior of the stem fragment (~100X, as polished)..

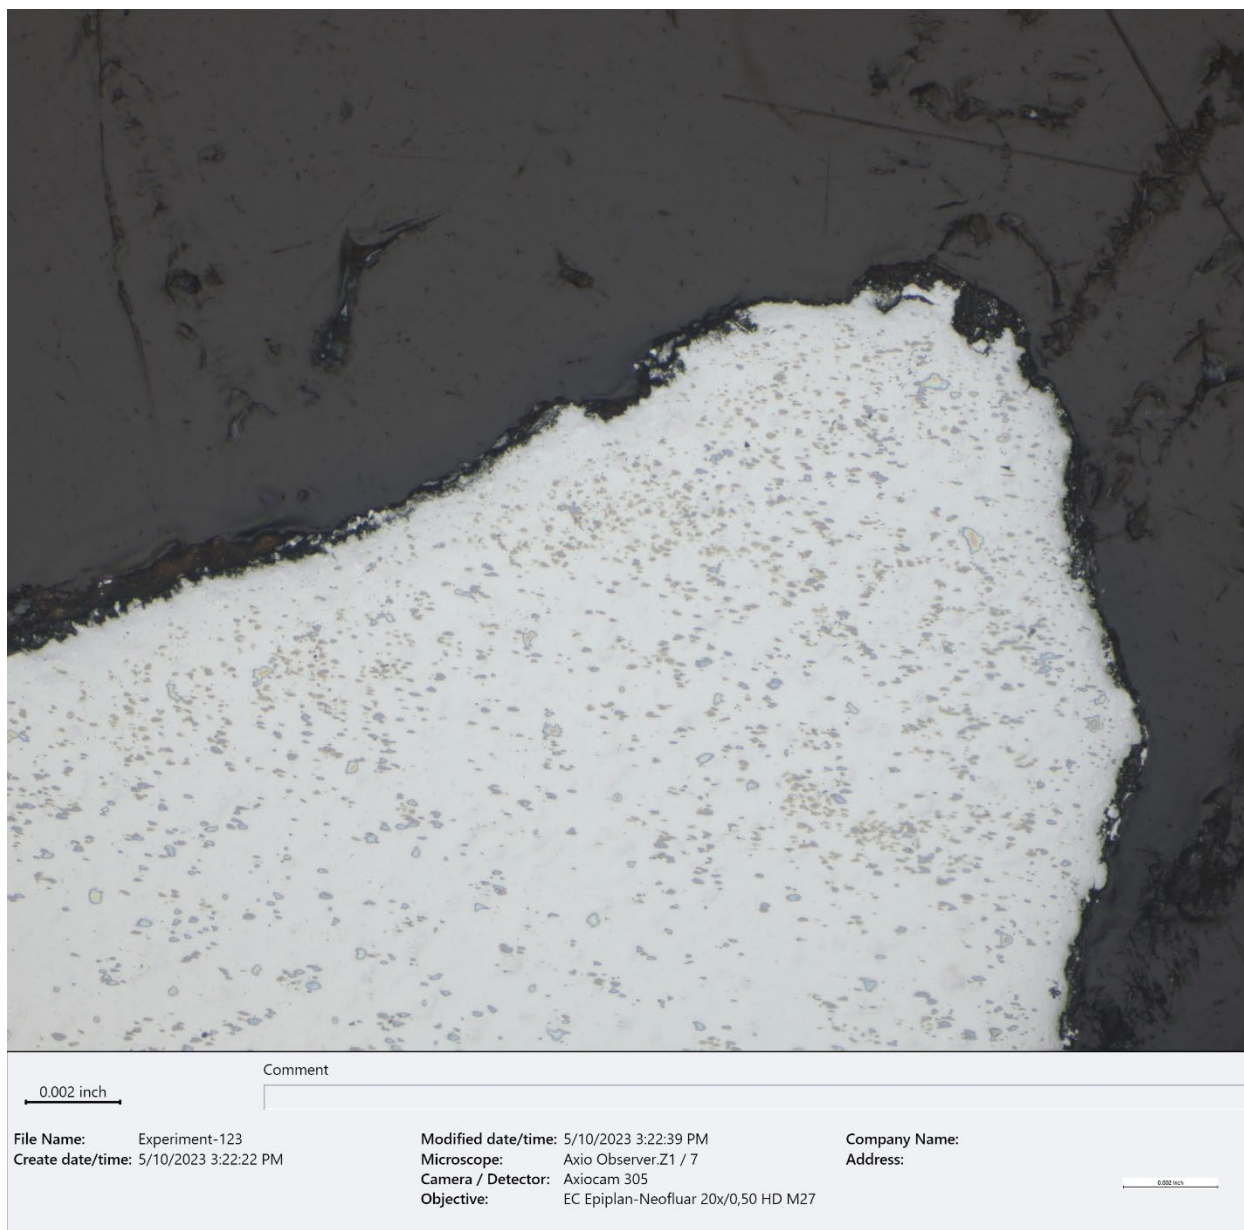
Also present were internal oxidation and subsurface attack, most prevalent towards the fracture surface, as shown in Figures 18 and 19. These features manifest as clusters of small needlelike phases beneath the exterior oxidation layer located within the stem metal (Figure 19).

**Figure 18.** BF optical micrograph of the outer corner of the exhaust valve surface and fracture surface. The boxed area is shown in Figure 19 (~100X, as polished).

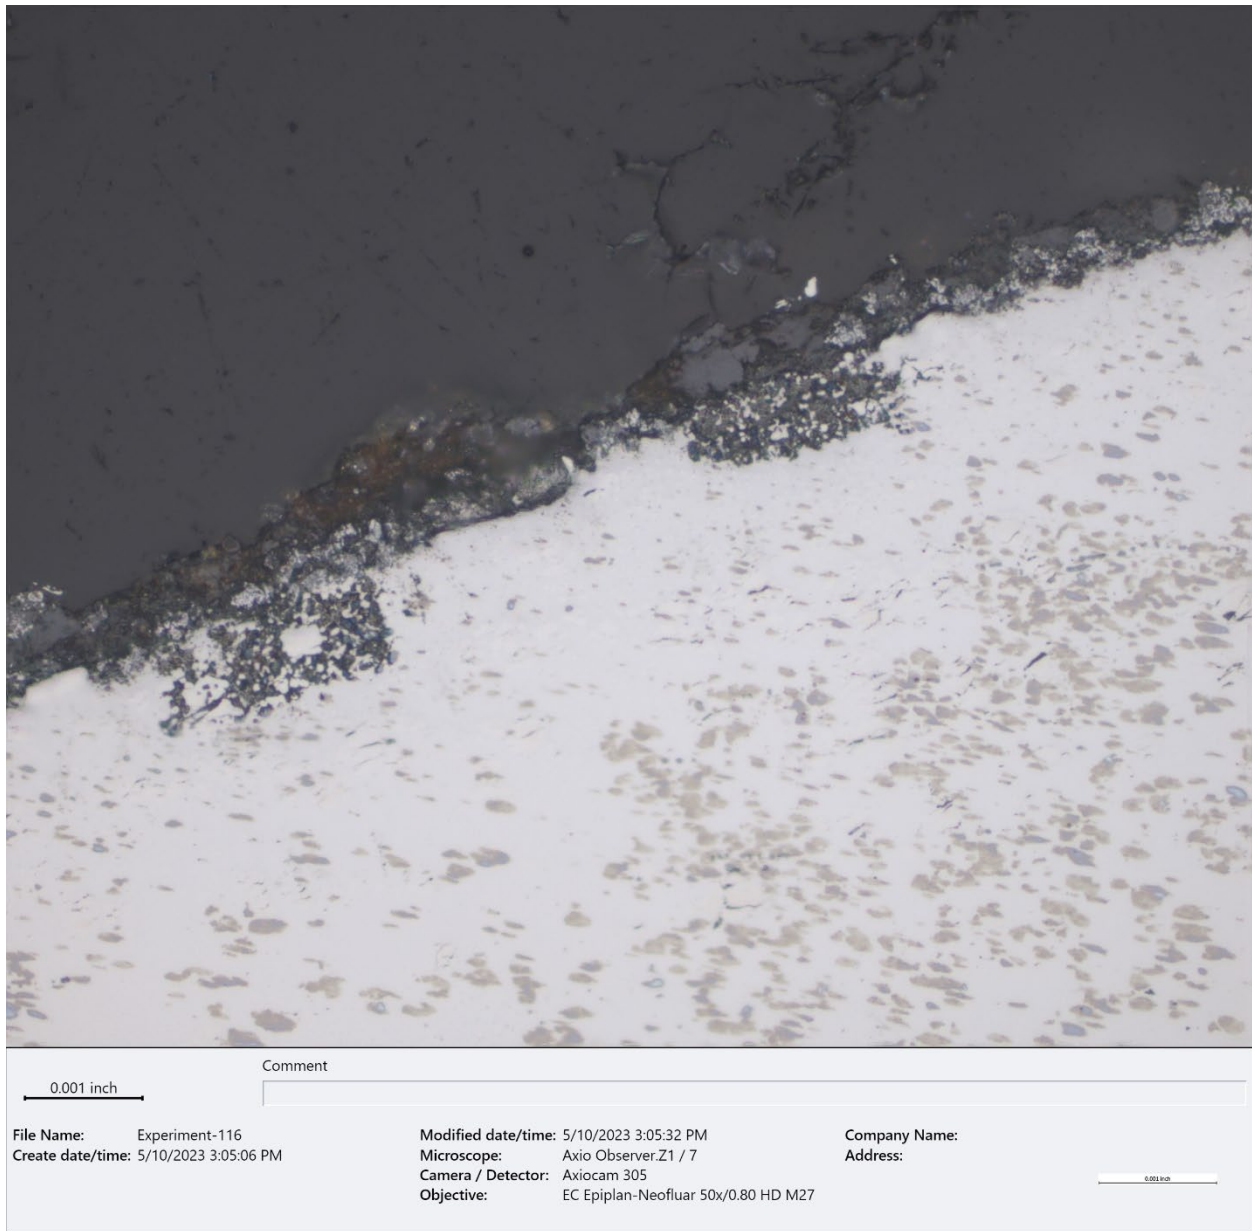
**Figure 19.** BF optical micrograph of the boxed area in Figure 18, showing areas of internal oxidation below the exterior surface (~200X, as polished).
