# National Transportation Safety Board

WPR22LA351

## **MATERIALS LABORATORY**

Factual Report 23-044

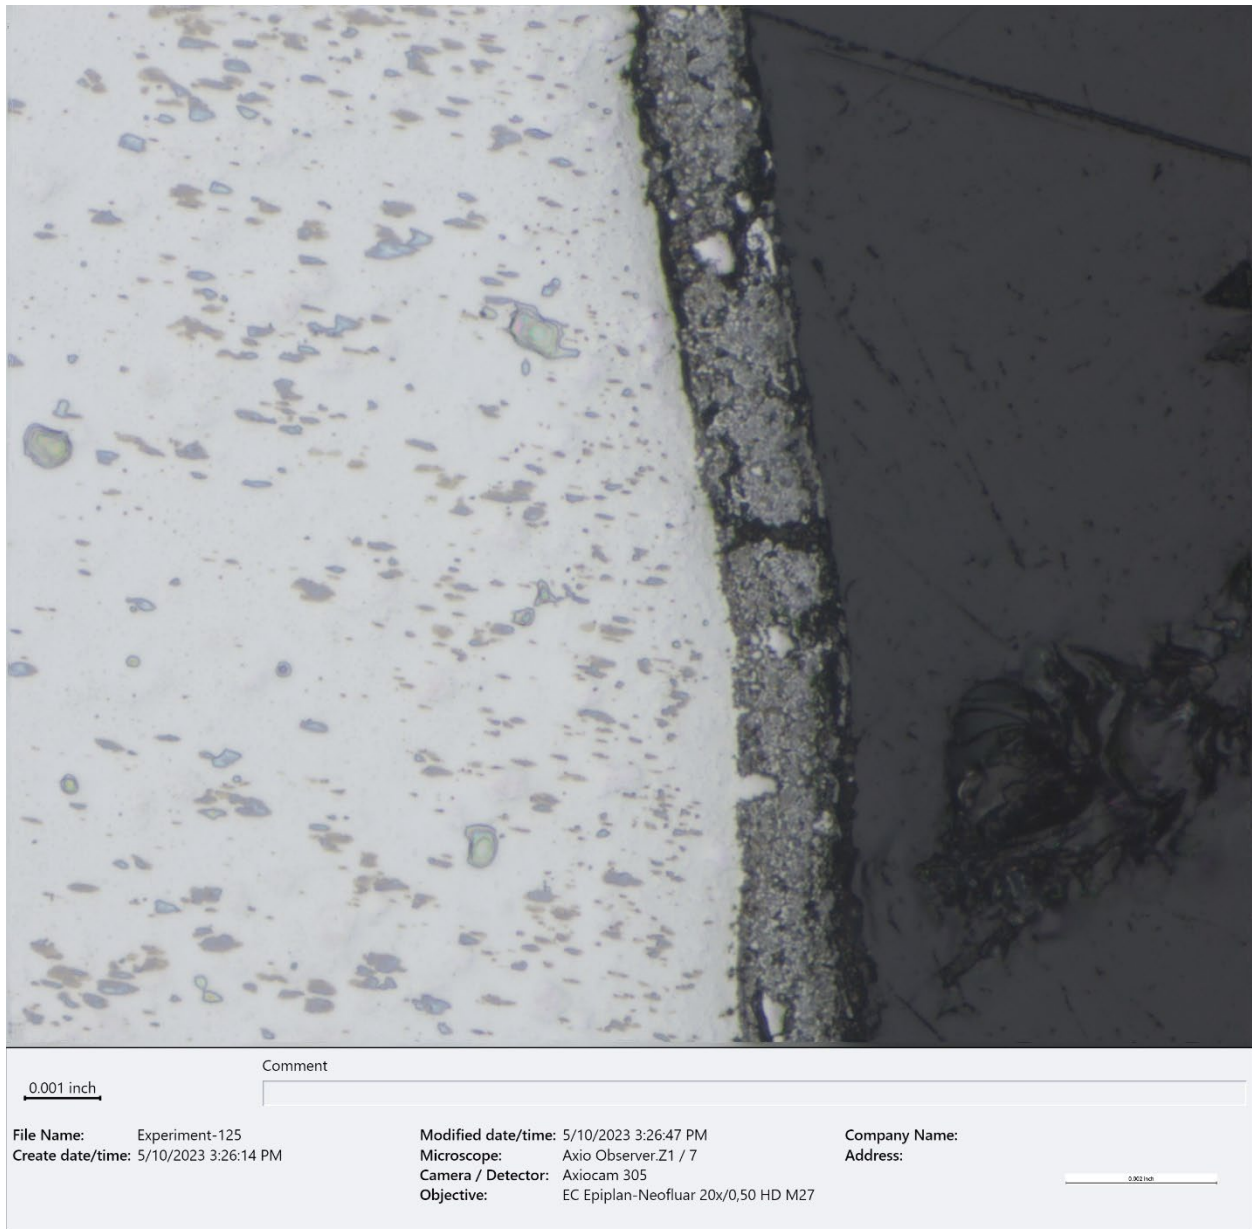
The cross-section through the fracture surface did not reveal subsurface oxidation but rather a more uniform layer approximately 50  $\mu\text{m}$  (0.002 inches) thick. Much of this layer was cracked. Due to the uniformity in thickness, the layer was consistent with post-fracture oxidation rather than corrosion occurring during crack growth.

**Figure 20.** BF optical micrograph of nonmetallic deposits on the fracture surface of the fractured valve stem (~500X, as polished).

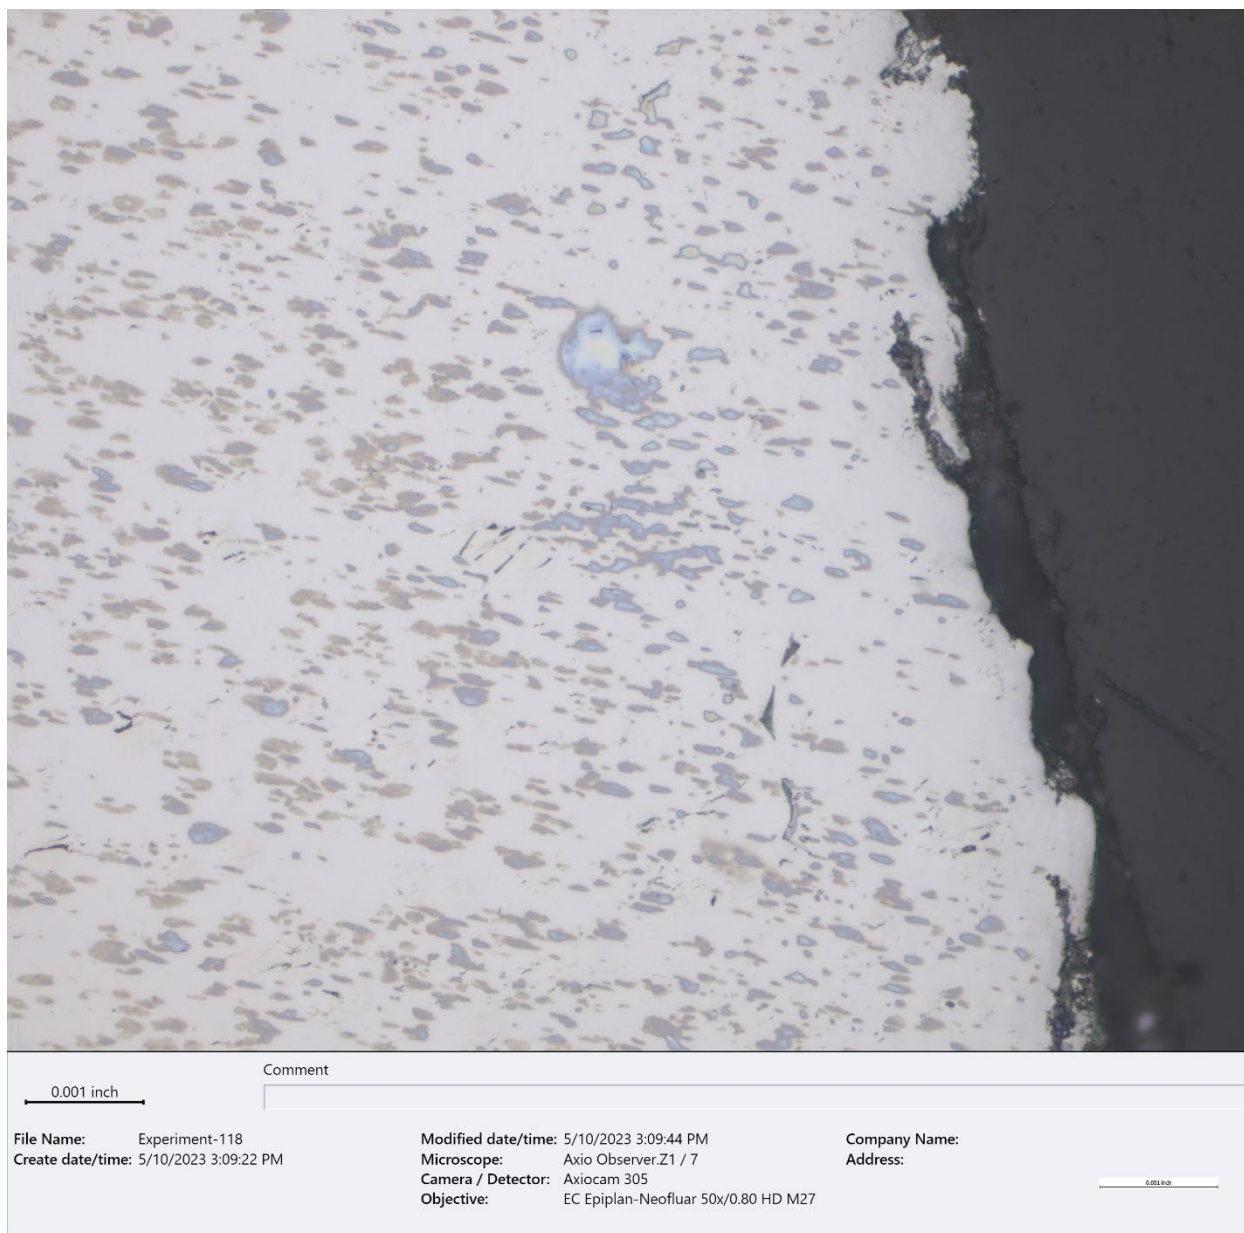
Figure 21 shows an area with rounded triple-point-shaped voids near the fracture surface. These features were consistent with void formation at high-temperature exposure, where diffusion and deformation occur along grain boundaries. These features were associated with small, shallow cracks that branched off from the main fracture surface in this location. Other small secondary cracks parallel to the fracture surface are depicted in Figures 22 and 23.

**Figure 21.** Closer view of an cross section of the fracture surface, showing sub surface cracks, and areas of internal intergranular porosity (~500X, as polished).

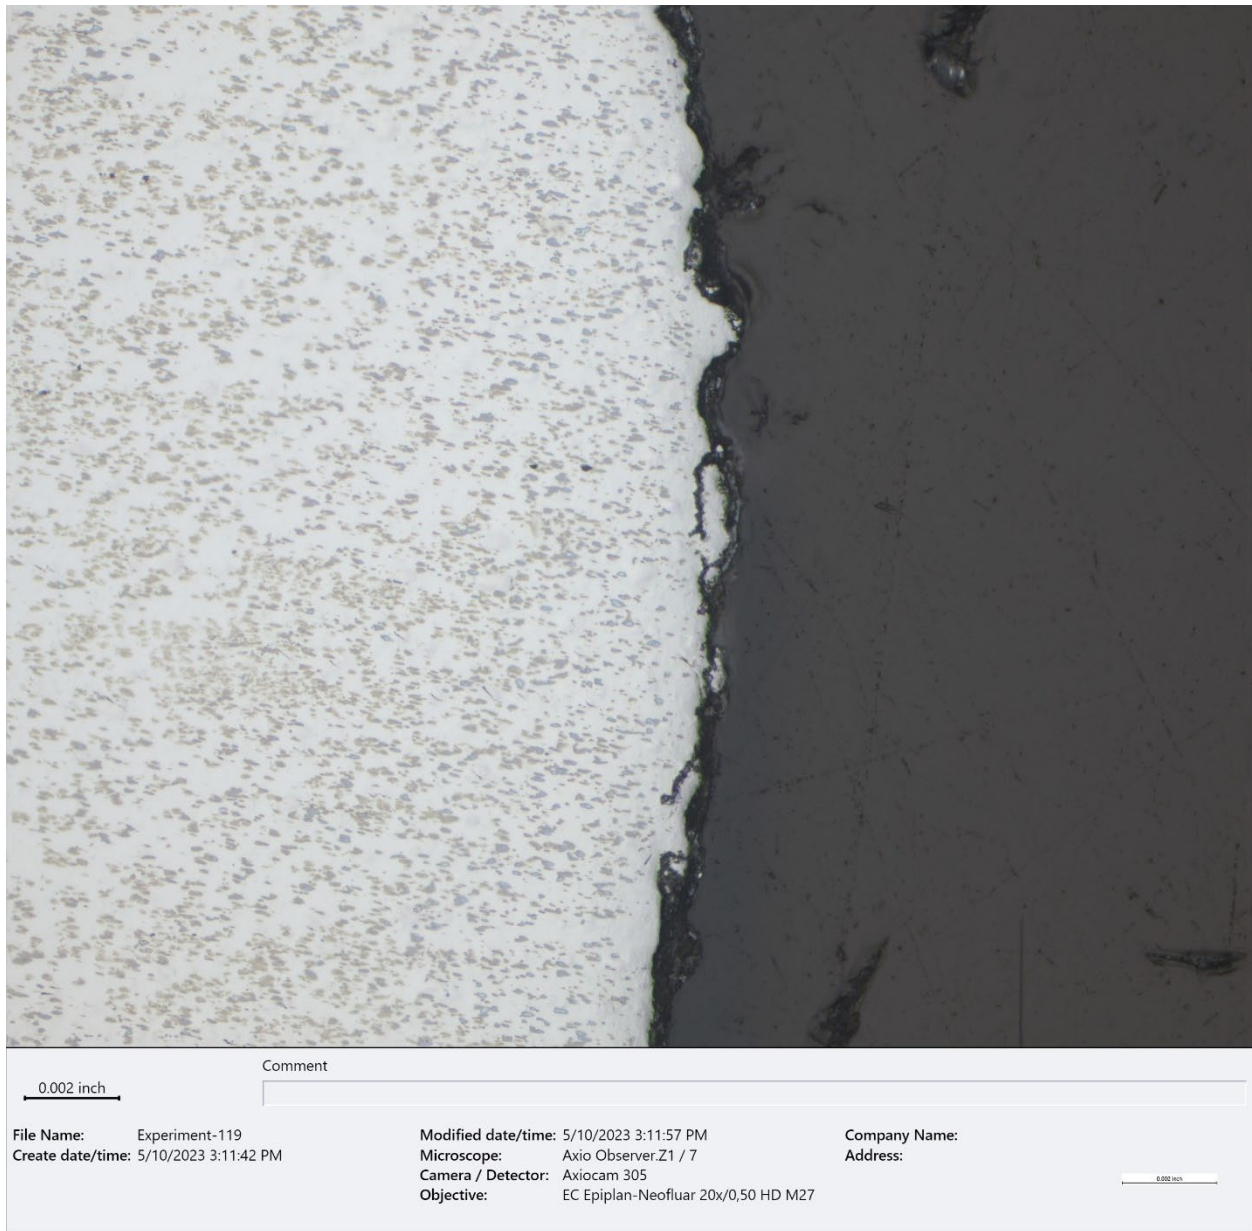
**Figure 22.** BF optical micrograph of small internal secondary cracks along the fracture surface (~200X, as polished).

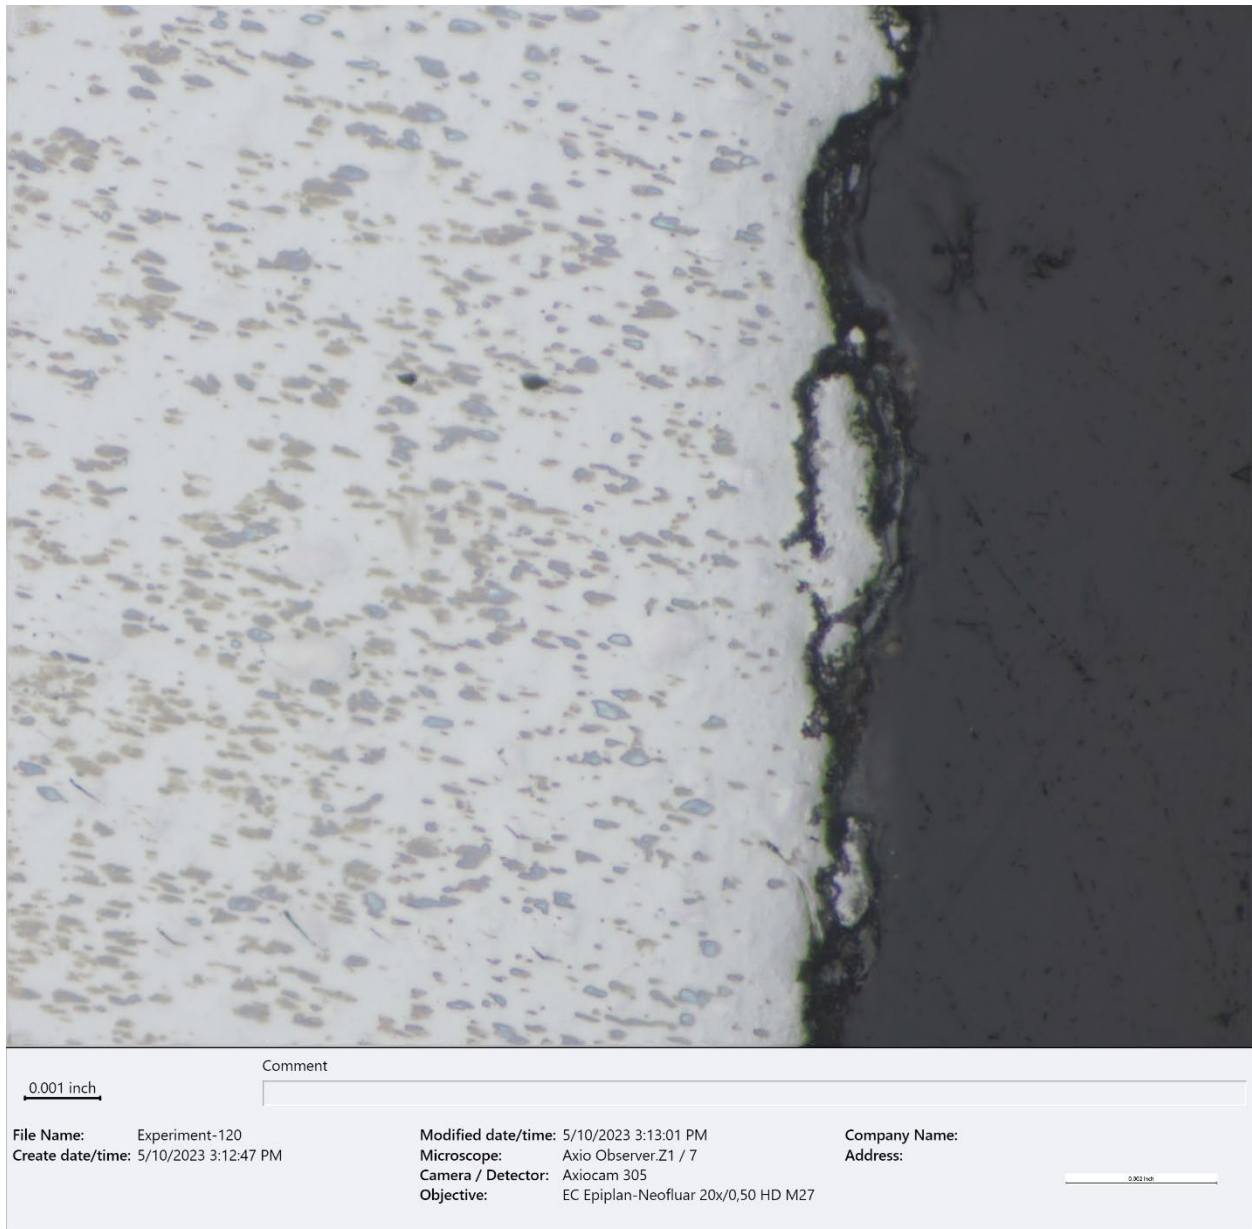
**Figure 23.** BF optical micrograph of secondary cracks in Figure 22, showing oxidation along the crack interior (~500X, as polished).
