# National Transportation Safety Board

WPR22LA351

## **AIRFRANE & ENGINE EXAMINATION**

Location: Ventura, California  
Date: September 16, 2022  
Time: 1630 Pacific daylight time  
Airplane: Cessna, 172L, N7917G

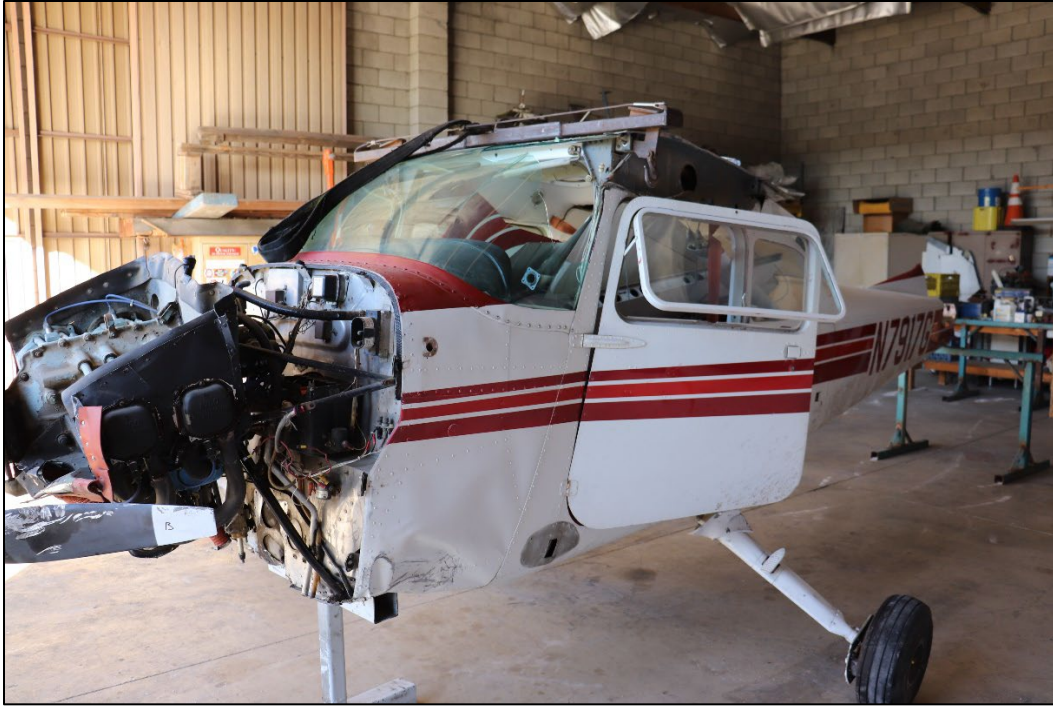
Examination of the recovered wreckage revealed that recovery organization had removed both wings, vertical stabilizer, horizontal stabilizer, both elevators and rudder for transport. The engine, engine mount, firewall, main landing gear, instrument panel and flight controls remained attached. The nose landing gear impact separated.

**Figure 1: View of airplane during examination**

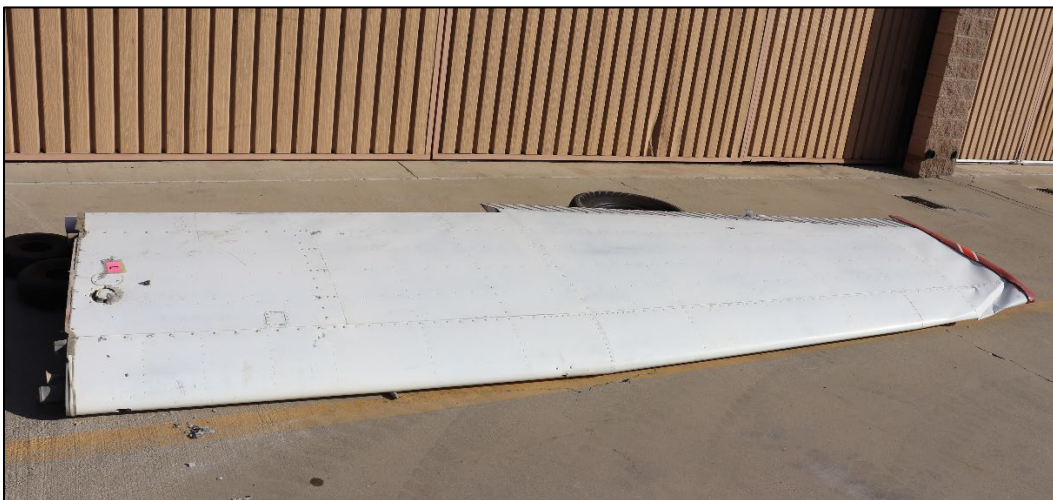
The left wing was separated from the fuselage at the wing root. Impact damage was observed on the leading edge near the wing tip. The left wing aileron and flaps remained attached to its respective attachment points. The wing tank was examined internally using a lighted borescope, no obstructions or debris was observed. Visual inspection of the left fuel cap revealed, rust and the rubber seal appeared worn. The left main filler port had rust and appeared worn.

**Figure 2: View of left-wing during examination**

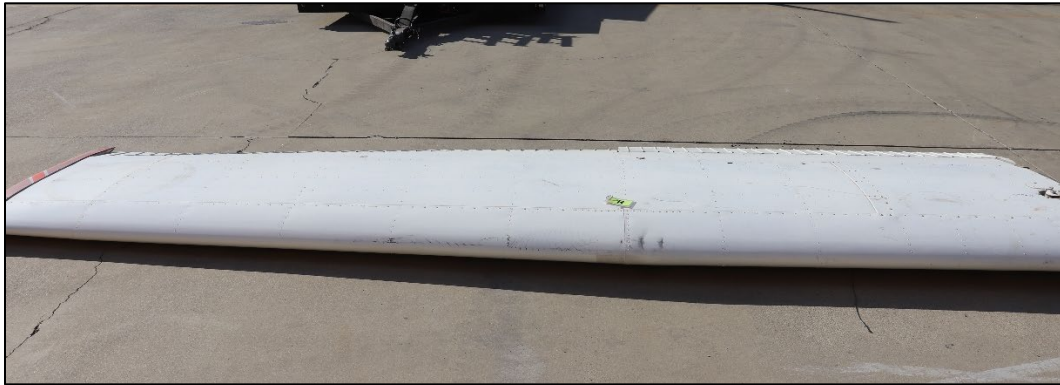
The right wing was separated from the fuselage at the wing root. The right wing aileron and flaps remained attached to its respective attachment points. The wing tank was

examined internally using a lighted borescope, no obstructions or debris was observed. Visual inspection of the right fuel cap revealed that the rubber seal appeared normal and unremarkable. The right main filler port was normal and unremarkable.

**Figure 3: View of right-wing during examination**

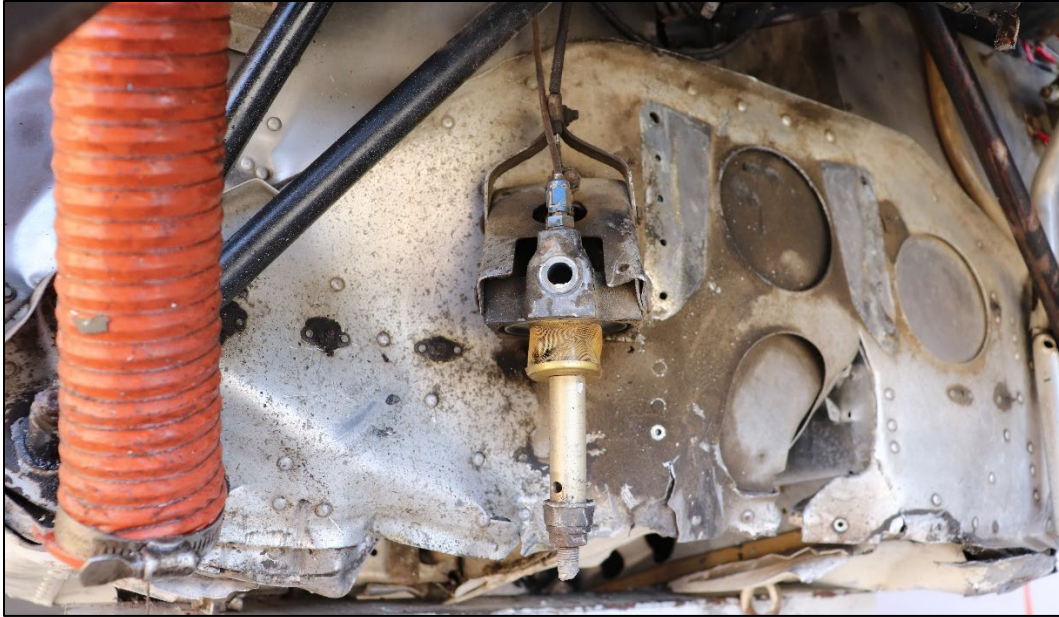
The fuel primer line and the bowl of the airframe fuel strainer assembly was separated and not observed with the wreckage.

**Figure 4: View of airframe fuel strainer assembly during examination**

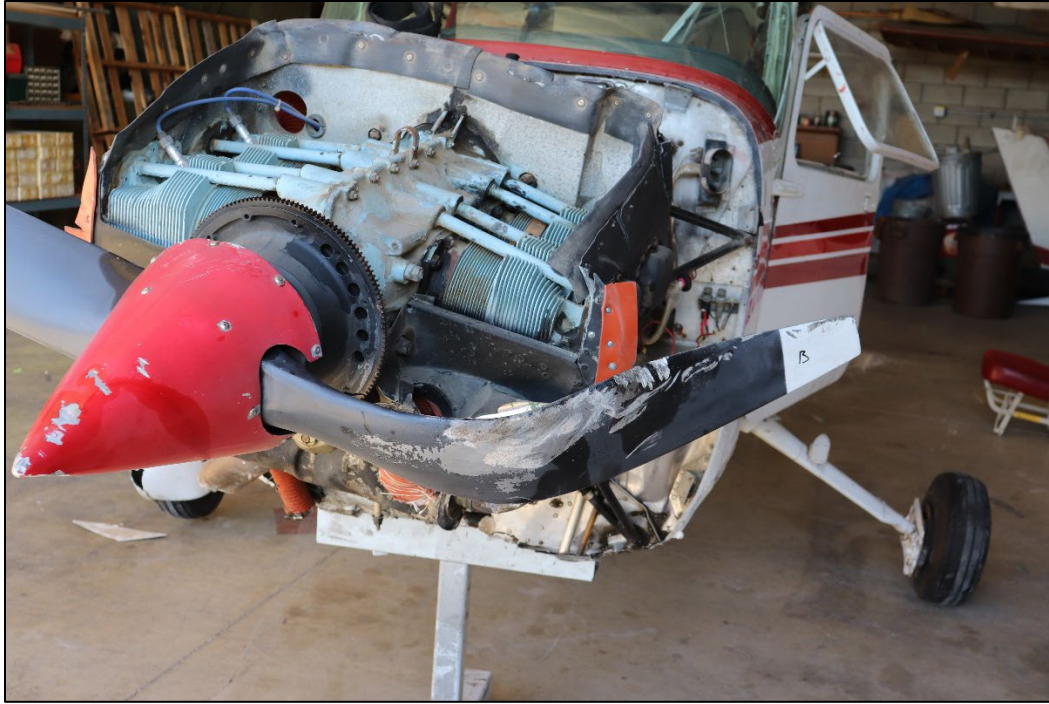
Examination of the recovered engine revealed that the engine remained attached to the airframe via the engine mounts. All four cylinders and all engine accessories remained attached. All fuel and oil lines that were removed were tight. No evidence of any mechanical damage was observed to the engine crankcase.

**Figure 5: View of engine during examination**

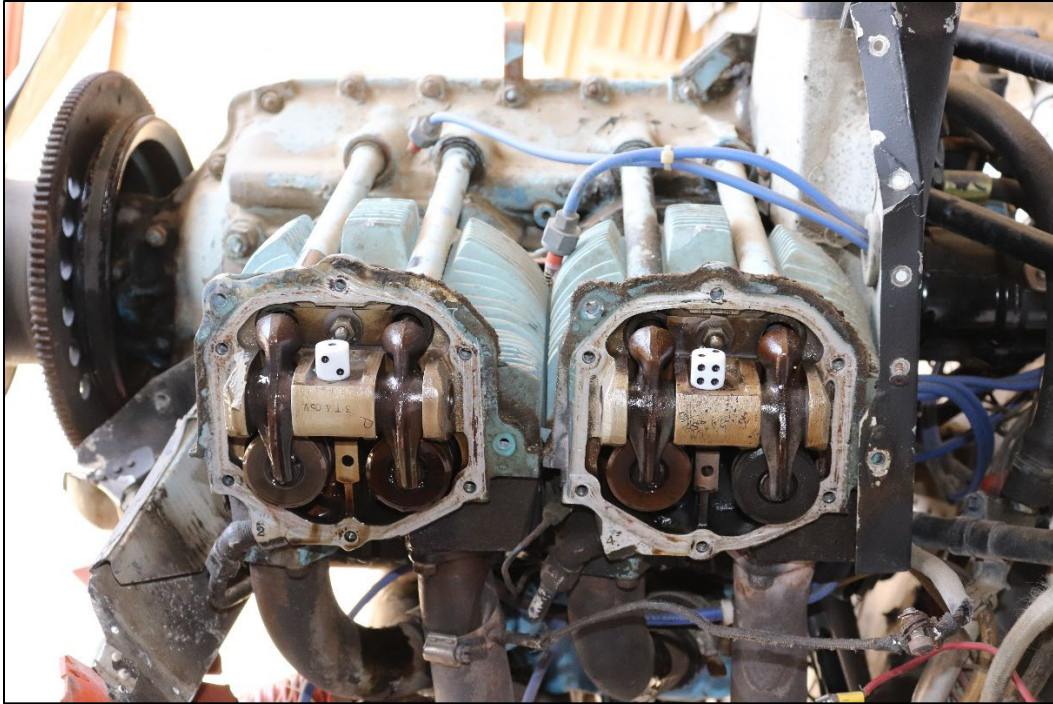
**Figure 6: View of left side of the engine**

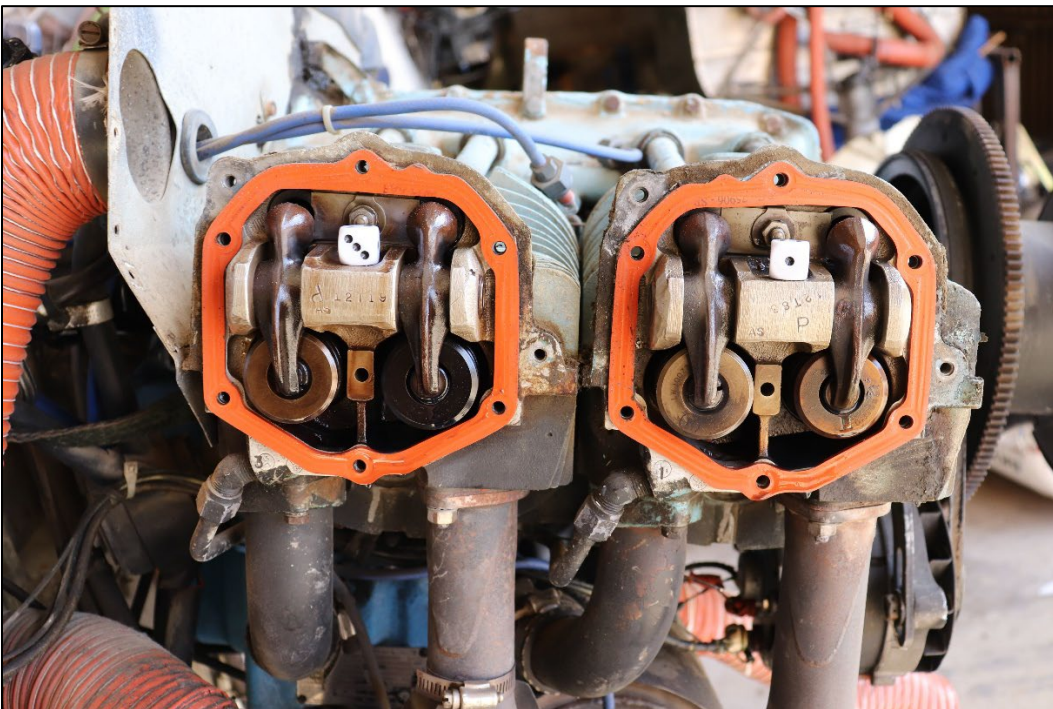
**Figure 7: View of right side of the engine**

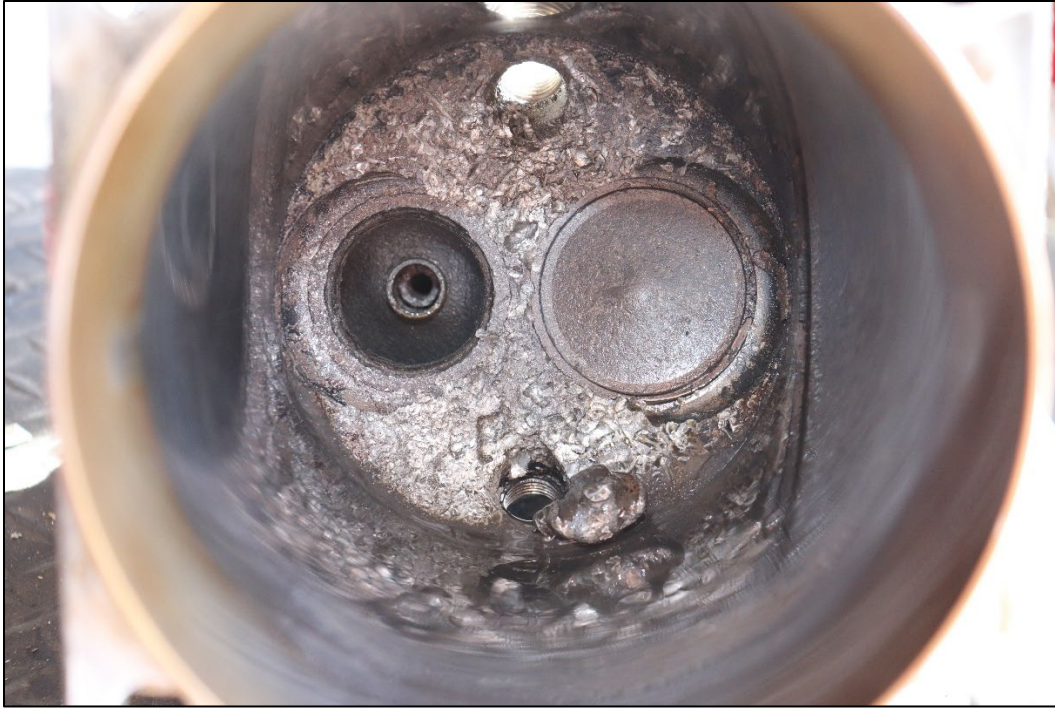
The number 3 and 4 cylinder were removed. Metallic debris was observed obstructing the number 3 cylinder intake valve. The number 4 cylinder was removed, remnants of the exhaust valve were observed within the cylinder.

**Figure 8: Interior view of number 4 cylinder**

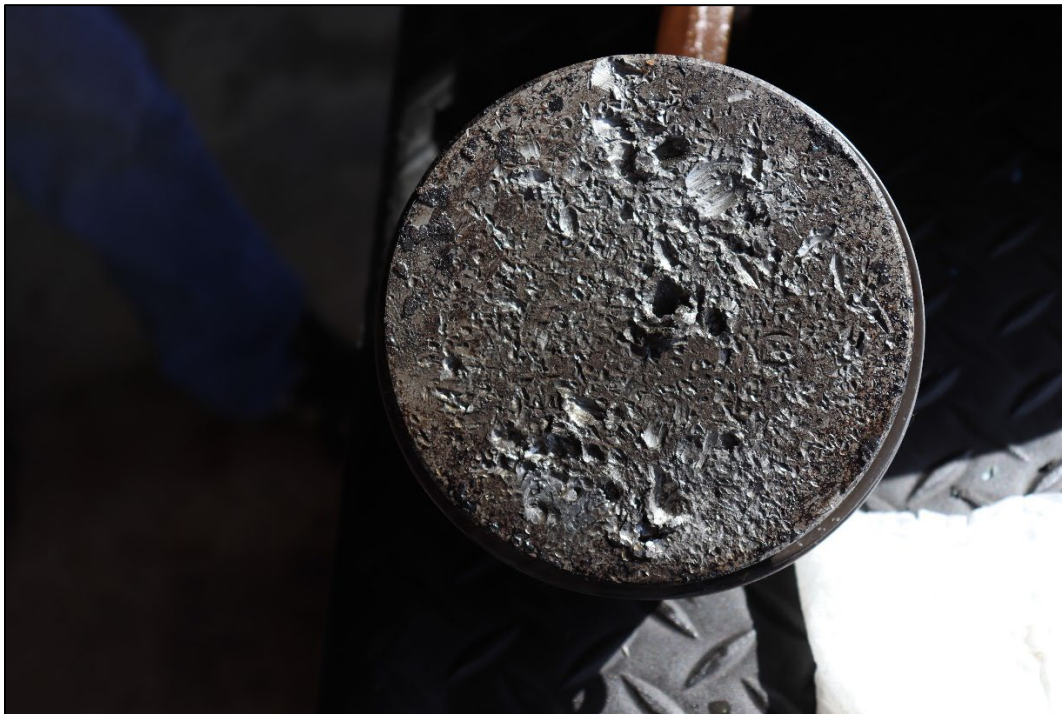
**Figure 9: View of number 4 cylinder piston face**

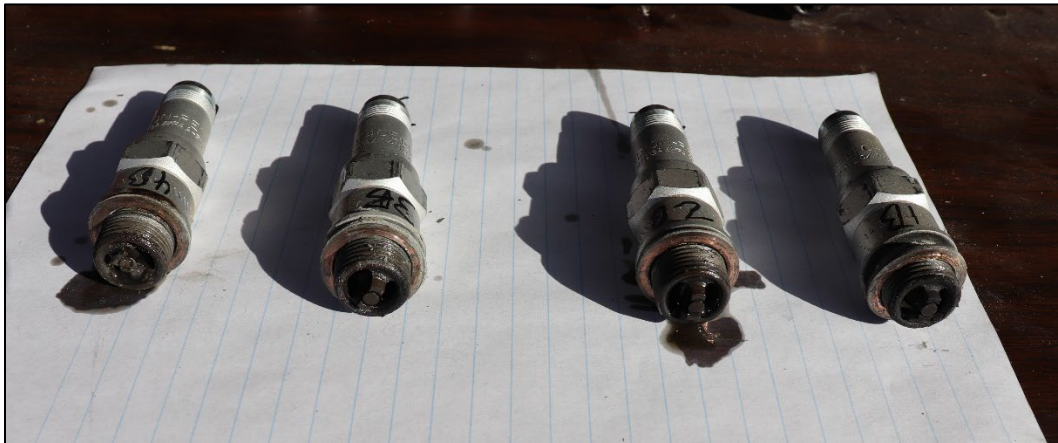
The bottom engine spark plugs were removed from the engine, and they were the massive electrode type. The sparkplugs exhibited black deposits within the electrode area. The number 1 and 3 cylinder spark plugs exhibited signatures consistent with NORMAL when compared to the Champion Check-A-Plug

comparison chart. The number 2 and 4 cylinder spark plugs were oil soaked and the number 4 electrode area was damaged.

**Figure 10: View of bottom engine spark plugs**

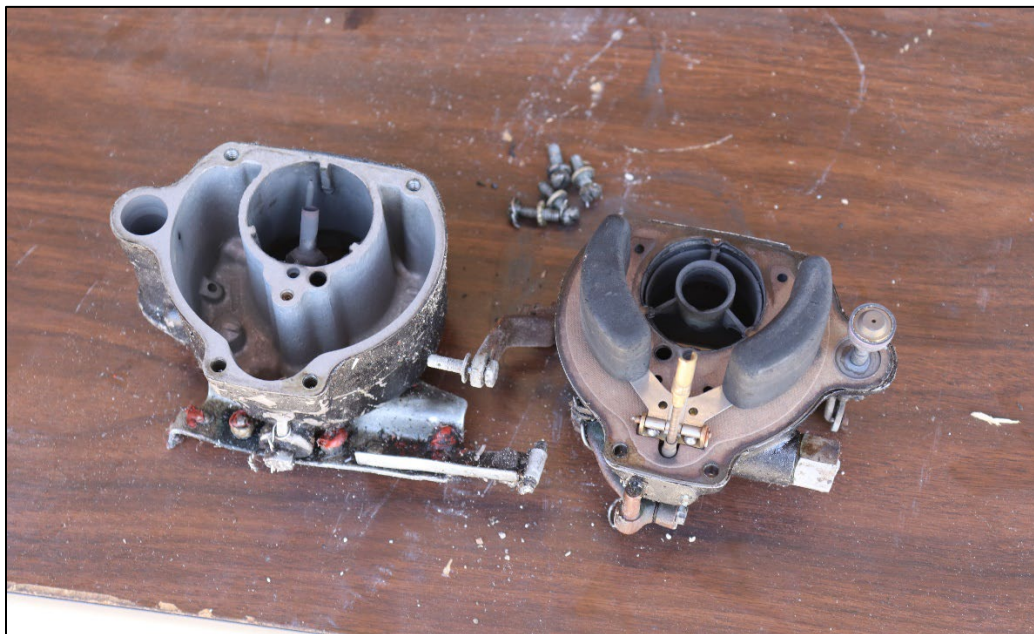
The carburetor remained attached to the engine and was impact damaged. The throttle and mixture control cable remained attached to the carburetor and was bent, consistent with impact damage. The carburetor was removed, and both the throttle and mixture control arms moved from stop to stop. No debris was observed in the carburetor inlet screen. The air induction body separated and was impact damaged. Crushing and bending throughout.

**Figure 11: View of carburetor**

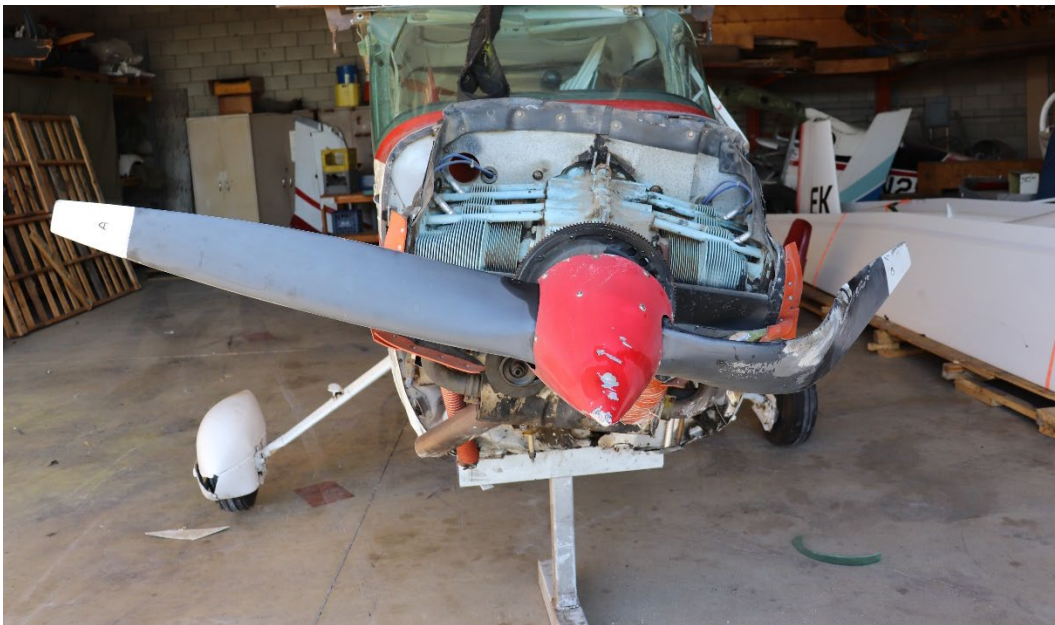
The airplane was equipped with a 2 blade McCauley propeller. Propeller blade B was bent aft about mid span and exhibited various striations on the cambered side of the blade.

**Figure 12: View of airplane propeller**
