WPR22LA352

## INVESTIGATION PHOTOGRAPHS

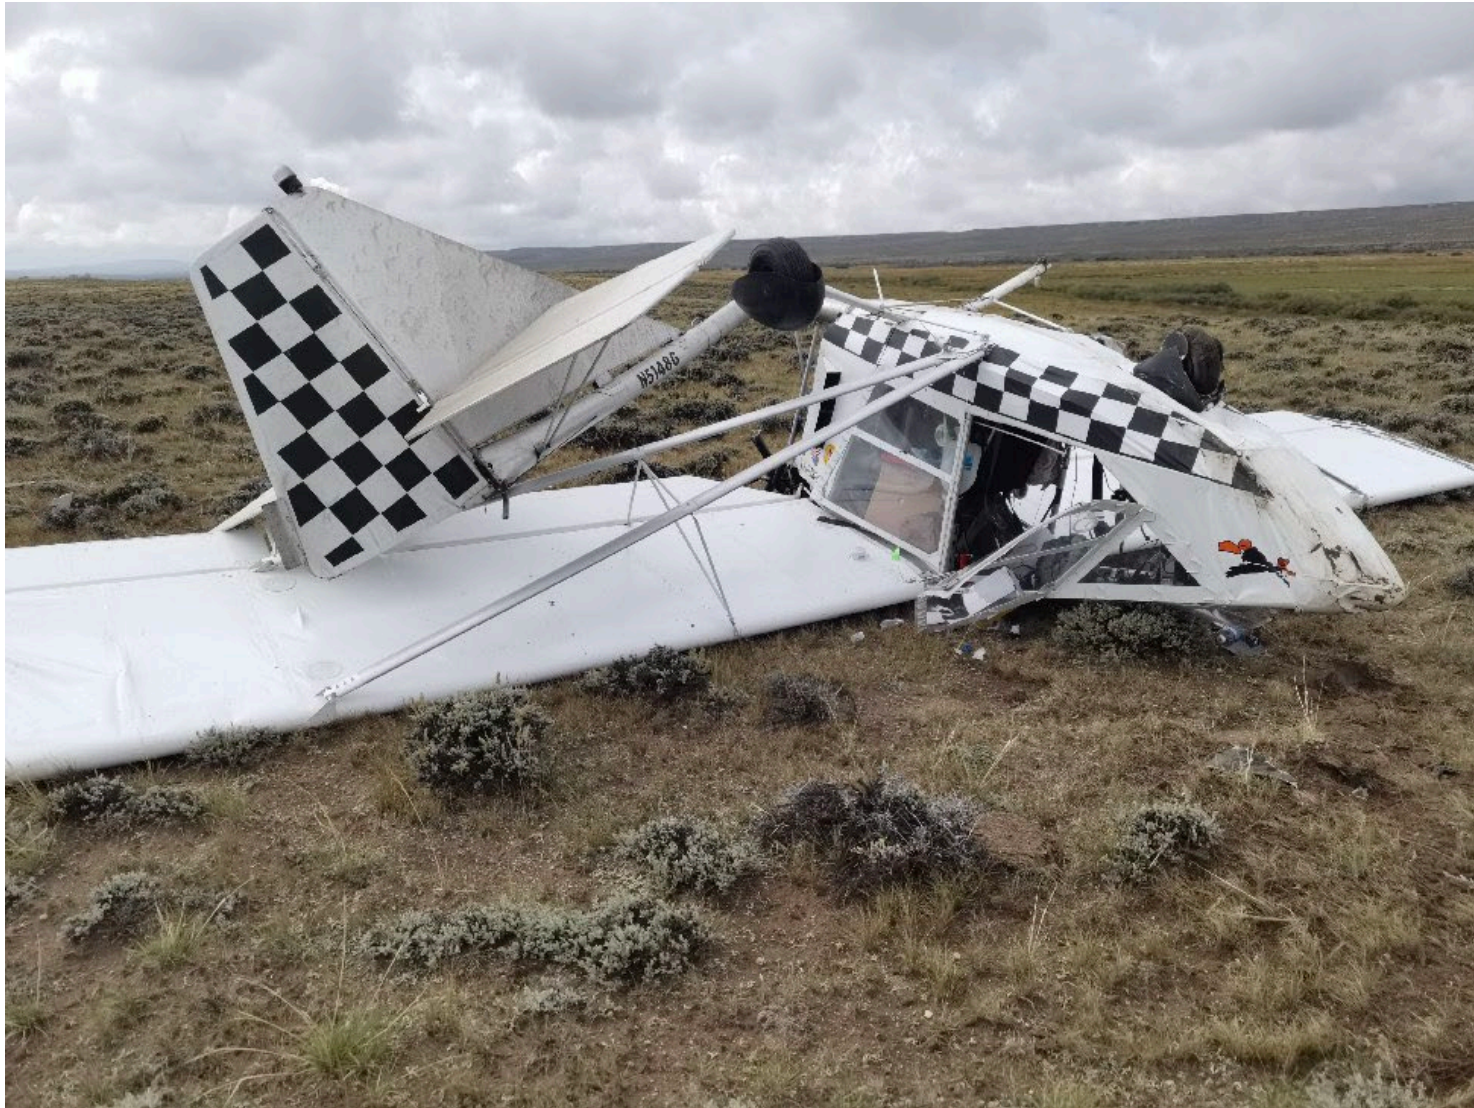
**Photograph 1 - View of nosed over airplane in an open field with damage to tailcone and wings  
(Courtesy of Highway Patrol Supervisor)**

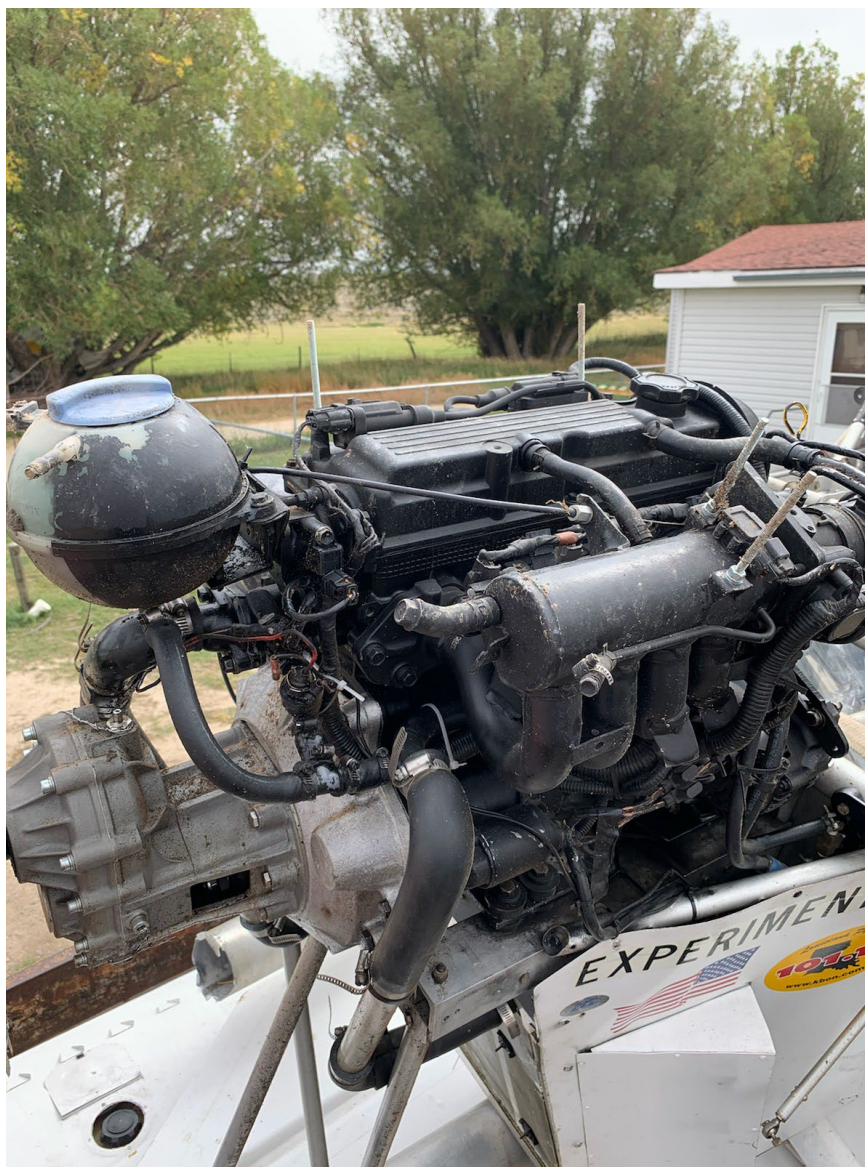
**Photograph 3 - View of accident engine (Courtesy of FAA Inspector)**

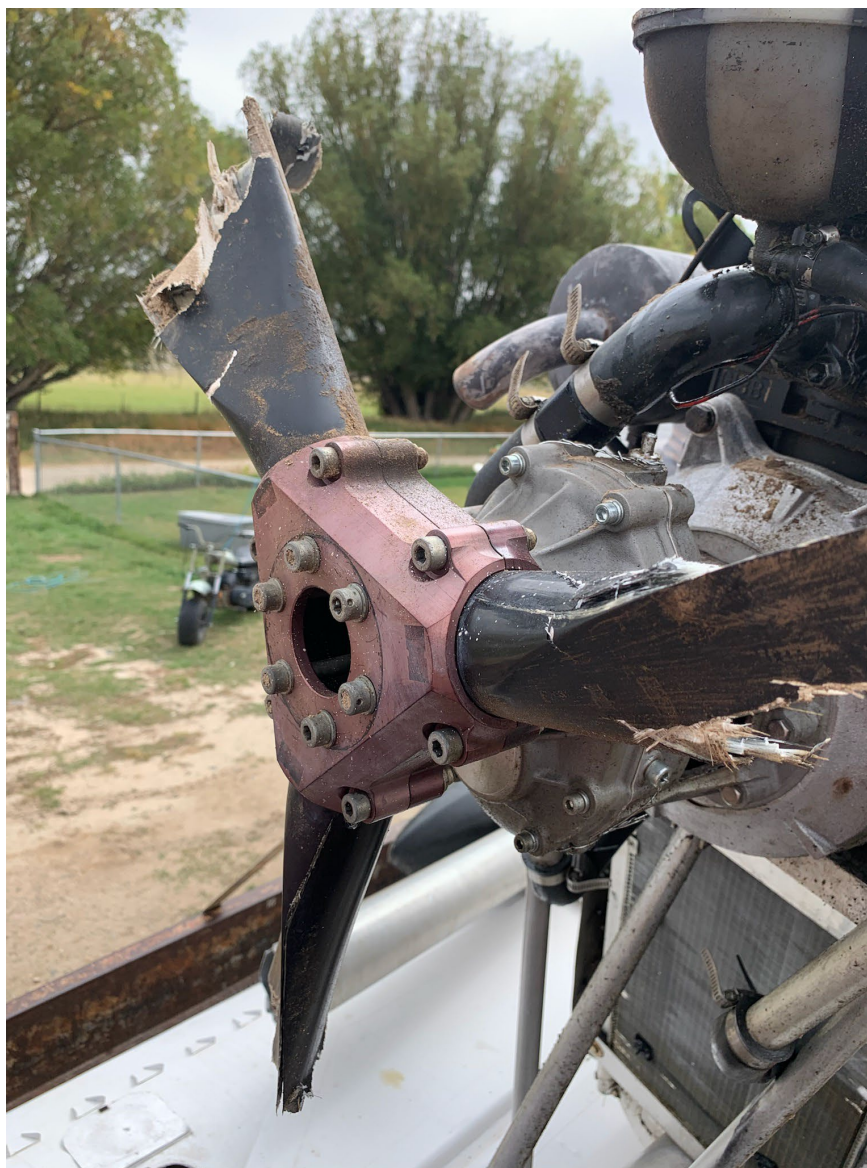
**Photograph 4 - View of damaged 3-bladed propeller (Courtesy of FAA Inspector)**

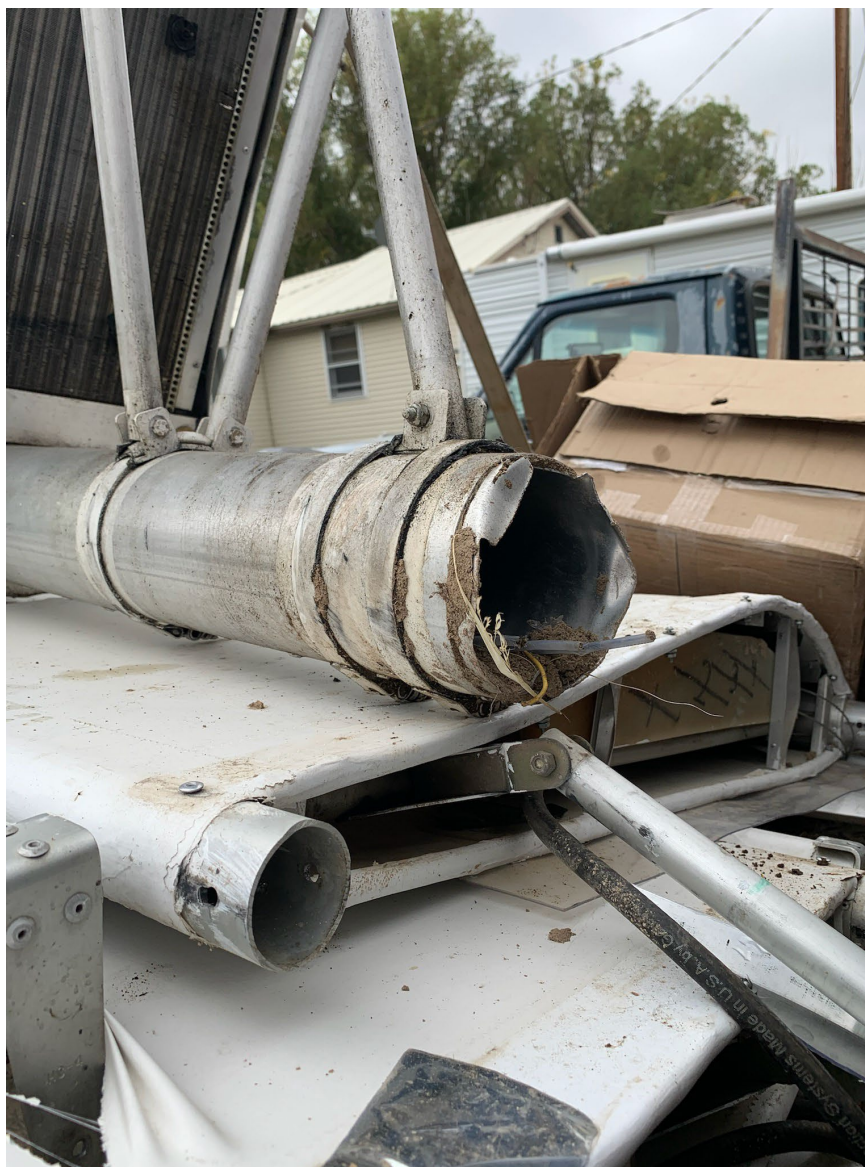
**Photograph 5 - View of damaged tailcone (Courtesy of FAA Inspector)**
