# National Transportation Safety Board

WPR22LA353

## **MATERIALS LABORATORY**

Factual Report 23-088

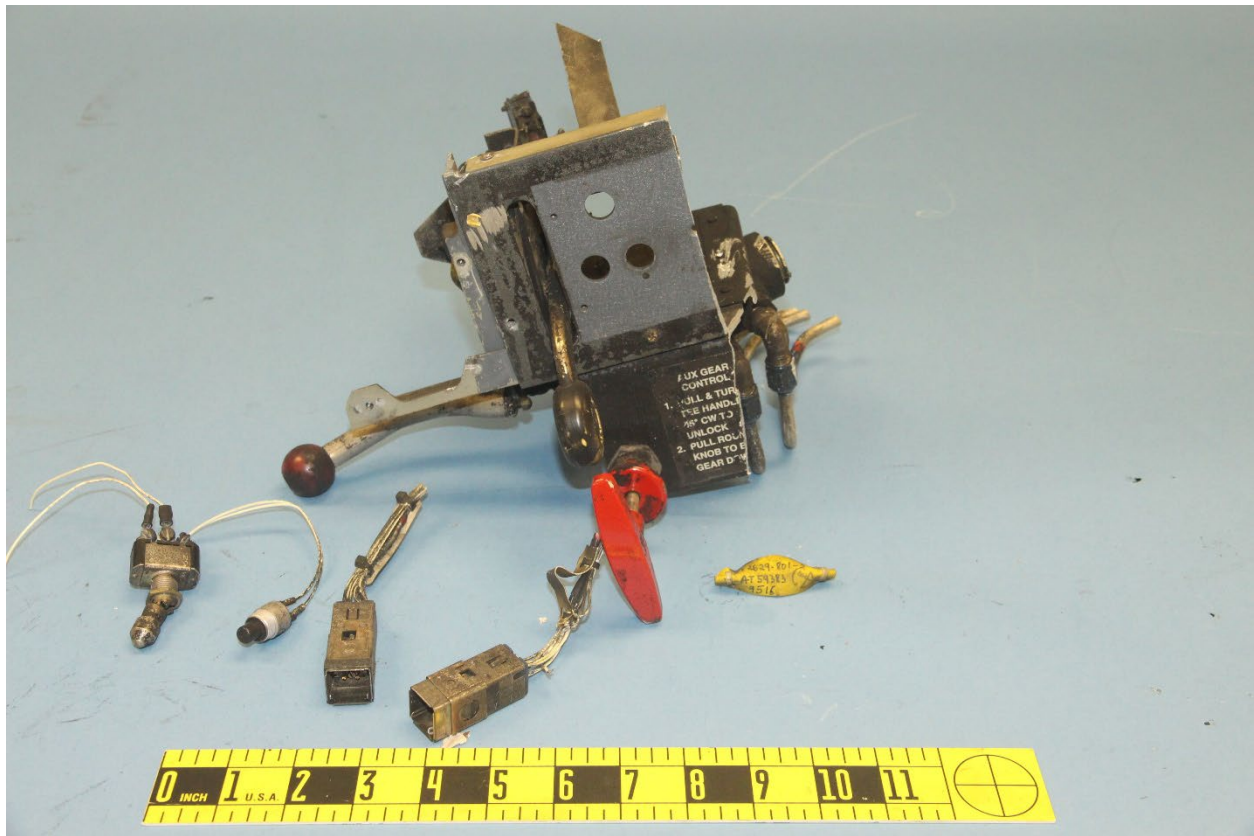
The portion of the instrument panel exhibited soot staining on both the outboard and inboard surfaces. The portion of instrument panel did not exhibit signs of high temperature exposure such as melting of the wire insulation on the electronic components or melting of the handle on the landing gear lever. The landing gear lever was received in the down position. To move the landing gear lever to the up position the handle on the lever is pulled towards the pilot (a limit switch becomes depressed) and then the lever is moved to the up position where it locks in place upon release of the handle (a different limit switch becomes depressed in the up position). There is a solenoid actuated stop pin which needs to retract for the lever to move to the up position. To move the landing gear lever from the up position to the down position the handle must be pulled towards the pilot and then the lever is moved to the down position and the handle is released. The solenoid activated stop pin is not involved in the lever movement from the up position to the down position. The landing gear lever was found to move freely as intended between the up and down positions and from the down to up position (By manually depressing the stop pin).

**Figure 1.** Portion of instrument panel containing the landing gear lever.
