# National Transportation Safety Board

WPR22LA353

## **AIRFRAME EXAMINATION**

Location: Pasco, WA  
Date: September 20, 2022  
Time: 0709 PDT  
1409 UTC  
Airplane: N528DV, Cessna 525B

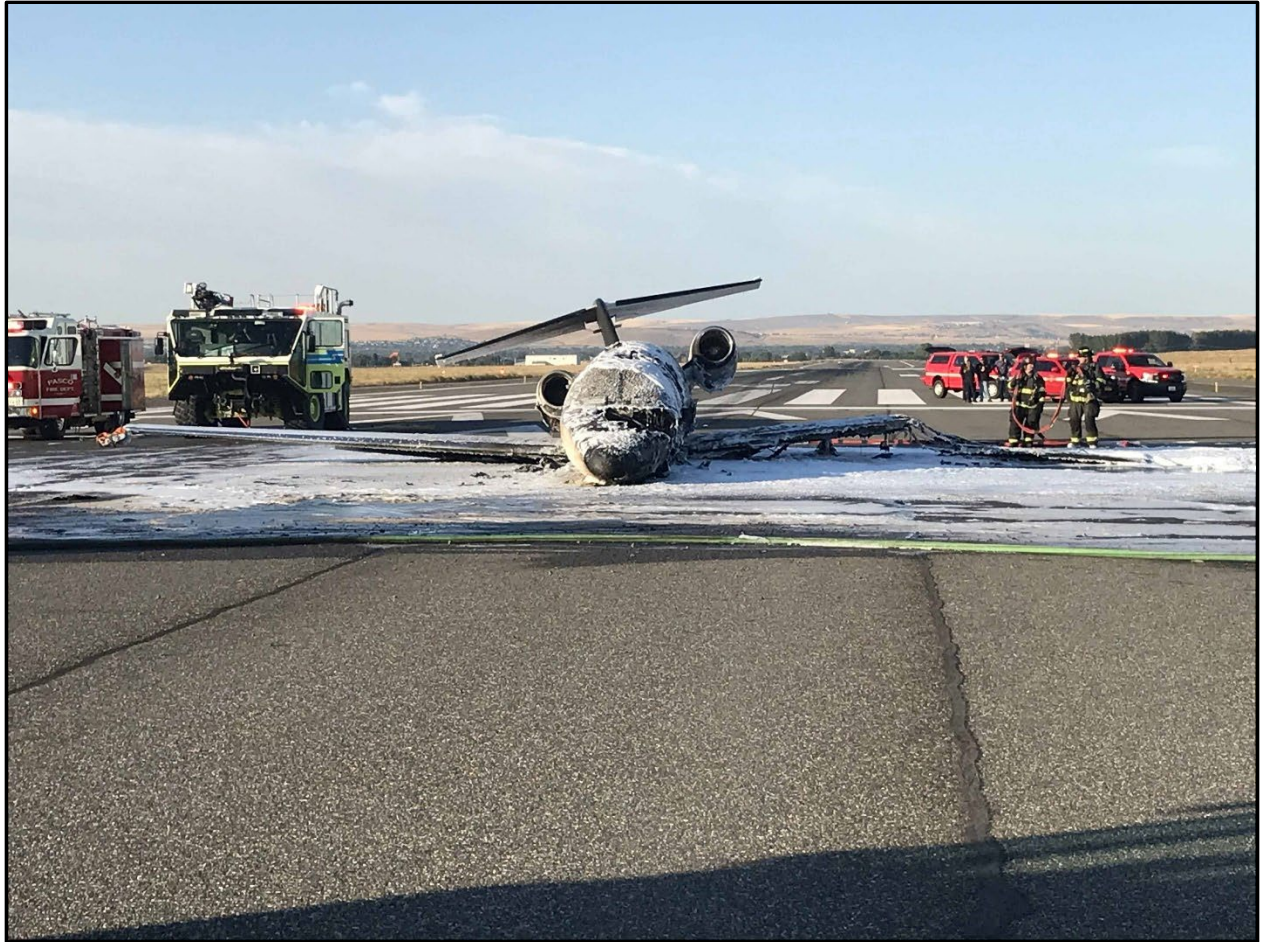
The airplane wreckage was recovered from the runway and situated in a hanger with the left main landing gear extended and the airplane resting on its nose and right wing. The aft portion of the fuselage was bent downwards and to the right. A majority of the wreckage sustained significant thermal damage. The entire fuselage sustained thermal damage.

**Photograph 1- Airplane wreckage on runway as viewed from the front. (Note: the left main landing gear door is partially extended).**

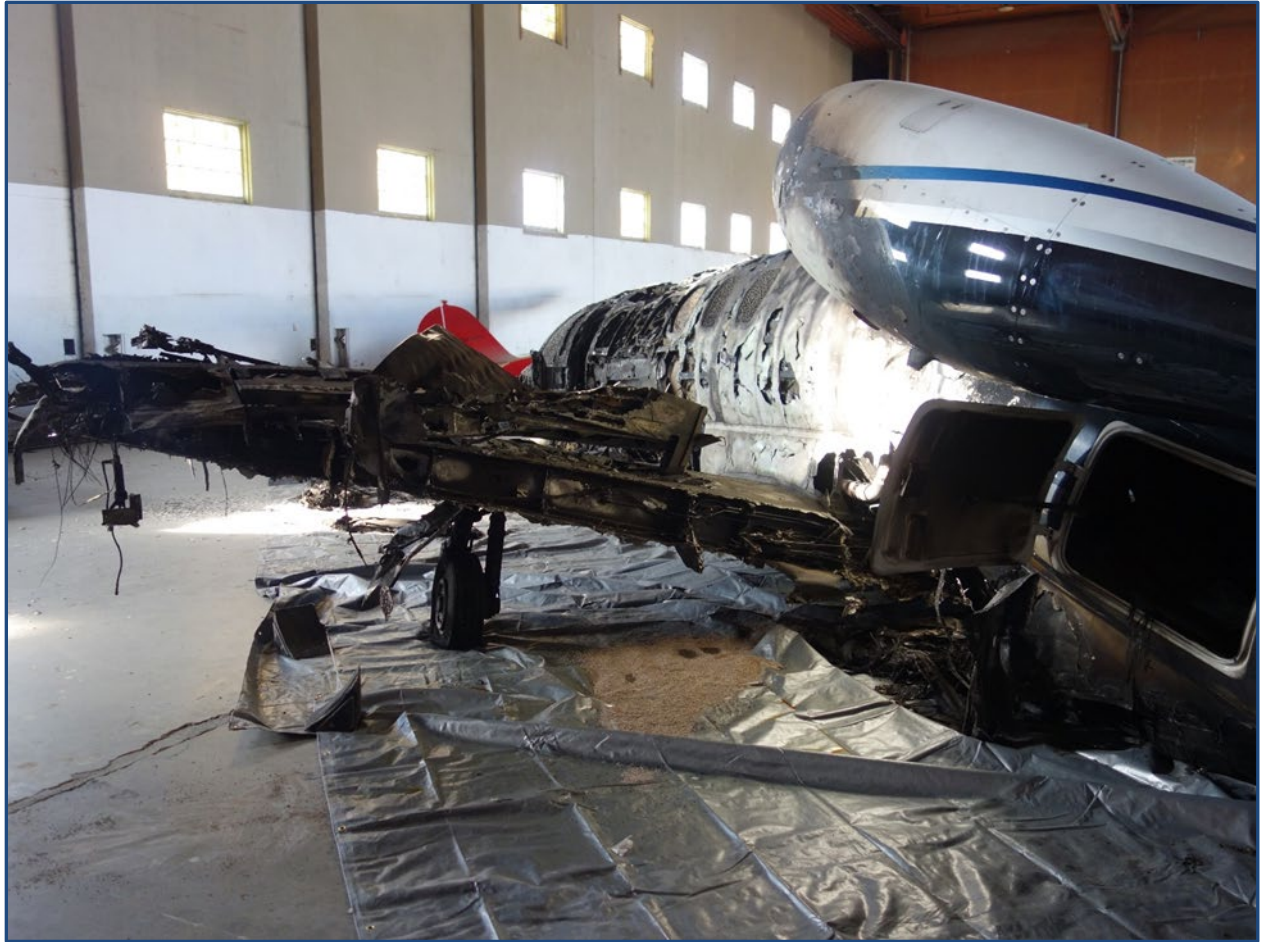
**Photograph 2- Airplane wreckage as viewed from the left side.**

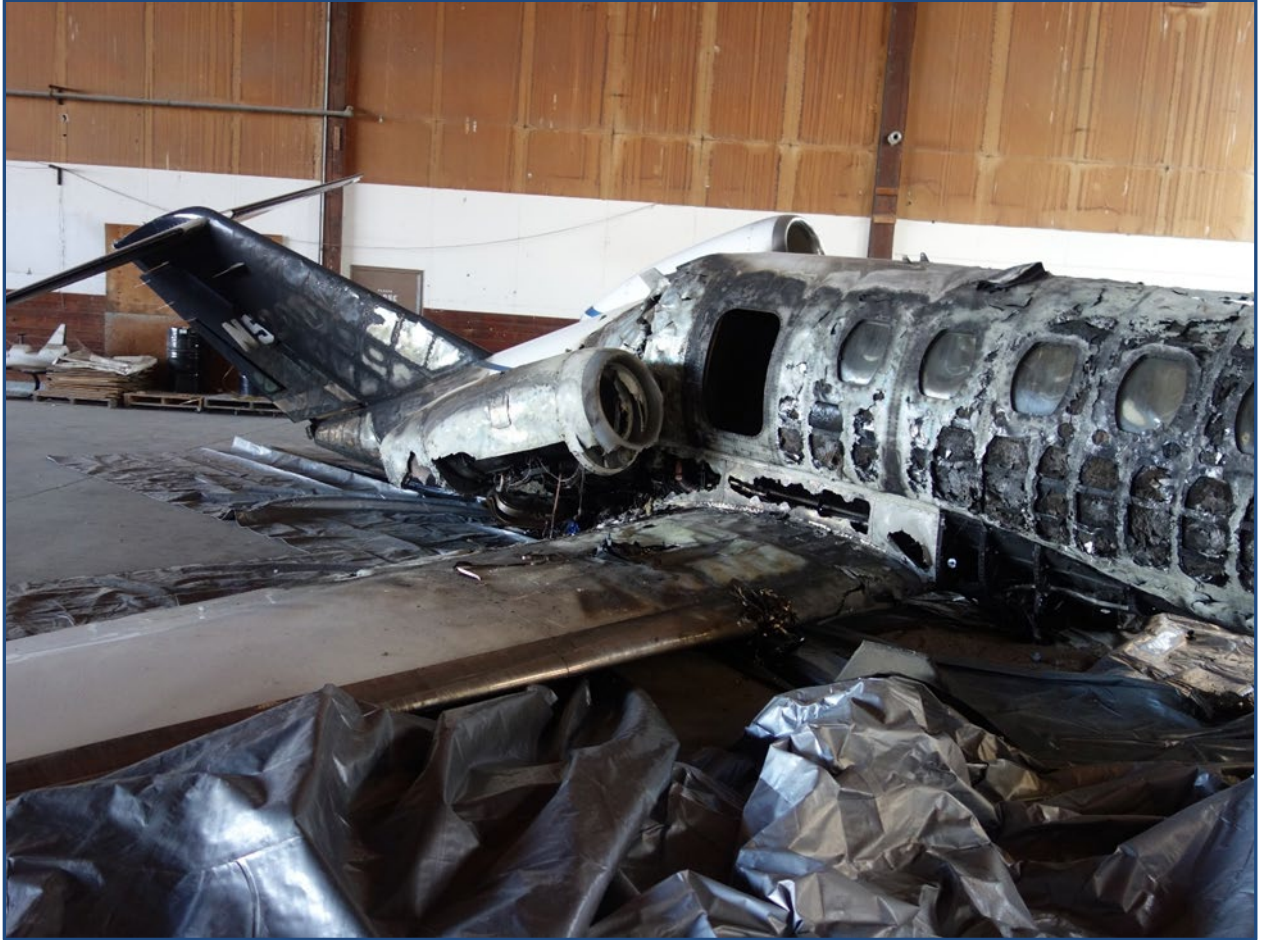
**Photograph 3- Airplane wreckage as viewed from the right side.**

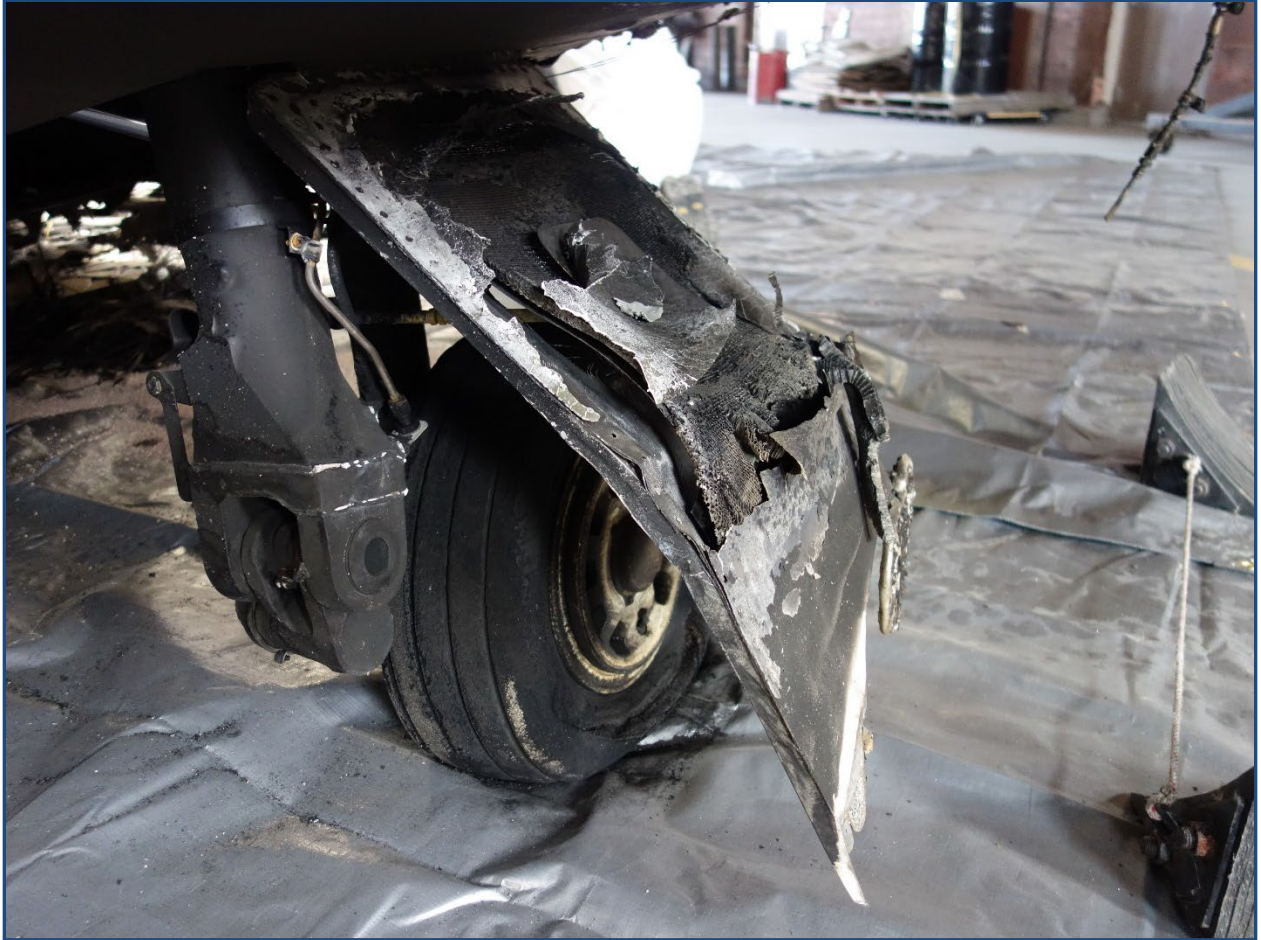
**Photograph 4- The left main landing gear as viewed from the front.**

Both main landing gear uplock hooks were observed in the gear released position. The left main landing gear down lock was examined and no anomalies were noted. The left main landing gear door sustained abrasion damage on the outboard edge. The left main landing gear tire sustained thermal damage. The right main landing gear's uplock hook lower end was separated. The separation was consistent with impact damage. The right main landing gear door could not be examined as no heavy equipment was available to lift the airplane wreckage.

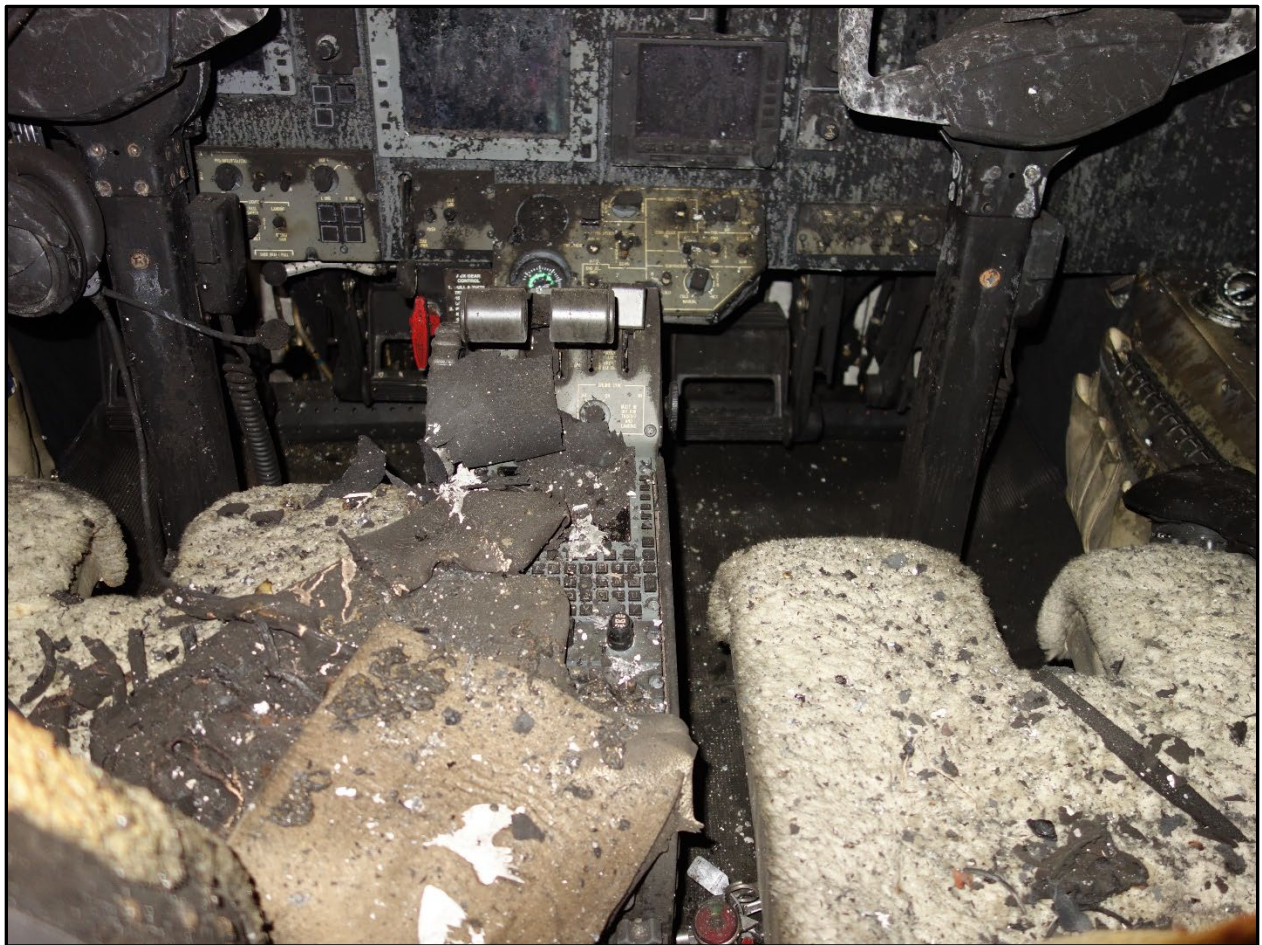
In the cockpit, the flaps were set to landing position. All circuit breakers were in. The throttles were at the idle position. The landing gear lever was observed in the down (gear extended) position and the emergency landing gear handle was observed in the stowed position. The battery was off. The cockpit and cabin interior sustained significant thermal damage.

**Photograph 5- Airplane cockpit area as viewed from the rear.**
