# National Transportation Safety Board

WPR22LA353

Specialist's Factual Report

Location: Pasco, Washington  
Date: September 20, 2022  
Time: 07:09 Pacific daylight time (PDT)  
Airplane: Cessna 525B, Private, N528DV

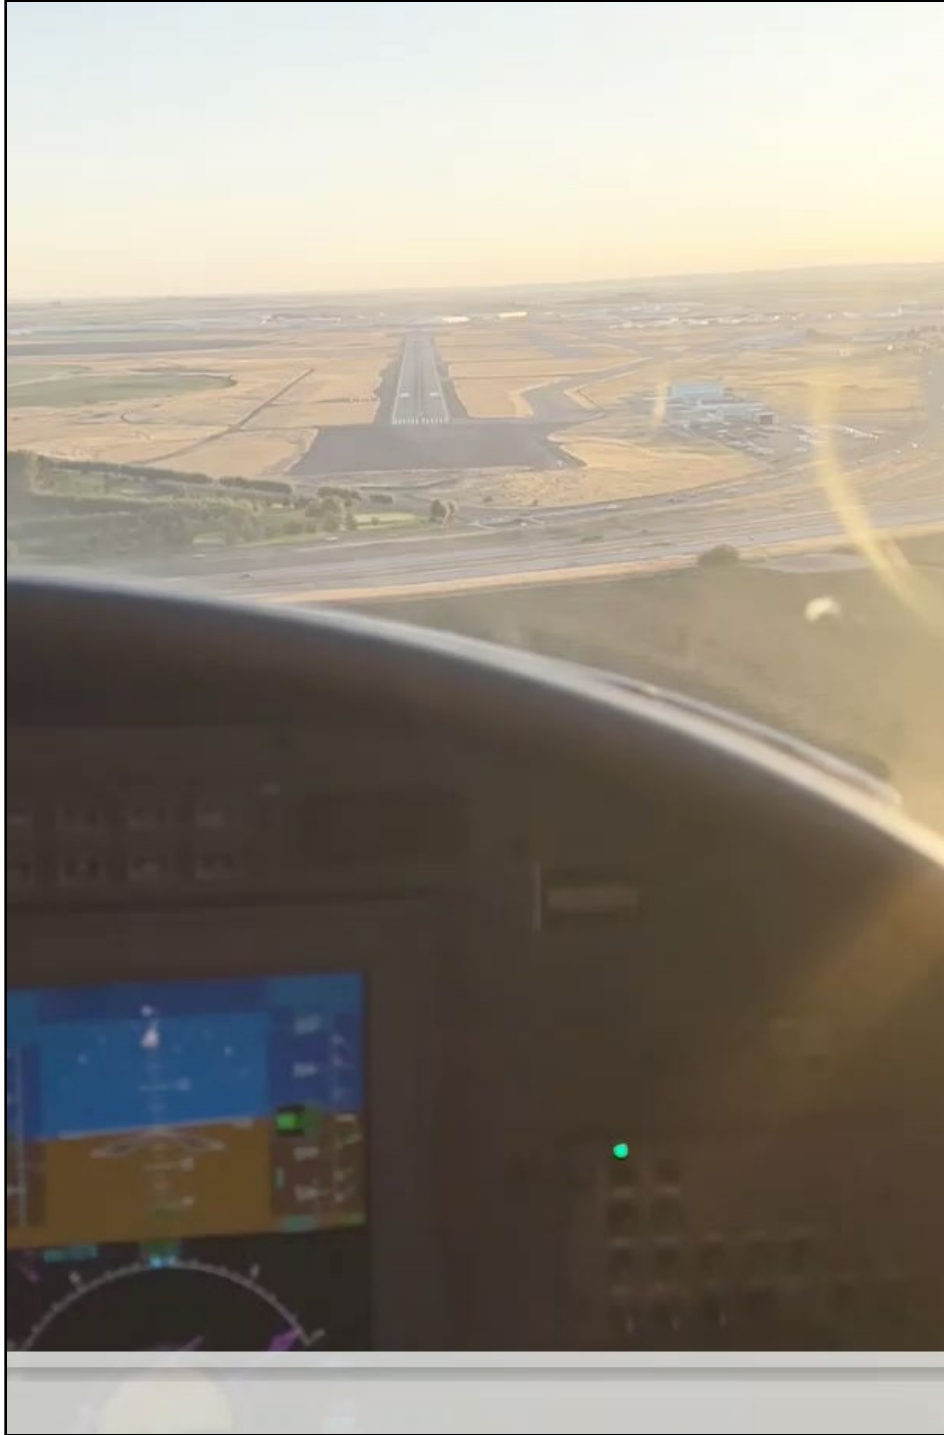
The video was recorded from the right front seat in the cockpit by a non-pilot-rated passenger. The view was external-facing with portions of the instrument panel visible. A screenshot of the first frame of the recording is shown in Figure 1.

**Figure 1.** The first frame of the video recording. Runway 3L at Tri-Cities Airport (KPSC), Pasco, Washington, is visible in the distance.
