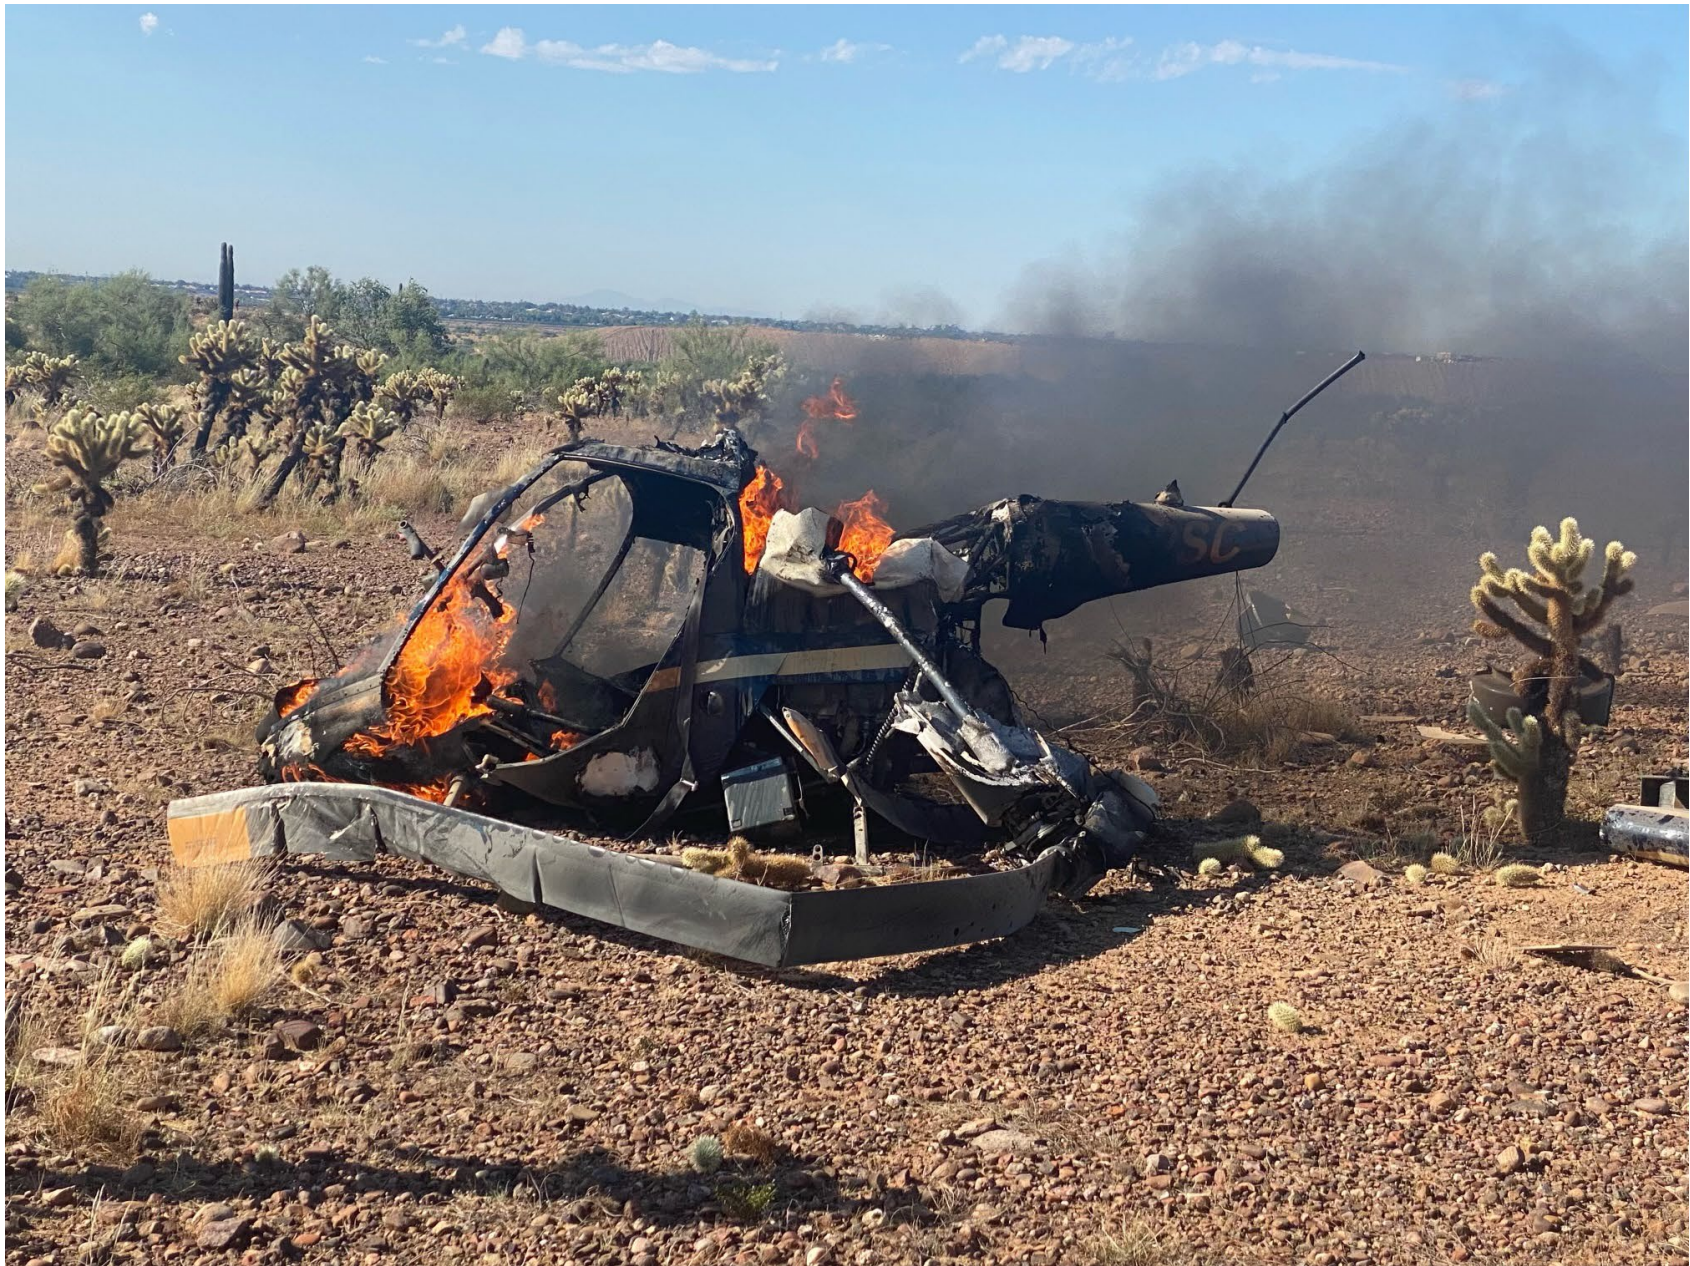
**Photo 1 – View of substantial damage to tail boom (provided by pilot)**
