# National Transportation Safety Board

WPR23FA047

## **AIRFRAME AND ENGINE EXAMINATION**

Location: Torrance, CA  
Date: 11/30/2022  
Time: 1100 PST  
1900 UTC  
Airplane: N60MY, Lightning

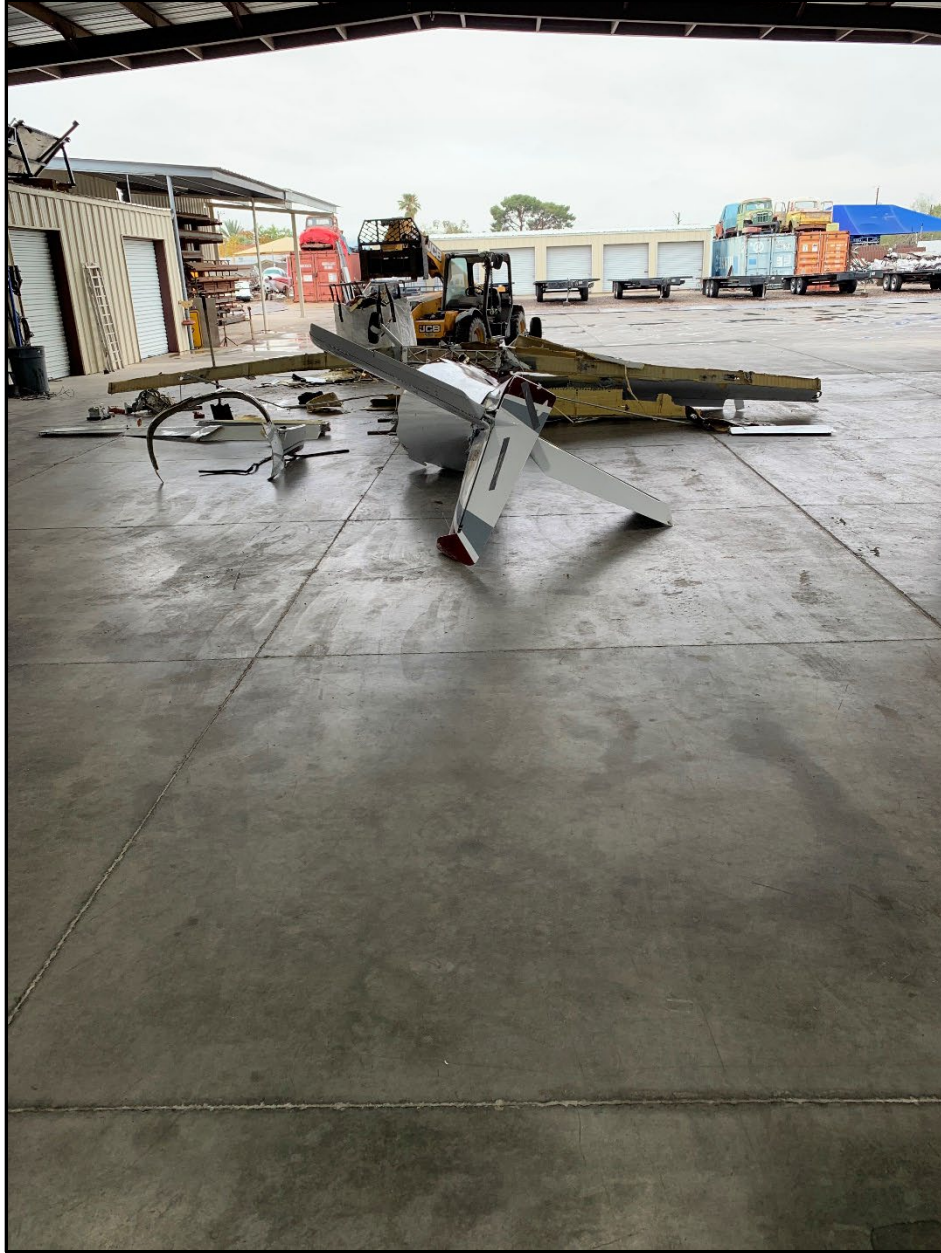
**Figure 1: Airplane wreckage as viewed from the rear.**

The airframe sustained impact damage to the fuselage and wings. The engine was separated from the fuselage for recovery. The empennage was relatively intact. The vertical stabilizer, rudder, horizontal stabilizers, and elevators were attached.
