# National Transportation Safety Board

WPR23FA047

## **ACCIDENT SITE SUMMARY**

Location: Torrance, CA  
Date: 11/30/2022  
Time: 1100 PST  
1900 UTC  
Airplane: N60MY

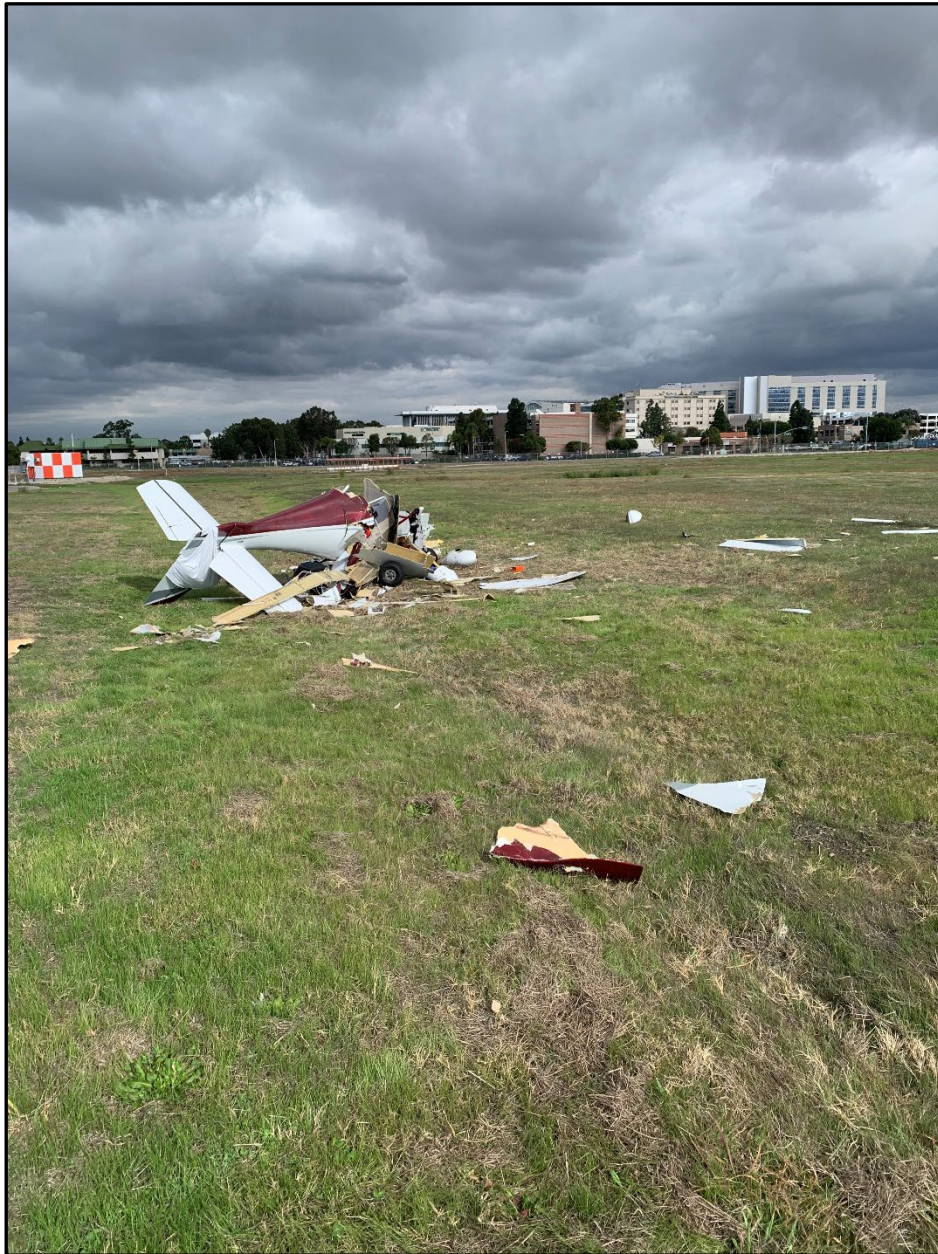
Examination of the accident site revealed that the white and maroon colored airplane impacted a grass field about 1250 ft short of the approach threshold of runway 11R. A ground disturbance consistent with the impact of the wings was observed in the ground. Numerous sections of the leading portion of the wings were observed in the ground disturbance. The terrain was generally flat with a drainage ditch, about a 1 ft

in depth, parallel to the runway. where the airplane impacted. The forward portion of the main wreckage was observed in a nose down attitude with the engine mostly buried in the ground. Most of the wreckage debris, consisting of small fragments, scattered about 25 ft from the main wreckage. Additionally, one propeller blade was located about 150 ft northwest of the main wreckage and a small section of the windshield was located about 100 ft north of the main wreckage. The wreckage site was at an elevation of about 90 ft.

**Figure 1: Airplane wreckage in the field.**
