WPR23FA073

## INVESTIGATION PHOTOGRAPHS

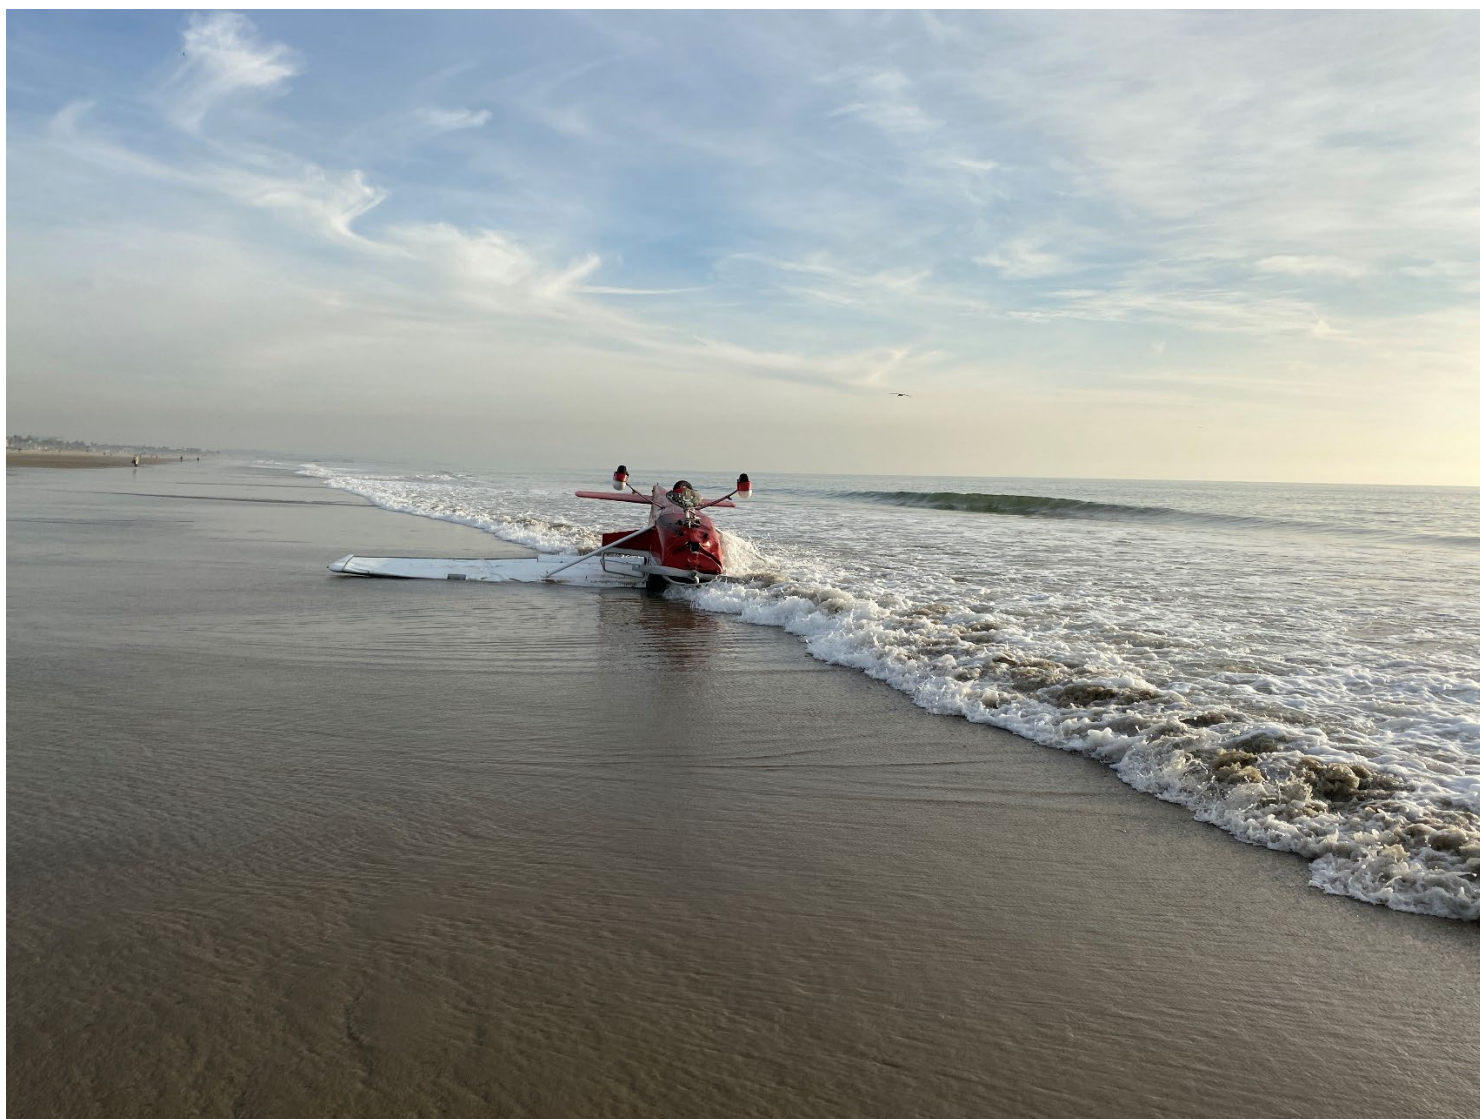
**Photograph 1 - View of the airplane at rest after nose over on shoreline with right wing submerged (Courtesy of LEO)**

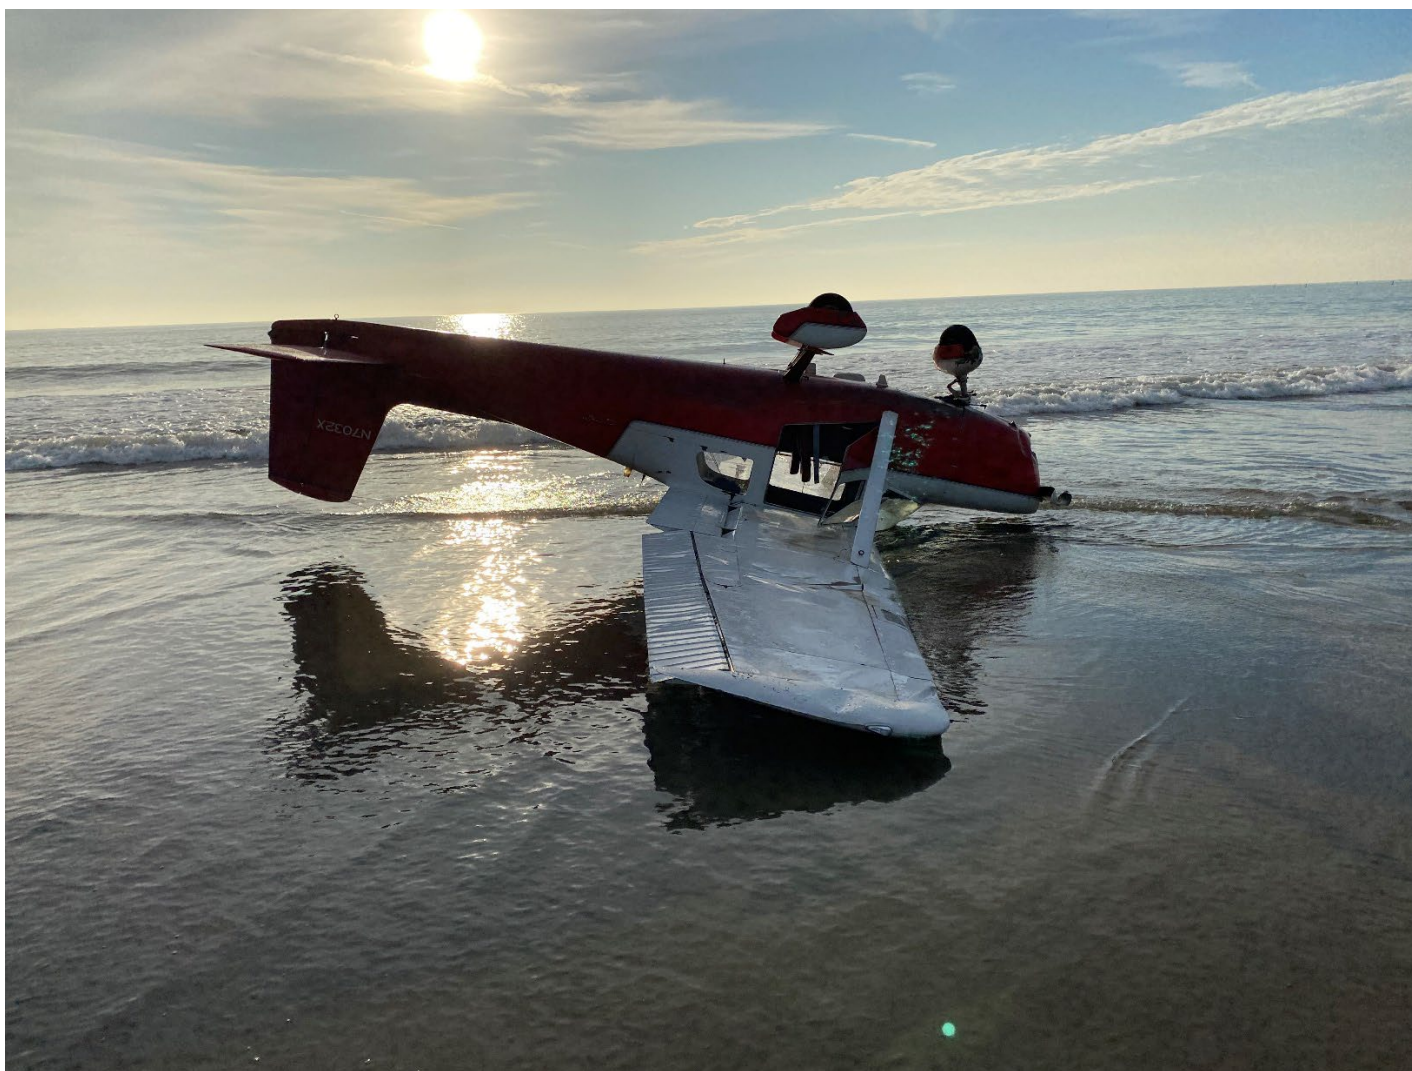
**Photograph 2 - View of inverted airplane -left side (Courtesy of LEO)**

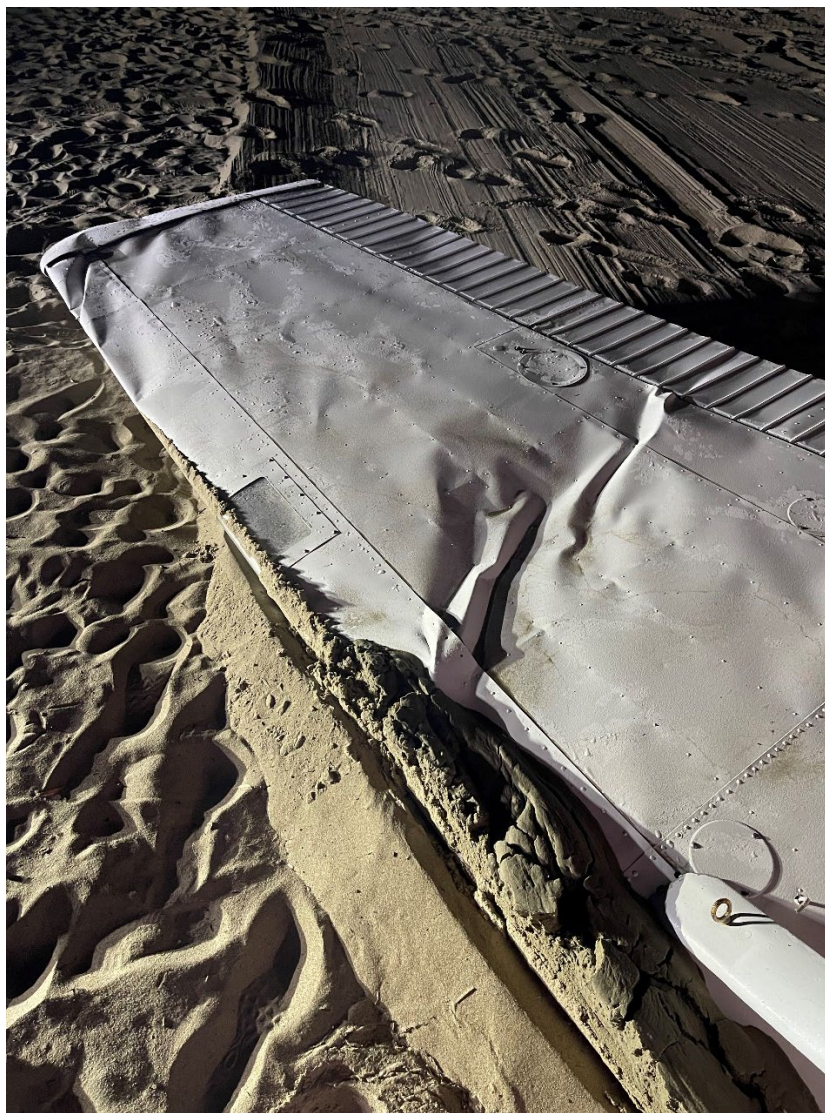
**Photograph 3 - View of damage to left wing (Courtesy of LEO)**

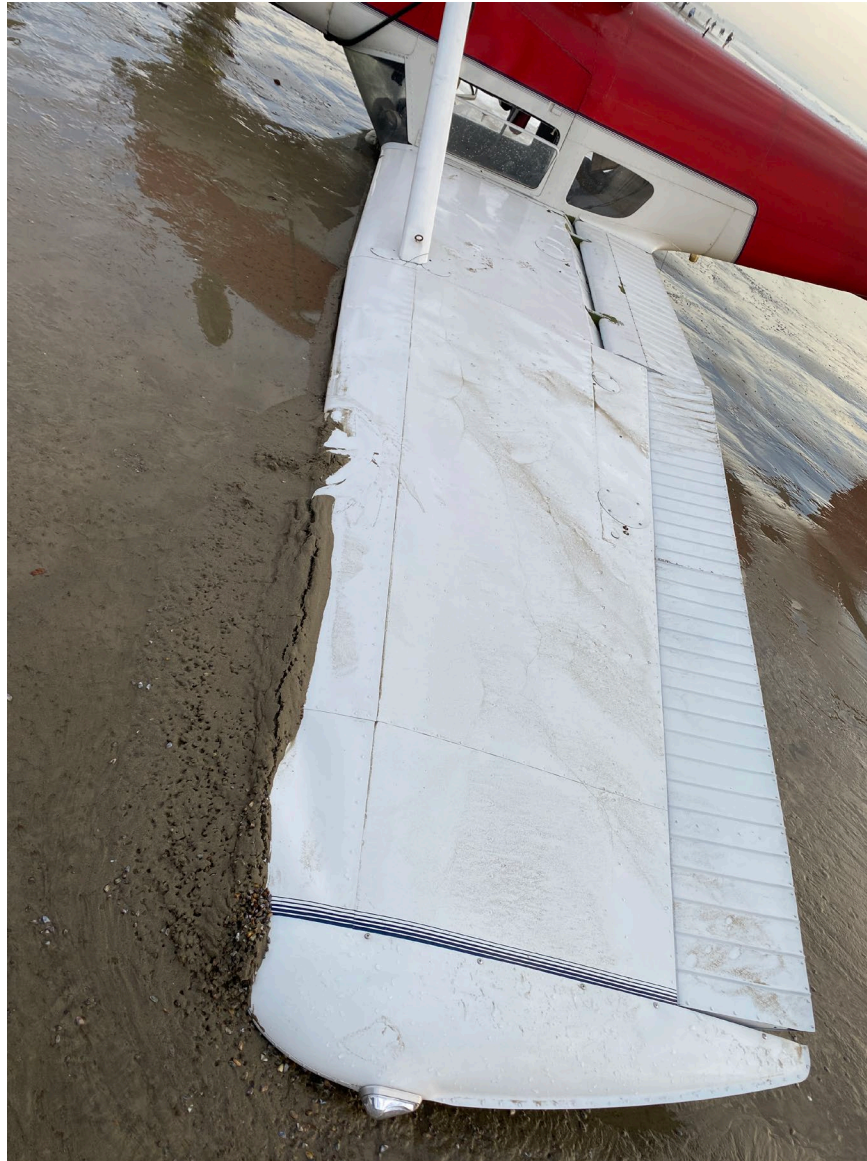
**Photograph 4 - View of damage to the right wing (Courtesy of LEO)**

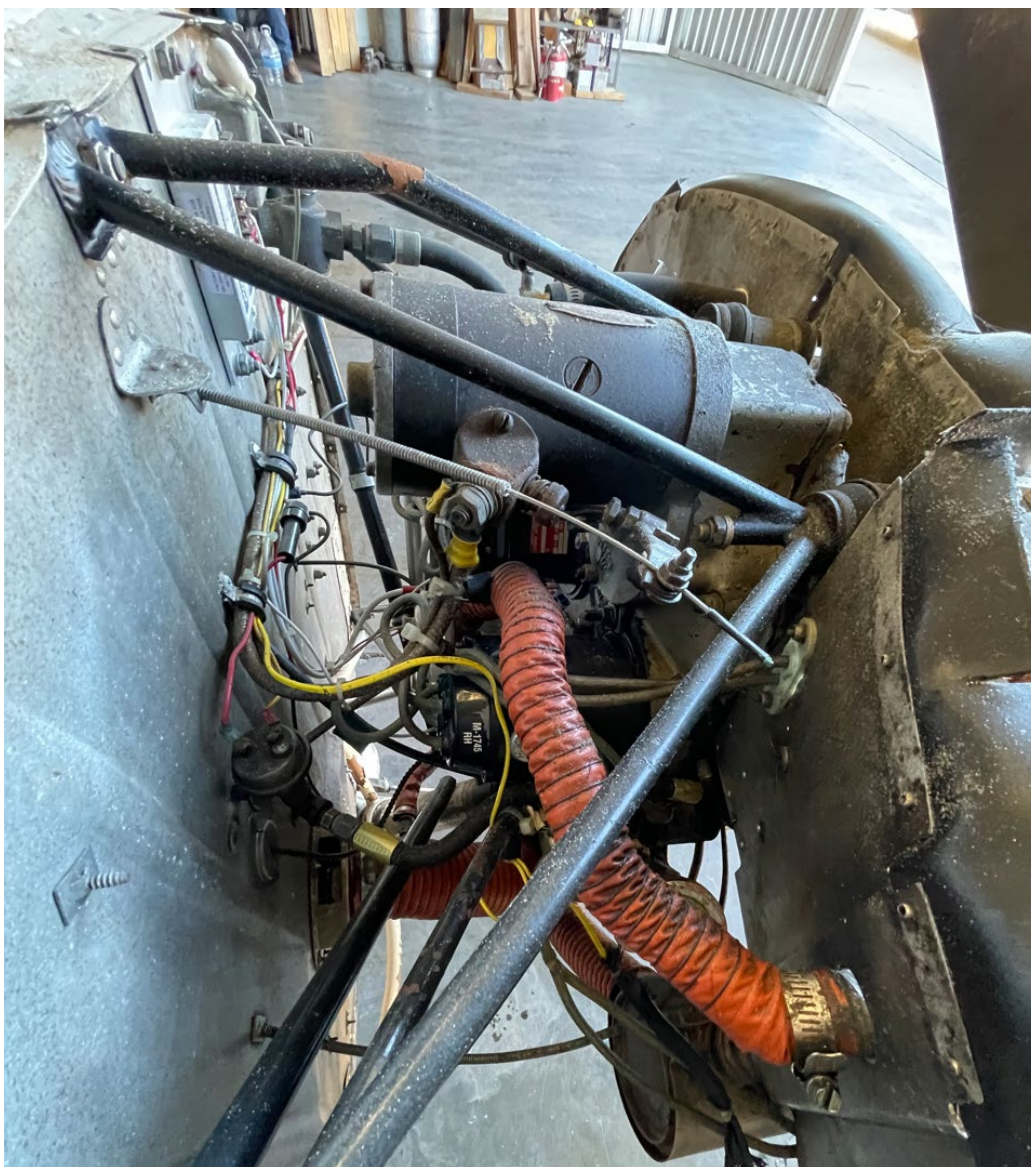
**Photograph 5 - View of damage to upper and lower engine mounts (Courtesy of IIC)**
