# National Transportation Safety Board

WPR23FA073

## ENGINE EXAMINATION

Location: Santa Monica, California  
Date: December 22, 2022  
Time: 1518 Local  
2315 UTC  
Year: 1960  
Make: Cessna  
Model: 150A

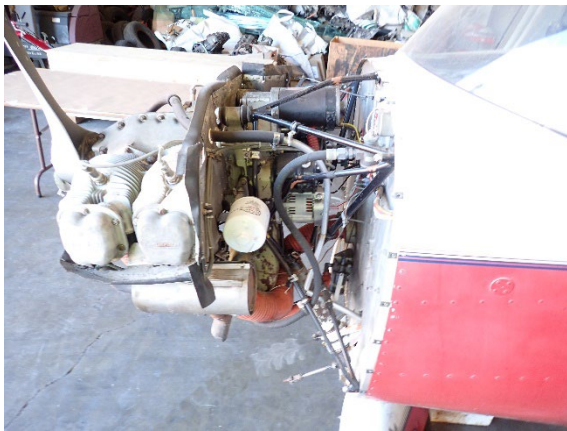
The Continental Motors O-200-A, serial number 2344-0-A, remained attached to the airframe. There were no holes in the crankcase. All accessories remained attached to the accessory case and revealed no impact damage. None of the rocker covers revealed gross deformations. The air induction housing sustained impact damage, and the exhaust assemblies sustained minor damage. Initially, the propeller could not be turned by hand, and experienced binding and restriction when rotated in the opposite direction and subsequent binding remained when rotated in the direction of rotation. The propeller spinner was crushed and remained attached to the propeller flange by only two of the six hub bolts. About 5 quarts of oil were extracted from the oil sump.

**Figure 1:** Left side view of engine

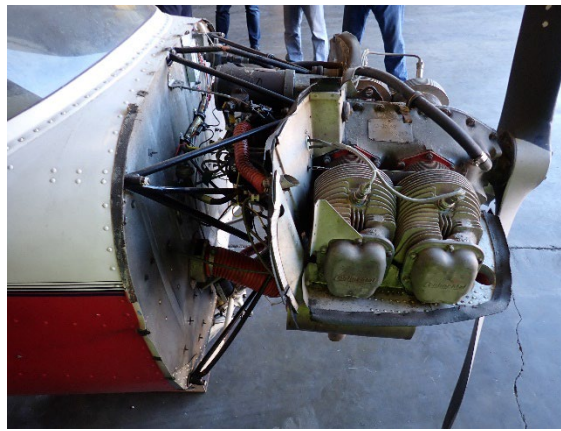
**Figure 2:** Right side view of engine

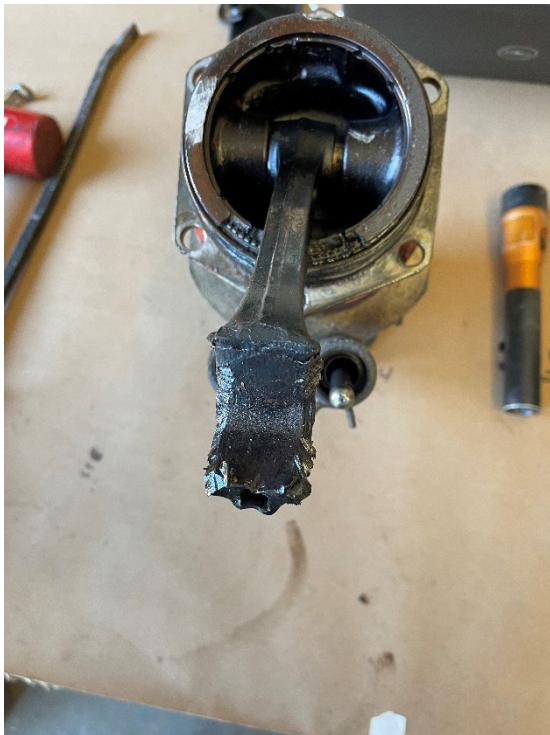
The examination of the engine revealed an oil starvation event that occurred at the No. 1 piston connecting rod bearing journal. The No.1 connecting rod separated into 5 identifiable pieces that were recovered from the crankcase. The No. 2, 3 and 4 crankshaft connecting rod bearings and journals showed various stages of thermal damage and discoloration. The examination of the engine sump oil pickup tube, oil filter adapter, and oil filter revealed no anomalies. Additionally, there were no anomalies associated with the engine oil galley or oil pressure relief valve.

The cylinders were removed and No's. 2, 3 and 4 revealed no anomalies. During the removal of the No. 1 cylinder, no damage was observed to the push rods, however, the No. 1 piston was seized to the cylinder. The No. 1 piston skirt revealed damage to the upper and lower sections in alignment with piston rod movement. The No.1 piston rod and bearing were separated from the crankshaft, and the connecting rod endcap and bearing remained in the crankcase. The connecting rod bolts were stretched, and the nuts remained attached to each bolt, but the bolt heads were separated and not present. The oil sump was removed and contained residual oil and metallic fragments.

**Figure 3:** No. 1 piston rod and bearing failure

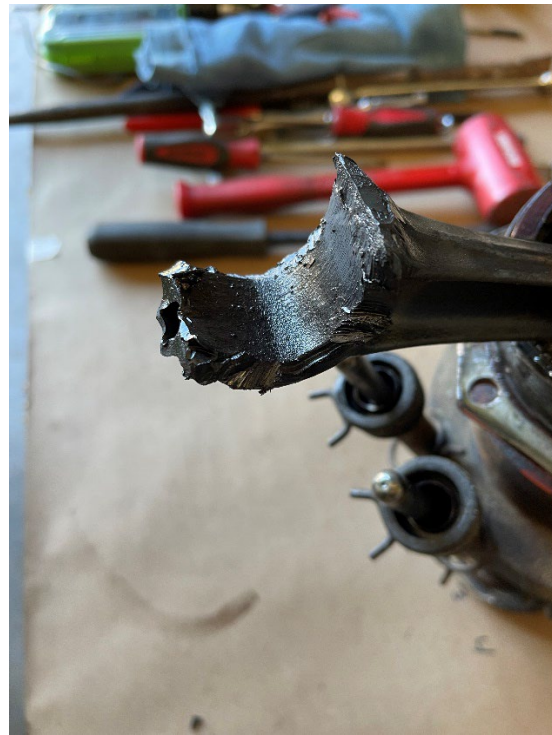
**Figure 4:** No. 1 piston rod and bearing failure

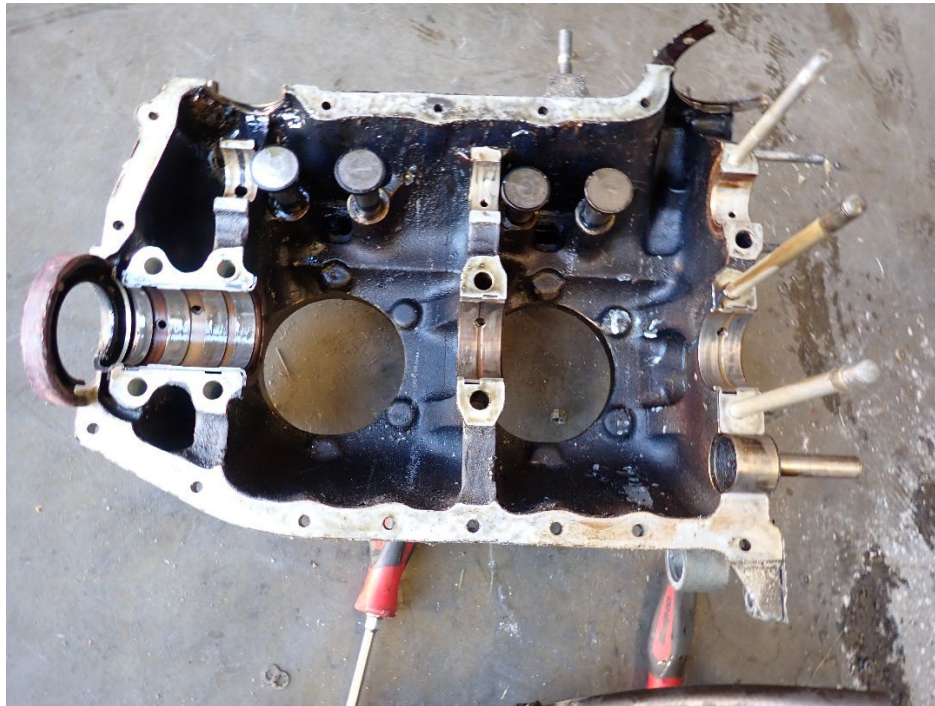
The crankcase halves were disassembled, and the crankshaft main bearings were intact and showed normal operational wear. The crankcase halves showed no signs of fretting or main bearing shift in the bearing saddle areas. The crankcase oil galley

**Figure 5:** Case half without fretting signatures

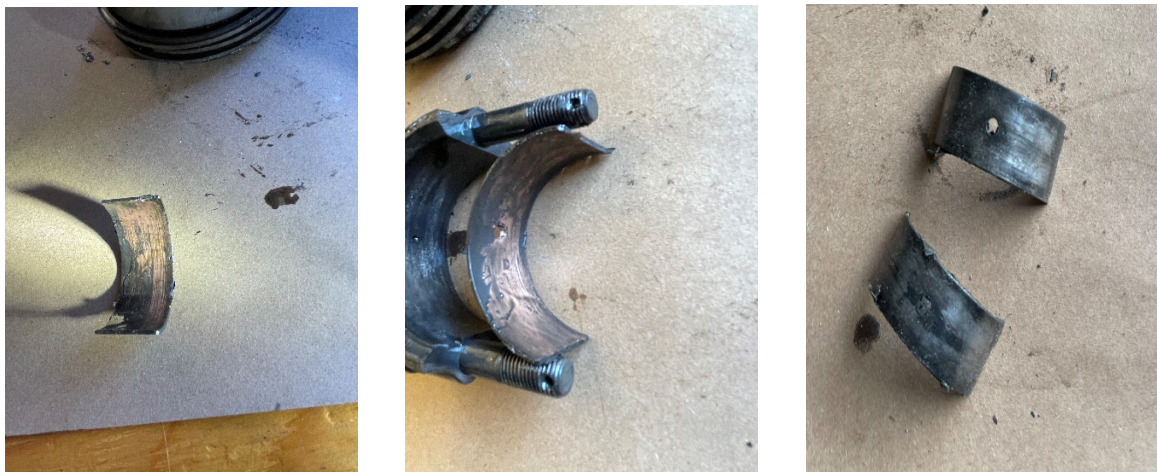
The No's. 2, 3 and 4 connecting rod ends were removed to observe the condition of the rod bearings. The No. 2 cylinder connecting rod bearings revealed thermal discoloration and metal deformation. The No. 3 cylinder connecting rod bearings revealed thermal discoloration, and metal deformation with one bearing seized to the connecting rod. The No. 4 cylinder connecting rod bearings revealed only thermal discoloration.

**Figure 6:** No. 2 connecting rod bearings

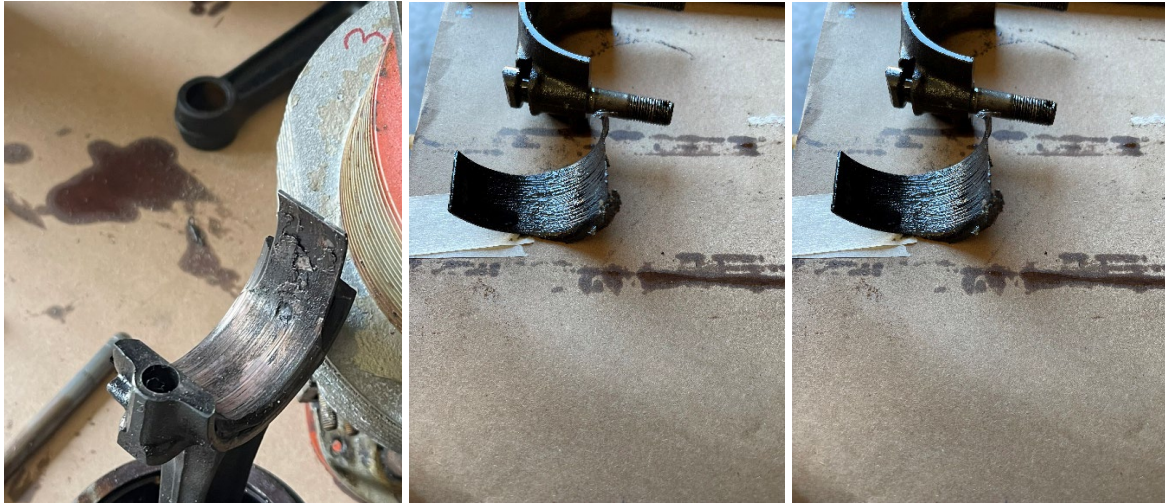
**Figure 7:** No. 3 Connecting rod bearings

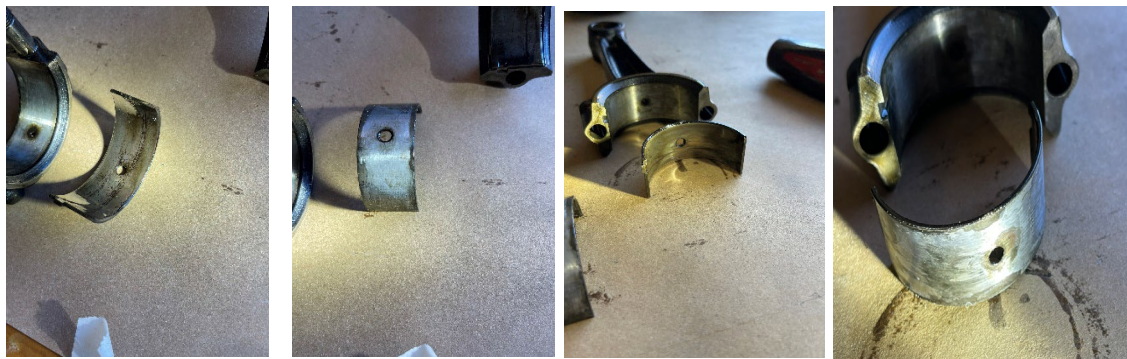
**Figure 8:** No. 4 Connecting rod bearings

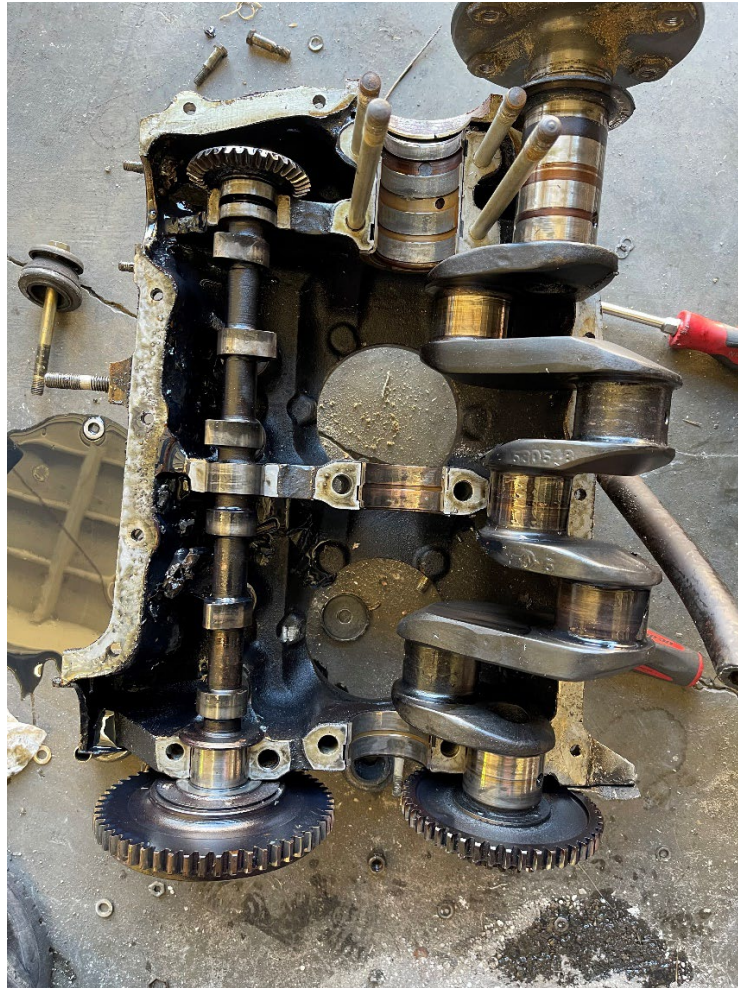
The crankshaft oil galleries were clear of obstructions. The crankshaft counterweights moved freely by hand. The camshaft had light impact damage to the area near cylinder No. 1 lifter areas. The camshaft and crankshaft gears were undamaged.

**Figure 9:** View of crankshaft with gears and camshaft with gears

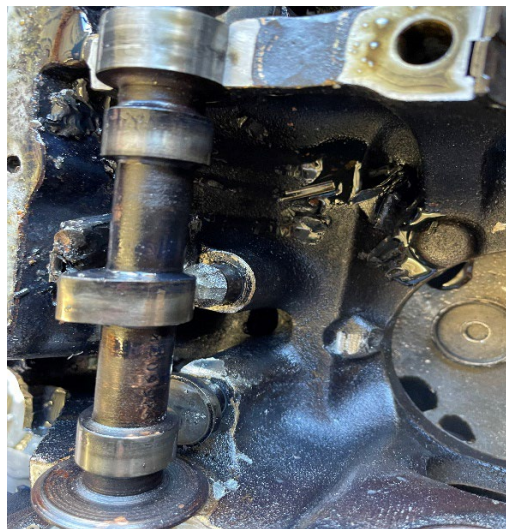
The lifters were removed and were unremarkable except for the No. 2 lifter, which sustained damage and was missing the face.

**Figure 10:** View of damaged No. 2 lifter
