# National Transportation Safety Board

WPR23FA083

## **ONSITE EXAMINATION**

Location: New Harmony, Utah  
Date: January 4, 2023  
Airplane: Piper PA34-220T N814WT

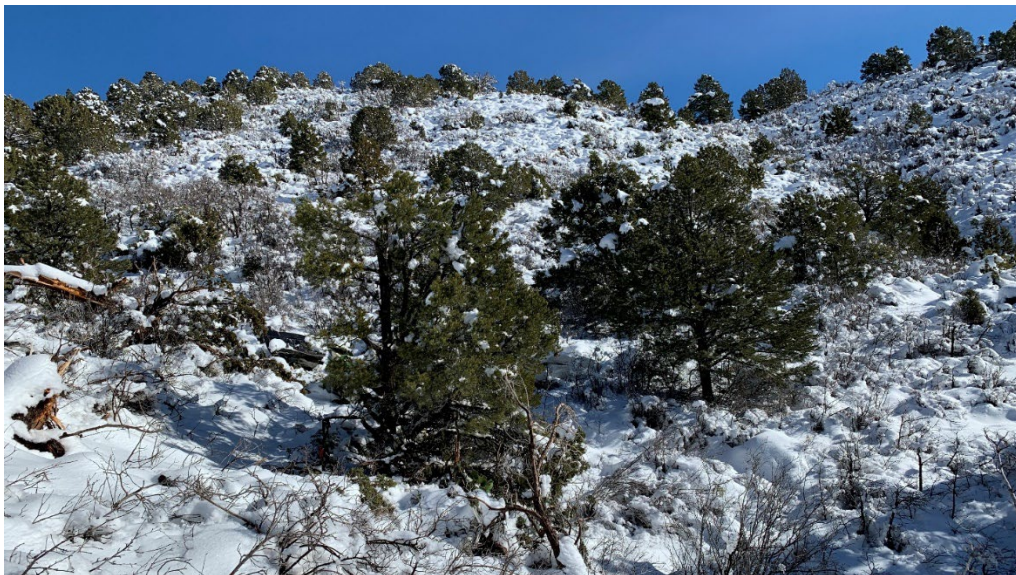
The main wreckage was located within a ravine, about 200 ft below the surrounding ridgeline (see figure 1). Photos taken by law enforcement personnel indicated that the morning after the accident, the airplane was coated in about 2 inches of snow (see figure 2). On the day of the examination, the wreckage was further obscured by a covering of about 6 inches of snow, with only partial airframe and engine components visible (see figure 3).

**Figure 1 - Accident site, with wreckage obscured by snow.**

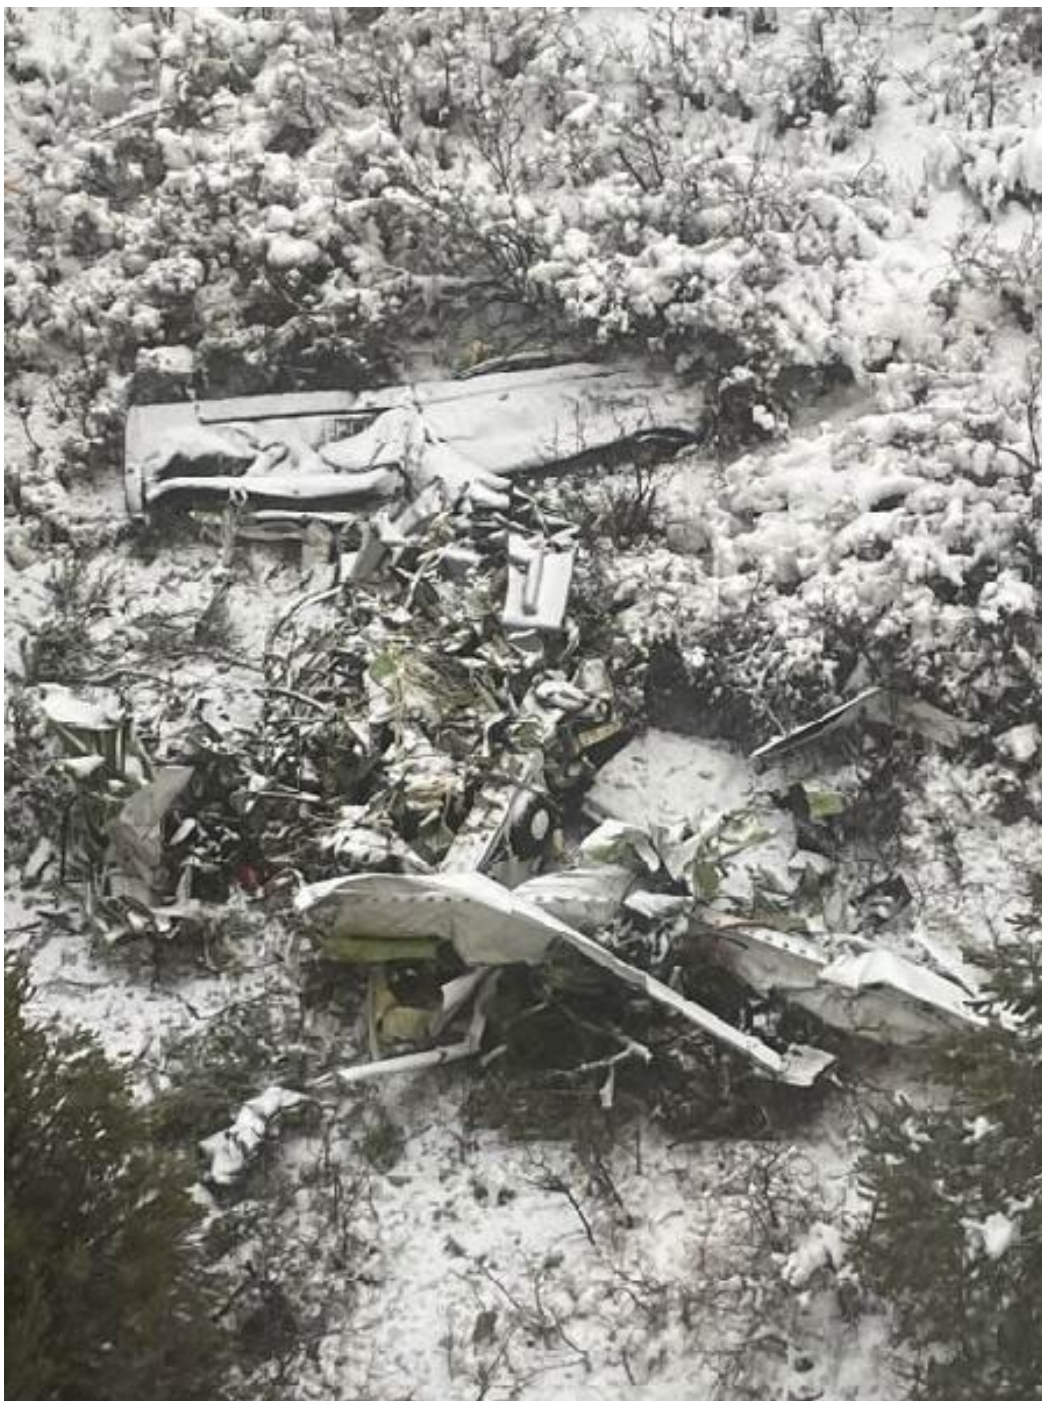
**Figure 2 - Accident site on January 5, photo courtesy of Washington County Sheriff Department.**

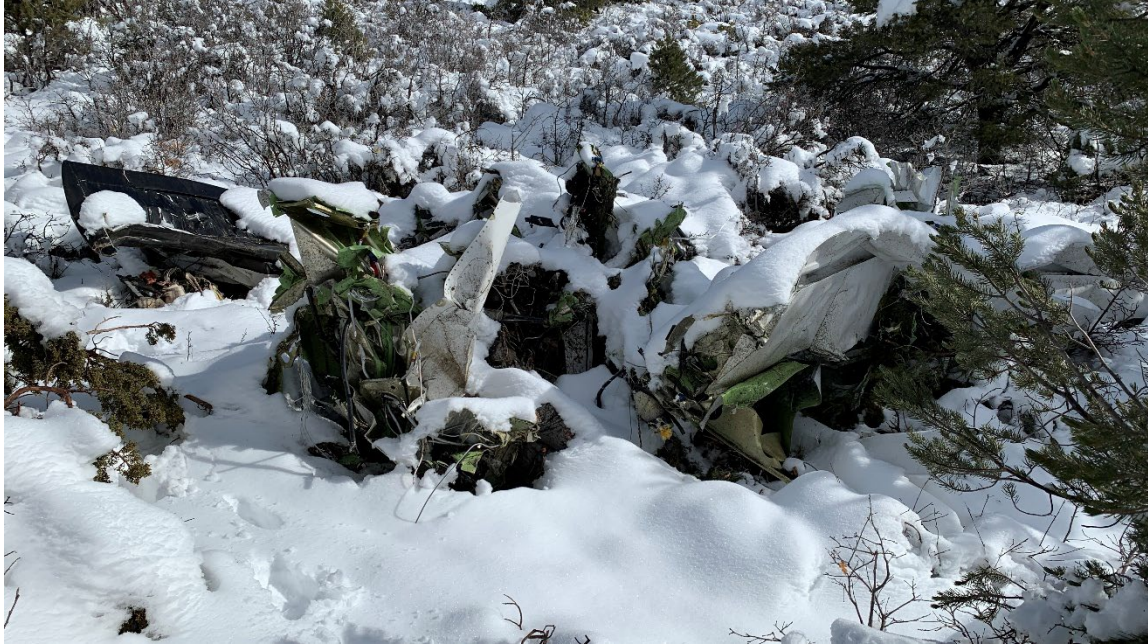
**Figure 3 - Main wreckage on January 8.**

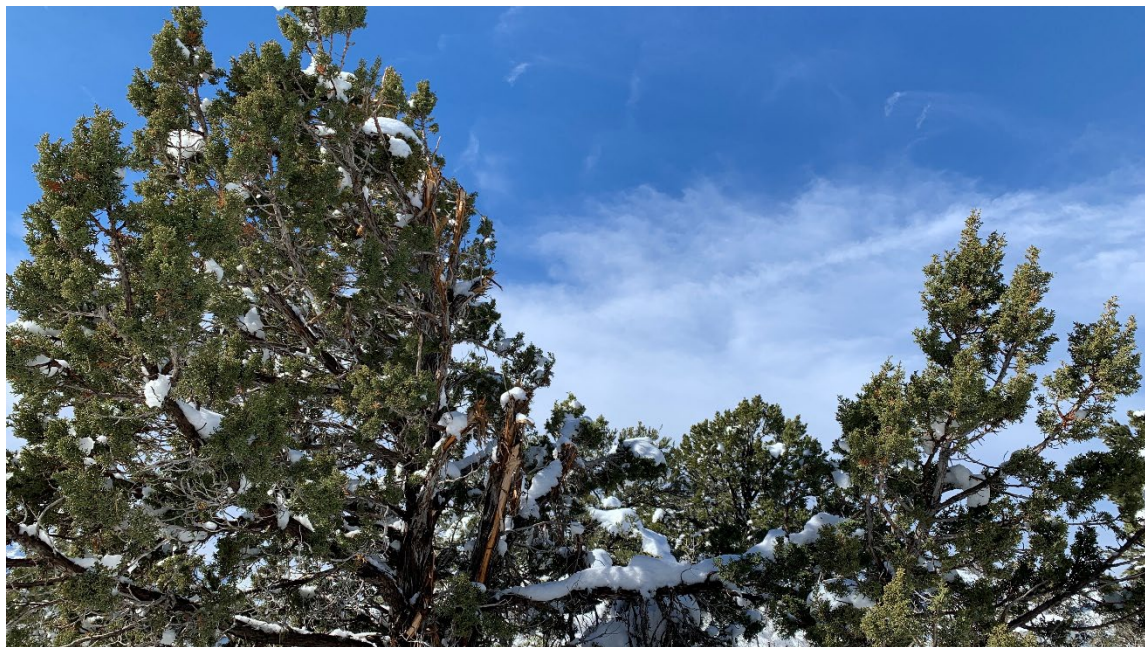
The first identified point of impact was about a 60-degree swath cut through a 20 ft tall juniper tree (see figure 4). The debris field continued on a heading of about 095 degrees true to the main wreckage 75 ft downrange (see figure 5). The first components located in the debris field were fiberglass and sheet metal shards associated with a wing. A propellor hub and three detached blades were 20 ft from

**Figure 4 - 60 degrees cut tree swath; photo taken towards the west.**

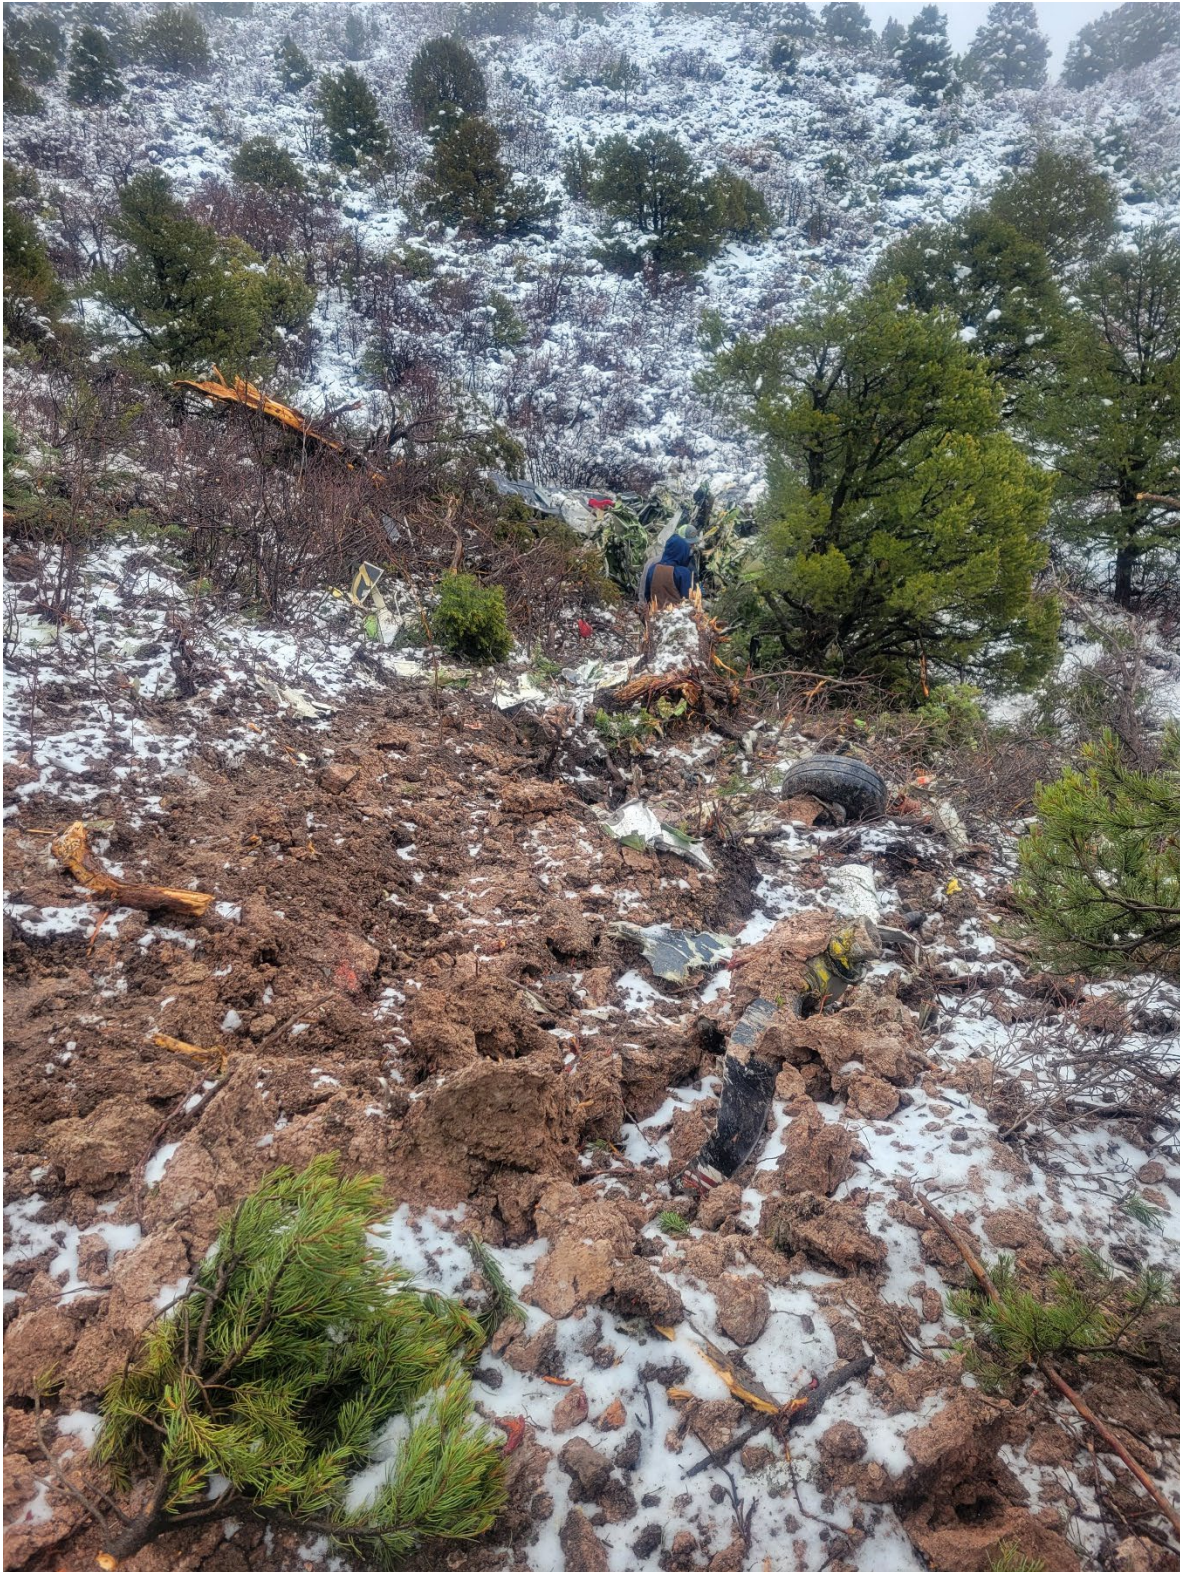
initial point of impact. All three blades exhibited leading edge gouging and chordwise scratches. One blade exhibited S bending with a serrated tip. Another blade had lost about 4" of its tip with serrated separation features. A second tree in the debris field exhibited similar 60-degree damage swath and contained remnants of a foot pedal. Further 20' east, an approximately 15' tall and 18" wide juniper tree had been uprooted and severed at its base (see figure 5,6). The nose landing gear assembly was located about 15' south of the stump.

**Figure 5 - Debris field to main wreckage with uprooted tree trunk in center of image.  
Photo taken on January 5, courtesy of the Washington County Sheriff Department.**

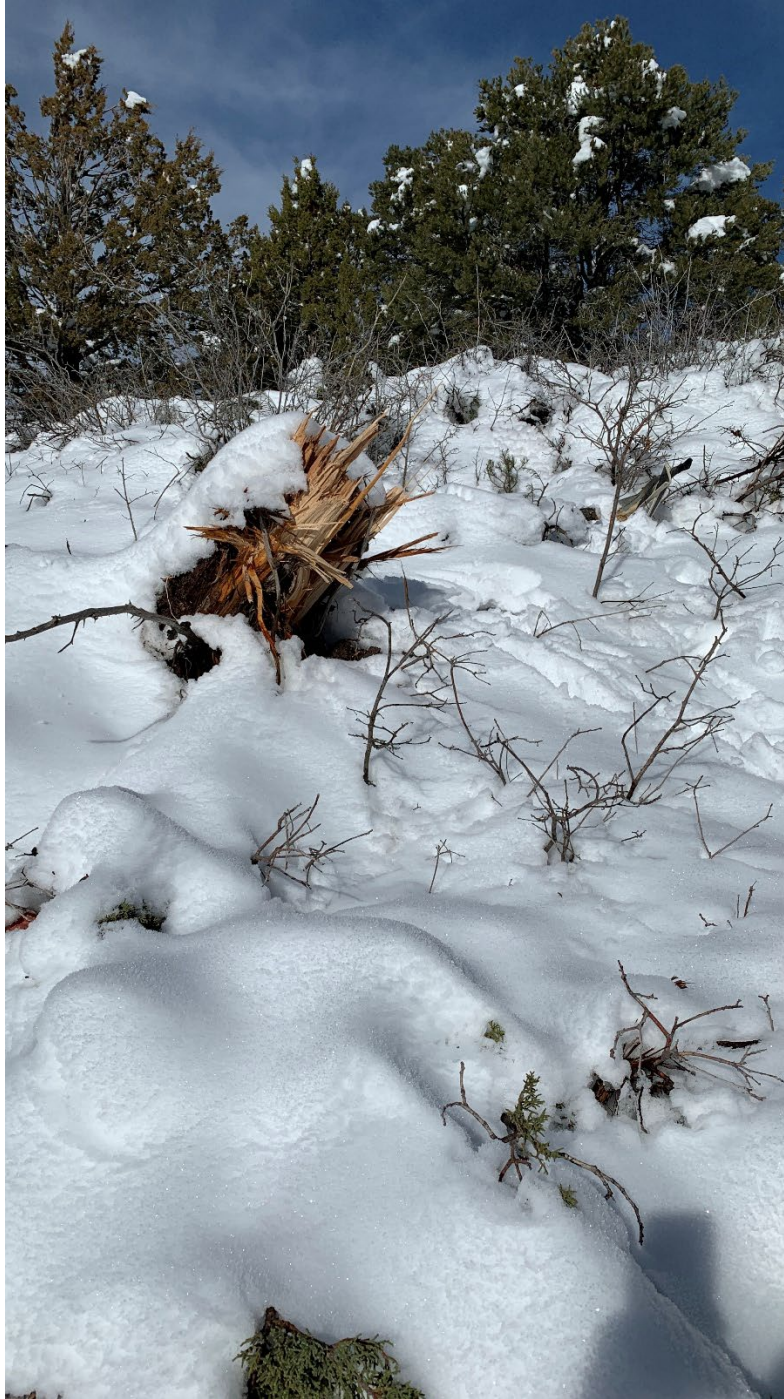
**Figure 6 - Uprooted tree trunk.**
