# National Transportation Safety Board

WPR23FA083

## **AIRFRAME AND ENGINE EXAMINATION**

Location: New Harmony, Utah  
Date: January 4, 2023  
Airplane: Piper PA34-220T N814WT

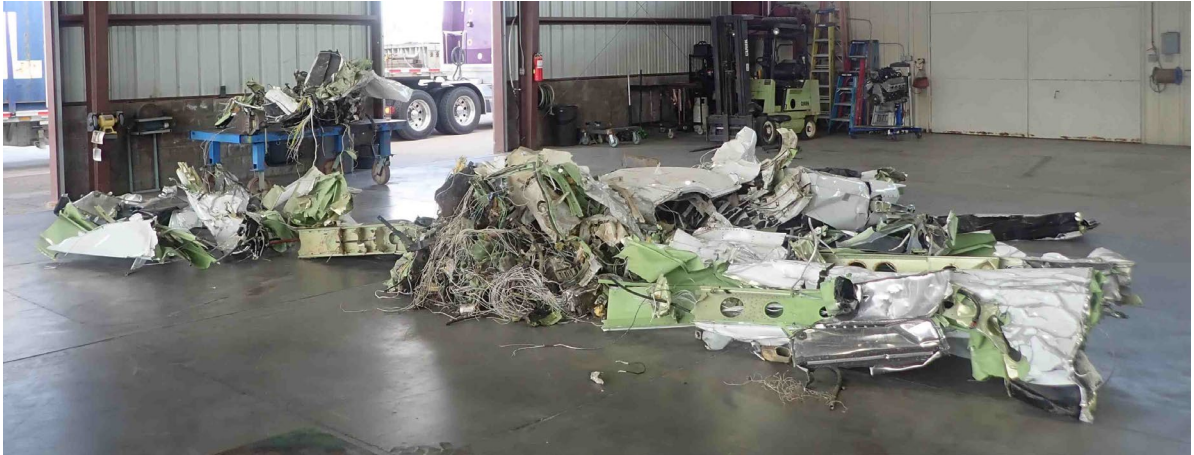
The airframe sustained significant crush and fragmentation damage throughout, exposing the entire cabin contents, flight controls, avionics, and electrical wiring. The cockpit and cabin were crushed through to the leading edge of the vertical stabilizer (see figure1). The aileron control cables throughout were separated into multiple fragments, all the separation features exhibited evidence of recovery cuts, or wire splaying features consistent with overload. No observed cables appeared to have unraveled.

**Figure 1- Main Wreckage**

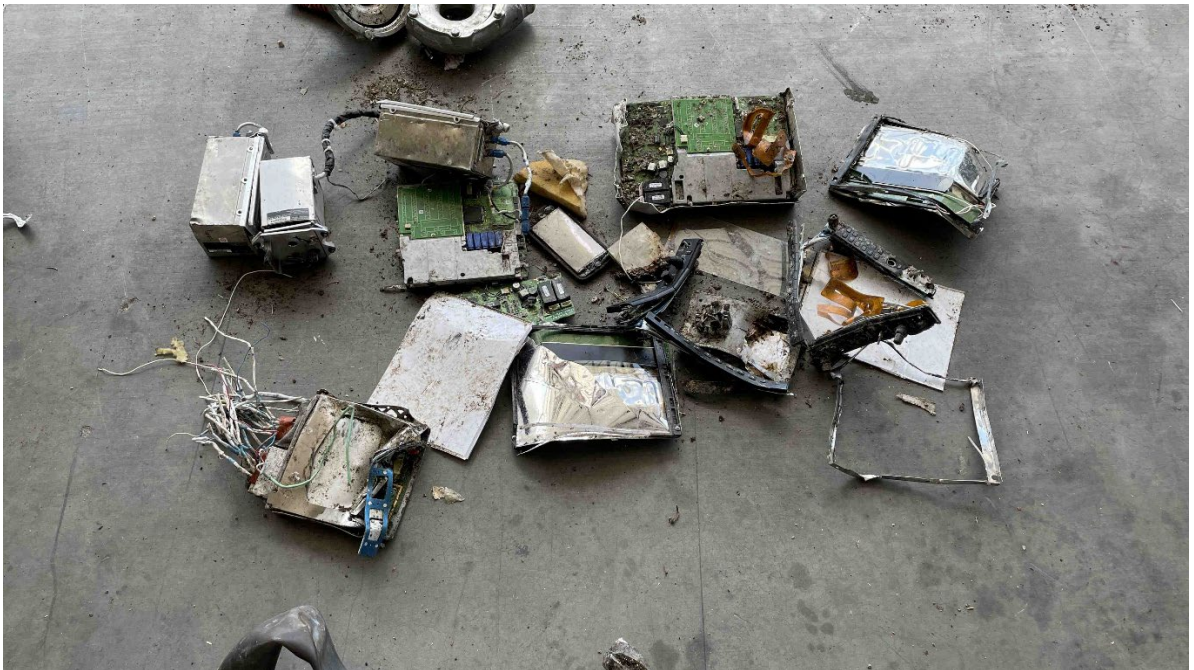
The airplanes delivery documents indicated that it was equipped with a fully electronic avionics suite, which included Garmin GFC-700 autopilot and a Garmin G-1000 series multi-function display, with an Aspen Avionics backup unit. Those units within the cockpit sustained extensive fragmentation damage such that their operational status at impact could not be determined (see figure 2). The components associated with the autopilot sustained varying degrees of impact damage. An iPad was found within the wreckage, the unit was crushed and folded in half and was damaged to the extent that data recovery could not be performed.

**Figure 2 - Avionics Remnants**

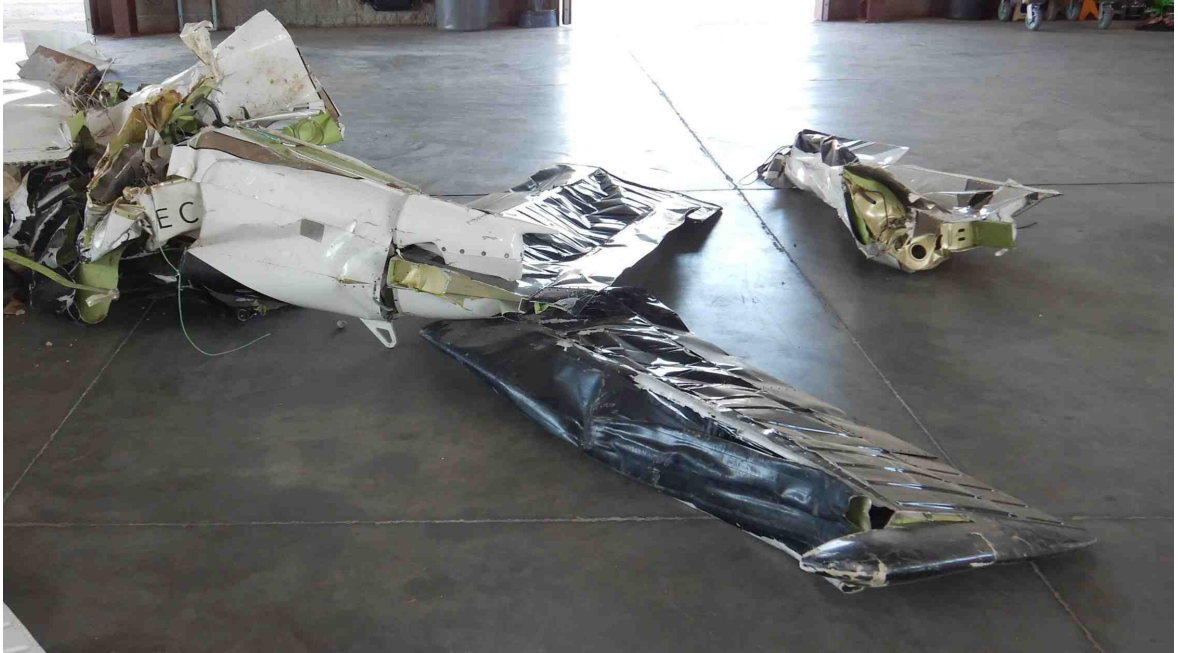
The stabilator remained attached to the tailcone (the left side was cut off during recovery) and the anti-servo tabs were still attached to the stabilator and the pitch control rod (see figure 3). The pitch trim actuator showed 19 threads (2 inches), which according to Piper documentation indicated full nose down trim. Closer examination revealed that this value may not have represented the position at the time of the accident, because the pitch trim cables and surrounding aluminum structure exhibited scratch and tear damage consistent with the cables being pulled through to the full nose down position at impact.

**Figure 3 - Empennage**

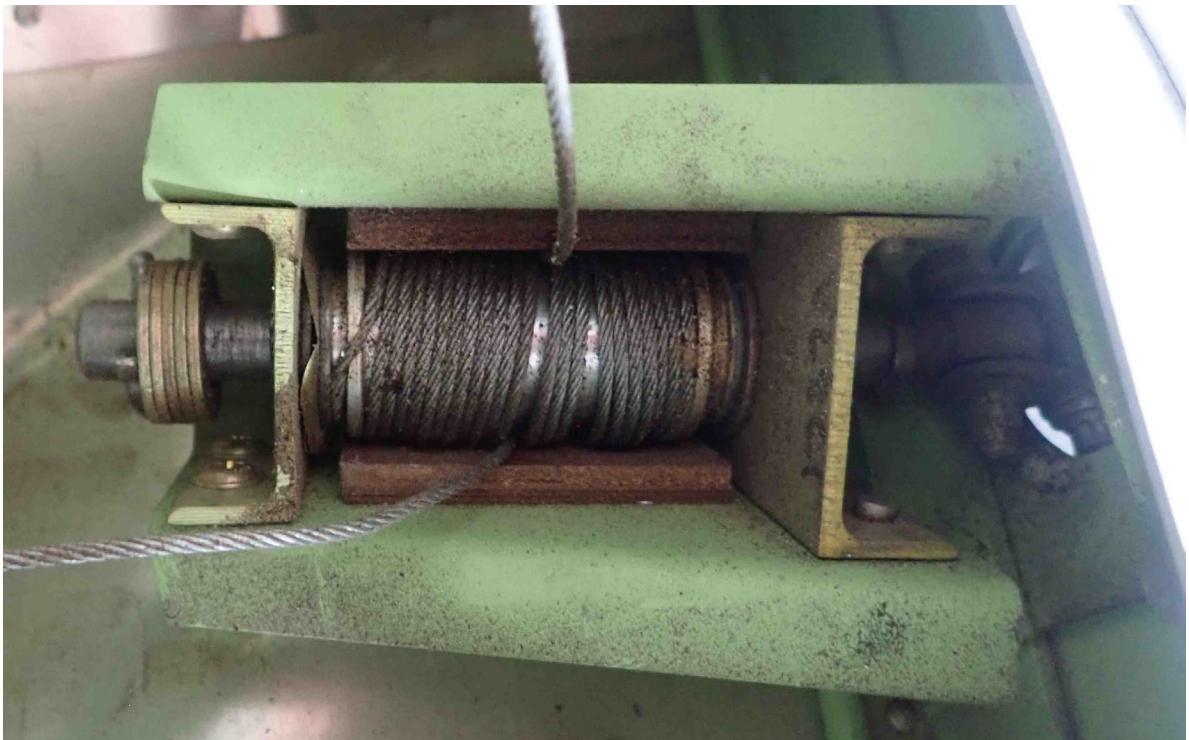
The rudder remained attached to the vertical stabilizer by all its hinges. The trim tab was intact, and the trim arm had pulled away from its horn. The rudder trim actuator was in the center position, consistent with neutral rudder trim (see figure 4). The rudder cables had been cut in the tail section by the recovery crew but were otherwise intact through to the rudder pedal fittings.

**Figure 4 - Rudder Trim**

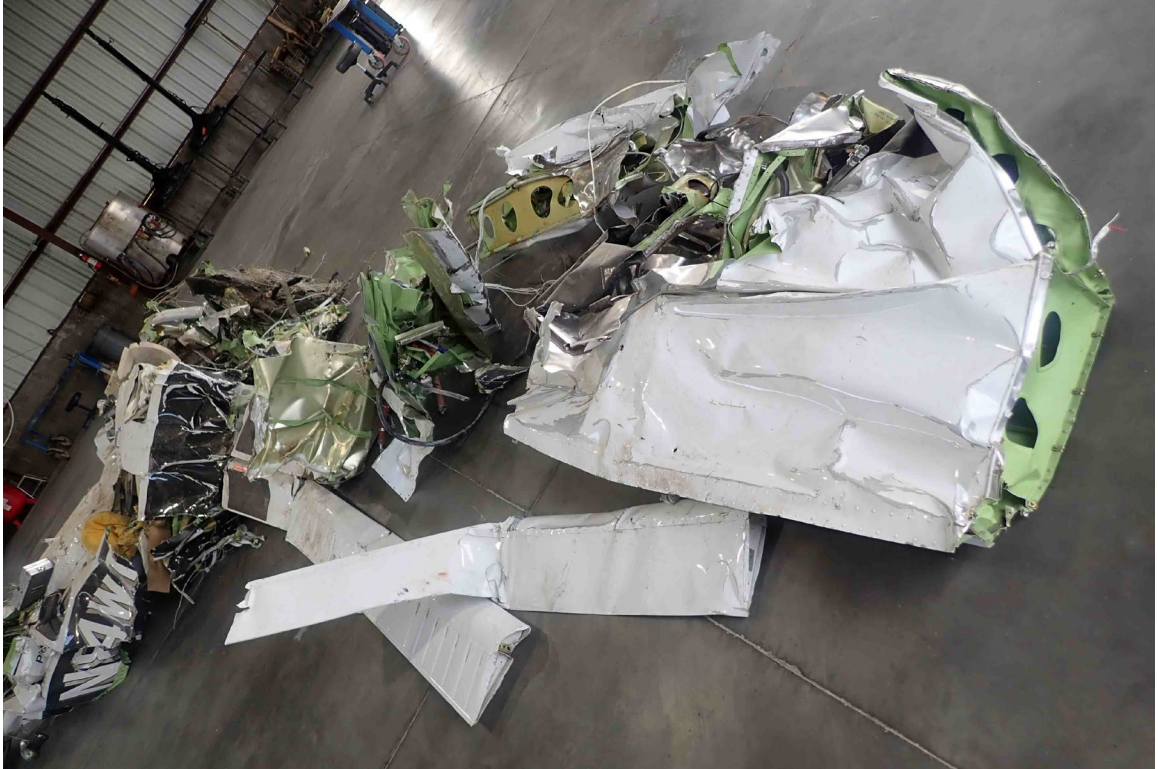
The right wing had broken into four distinct sections, all of which exhibited skin deformation such that the main spar was exposed (see figure 5). An inboard 3-ft-long section of the flap remained attached; the rest of the flap had pulled away from the structure. The aileron had completely separated, and both of its outboard hinge eyes were intact.

**Figure 5 - Right Wing**

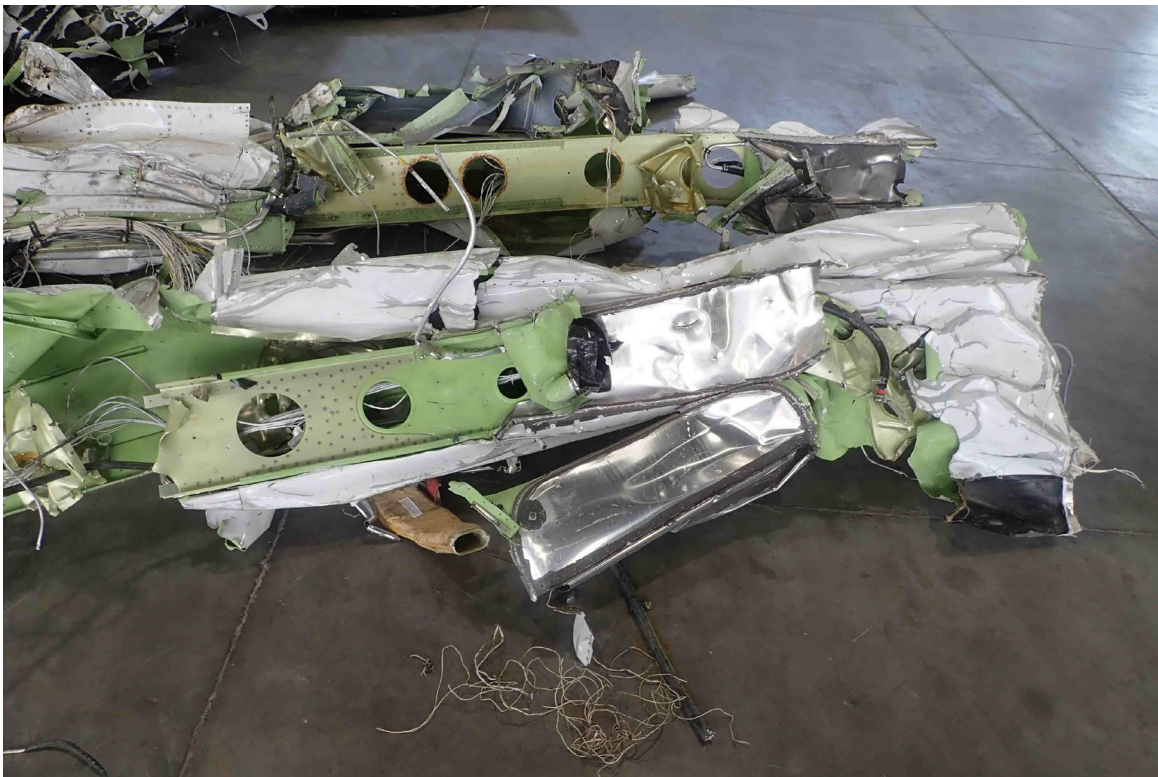
The left wing had broken into two parts about midspan. The leading-edge skins were crushed and had mostly detached exposing the main spar. The fuel tanks were breached and split open (see figure 6).

**Figure 6 - Left Wing**

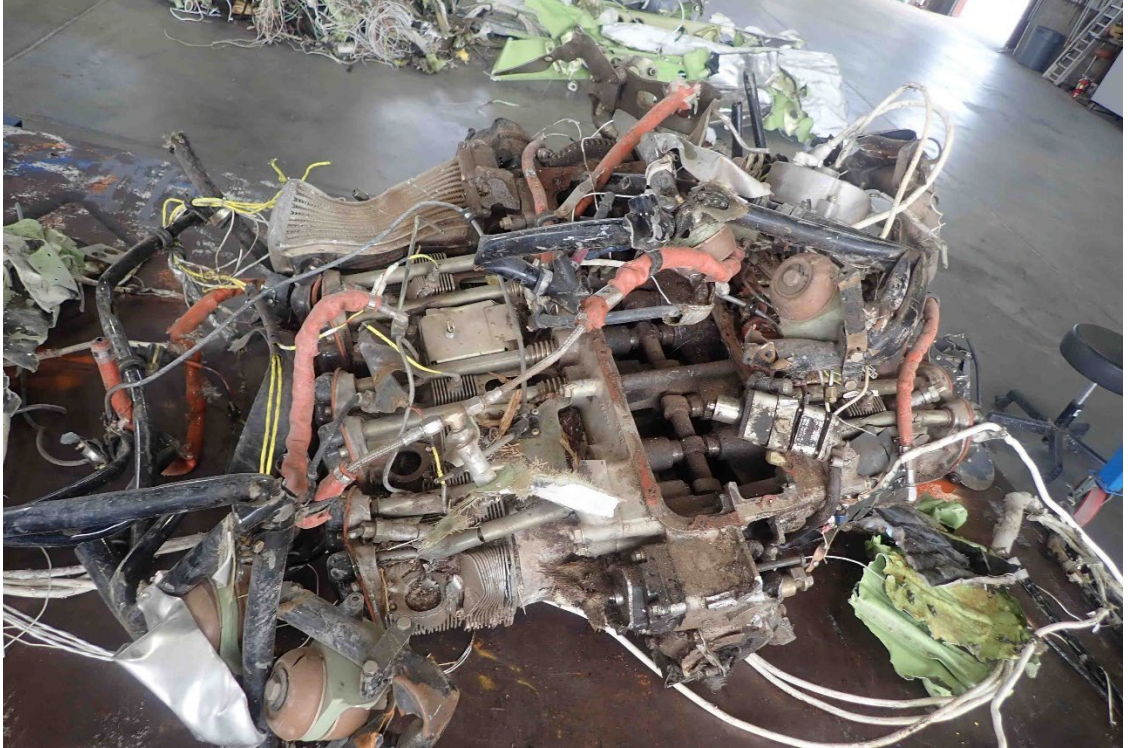
The engine sustained extensive impact damage and remained attached to sections of its mount, which had broken away from the airframe (see figure 7, 8). The alternator, starter motor, air conditioning compressor assembly, vacuum pump, and the right magneto had been liberated during the accident. The oil cooler assembly remained attached to the engine but had been crushed forward. The upper section of the accessory case had detached, revealing the internal gears which were bright, clean, and coated in oil.

**Figure 7 - Left Engine**

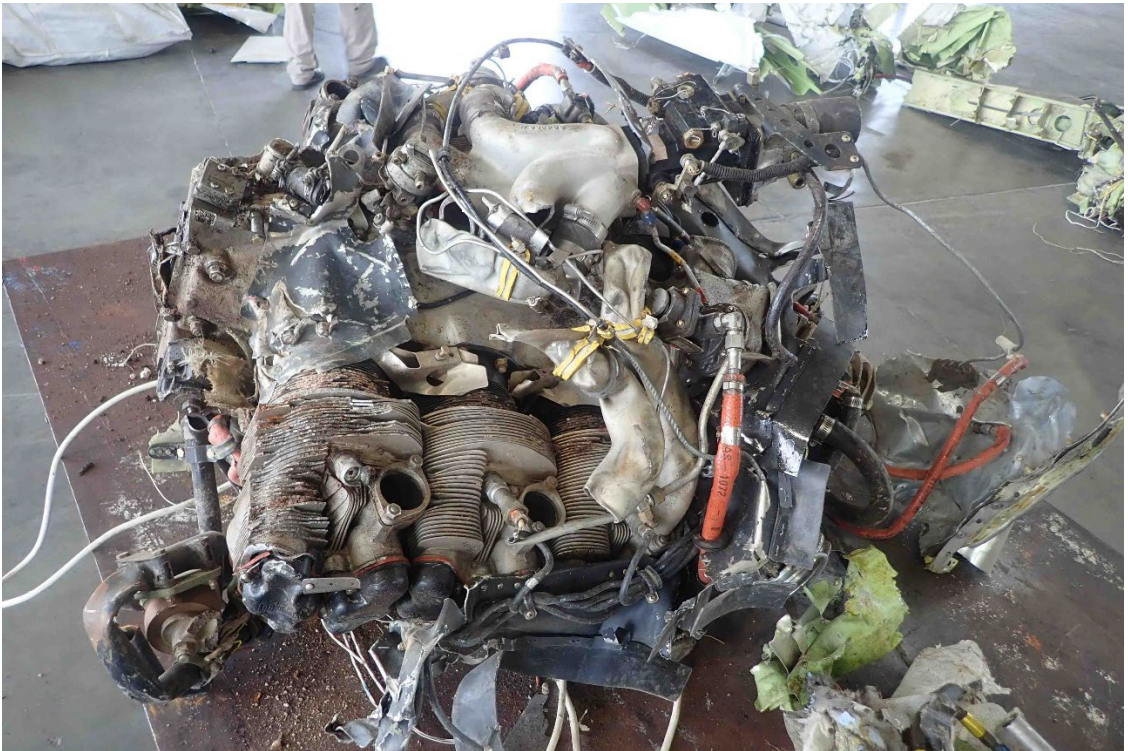
The propeller hub had separated from the front of the crankshaft and the forward two cylinders (5,6) sustained crush damage to their front fins and pushrods (see figure 8). The oil sump was detached, revealing the camshaft and followers. The camshaft was intact, and all lobes appeared clear and bright (when wiped clear) with no evidence of galling or lobe deformation (see figure 9). Looking inside the engine, the crankshaft was intact, and there was no evidence of catastrophic internal failure or thermal distress.

**Figure 8 - Left Engine**

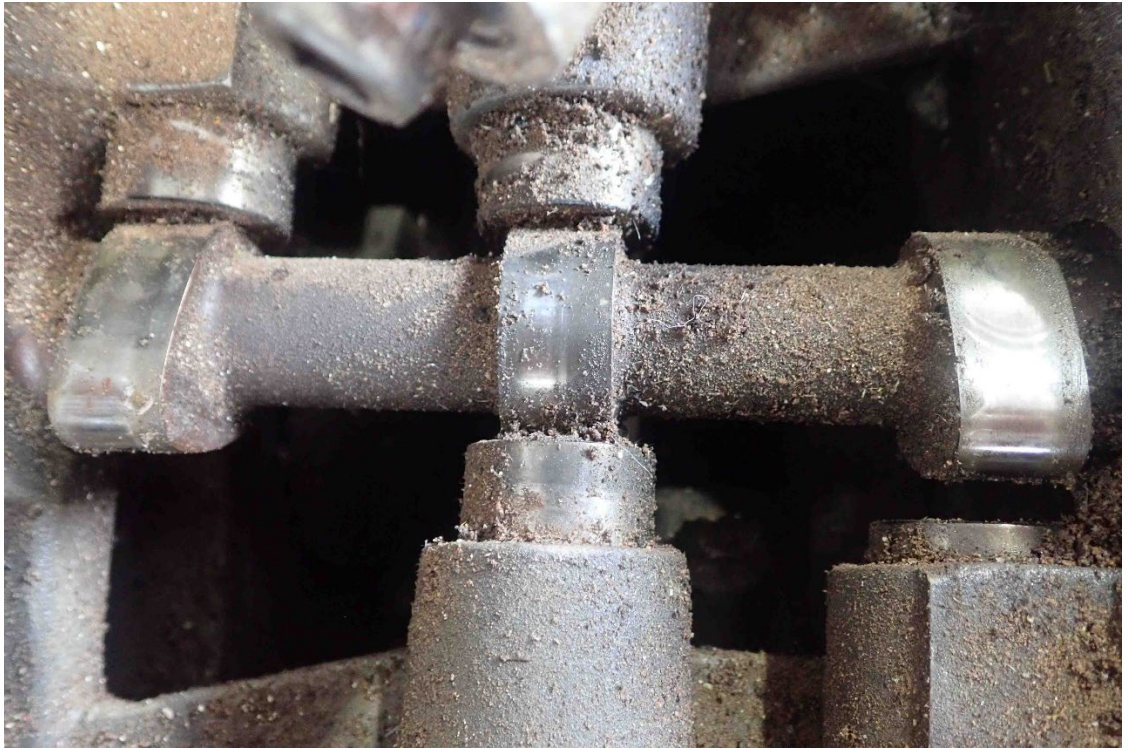
**Figure 9 - Section of Left Engine Cam Lobe**

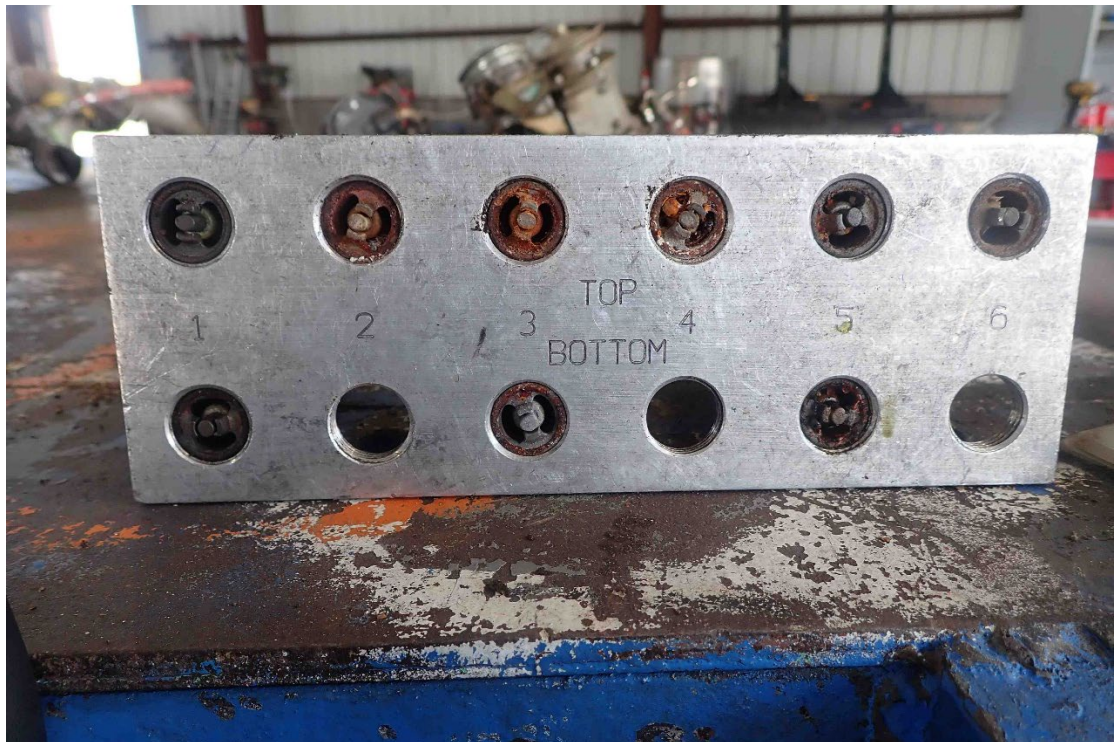
All of the top spark plugs, along with the bottom plugs for cylinders 1, 3, and 5 were removed. All exhibited wear signatures consistent with "normal" to "worn-out normal" when compared to the Champion AV-27 chart. The top plugs for cylinder 2, 3 and 4 and the bottom plug for cylinder 5 exhibited rust collared deposits indicative of post-accident contamination and storage, and all the other plugs exhibited light grey coloration consistent with normal operation (see figure 10).

**Figure 10 - Left Engine Park Plugs**

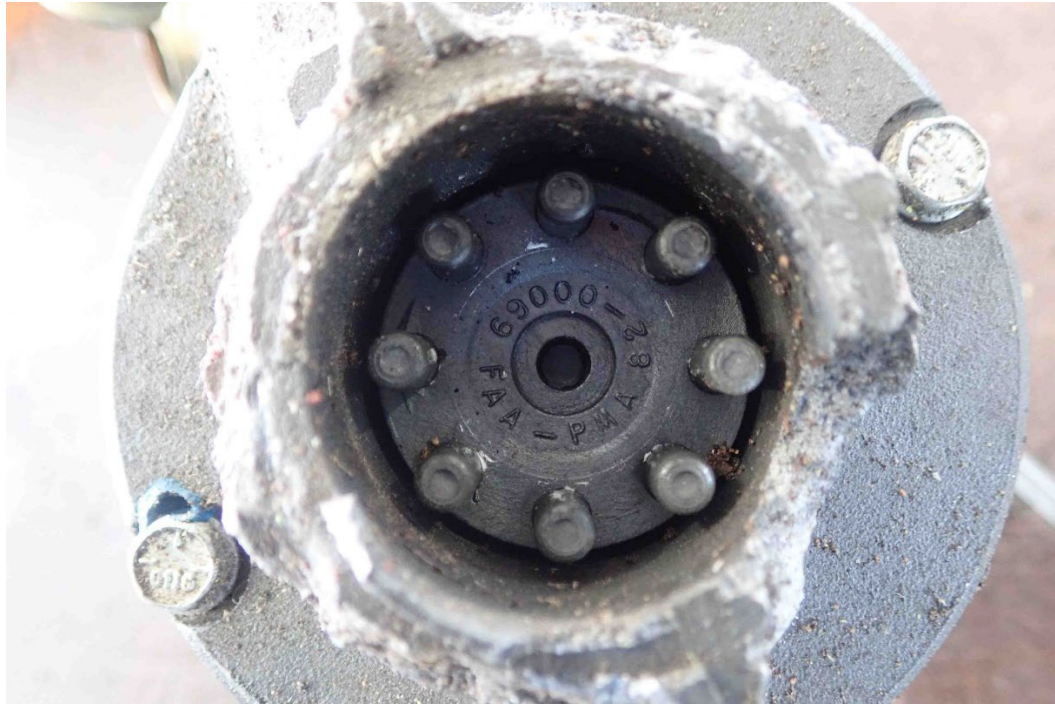
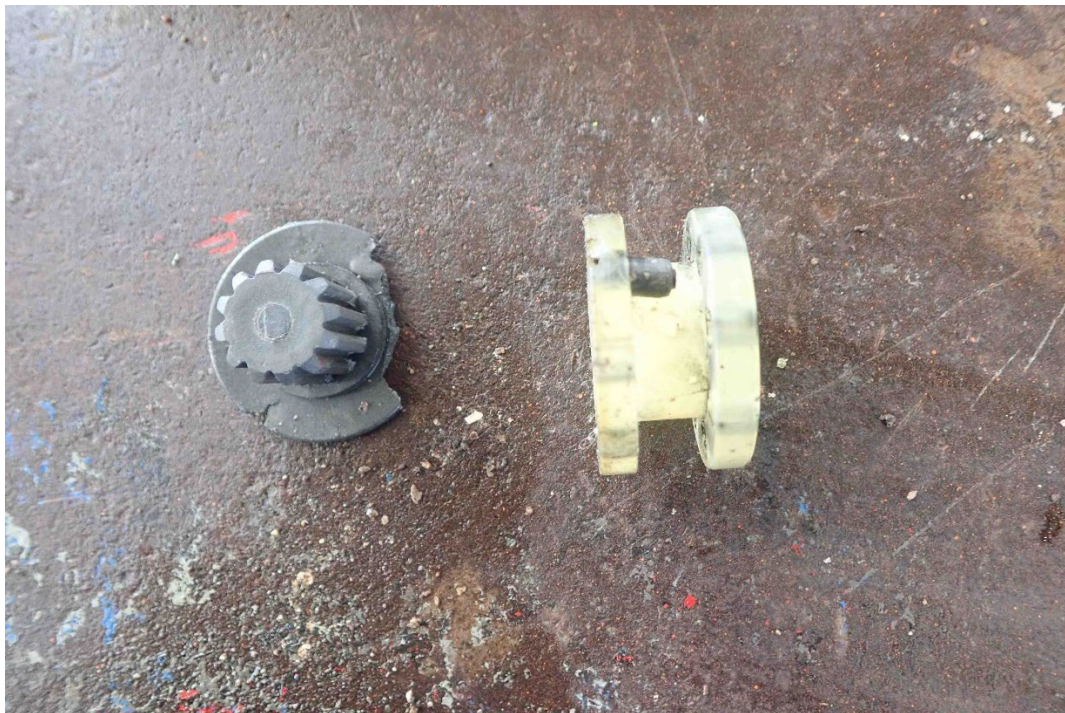
The vacuum pump had detached at its coupling, which had broken. There was no indication of plastic smear or other rotation signatures that would have indicated rotation following coupling failure (see figure 11, 12). The pump was disassembled,

**Figure 11 - Left Engine Vacuum Pump Drive Input**

**Figure 12 - Left Engine Vacuum Pump Drive Coupling**

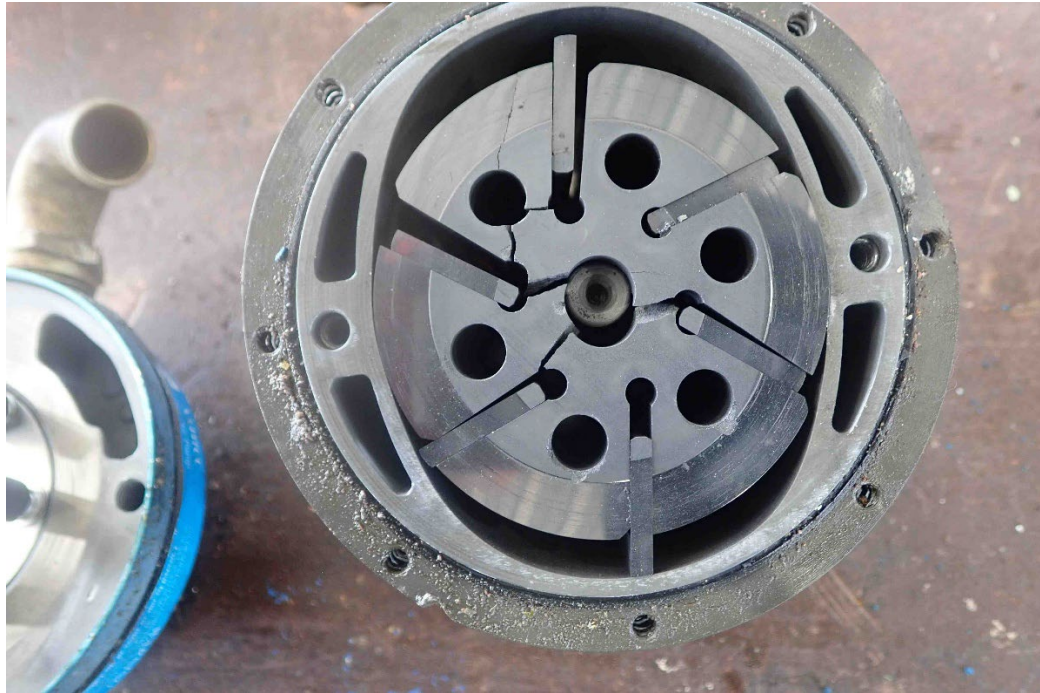
and the rotor had fragmented put was in place (see figure 13). The vanes were about 19 mm long.

**Figure 13 - Left Engine Vacuum Pump Vane and Blades**

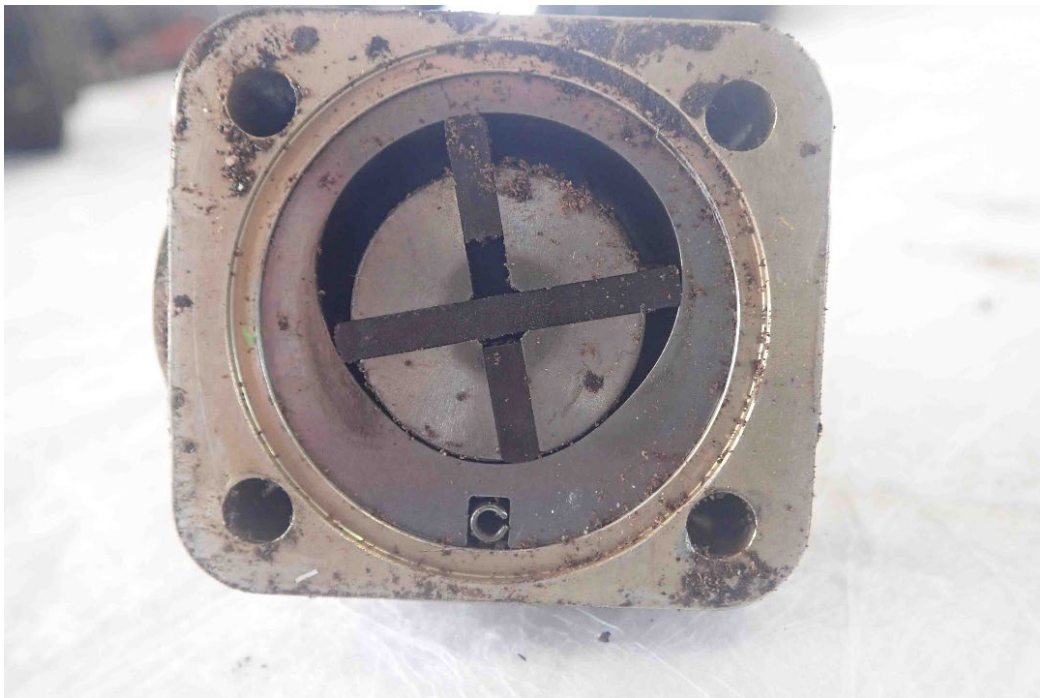
The engine driven fuel pump had broken away from its pad and had begun to come apart. Within the pump, the rotor assembly did not show any evidence of seizure (see figure 14).

**Figure 14 - Left Engine Fuel Pump**

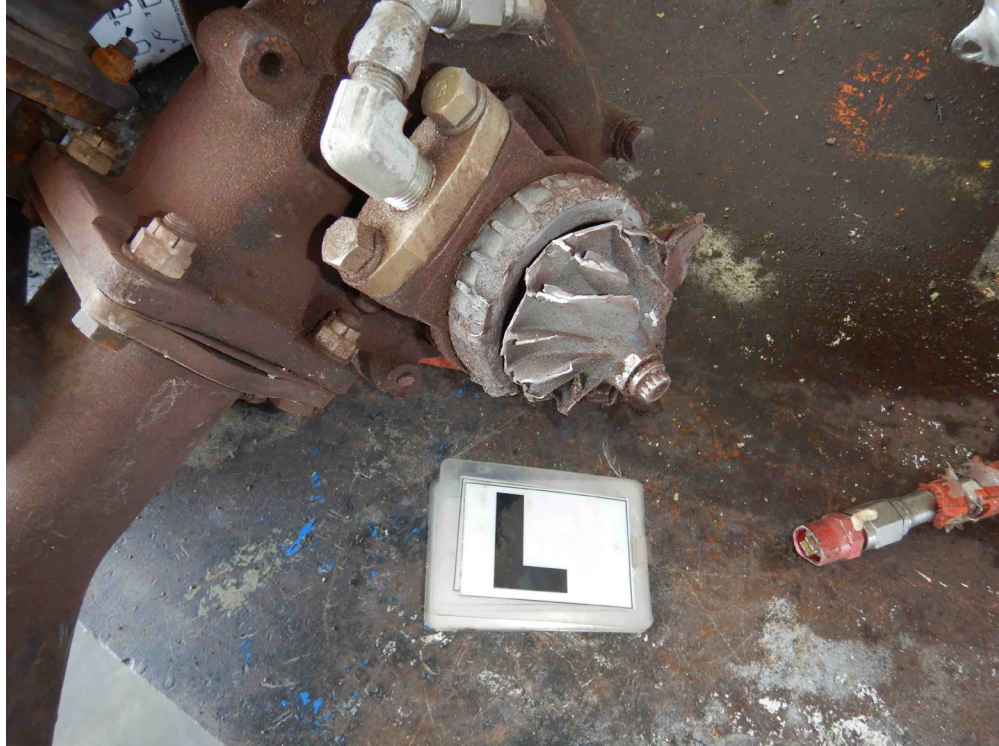
The entire turbocharger assembly had detached from the engine. The V-Band clamp that connected the compressor outlet to the exhaust pipe along with the clamps for both exhaust inlet branches were intact. The turbine cover had broken away exposing the compressor wheel which had sustained severe rotational damage to all its blades, tearing and bending them opposite the direction of rotation (see figure 15). The compressor wheel could be partially rotated by hand by about 90 °.

**Figure 15 - Left Engine Turbocharger Compressor**

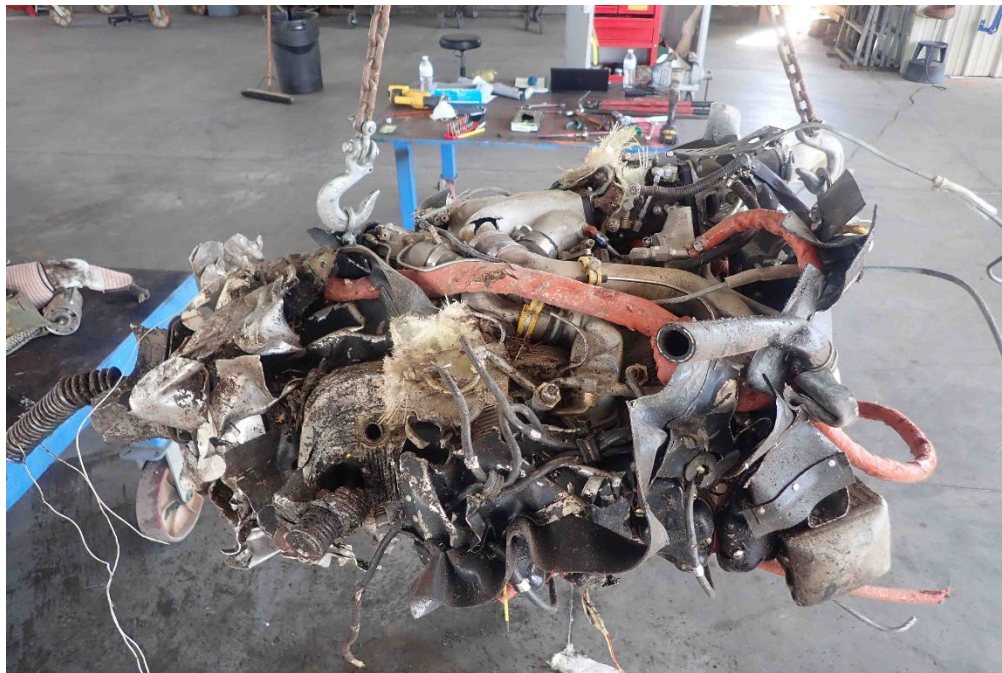
The engine sustained extensive impact damage and remained attached to segments of its mount, which had broken away from the airframe (see figure 16). The starter motor, vacuum pump, and the left magneto had all separated, and the oil cooler assembly remained attached to the engine but was crushed.

**Figure 16 - Right Engine**

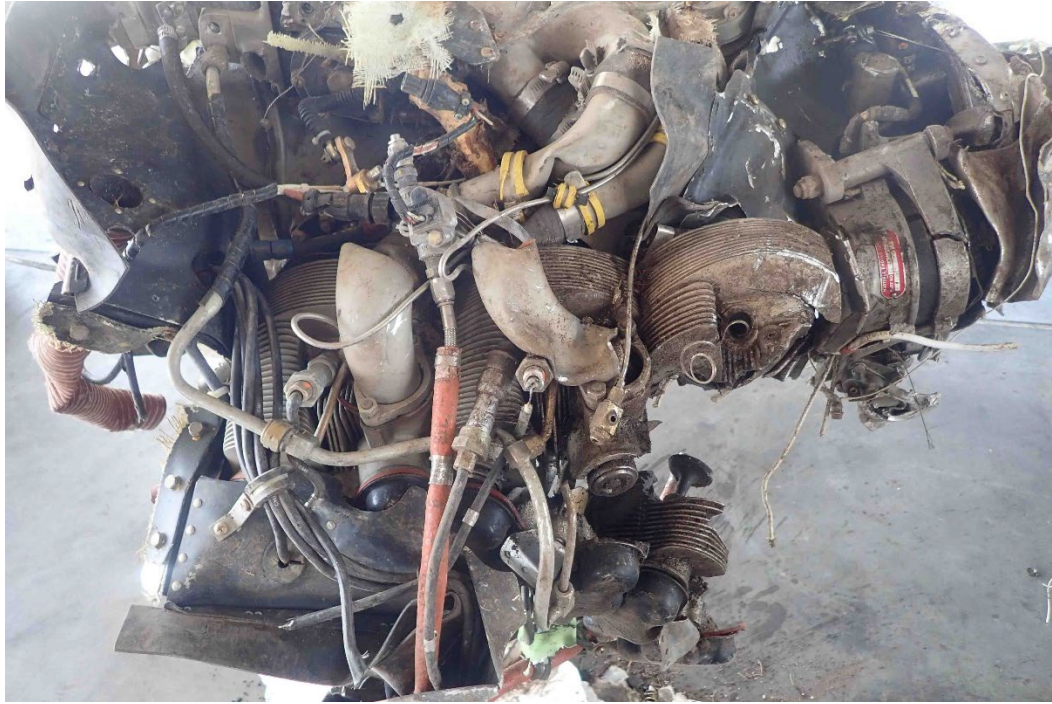
The forward two cylinders (5,6) sustained crush damage detaching all of their pushrods. For cylinder number 5, the head had broken away exposing the piston dome and cylinder sleeve assembly (see figure 17). For cylinder 6, the exhaust valve assembly had broken away from the head, and although the intake valve was in place, its rocker had detached.

**Figure 17 - Right Engine**

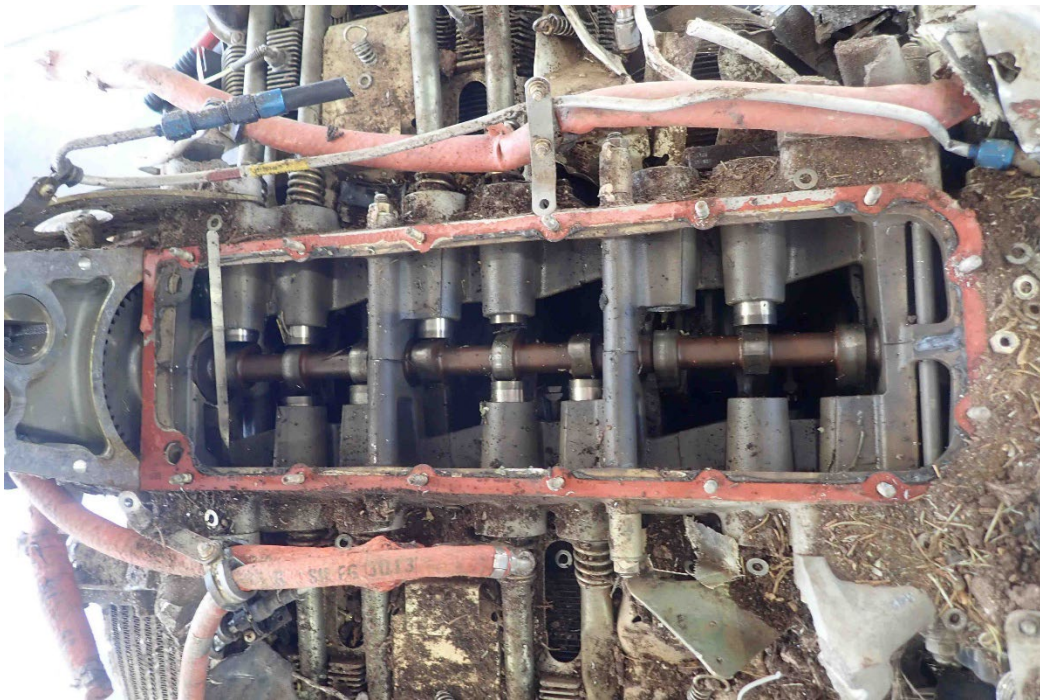
The oil sump remained attached but was breached just aft of the drain plug with a 6-inch irregular hole that had deformed inwards. Removal of the sump revealed that the camshaft was intact, and all lobes appeared clear and bright with no evidence of galling or lobe deformation (see figure 18). Looking inside the engine, the crankshaft was intact, and there was no evidence of catastrophic internal failure or thermal distress.

**Figure 18 - Right Engine Camshaft**

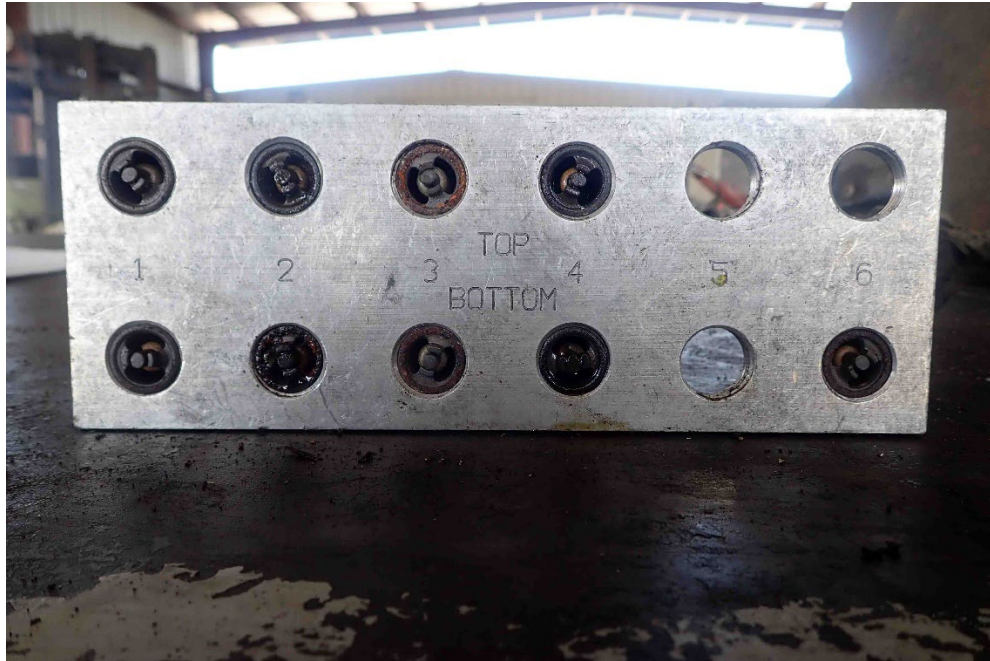
The top and bottom spark plugs for cylinders 1 through 4, along with the bottom plugs for cylinders 6 were removed. All exhibited varying wear signatures consistent with "normal" to "worn-out normal" when compared to the Champion AV-27 chart. The plugs for cylinder 1, 3 and 6 exhibited light and dark grey rust-colored deposits consistent with normal operation; the remaining plugs were similarly colored but coated in oil (see figure 19).

**Figure 19 - Right Engine Spark Plugs**

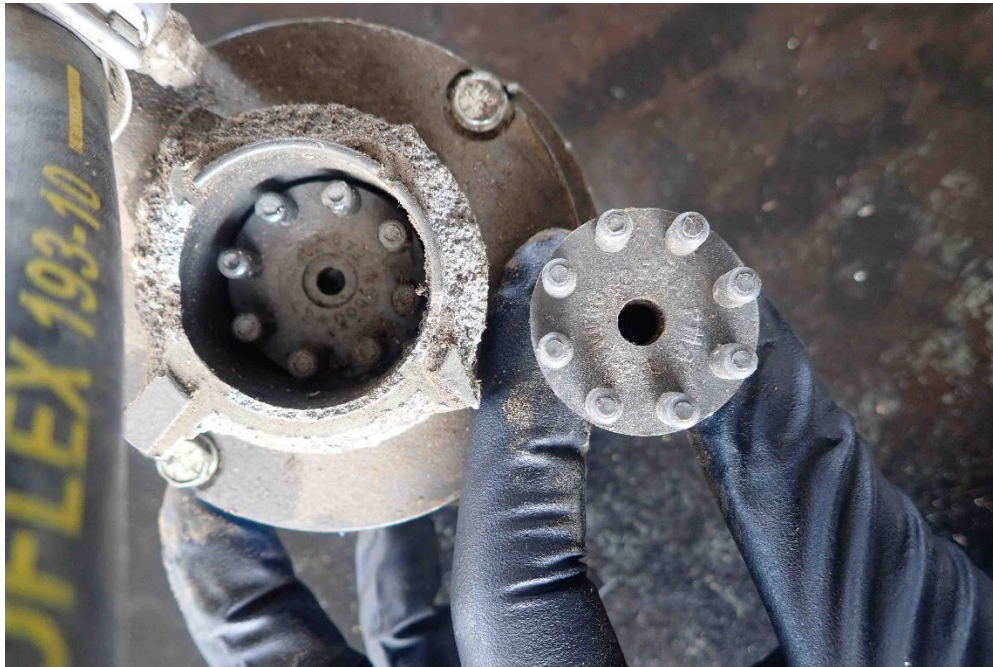
The vacuum pump had detached at its pad. The black "finger" couplings were both intact, but the plastic intermediate coupling was not located (see figure 20). There was no indication of plastic smear or other rotation signatures indicating rotation following coupling failure. The pump was disassembled, and the rotor was intact and undamaged (see figure 21). The vanes were about 19 mm long.

**Figure 20 - Right Engine Vacuum Pump Drive Coupling**

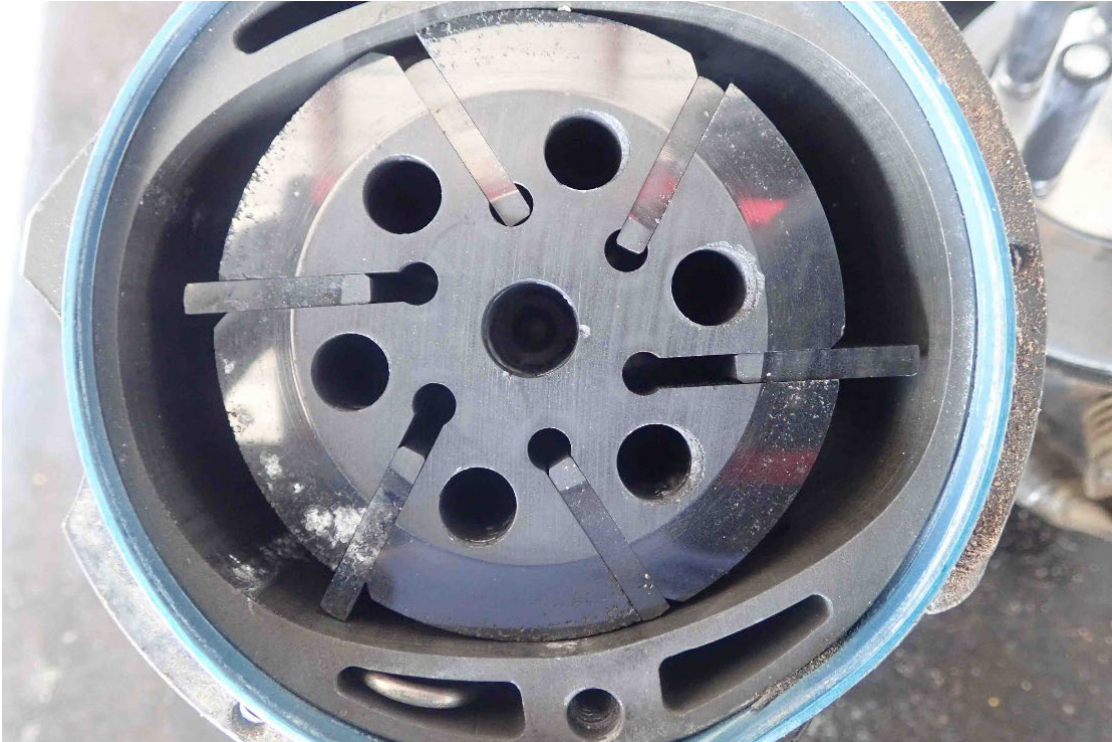
**Figure 21 - Right Engine Vacuum Pump Vane and Blades**

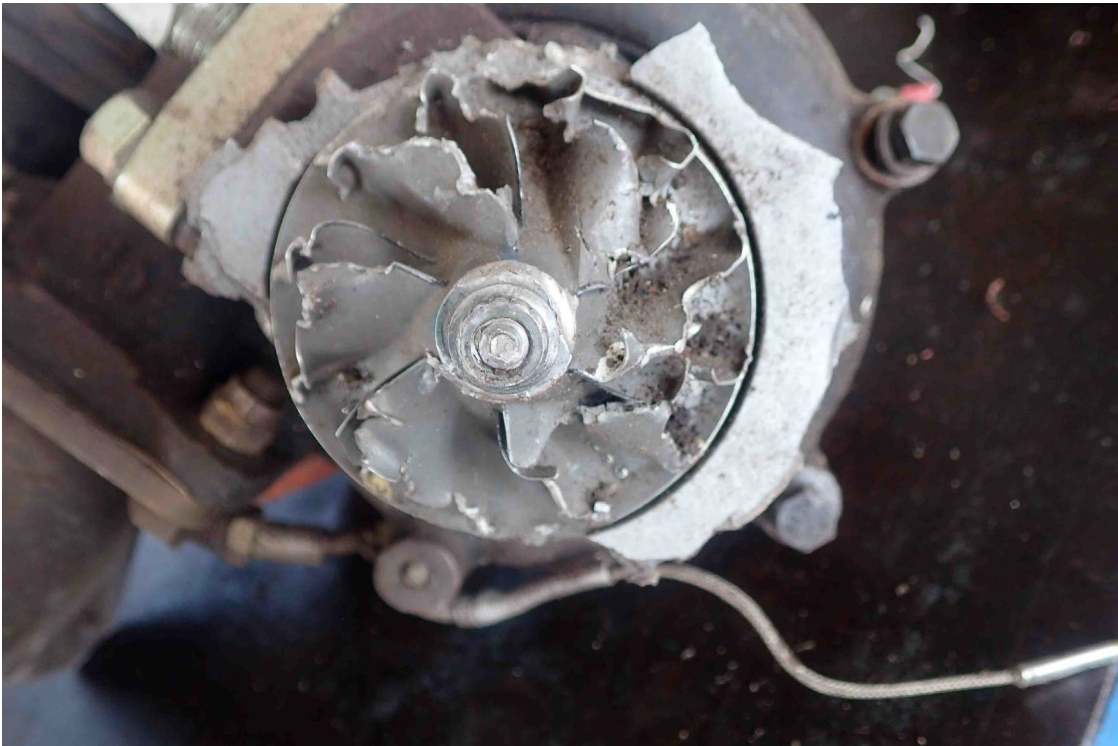
The entire turbocharger assembly had detached from the engine. The V-Band clamp that connects the compressor outlet to the exhaust pipe was intact, along with the clamps for both exhaust inlet branches. The turbine cover had broken away exposing the compressor wheel which had sustained severe rotational damage to all its blades, tearing and bending them opposite the direction of rotation (see figure 22).

**Figure 22 - Right Engine Turbocharger Compressor**

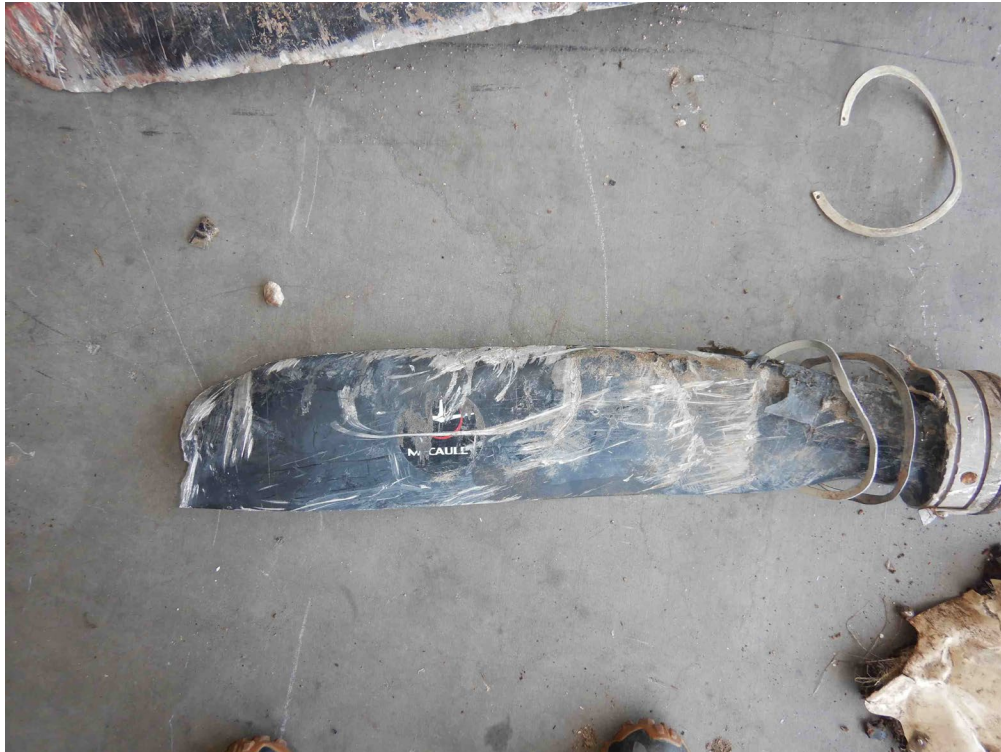
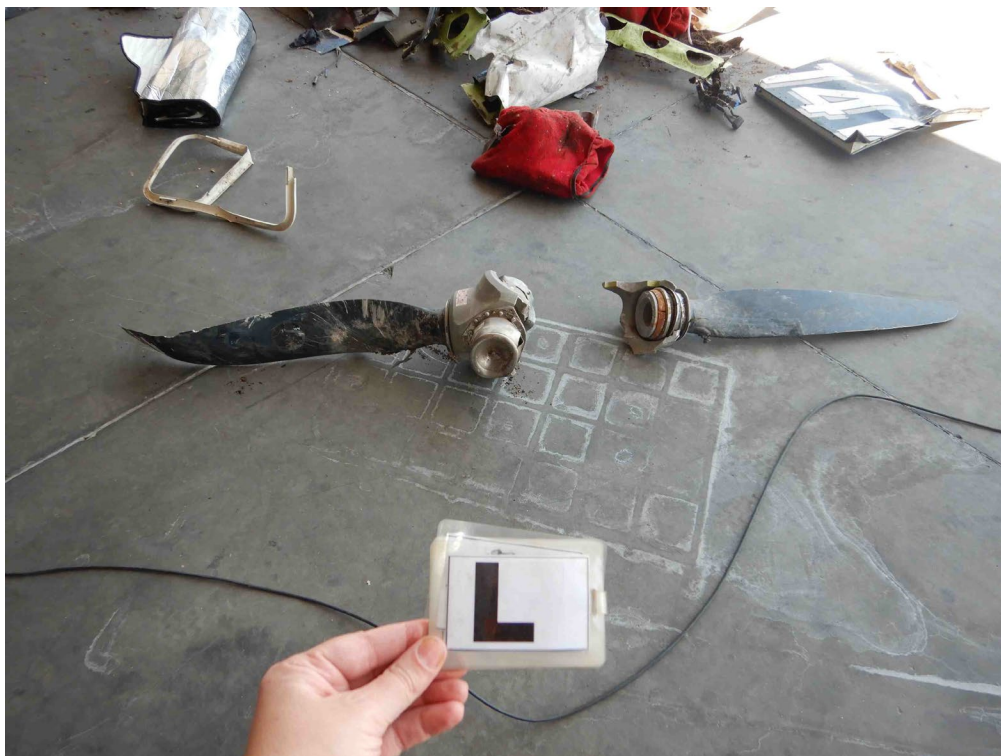
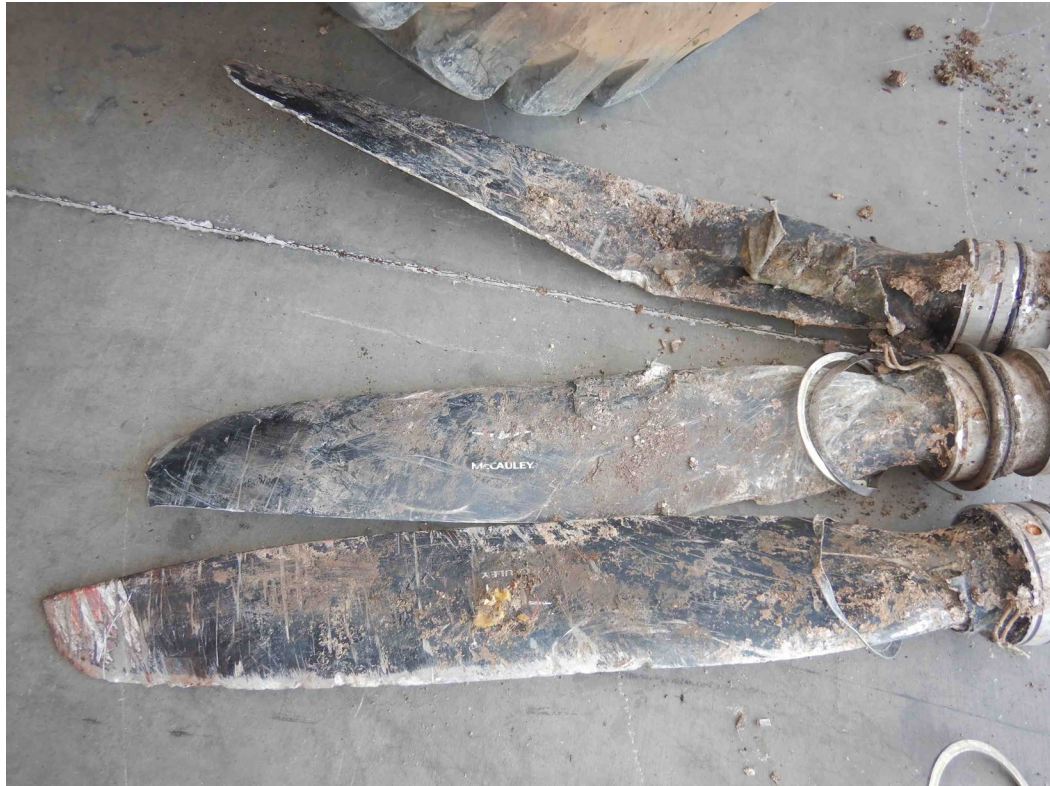
All six propeller blades were recovered. Two from the left engine remained attached to remnants of the hub, the remaining four had completely detached from their respective hubs. All blades exhibited significant leading-edge damage, along with varying degrees of tip curl, serration, chordwise striations and S-beading (see figures 23, 24, 25).

**Figure 23 - Left Propeller Blade**

**Figure 24 - Left Propeller Blades**

**Figure 25 - Right Propeller Blades**
