**NTSB File No.:** WPR23FA122

**Aircraft:** Rockwell International S-2R

**Written by:** Les Doud  
Air Safety Investigator – Hartzell Propeller Inc.

**PROPELLER TEARDOWN REPORT**

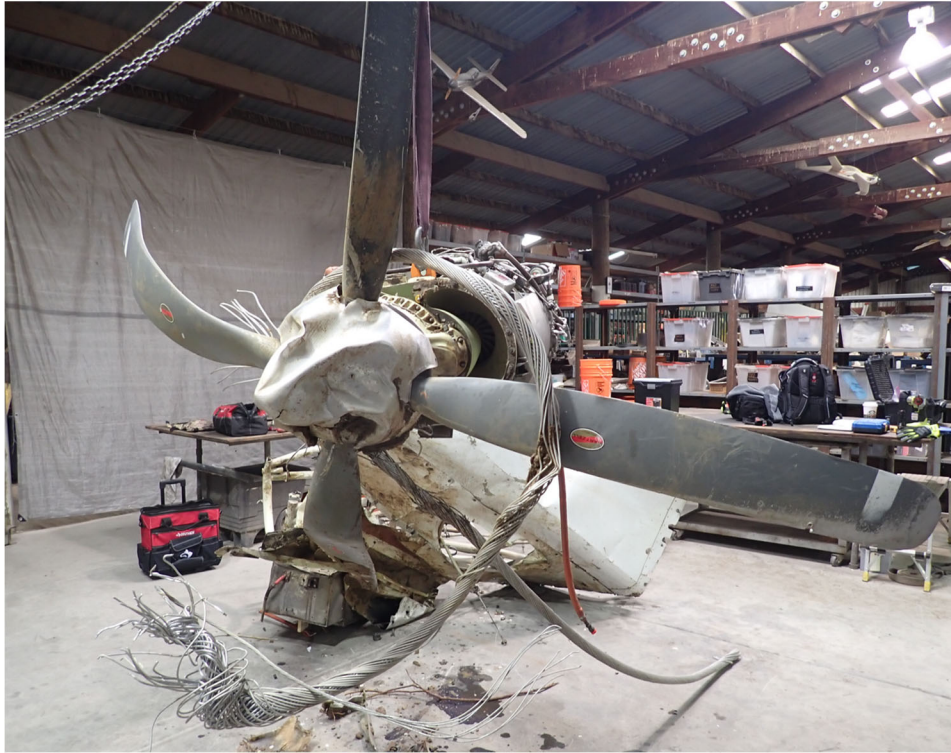
**As Received Condition:** The propeller is shown in Photo #1 before removal from the engine. There were remnants of a power line wrapped around the propeller and engine propeller shaft. The propeller was removed by on-scene investigators and recovery personnel. The spinner dome was removed and all four blades were cut to facilitate shipping. The propeller was shipped to Honeywell in a crate. It arrived at Honeywell as shown in Photo #2.

Photo #1 - Propeller prior to removal from engine (photo courtesy of Honeywell)

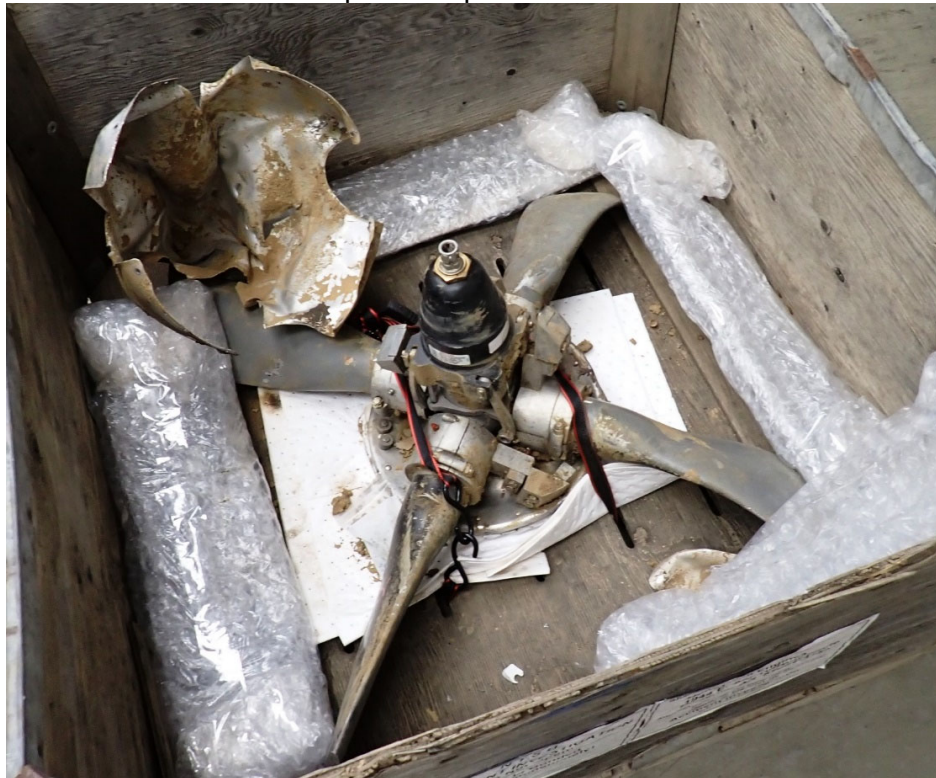
Photo #2 – Propeller as presented for examination

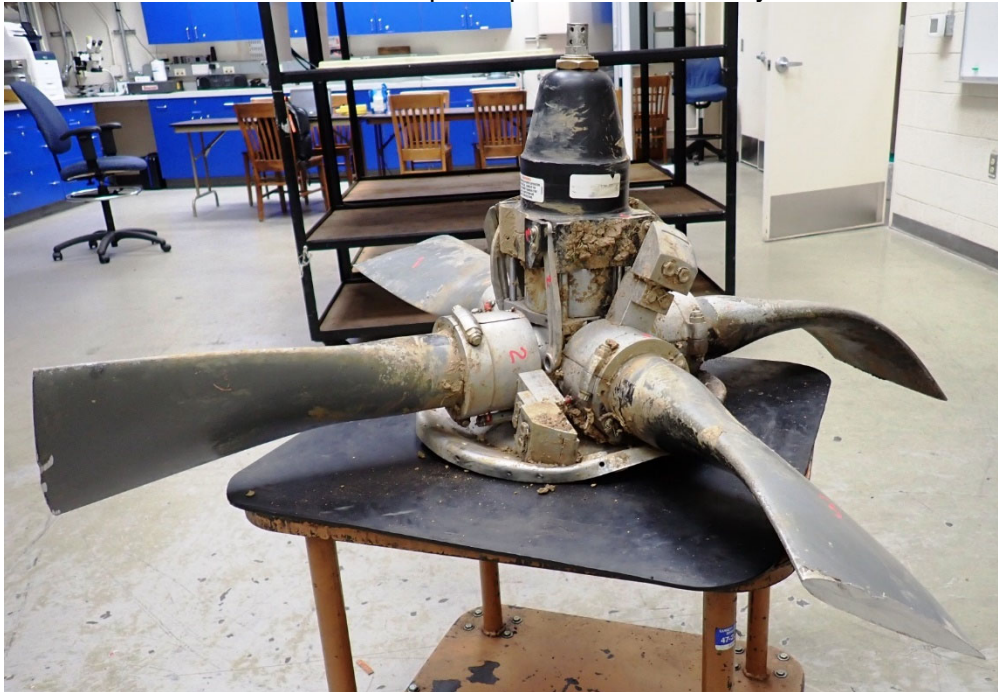
All four blades were cut approximately 16-21" from the blade butts. There were cable "notches" in the leading edges of blades #1, #2 and #4. Blades #1, #3, and #4 were in a low pitch position, blade #2 was in a position beyond feather and the counterweight impacted the spinner bulkhead. The #2 link screw was fractured from the clamp and not recovered. Therefore the #2 link arm was not attached at the clamp allowing free rotation of the #2 blade. The piston was jammed in a forward/low pitch position, under feathering spring tension with no apparent fractures. All four link arms remained attached to the piston. The cylinder remained attached to the hub. There was no apparent blade slippage in the clamps. The propeller is shown in Photo #3 prior to disassembly.

Photo #3 - Propeller prior to disassembly

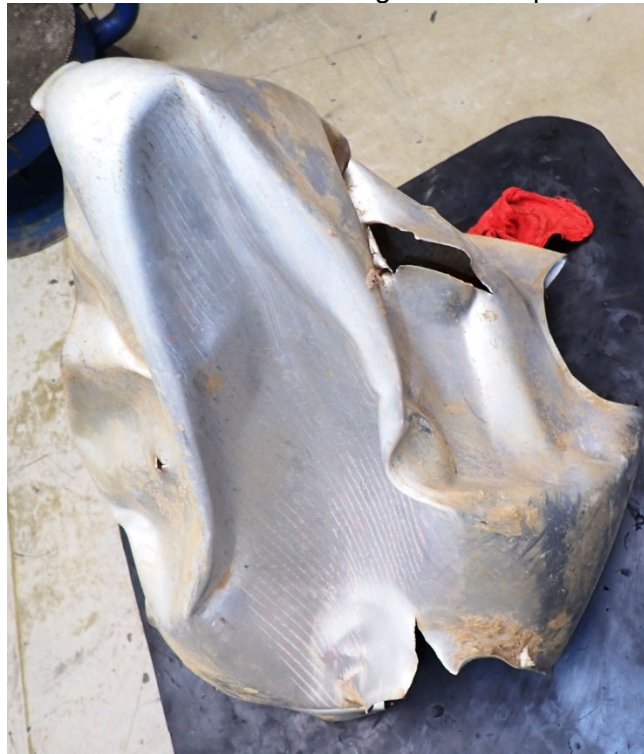
**Spinner Dome:** The spinner dome was crushed and torn. There was visible torsional distortion. There were two counterweight impressions/cuts in the dome, one at approximately 17.4° (Photo #5) and another at 8.6°. It was not determined which blade/counterweight made each mark. There were also braided cable scoring marks in the dome (Photo #4).

Photo #4 - Braided cable scoring marks in spinner dome

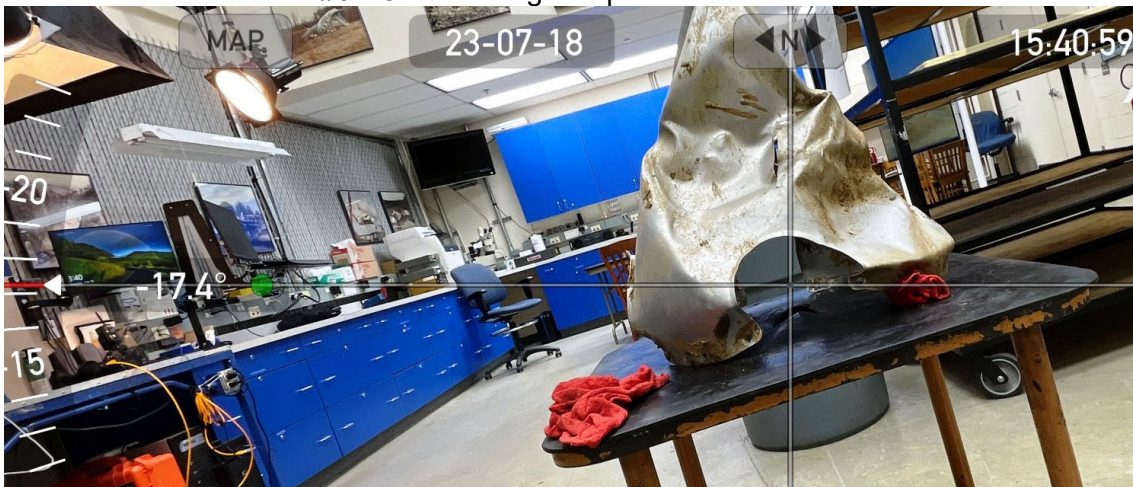
Cable remnants wrapped around the propeller shaft suggested it may have reduced rotational energy prior to impact into terrain. A counterweight impact mark in the spinner dome at  $17.4^{\circ}$  is equivalent to a blade angle of approximately  $4^{\circ}$ , which would be closer to flight idle and consistent with lower power at time of impact with terrain.

Photo #5 - Counterweight impression measurement

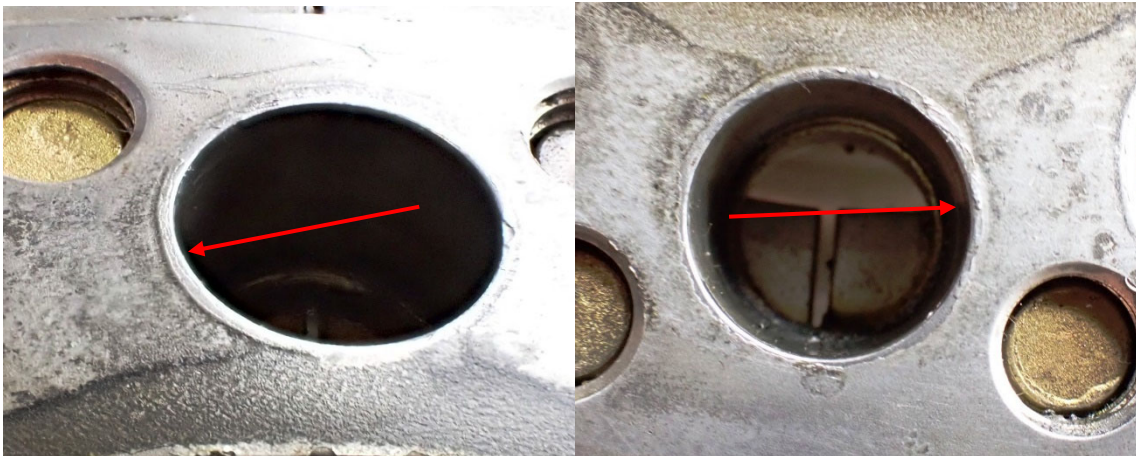
**Engine/Propeller Mounting:** According to the Honeywell ASI, the propeller remained securely attached to the propeller shaft flange with all eight mounting bolts secure. The flange was intact but both dowel pin holes appeared to have deformation in the direction of rotation indicating torque at impact (Photo #6).

**Hub Unit:** The hub unit remained intact with no apparent fractures. The mounting flange remained intact with all eight bolts secured before removal. The dowel pin holes appeared to have deformation in the direction of rotation. All four pilot tubes remained intact. There were some clamp-to-hub arm contact marks on the trailing edge side of the hub arm. The bearings appeared intact with fresh/serviceable grease.

Photo #6 - Dowel holes deformation in direction of rotation

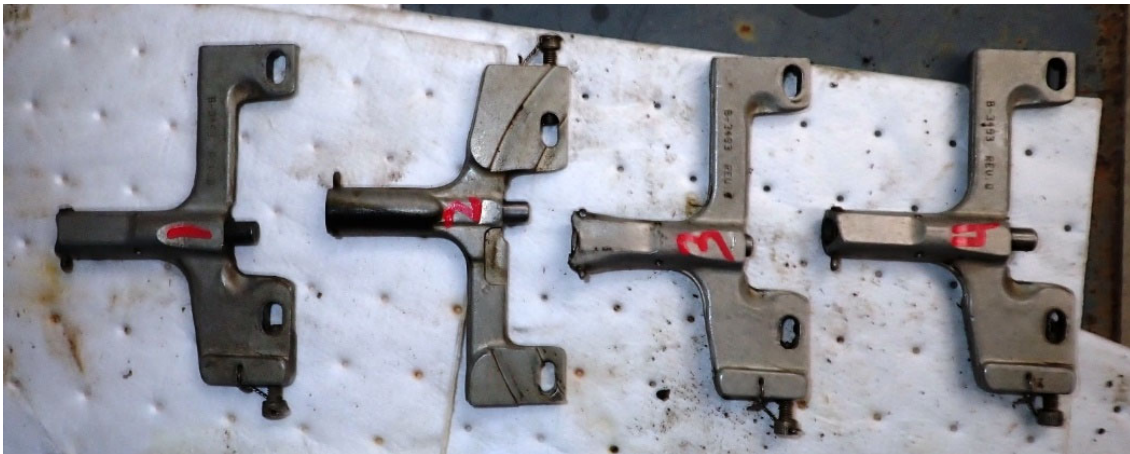
**Start Lock:** All four start lock brackets were intact but the #3 bracket was smashed thus retaining the pin in the retracted position (Photo #7). None of the pins appeared to have impact damage indicating forceful contact with the start lock plates. The pins for #1, #2 and #4 actuated with finger force. The #1 start lock plate was impact-separated from the clamp and not recovered. The other three plates remained attached to their clamps.

Photo #7 - Start lock assemblies

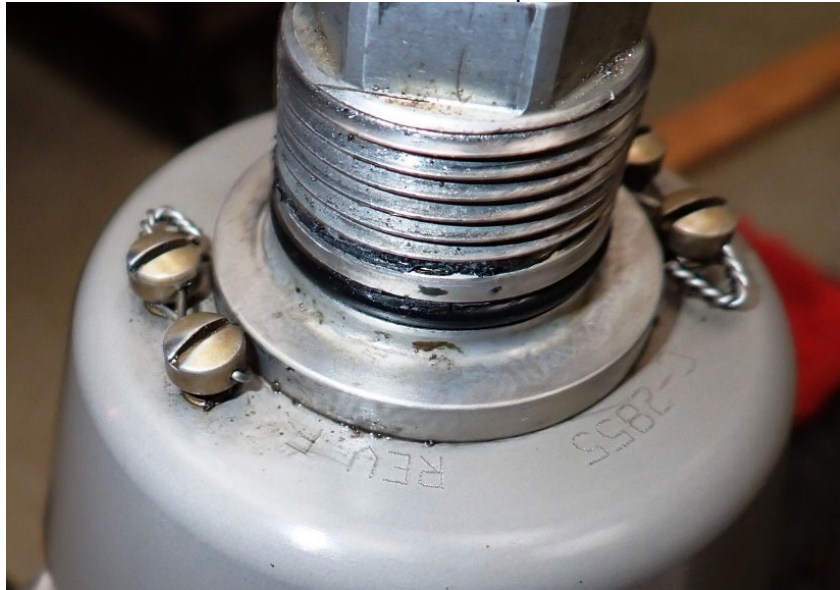
**Feather Stop Screws:** The feather stop screws appeared intact and undamaged confirming the propeller was not on the feather stop at impact (Photo #8).

Photo #8 - Feather stop screws

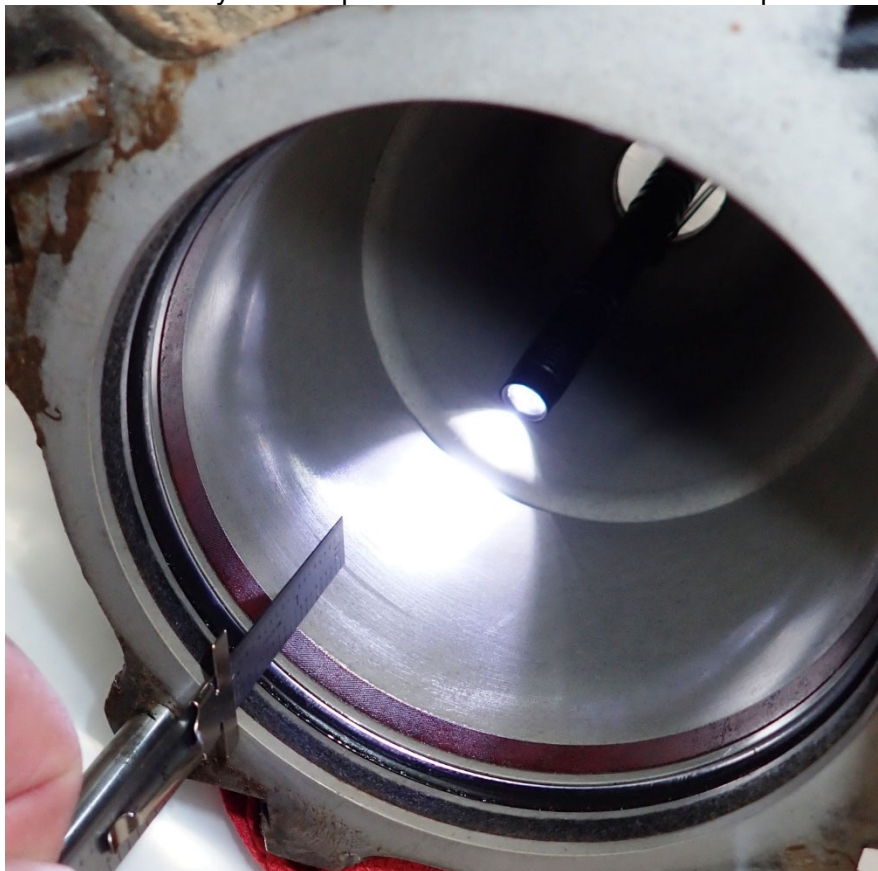
There were no discrepancies noted that would prevent or degrade normal operation prior to impact with a power line. All damage was consistent with high impact forces associated with a power line strike and impact with terrain. An impact signature in the piston suggested power level was moderate-to-high at the time of the cable strike and decreased prior to impact with terrain.

**Piston:** The piston was intact and secured by the piston nut. There were no apparent fractures, cracks or indications of oil leakage. There some random scoring on the external surface due to contact with the spinner dome. There was one remarkable impact mark on the internal surface of the piston due to contact with the cylinder top corner (Photo #9) and is described in Table #1.

| Internal Marks from<br>Bottom Piston Edge | Approximate<br>Equivalent<br>Blade Angle | Pre-impact Confidence Level / Why? |
|---|---|---|
| 2.2" from bottom edge | 17.7° | HIGH – At 100 KTAS SL/ISA this blade angle<br>absorbs 409 Hp @ 1591 RPM |

Photo #9 - Cylinder impact mark on internal surface of piston

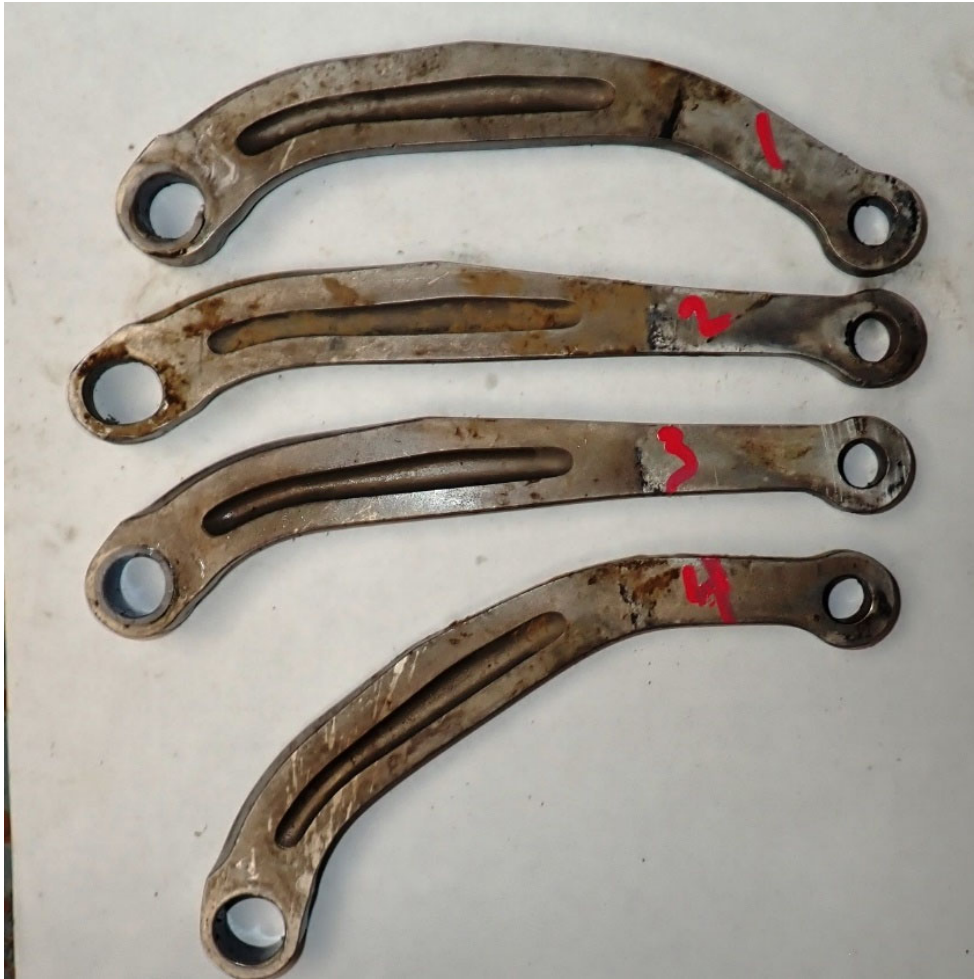
**Link Arms:** All four link arms remained attached to the piston link pins. The link arms are shown in Photo #10.

| Link Arm | Link Arm Condition |
|---|---|
| 1 | Bent in compression/buckled |
| 2 | Stretched in tension, link screw hole elongated |
| 3 | Unremarkable |
| 4 | Bent in compression/buckled |

Photo #10 - Link arms

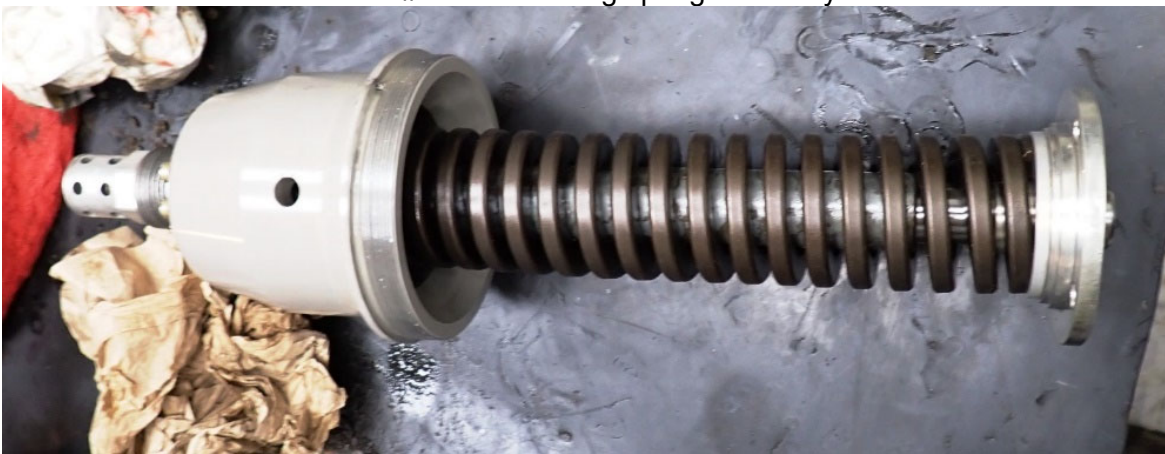
**Feathering Spring Assembly:** The feathering spring assembly remained intact and appeared undamaged (Photo #11).

Photo #11 - Feathering spring assembly

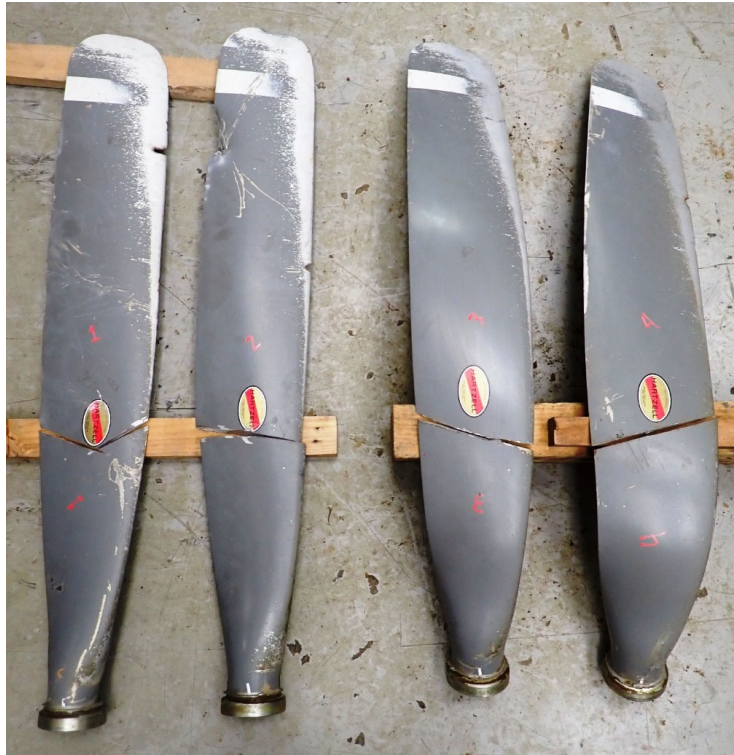
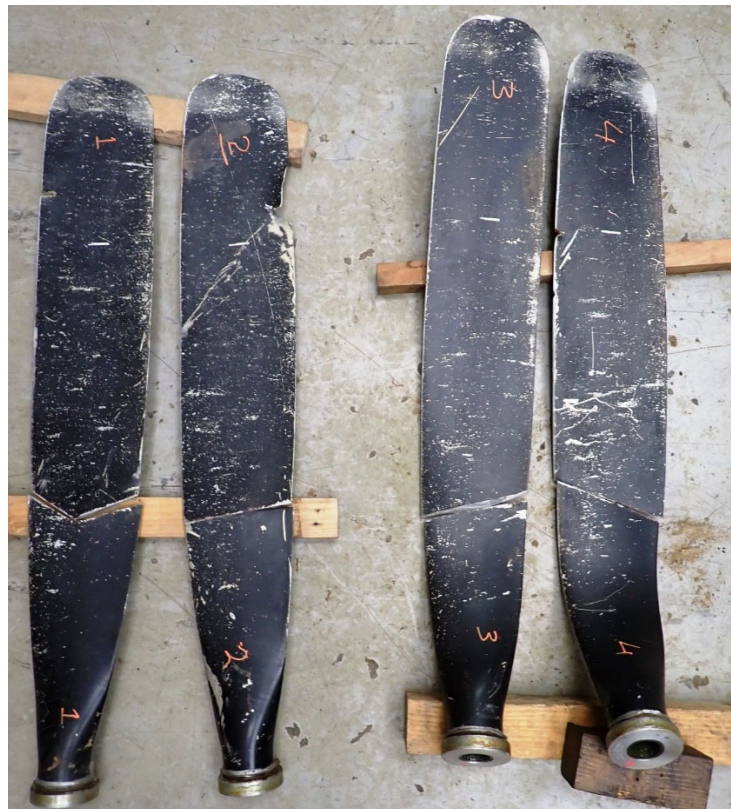
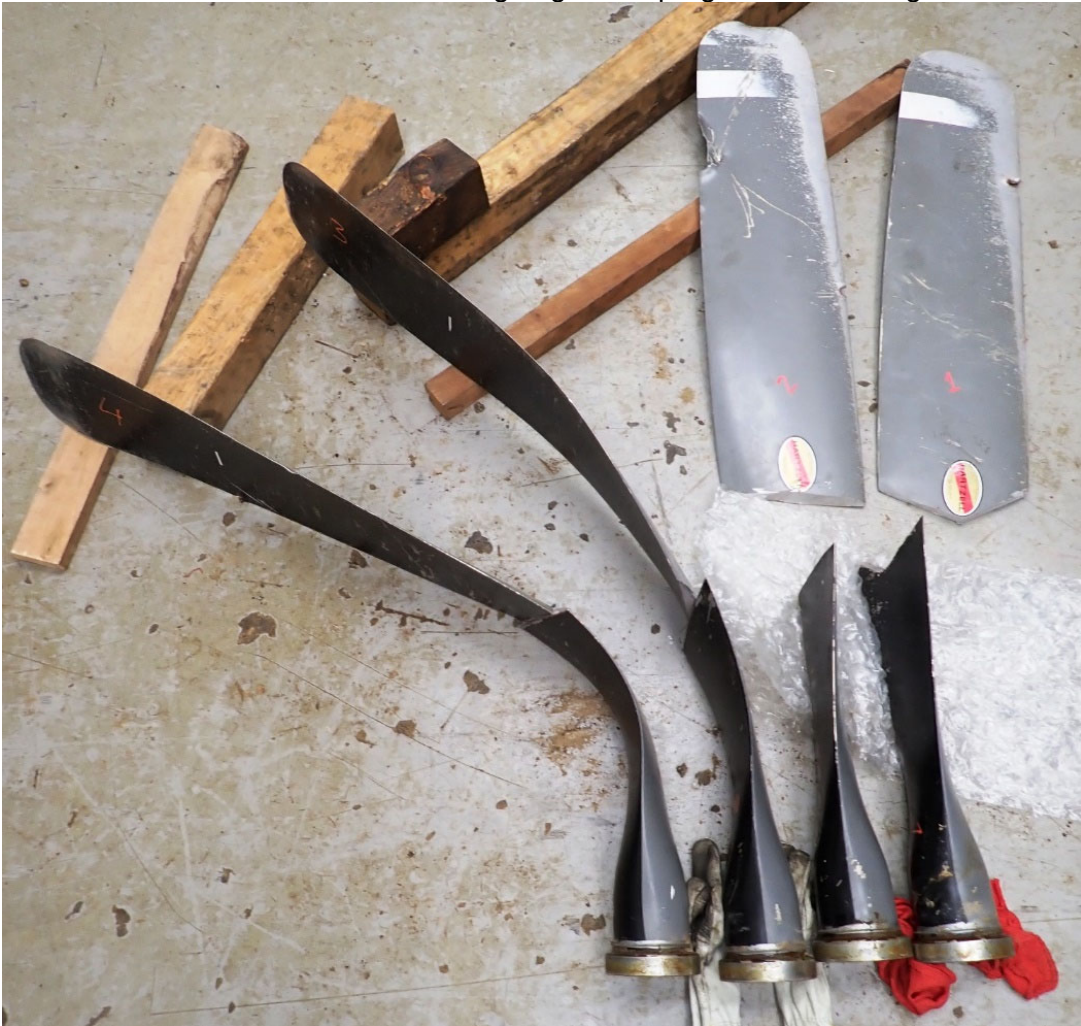
No pilot tubes were fractured suggesting that rotational energy was relatively low by the time of impact with terrain. Additionally, there was only simple aft bending in blades #3 and #4 with no remarkable twisting or bending opposite rotation, also consistent with a lower power at impact with terrain.

**Blade Properties:** See Photos #12 through #16

Photo #12 - Blades camber side

Photo #13 - Blades face side

Photo #16 - Blades trailing edge view/progressive bending

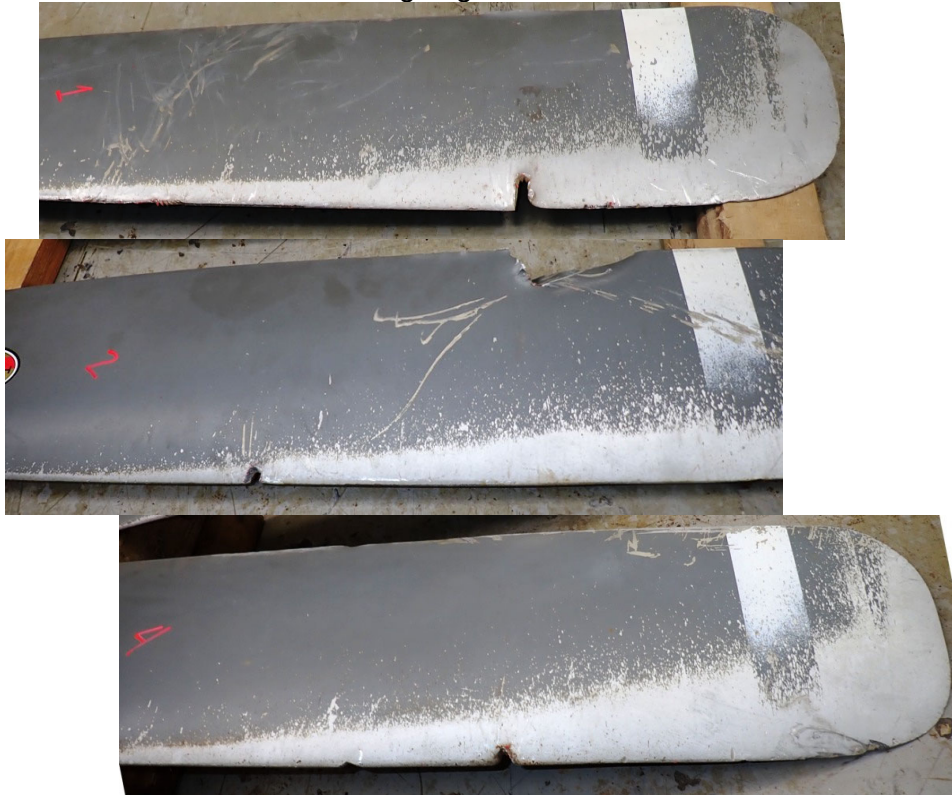
The propeller blade damage included chordwise/rotational scoring and leading edge cable notch/cuts that are consistent with inflight impact into a cable while rotating. Blade #2 pitch mechanisms indicated the blade was forcefully rotated toward high pitch by the cable strike. An impact signature on the internal surface of the piston is equivalent to a blade angle of approximately  $17.7^{\circ}$  and would be consistent with a power condition inflight. The two dowel pin holes on the mounting flange appeared deformed in direction of rotation also indicating moderate-to-high torque.

| Lead edge damage | Cable notch/cut approximately 9.5” from tip (Photo #14) |

| Lead edge damage | Cable notch/cut 19” from tip (Photo #14) |

| Lead edge damage | Cable notch/cut 13” from tip (Photo #14) |

Photo #14 - Blade leading edge cable notch/cuts

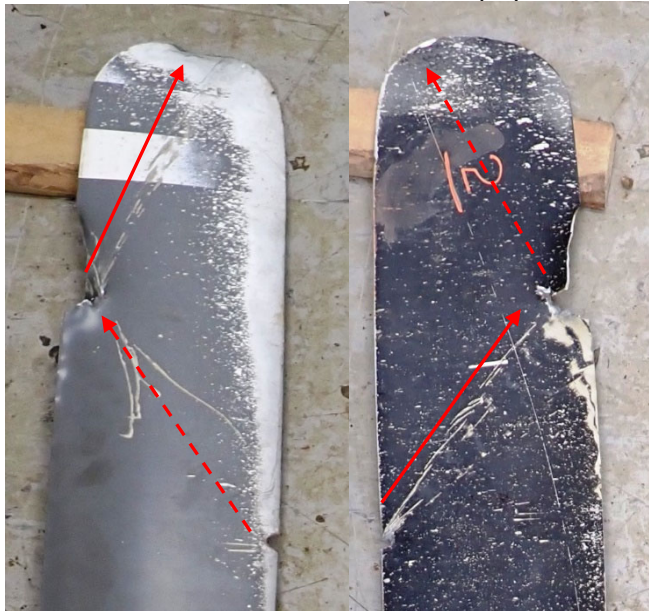
| Camber side | Chordwise/rotation scoring, cable wrap pattern (Photo #15) |
| Face side | Chordwise/rotation scoring, cable wrap pattern (Photo #15) |

Photo #15 - Blade #2 "cable wrap" pattern
