# National Transportation Safety Board

WPR23FA122

## **ONSCENE AND WRECKAGE EXAMINATION**

Location: Willows, California  
Date: March 7, 2023  
Time: 1400 PST  
0000 UTC  
Airplane: Rockwell S2R (N8424V)

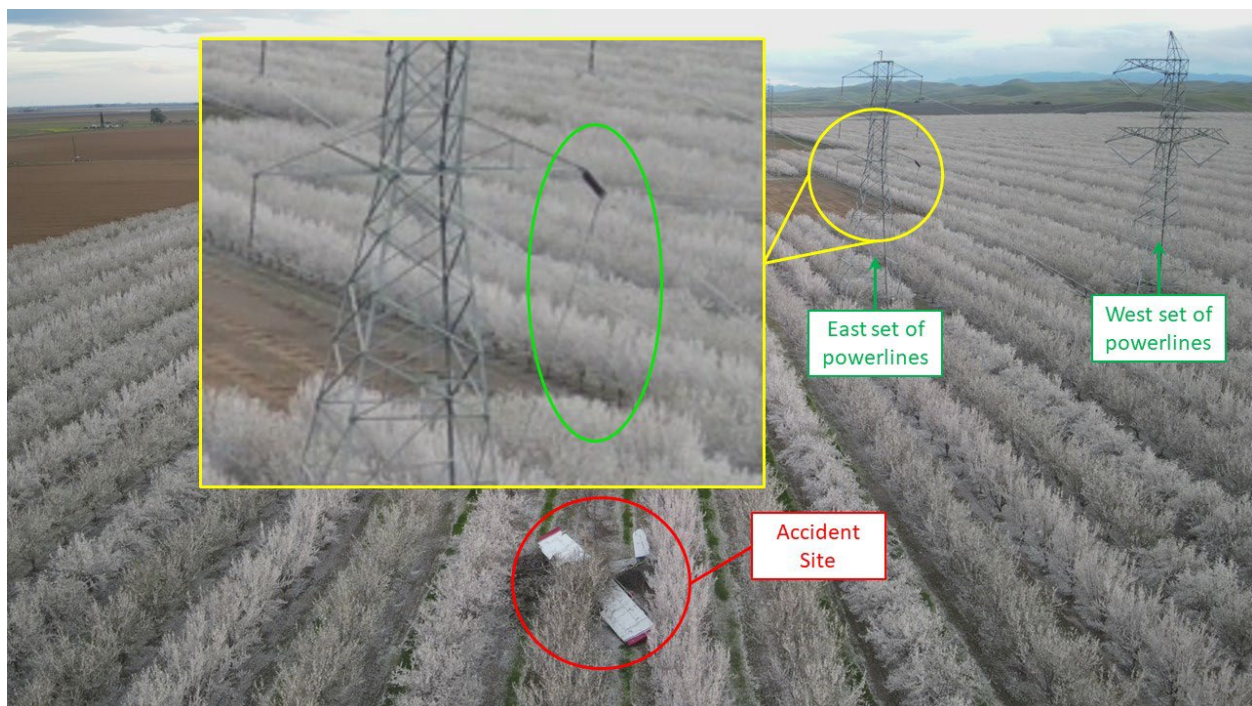
The airplane came to rest inverted in an almond orchard about 500 ft northeast of a powerline tower and was oriented on a heading of 038° magnetic. All of the major structures of the airplane were accounted for at the accident site. The debris field was marked by several broken tree branches about 50 ft southeast of the accident site. A ground scar about 5 ft in diameter was collocated with the main wreckage. Both ailerons and flaps remained attached to their respective wings, which were both attached to the fuselage. The right wing displayed a depression about 3 ft in diameter with accordion style deformation and tree remnants several feet outboard of the wing root. The left wing leading edge exhibited a depression about 10 ft from the wing root. A conductor (powerline) about 2 inches in diameter that was wrapped around the propeller hub was traced through the left wing depression to the trees southeast of the accident site. Both elevators remained connected at their respective horizontal stabilizers and the rudder remained attached to the vertical stabilizer, which were both bent about midspan. The elevator trim tabs were attached to their respective elevators; the left elevator trim tab was deflected downward and the right elevator trim tab exhibited an upward deflection. Photographs and overhead footage furnished by law enforcement showed that the airplane impacted the inside (west) conductor on the east tower of powerlines near the midspan point between two towers.

**Figure 1: Powerlines and accident site**

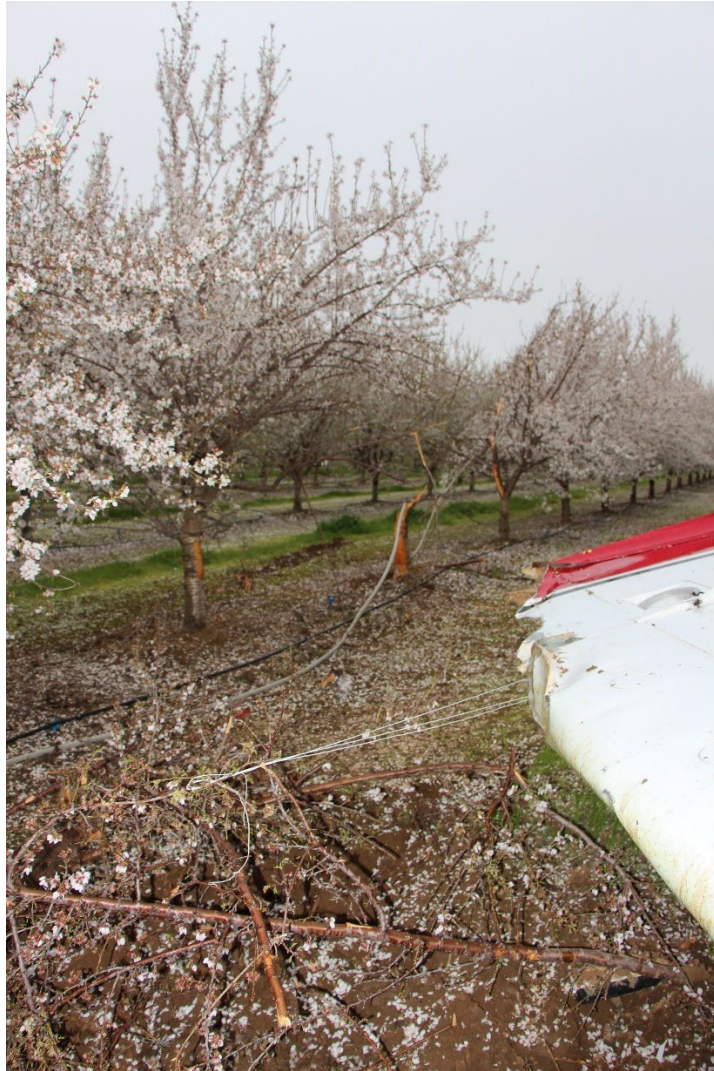
**Photograph 1: Broken trees and ground scar**

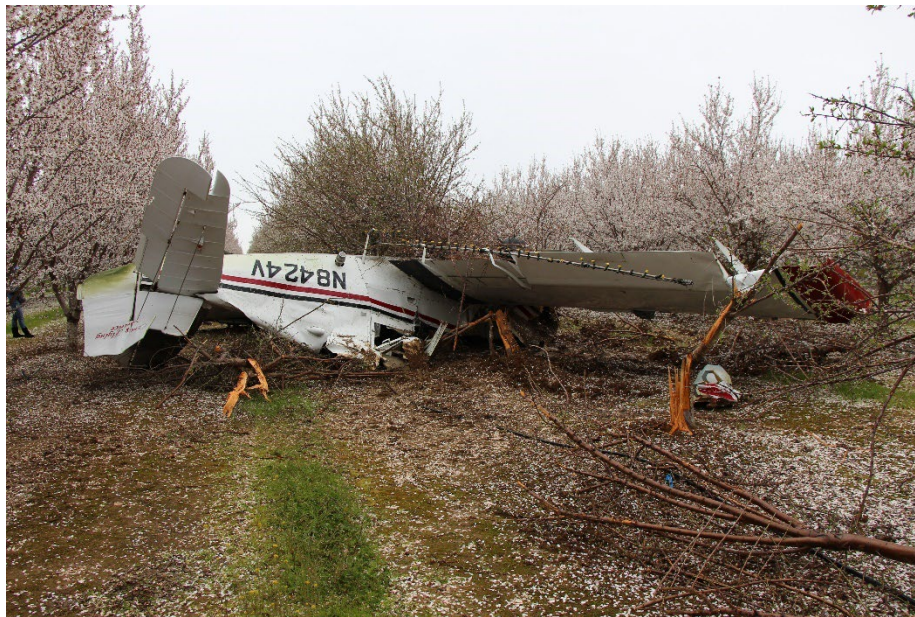
**Photograph 2: Airplane at accident site**

The airplane came to rest inverted in an almond orchard about 500 ft northeast of a powerline tower and was oriented on a heading of 038° magnetic. All of the major structures of the airplane were accounted for at the accident site. A ground scar about 5 ft in diameter was collocated with the main wreckage. An odor consistent with JET A fuel was noted beneath the right and left wings and fuselage at the accident site.

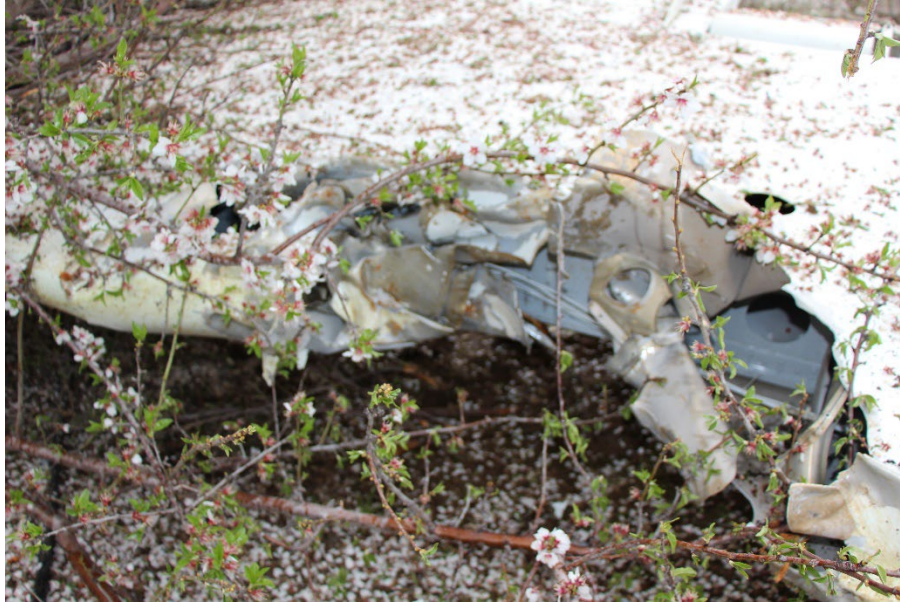
Both ailerons and flaps remained attached to their respective wings, which were both attached to the fuselage. The right wing displayed a depression about 3 ft in diameter with accordion style deformation several feet outboard of the wing root and bending at the wingtip. The left wing leading edge exhibited a depression about 3.5 ft in diameter 10 ft from the wing root. A conductor (powerline) about 2 inches in diameter ran from the propeller hub through the left wing depression to the trees southeast of the accident site. Both elevators remained connected at their respective horizontal stabilizers and the rudder remained attached to the vertical stabilizer, which were both bent about midspan. The elevator trim tabs could not be actuated by hand. The left elevator trim tab was deflected downward and the right elevator trim tab exhibited an upward deflection.

**Photograph 3: Accordion style deformation at right wing**

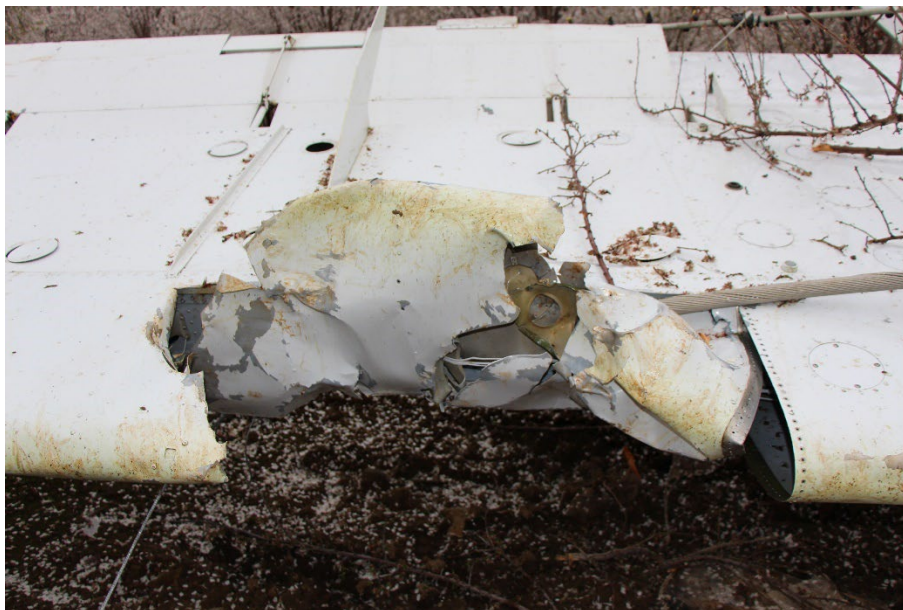
**Photograph 4: Midspan damage at left wing with conductor**

A two-inch thick conductor (powerline) was wrapped around the propeller that was traced through the depression in the left wing and terminated at the trees located about 50 ft from the main wreckage. A green colored residue was observed along the leading edges of both wings. Brown transfer marks and tree debris were observed within the according style deformation at the depression in the right wing. A flat impact mark was located on outboard leading edge of the left wing that extended about 16 inches in length. The left-wing tip was separated from the outboard leading edge. Both main landing gear and the tailwheel remained attached.

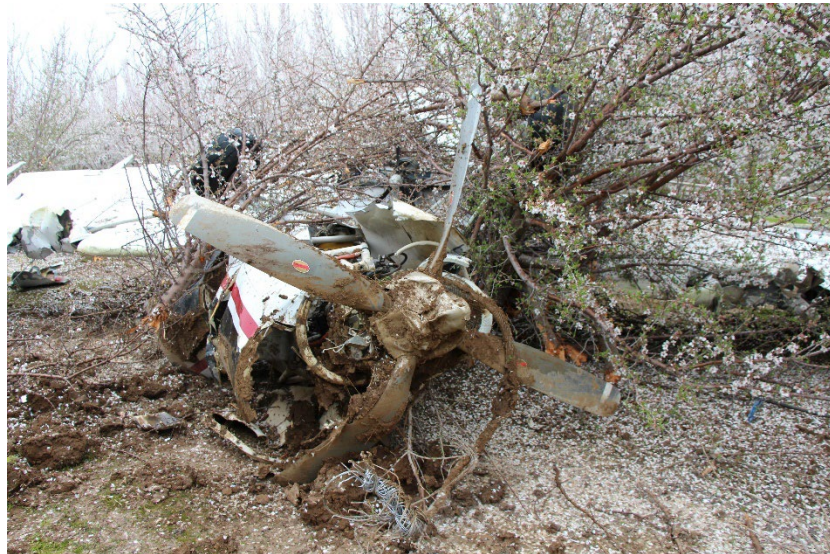
The four bladed propeller remained attached to the engine at the propeller flange. One blade was in contact with the ground and exhibited a bend towards the blade face near the blade root. Another blade was straight and displayed a large gouge on the leading edge outboard and minor bending along the trailing edge about midspan. Another blade exhibited a large gouge about midspan on the leading edge and the last propeller blade was unremarkable.

**Photograph 5: Propeller from front of airplane**

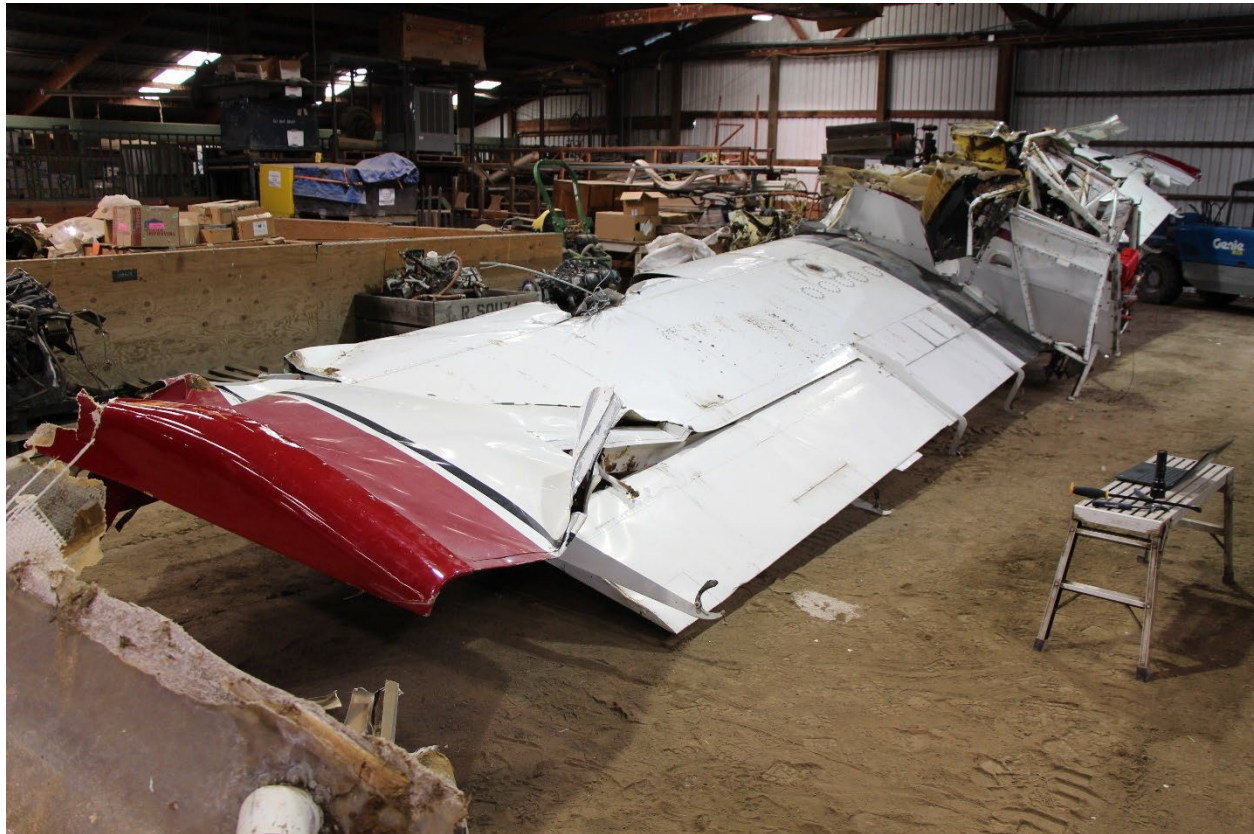
**Photograph 6: Wings and fuselage prior to examination**
