# National Transportation Safety Board

WPR23FA138

## **ACCIDENT SITE AND WRECKAGE EXAMINATION REPORT**

Location: Santa Teresa, New Mexico  
Date: April 1, 2023  
Time: 0730 MDT  
Airplane: Aerotrike Cobra

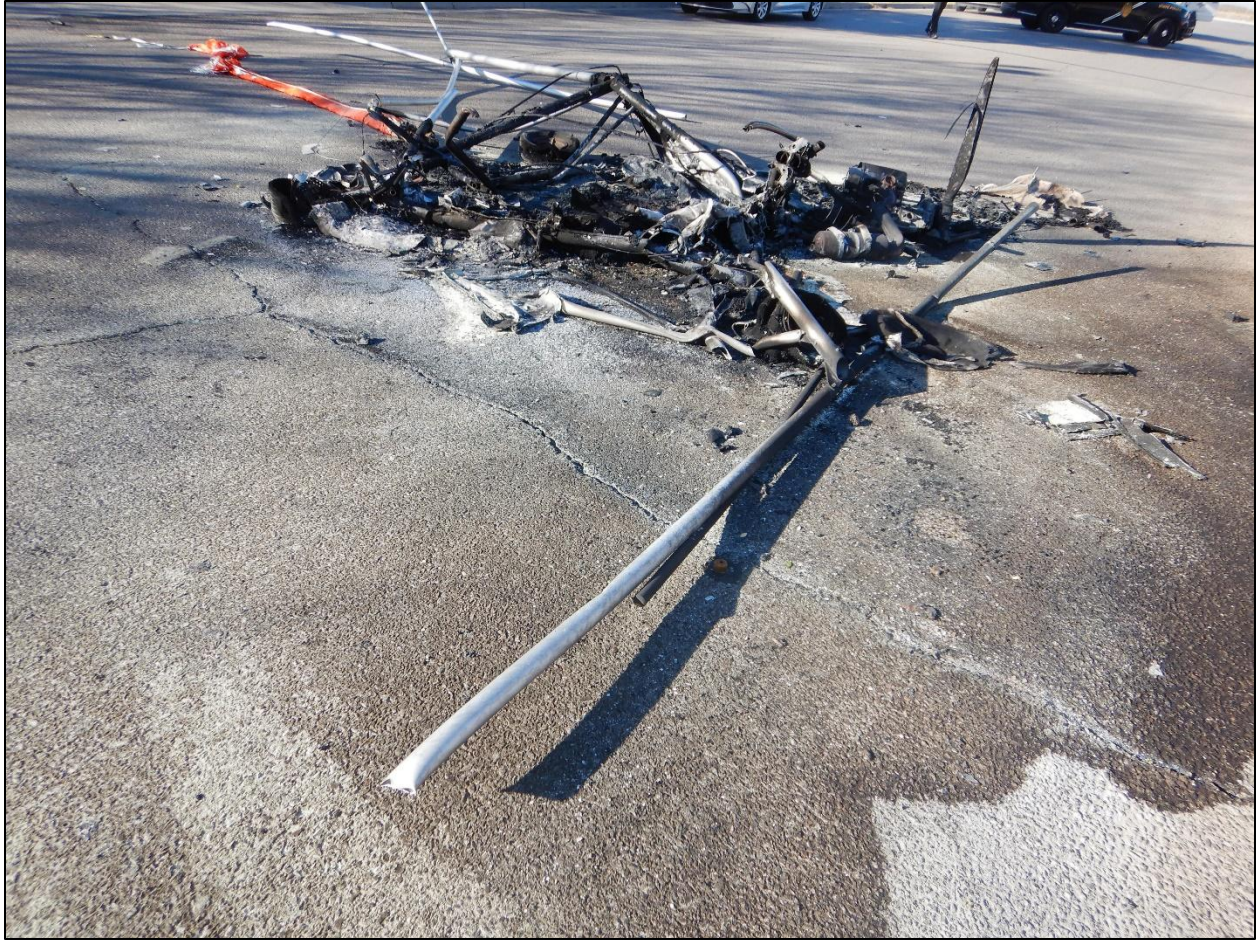
An examination of the accident site revealed that the trike impacted the road surface at an elevation of 4,114 ft mean sea level (msl). Impact marks on the asphalt road surface were not identified. A small area fire ensued consuming the wing sail, some of the wreckage and burning the grass covered medians. Thirty-foot-tall trees border the road, and one tree nearest the wreckage was burned on one side. The wing structure and carriage which remained partially attached and had impact and thermal damage.

**Figure 1-Accident site, main wreckage.**

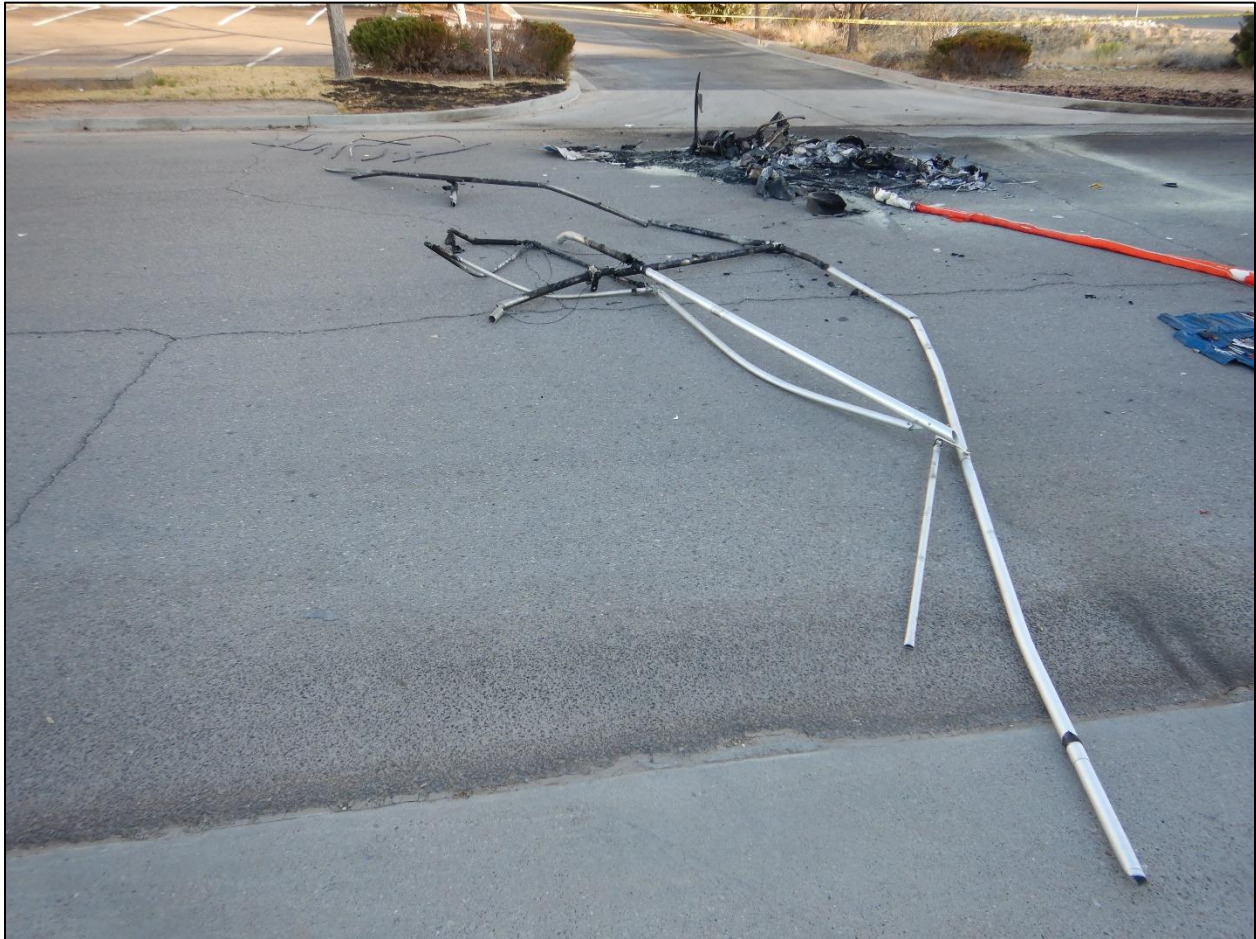
The bolt that attaches the wing to the mast was removed and the wing was separated from the cockpit. The bolt shaft was deformed.

**Figure 2-Accident site, wing removed from the main wreckage.**

The wing was separated and damaged in multiple areas. All bolt connections, safety rings and hardware remained attached to the wing. The cables remained intact and their attachments undamaged.

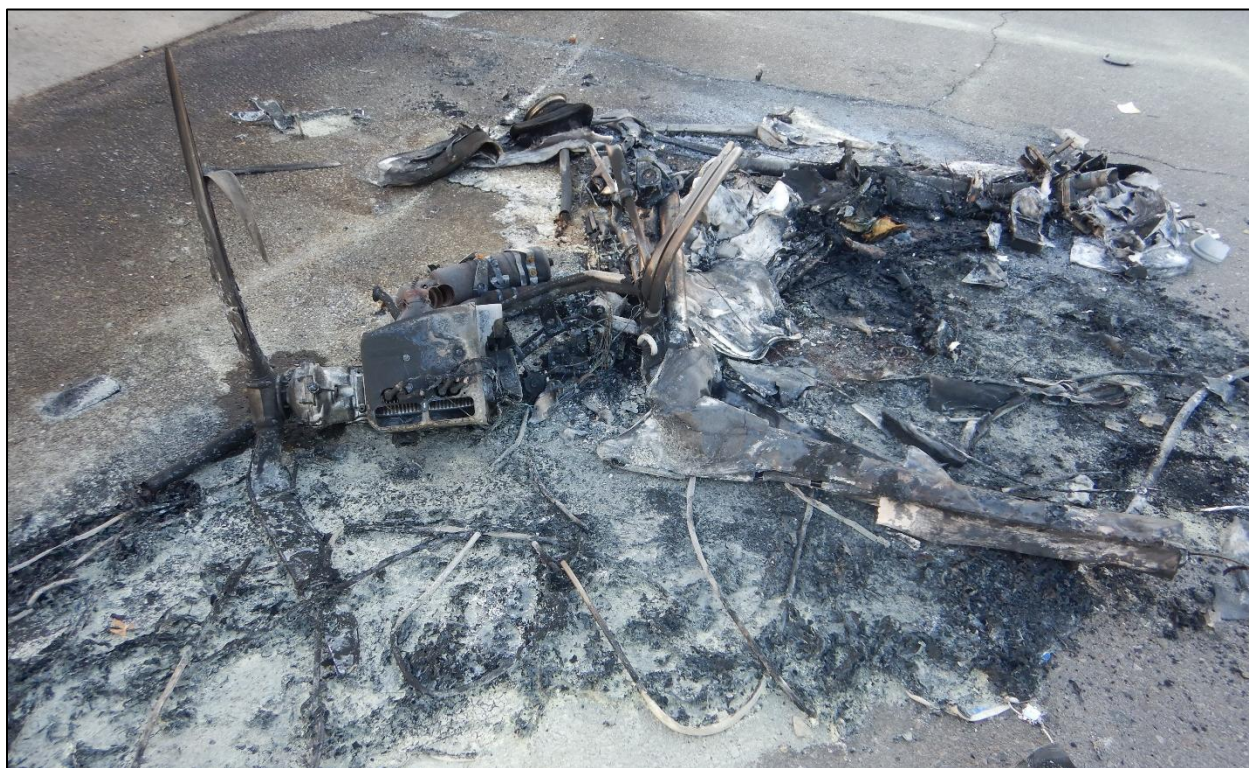
**Figure 3-Accident site, cockpit and engine.**

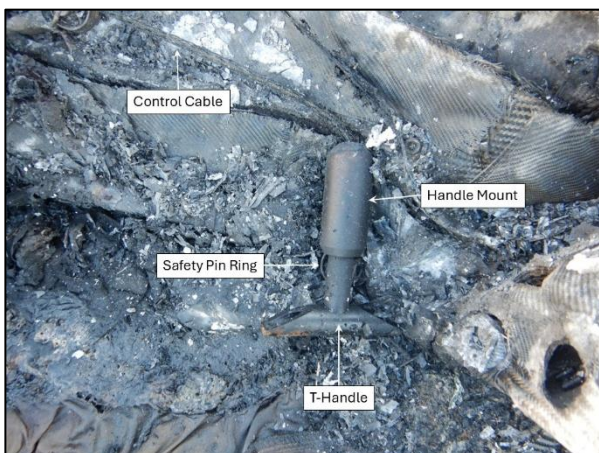
The cockpit had impact and thermal damage. The parachute deployed from its containment bag and remained in the parachute sleeve. The parachute T-handle remained in the handle mount and the safety pin was found adjacent to the pin hole area. The safety pin engagement surface area had less sooting residue than the head of the pin. (See figure 5 and 6)

**Figure 4-Accident site, parachute T-handle and pin.**

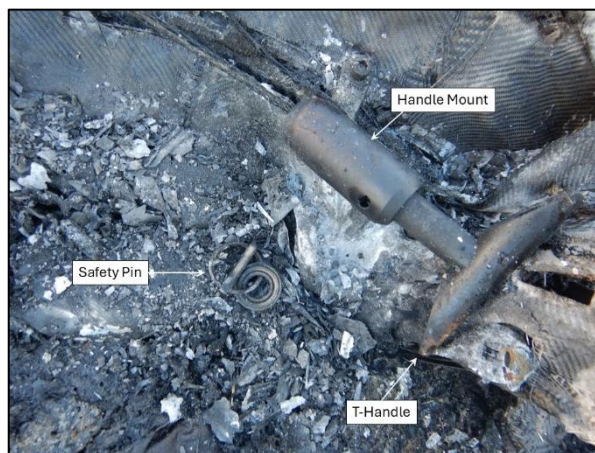
**Figure 5-Accident site, parachute T-handle and pin.**

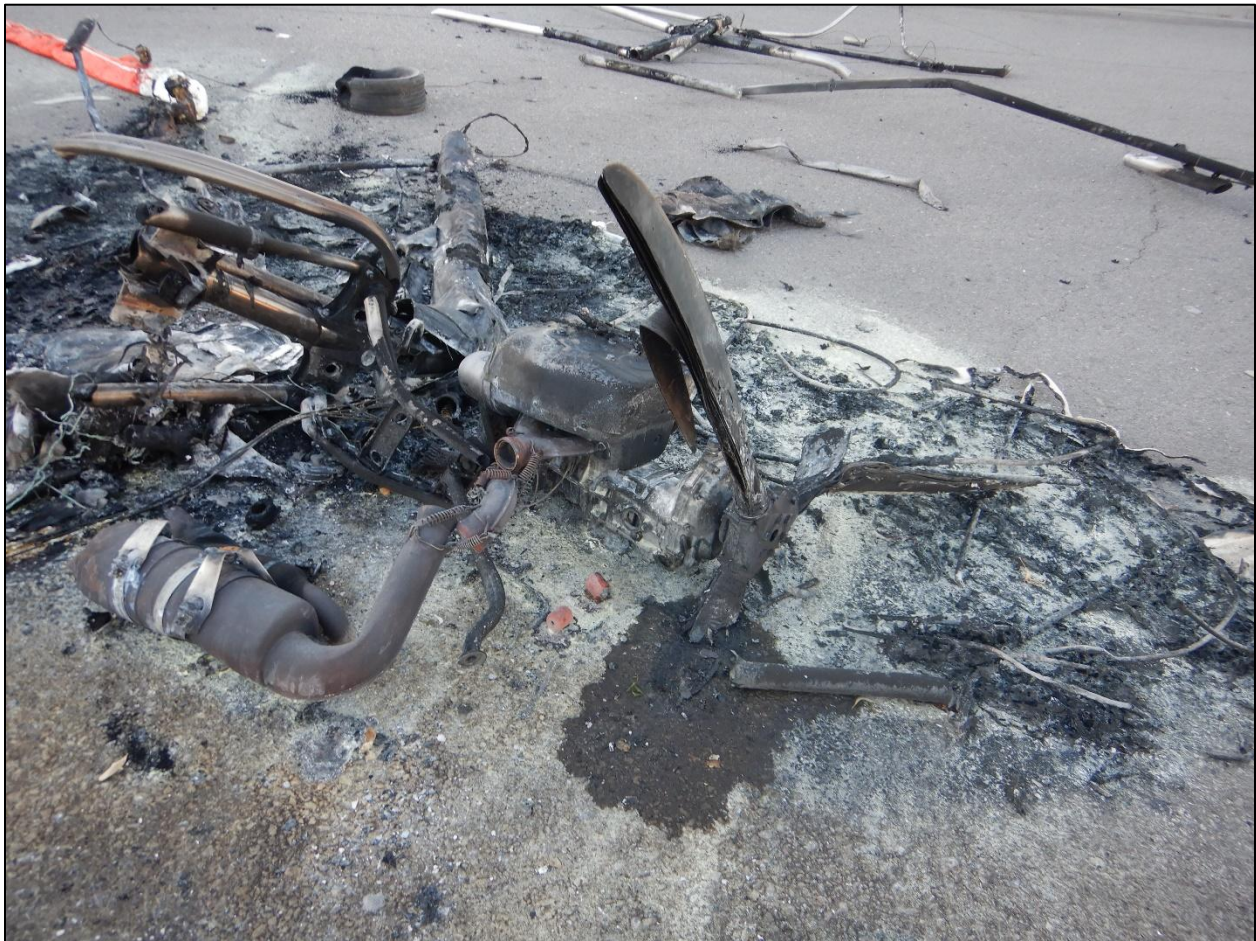
The engine remained attached to the cockpit and the propeller remained attached to the engine crankshaft flange. The engine had excessive thermal damage. Two of the propeller blades showed thermal damage. The carburetors and air filters separated from the engine and had thermal damage. The throttle cable continuity was traced from the throttle lever to the carburetor locations.

**Figure 6-Accident site, engine and propeller.**
