WPR23FA141

## INVESTIGATION PHOTOGRAPHS

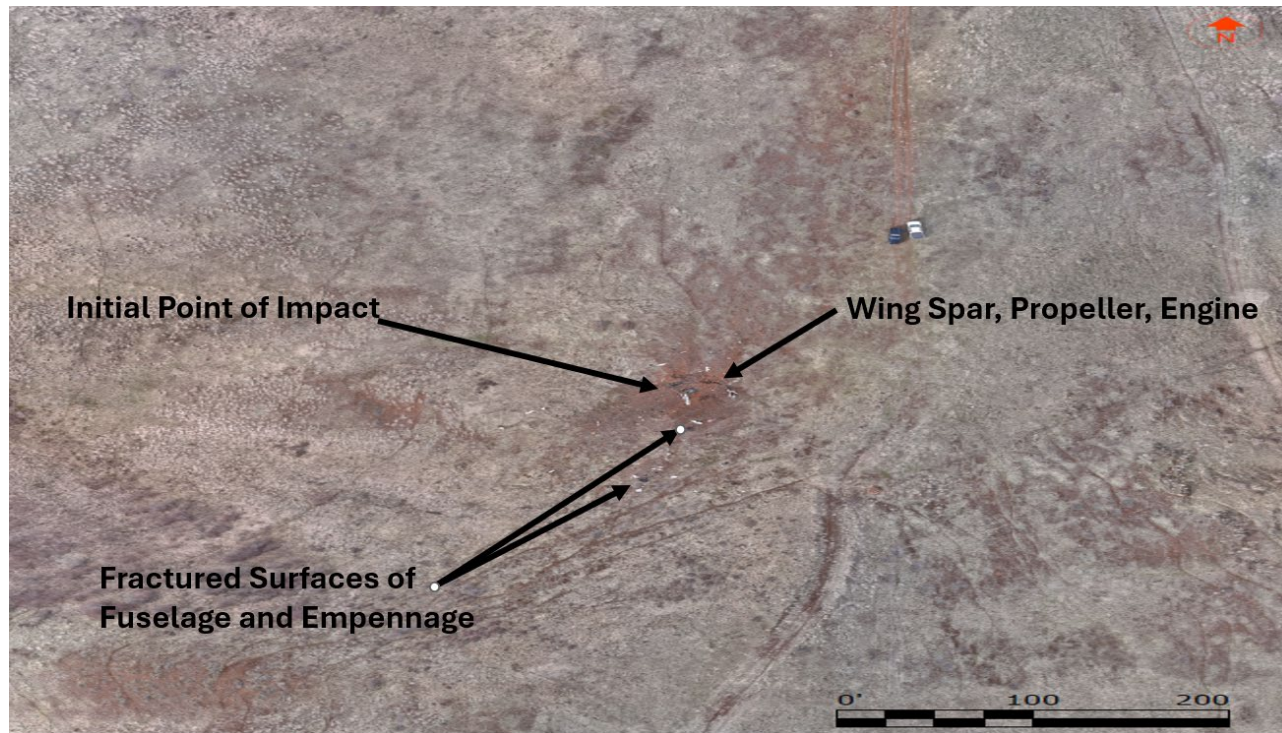
**Photograph 1 - Aerial view of impact crater and main wreckage (Courtesy of LEA)**

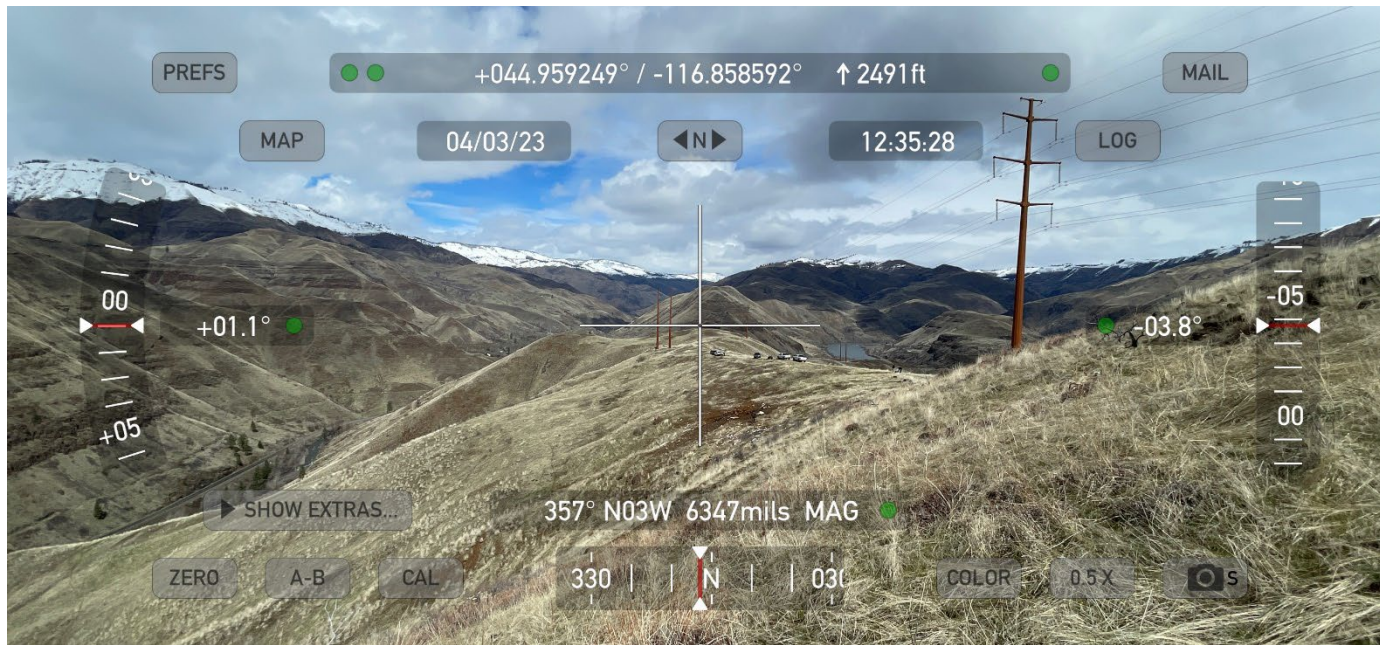
**Photograph 2 -View of main wreckage as viewed from North to South (Courtesy of IIC)**

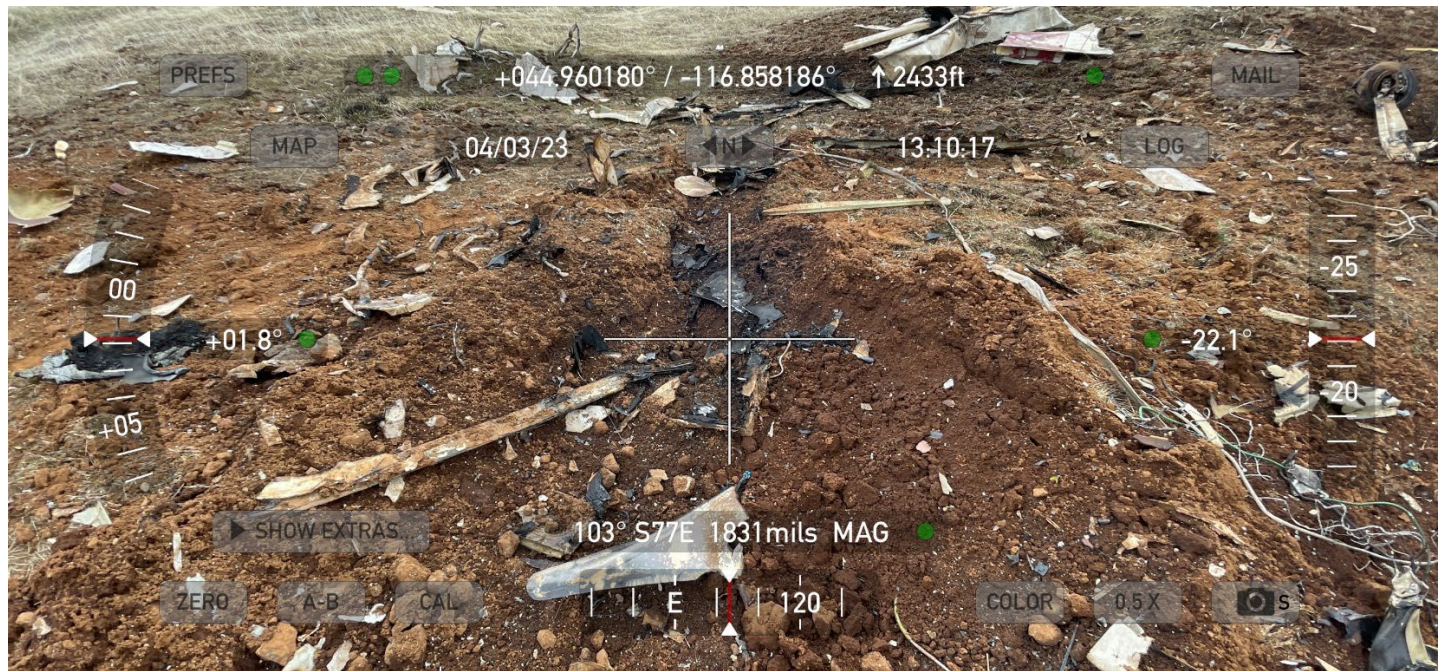
**Photograph 3 - View of main wreckage taken from inside the impact crater (Courtesy of IIC)**

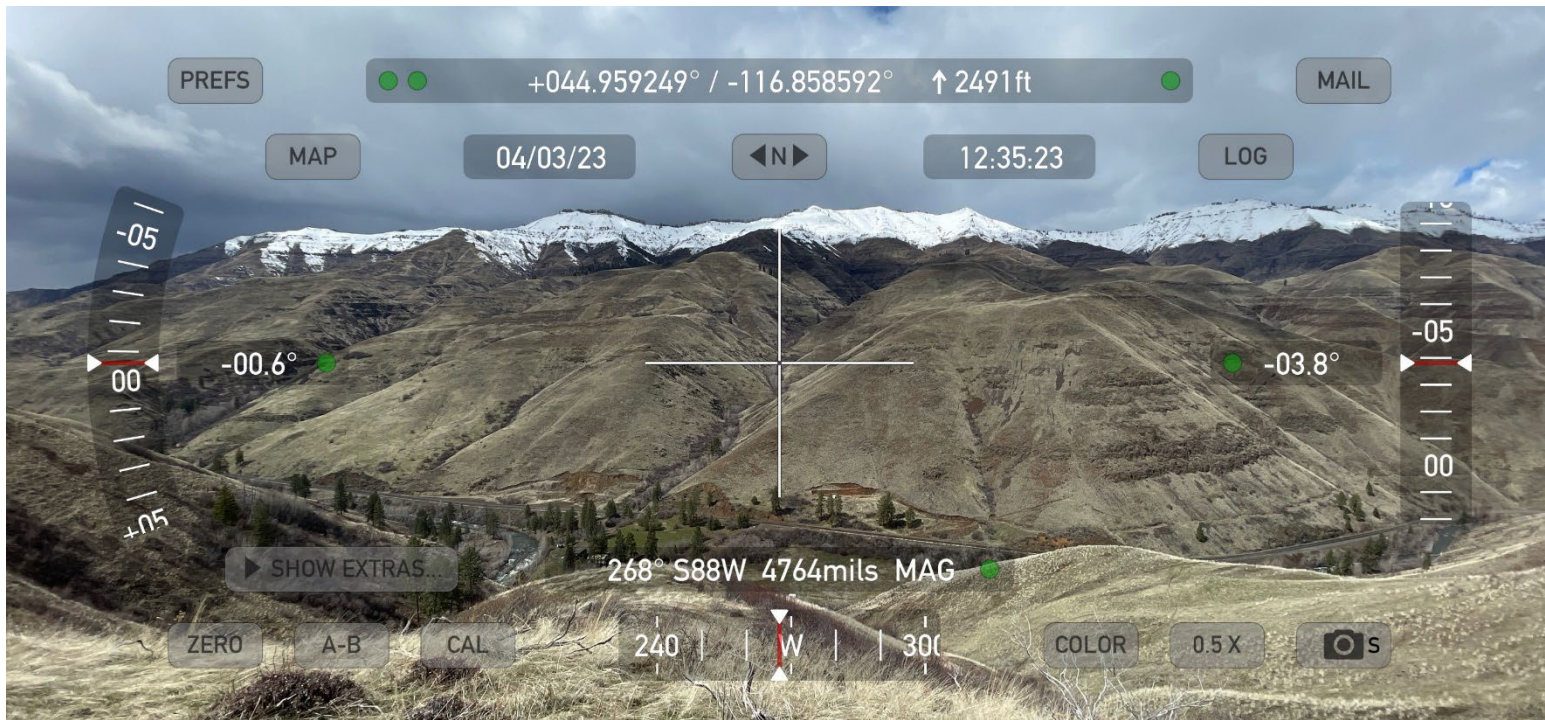
**Photograph 4 - View of accident site location as viewed from East to West (Courtesy of IIC)**

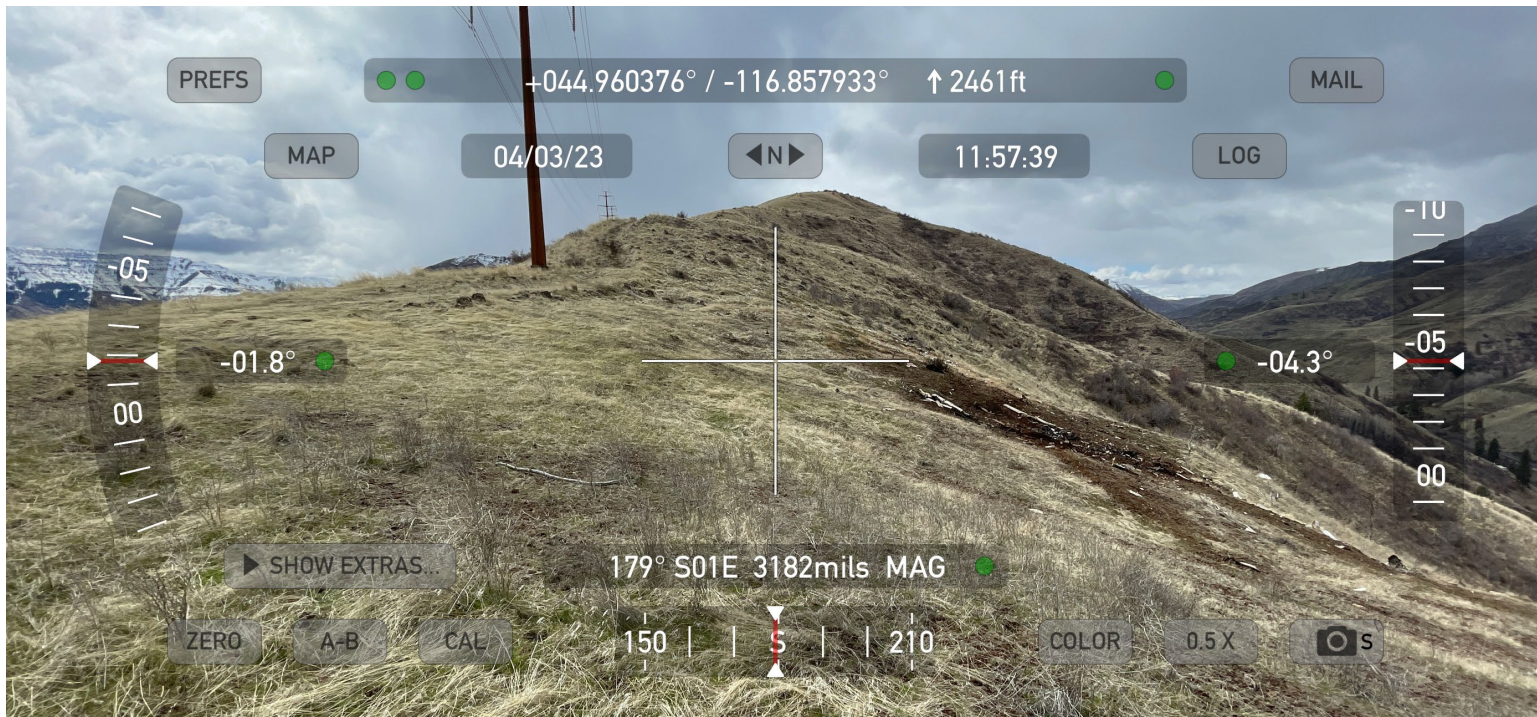
**Photograph 5 - View of main wreckage as viewed from North to South (Courtesy of IIC)**

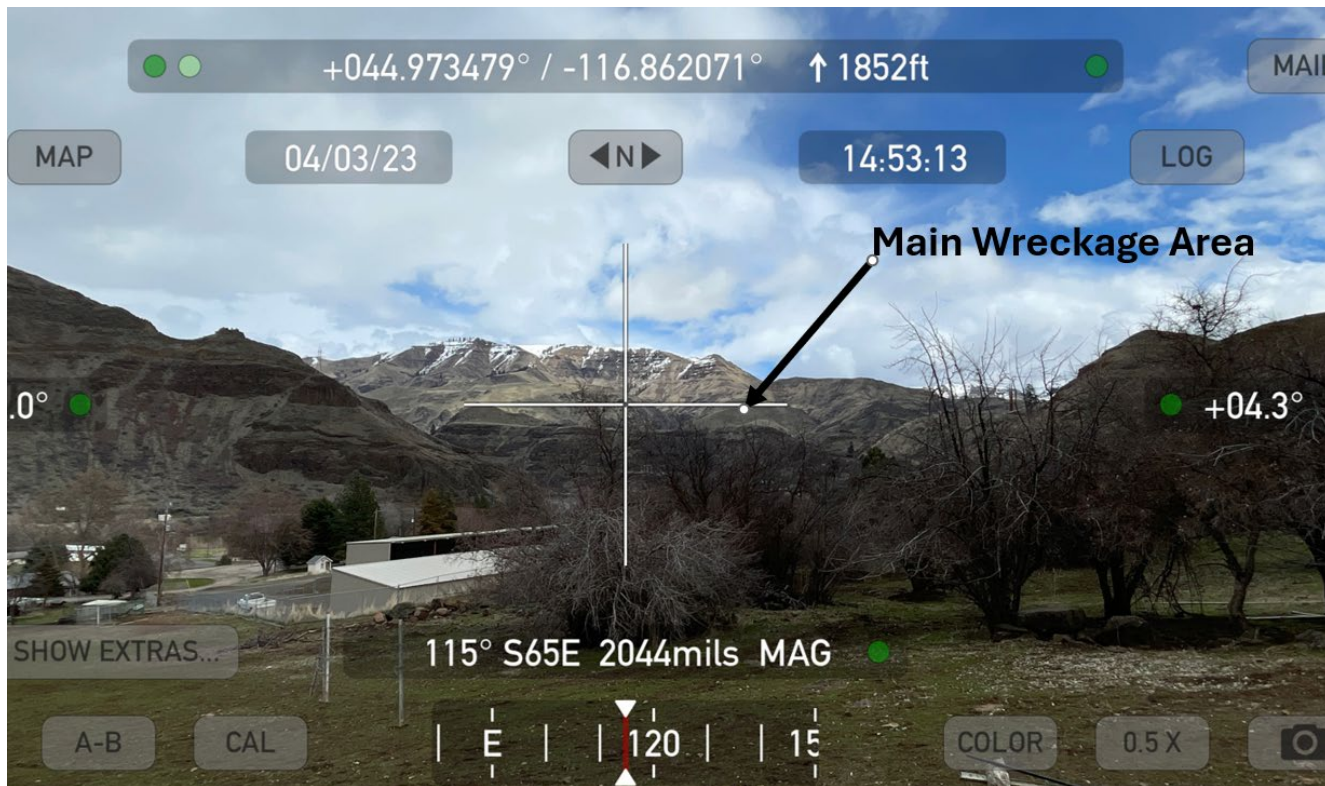
**Photograph 6 - View from the resting location of the upper 1/3 of the vertical stabilizer and the rudder over 1 mile away from main wreckage (Courtesy of IIC)**

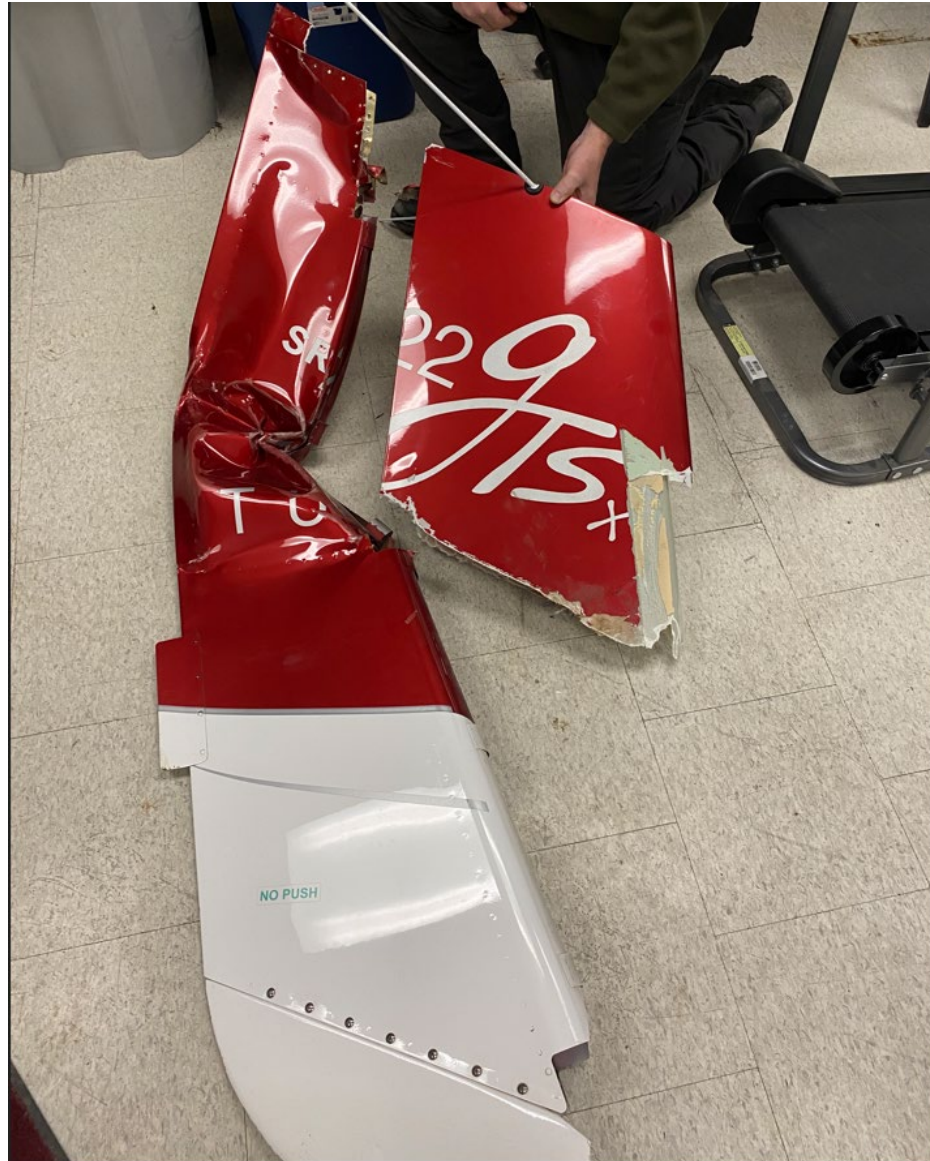
**Photograph 7 - View of the upper 1/3 of the vertical stabilizer and rudder (Courtesy of IIC)**
