National Transportation Safety Board

WPR23FA153

**INVESTIGATIVE SUPPLEMENTAL MATERIAL**

Location: Cal-Nev-Ari, Nevada  
Date: 04.11.2023  
Time: 0419 Pacific standard time  
Airplane: Glastar GS-1

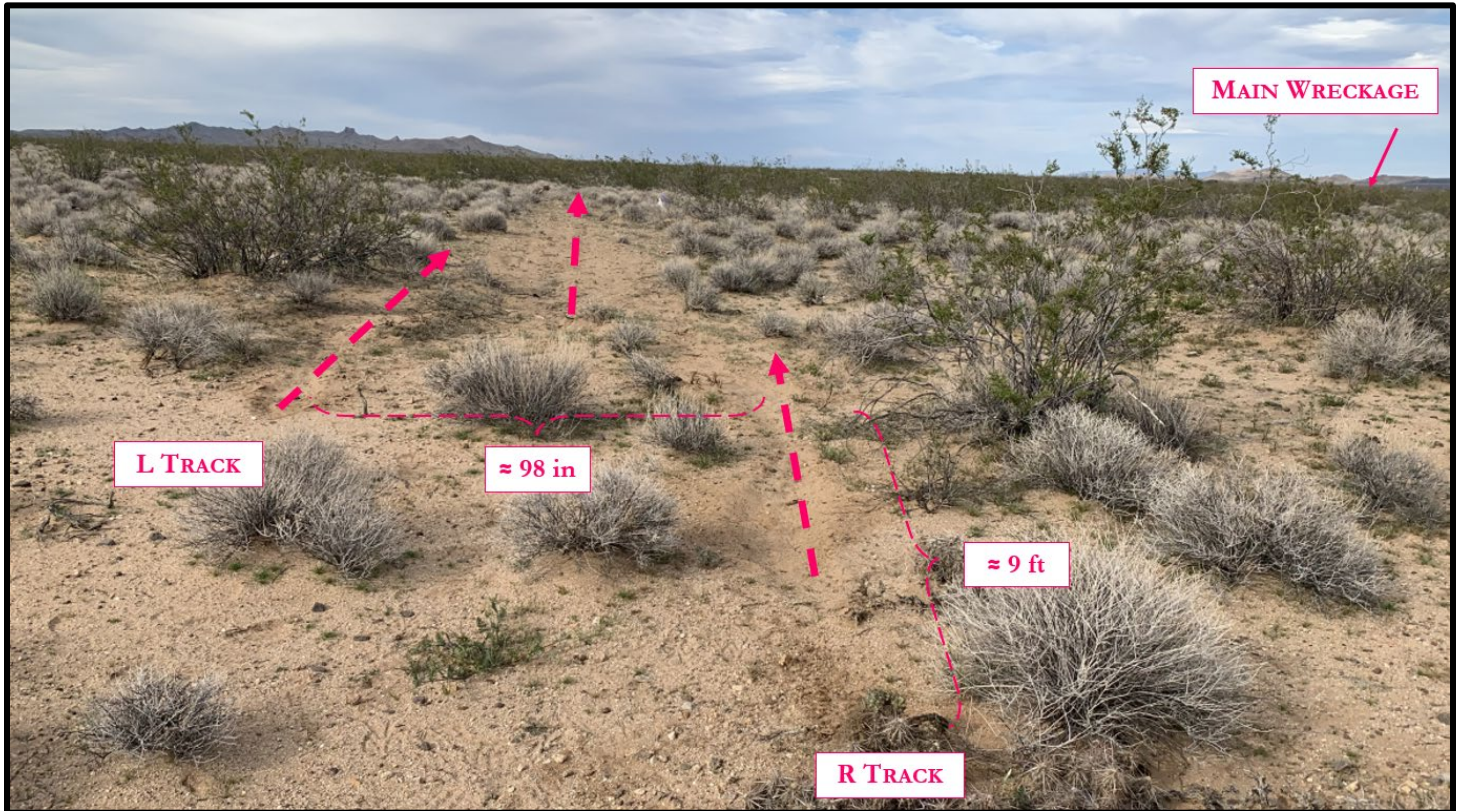
Figure 11: First impact site.

The first identified points of contact consisted of disrupted cacti and dirt on the flat desert terrain making up the far southwestern end of the debris field. The markings started as two nearly parallel indentations in the vegetation and dirt spaced about 98 inches apart. The right crater started about 9 ft prior to the left crater and they both continued on a heading of 025°. The indentations were continuous and then merged for 121 ft and at the beginning there were several parallel ground scars located perpendicular to the direction of the center indentation and immediately over it. The size and location was consistent with propeller slashes and fragments of propeller material were found imbedded in the soft dirt.

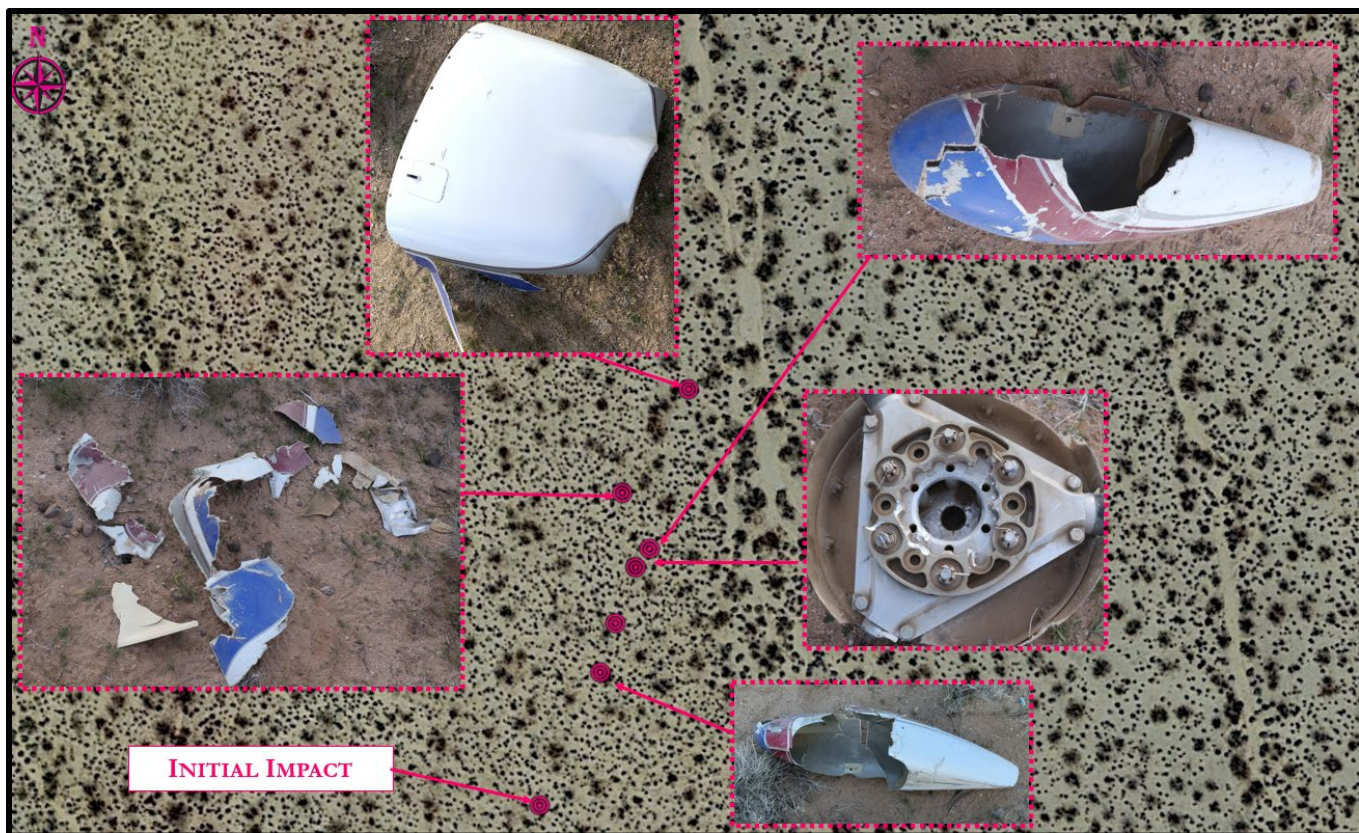
Figure 12: Initial impact site.

Along the first debris field investigators found the fragmented right wheel pant about 70 ft from the initial wreckage; propeller hub about 125 ft from the initial impact; the left wheel pant about 130 ft from the initial impact; the lower nose cowl was fragmented and found throughout the debris field. The upper nose cowling was at the end of the first debris field and contained two blue paint transfers on the top of the cowling with parallel lines. The bottom of the cowling contained a series of parallel black lines in the aft, left area, consistent with a belt rubbing.

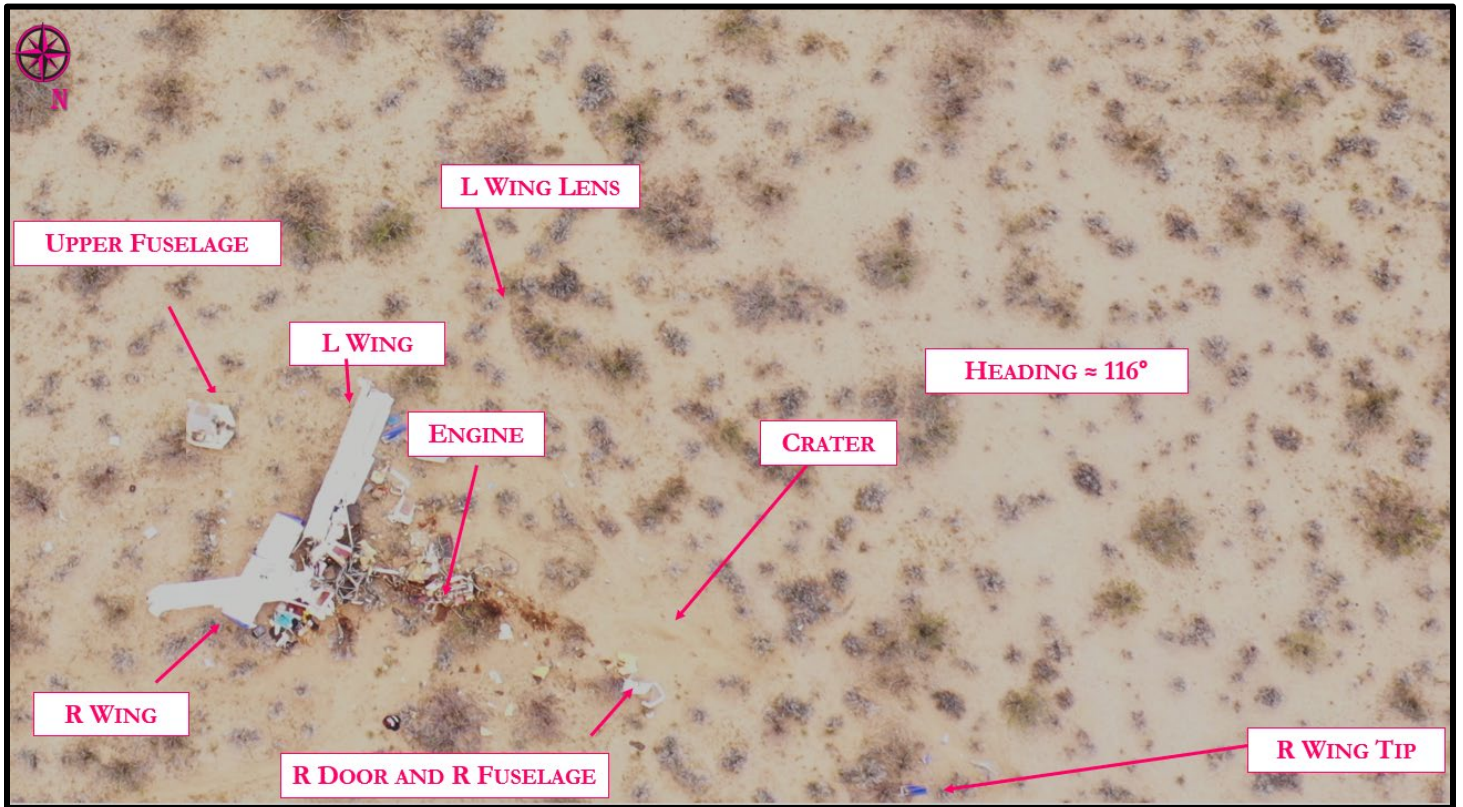
Figure 14: Wreckage at second impact site.

The second debris field consisted of disrupted dirt and vegetation making up northeast end of the debris field. The markings started as an 5 in wide indentation in the vegetation dirt blue/green lens and with almost the entirety of the right wing tip fragments imbedded. The fragmented right wing tip was located immediate adjacent to the initial impact area. There were bushes about 3 ft in height that were on either side of the crater as it extended toward the main wreckage on a heading of 116°. The crater was about 35 feet from the right wing tip and contained the right door and part of the right fuselage just forward of the door.

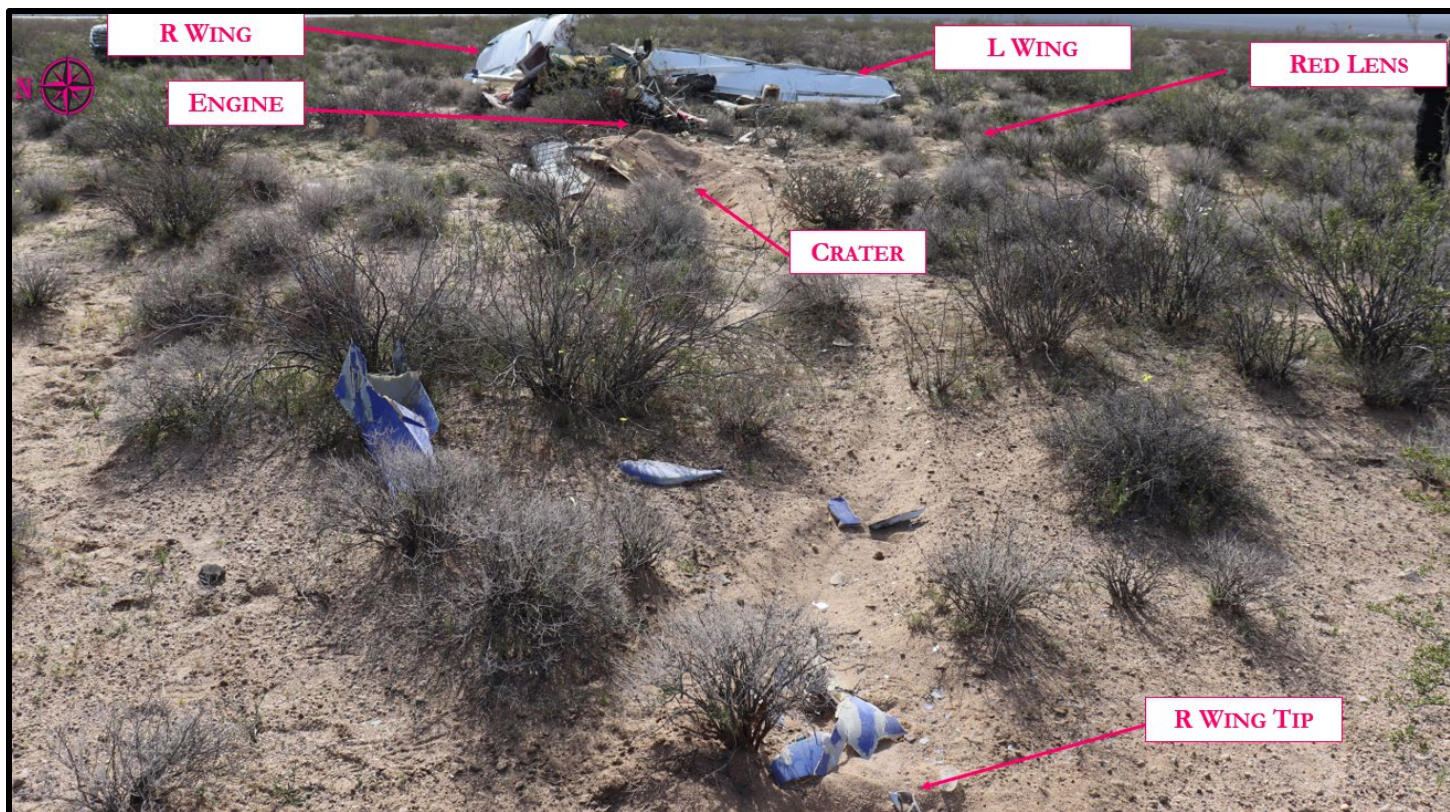
Figure 15: Second impact site.

The engine and firewall (with fragments of the front panel) came to rest upright and was located between the crater and the main wreckage. The left door and part of the left forward side fuselage adjacent to the door were entangled in the engine and panel.

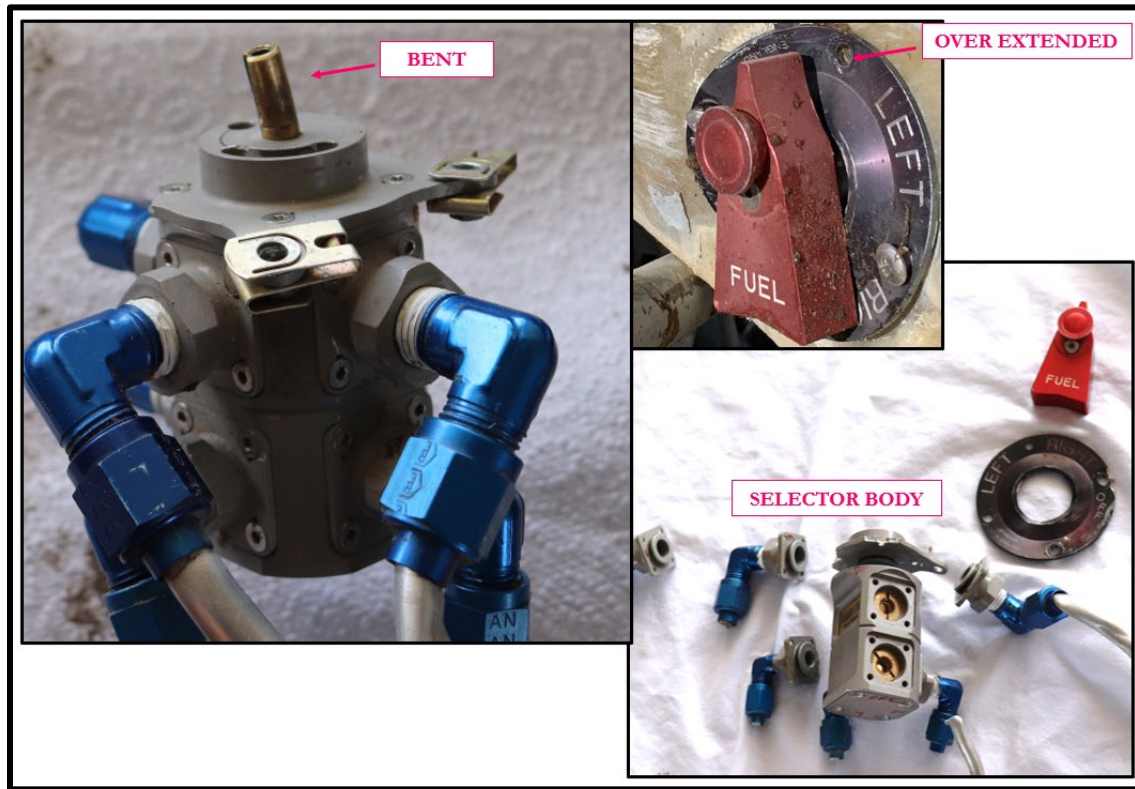
Figure 20: Fuel selector

There was fluid in both wing tanks consistent in odor and color with that of 100LL Avgas. The fuel selector was in an over-extended position and sustained crush damage with the selector post bent. There were witness marks on the face are consistent with it likely being in the “LEFT” position at the time of impact. There was white

Teflon tape on all the selector fittings that had the appearance of being recently installed. The detents and selector rotated when the post was turned. The fuel lines were all fractured in various places.

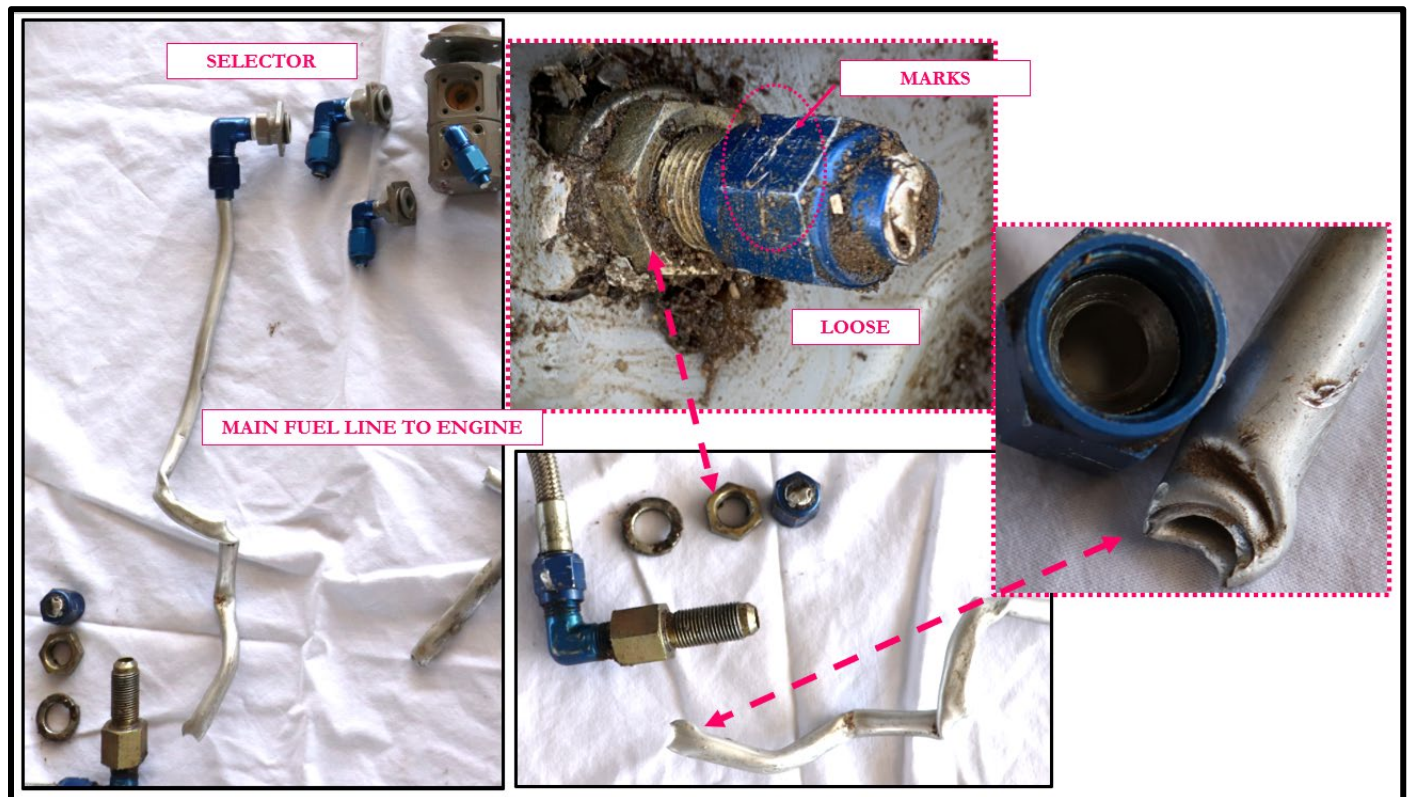
Figure 21: Firewall fitting

The fitting from the selector through the firewall was broken and the b-nut was loose; there were scrapes on the nut. It could not be determined if there was odor or wetness in the area of the firewall.

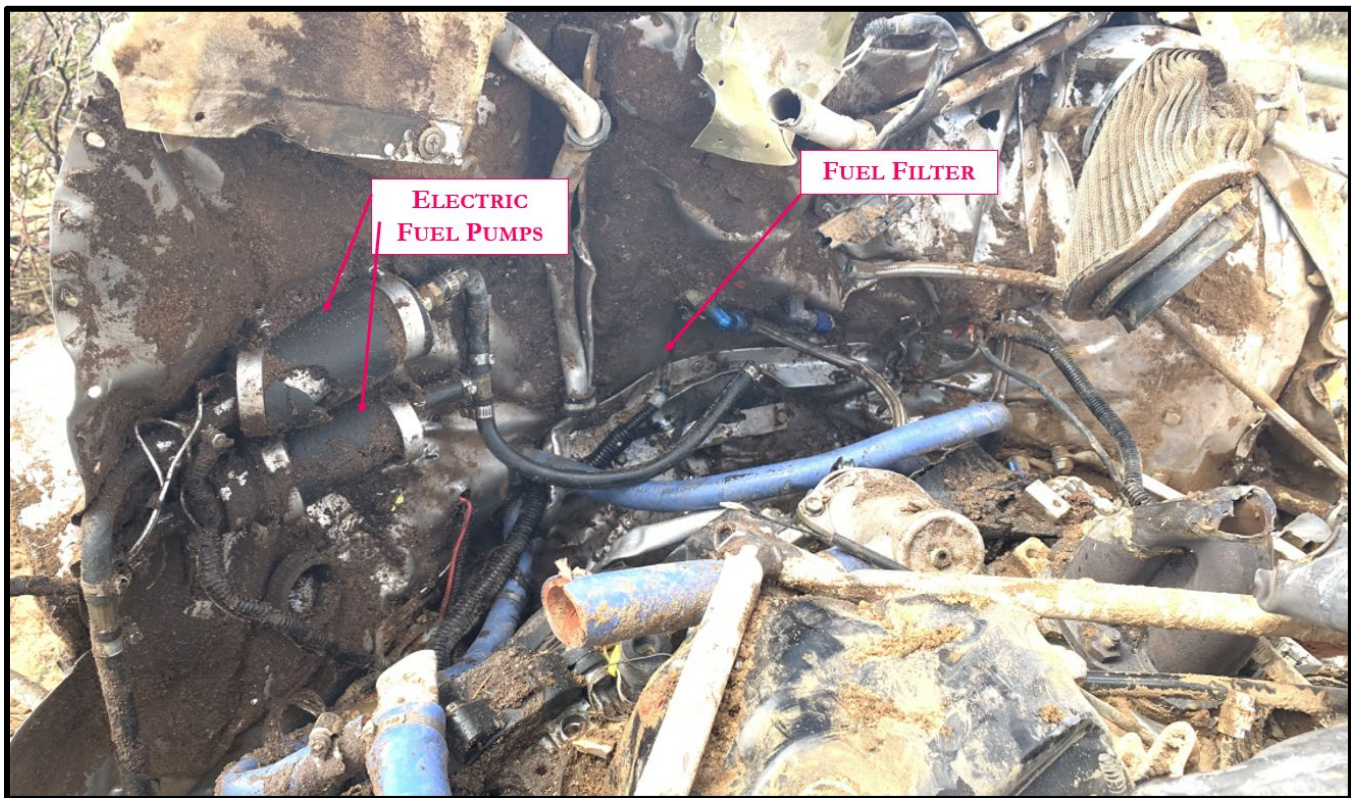
Figure 22: Fuel filters installed on the firewall.

The Aermotive fuel filter was punctured open. The fluid inside was grainy and dirty and tested positive for containing water. The cooling reservoir was located above the filter and was punctured. The rubber tubing to the lower fuel pump was ruptured. The pumps were hooked up to power and could be felt clicking and having suction on the inlets. The paper filter was cut open and found to be discolored. Numerous lines had fractures and were not attached.

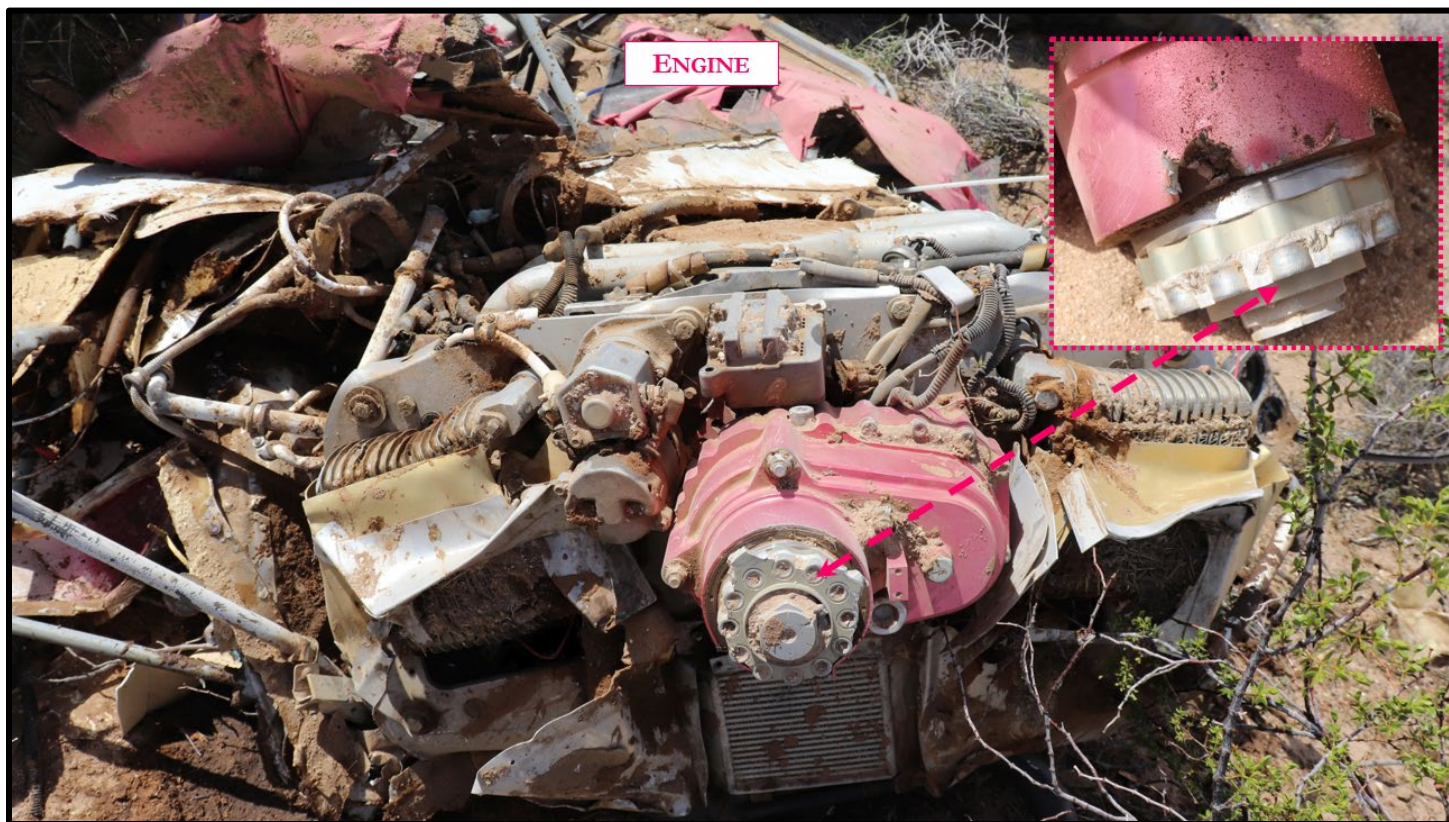
Figure 24: Engine as found at the accident site.

The Eggenfellner Subaru EL25 was partially intact. Investigators were unable to achieve manual rotation of the crankshaft by rotation the crankshaft spline. The alternator was belt and gear had areas of wear, consistent with it making contact with the nose cowling. The aft plastic gear housing was partially broken at the left (cylinder Nos 1 and 3) camshaft drive. The belt was still intact and on the gears of both camshafts, the crankshaft and through the idler gears including the oil pump.

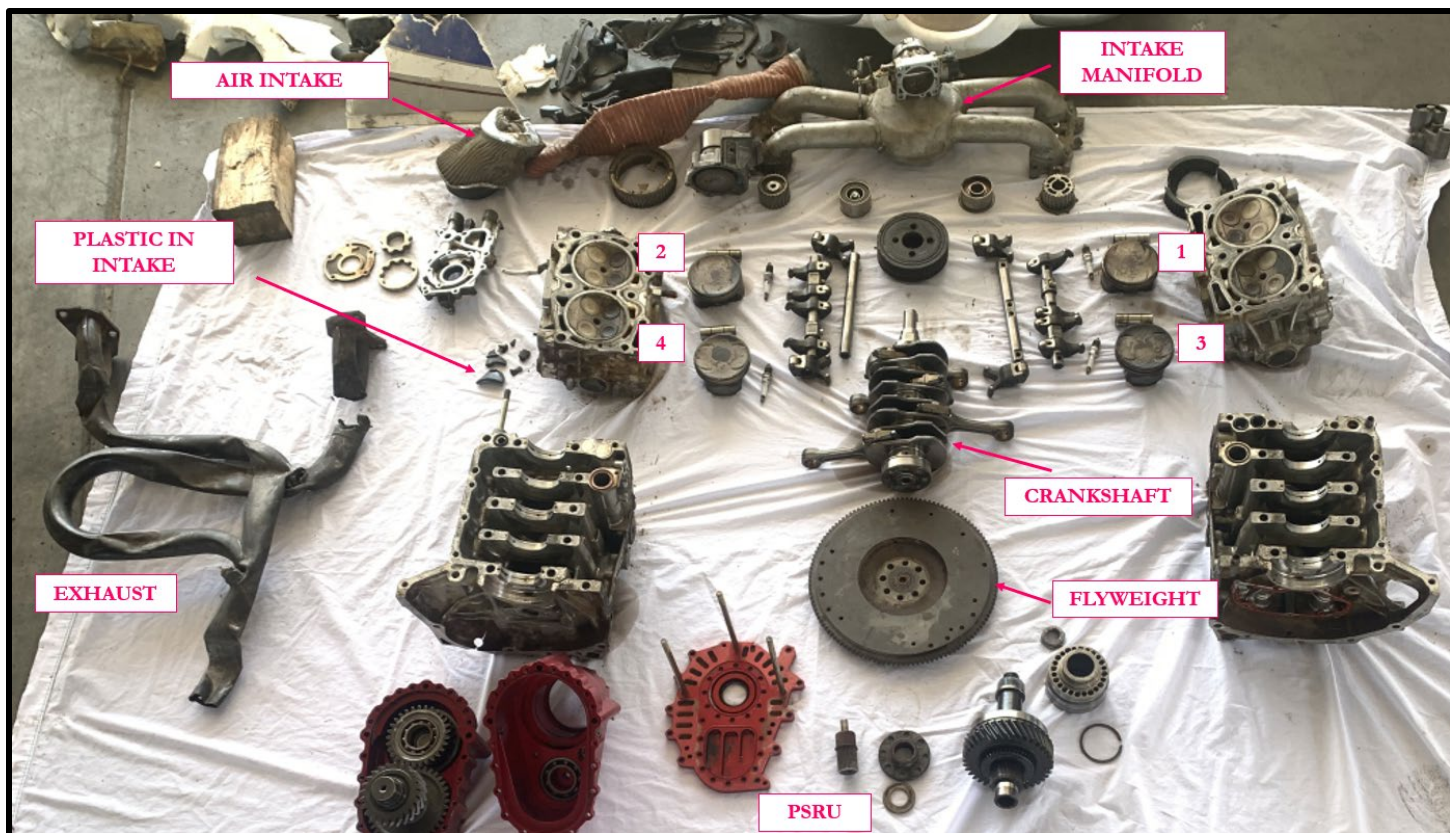
Figure 25: Engine layout at examination.

As part of the postaccident examination, a majority of the engine, the PSRU, and the components were completely disassembled. In pertinent part, there were large plastic shards found in the No. 4 intake (entering into the cylinder) and smaller pieces were in the No. 3, consistent with the plastic connection at the air intake fragmenting while the engine was still running at impact. The entire drive train was intact. The deposits on the pistons and spark plugs were all consistent with normal operation. The PSRU splines and bearings were all intact; fine metallic shavings were found in the oil. The examination of the engine and PSRU revealed no obvious evidence of pre impact anomalies or failures that would have precluded normal operation.

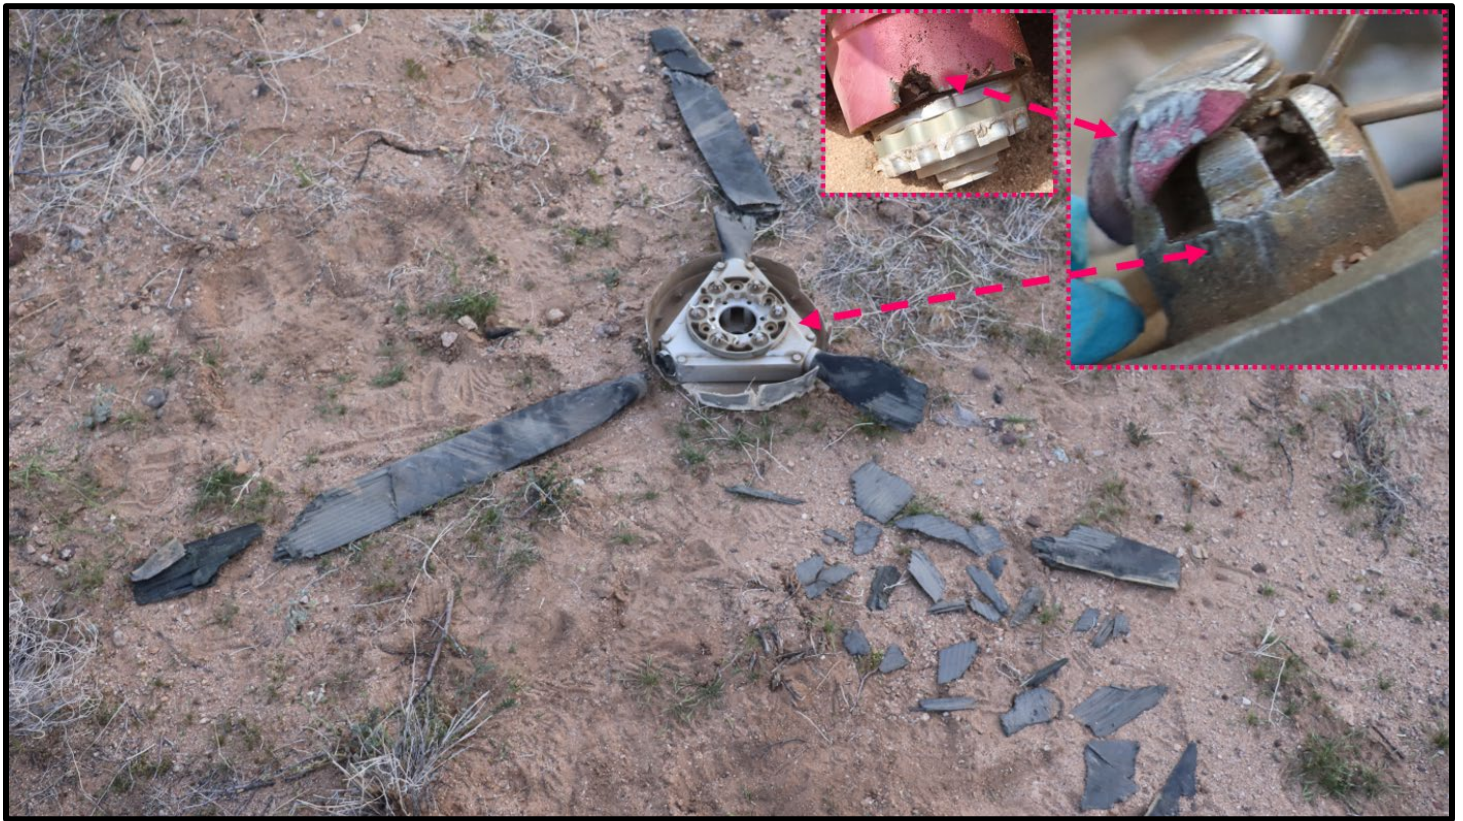
Figure 27: Propeller at accident site.

The three composite propeller blades were found in the debris field.
