# National Transportation Safety Board

WPR23FA172

## EXAMINATION REPORT

Location: Hollywood Hills, Los Angeles, California  
Date: April 29, 2023  
Time: 1950 LCL  
Airplane: Cessna 172S N575ND

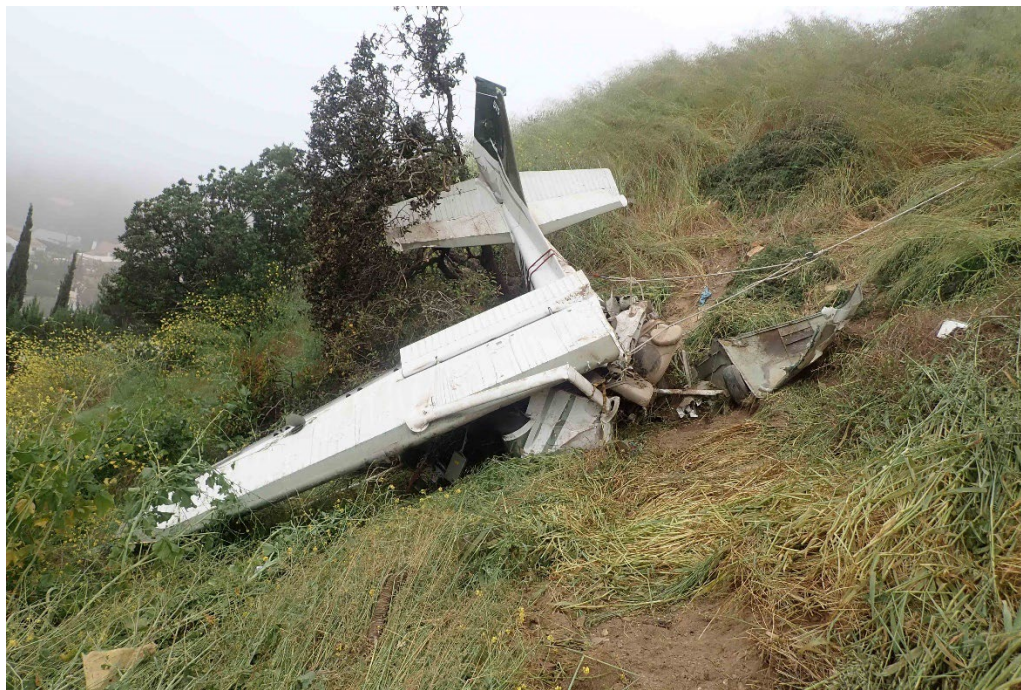
The main wreckage came to rest at an elevation of 1,345 ft msl, on a 45° south-facing slope, about 40 ft below the peak of a hill within the Hollywood Hills residential area, 6.5 miles South-Southeast of Van Nuys Airport (figure 1). A water tank was on city-owned property at the top of the hill. The first identified point of impact was a 5 ft wide bush, about 150 ft east of the main wreckage, that had been topped almost completely level (figure 2). A disturbance in the ground just to the west contained fragments of the left wing tip. The ground disturbance continued on a track of about 285° true and was characterized by disrupted dirt and flattened black mustard vegetation folded in the direction of the main wreckage. The debris field initially contained fragments of the right wingtip, followed by the right main landing gear, right door and window, propeller and hub, and remnants of the instrument panel.

The cabin sustained crush and impact damage through to the tailcone bulkhead (figure 1). The firewall was compressed around the engine, and the forward seats were exposed (figure 3). The instrument panel and forward flight control assembly had partially detached from the cabin and were separated during airplane recovery (figure 4).

**Figure 1 - Airplane at the accident site**

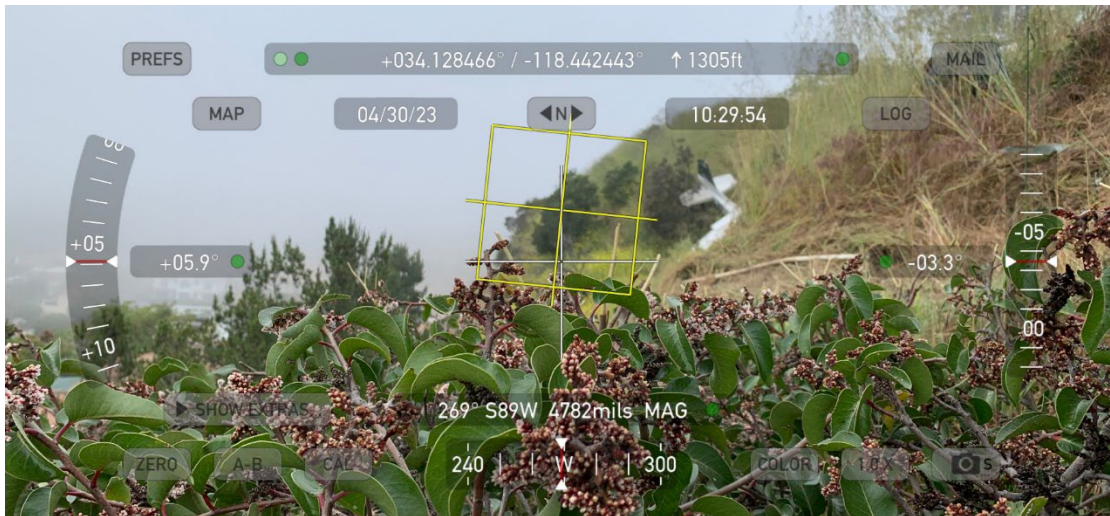
**Figure 2 - Topped bush with airplane in the background**

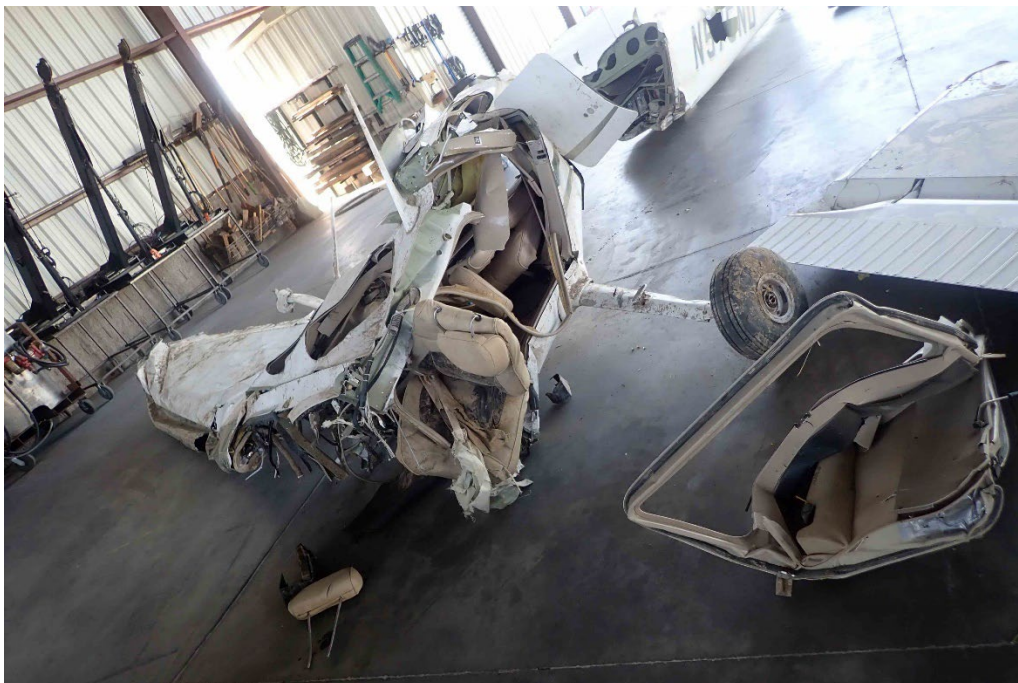
**Figure 3 - Airframe with front left seat**

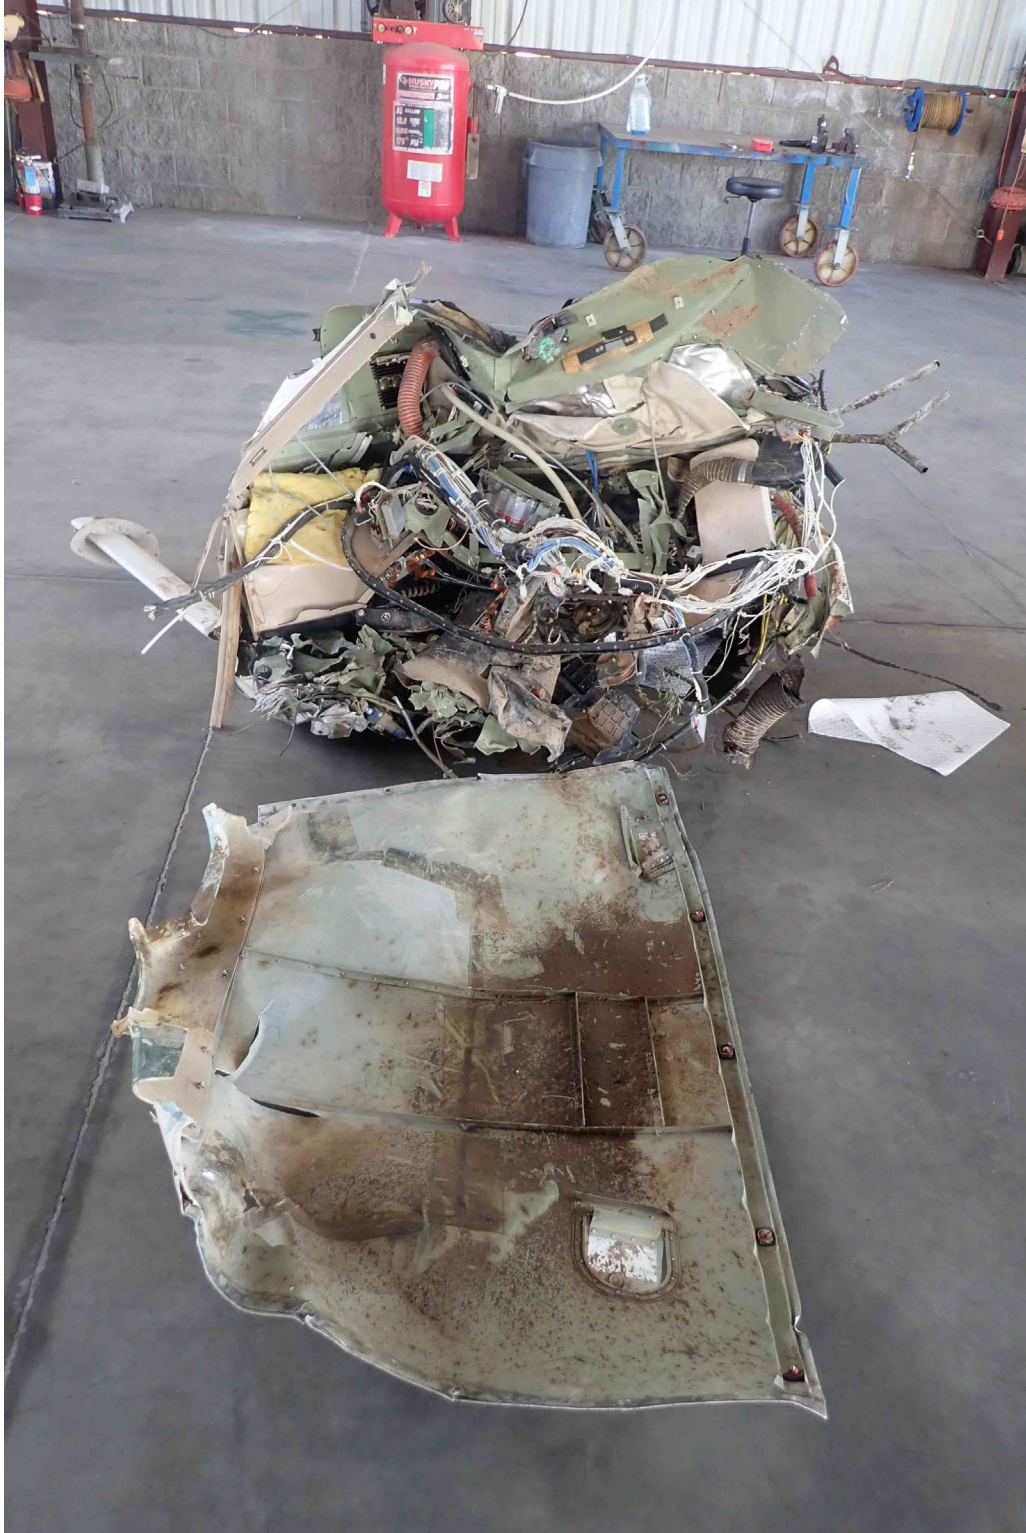
**Figure 4 - Forward cabin with top engine cover**

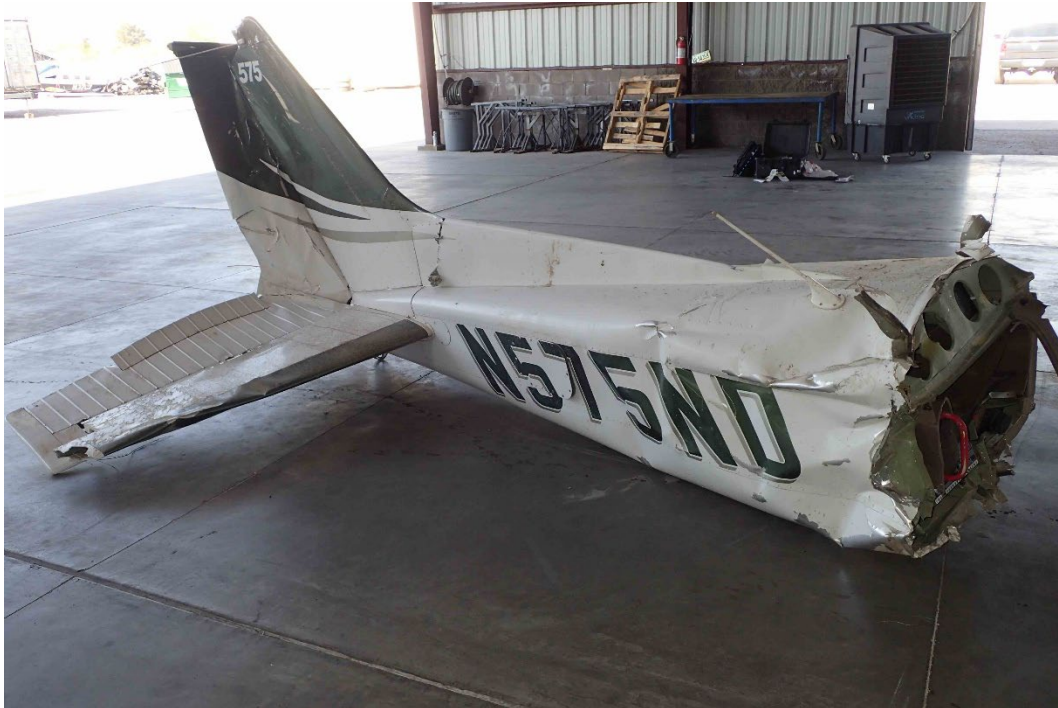
Tail cone detached from aft cabin bulkhead. The empennage was still attached, and the rudder was crushed along its entire length. The rudder and horizontal stabilizers remained attached by all to their hinges, and all balance weights were intact (figure 5). The control cables were all attached, and continuous to the tailcone break, where

**Figure 5 - Tail section (left horizontal stabilizer removed)**

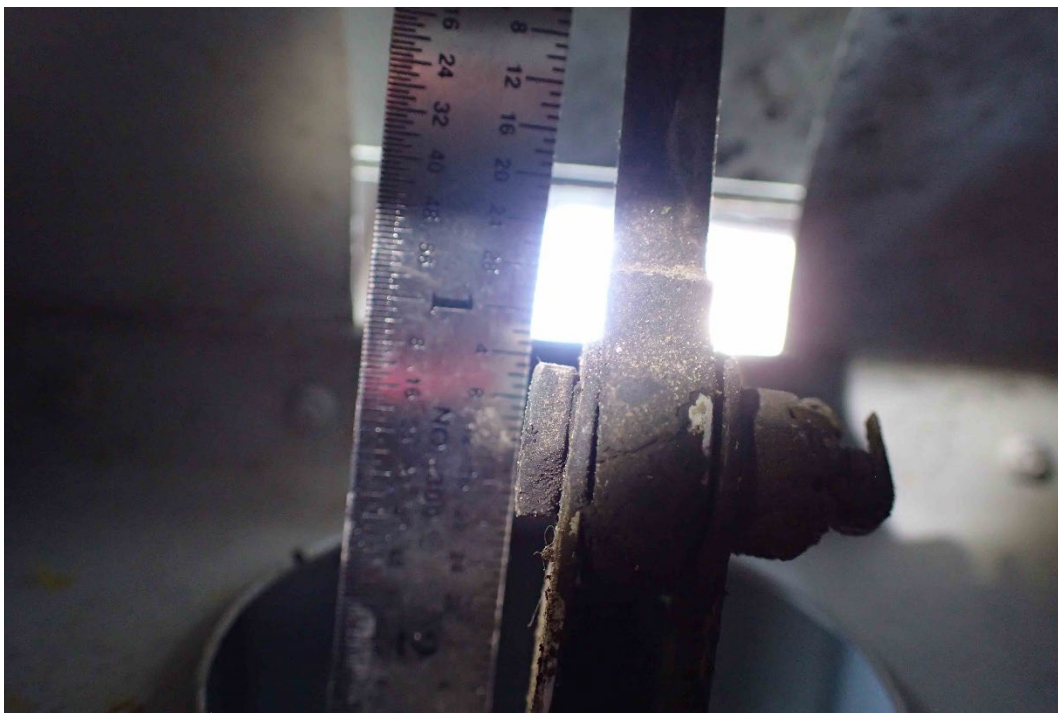
they had been cut by recovery personnel. The elevator trim tab actuator displayed 1.375 inches (figure 6) of extension which corresponded to with 5° tab up (range 25° tab up to 13° tab down).

**Figure 6 - Elevator trim tab actuator**

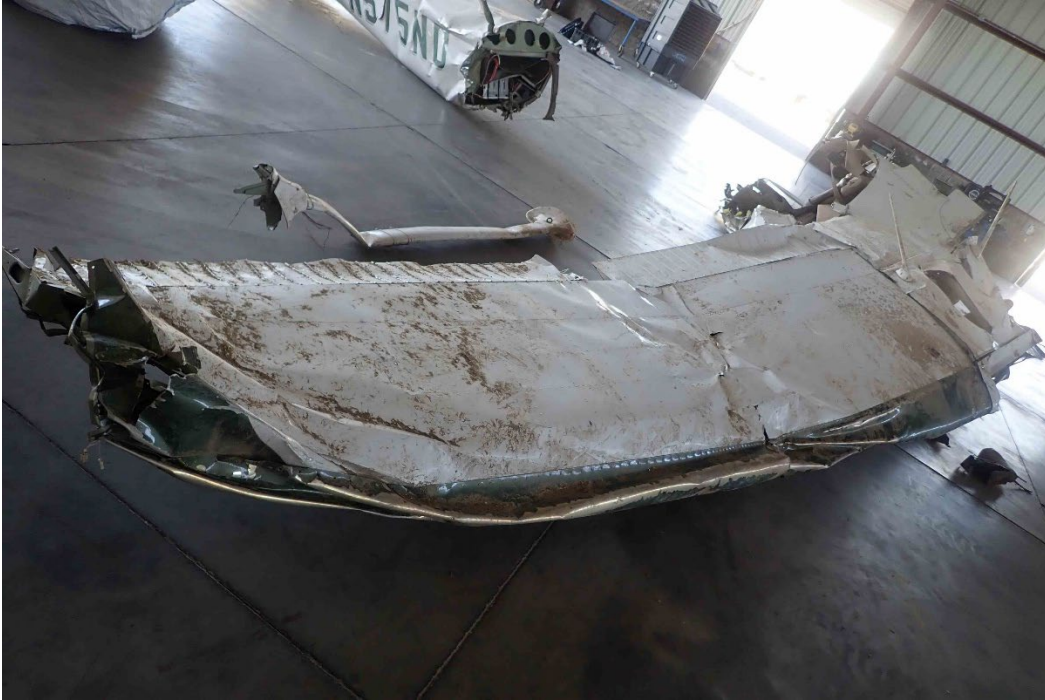
The right wing remained attached to the cabin. The lift strut had pulled away from both its wing and cabin attach points, and its bolts and fittings were intact at each end. The wing sustained leading edge crush damage along its entire length, and 45 degree aft crush damage at the tip (figure 7). The fuel tank was intact and contained multiple gallons of fuel when observed through the filler neck at the accident site. The fuel cap was in place at the filler neck, and cap was attached by its chain.

**Figure 7 - Right wing**

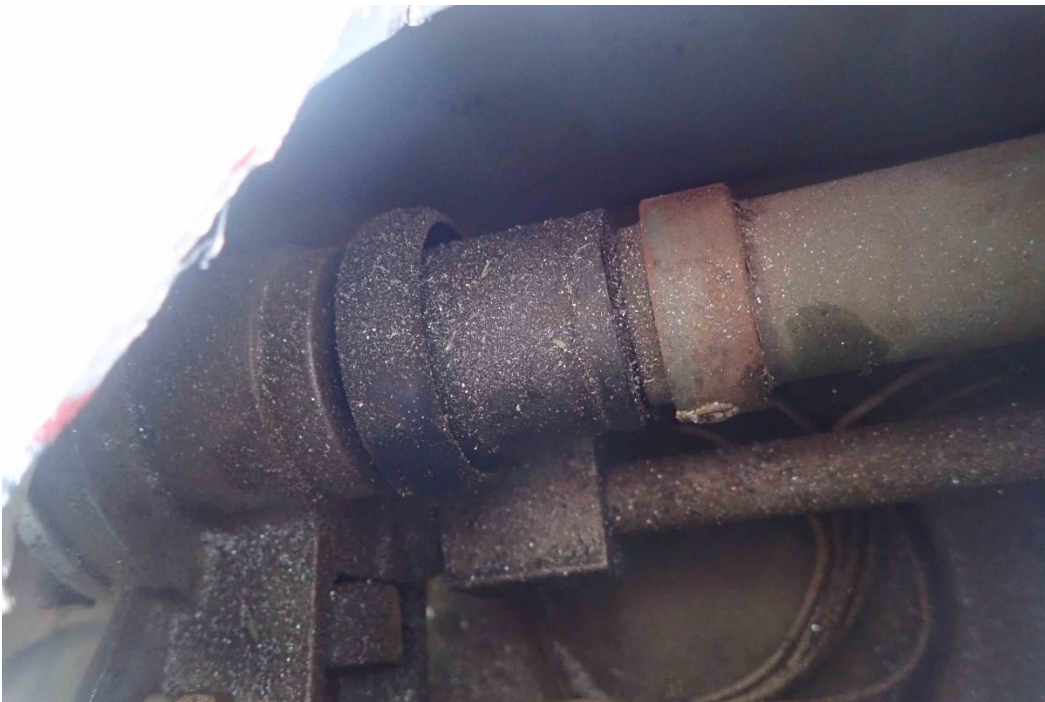
The flap actuator was intact and in the fully retracted position consistent with retracted flaps (figure 8). The flap cables were intact and continuous to the cabin where they had separated in a frayed manner consistent with undergoing tension overload forces. A cable in the center section exhibited fray and strand separation, with only two wire ropes still attached. The remaining cables within the cabin roof, exhibited damage consistent with overload or recovery cuts. The flap pulleys were intact.

**Figure 8 - Flap actuator**

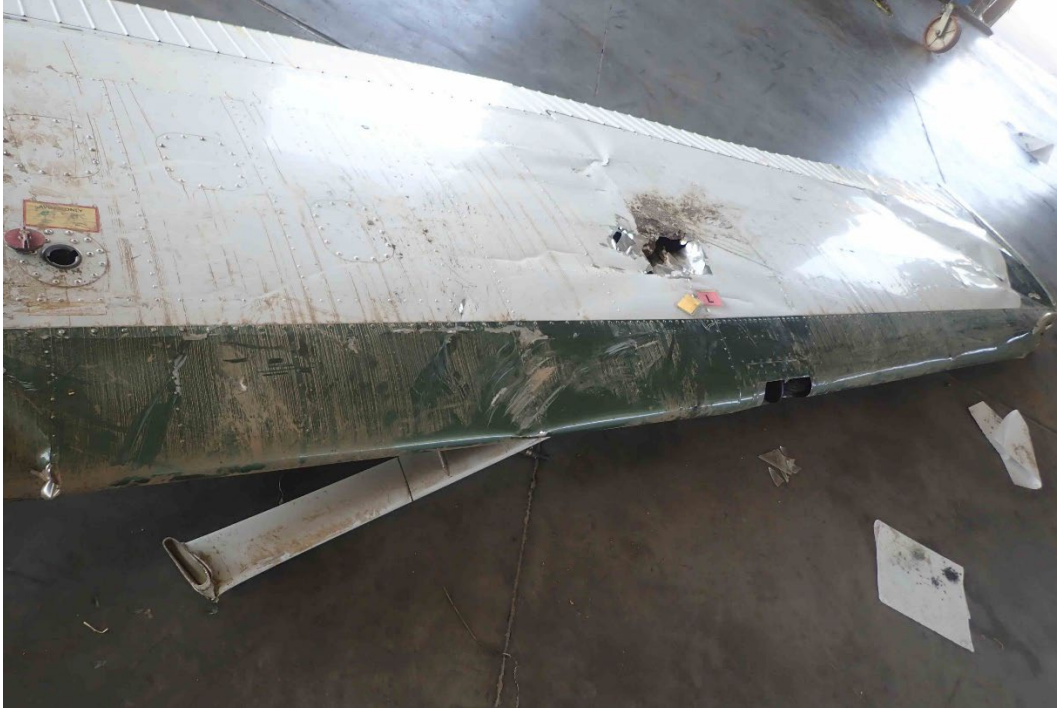
The left wing had broken away from the cabin, but was largely intact with slight skin wrinkles, 45 degree aft crush damage at the tip, and a puncture midspan to the top skin (figure 9). The aft spar attach bolt was intact and still attached to the spar with remnants of the cabin attach fittings. All failure surfaces exhibited bending and tear-like deformation. The forward spar attach point had broken away from its fitting at the cabin, with similar deformation signatures. The lift strut remained attached to the wing and cabin. The strut was bent inwards about midspan and had been cut by recovery personnel.

**Figure 9 Left wing**

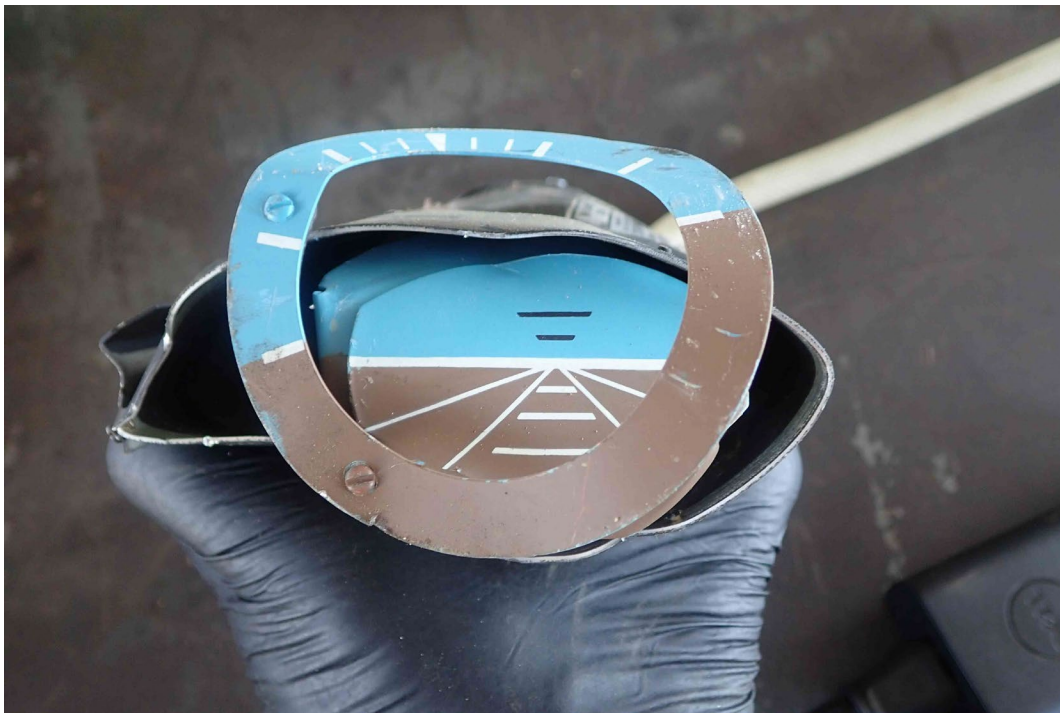
All flight instruments, including both G1000 units sustained crush and fragmentation damage, the SD card for the G1000 units were not located, nor was one of the G1000 display panels. The backup attitude indicator was crushed, and its display indicated a level attitude, zero bank when compared against the case (figure 10). The face of the backup altimeter had broken away from the unit and the Kollsman window indicated 29.8; the altitude needles were mechanically disconnected and spun freely. The Hobbs-hour meter read 1,426.7 hrs.

**Figure 10 - Backup attitude indicator**

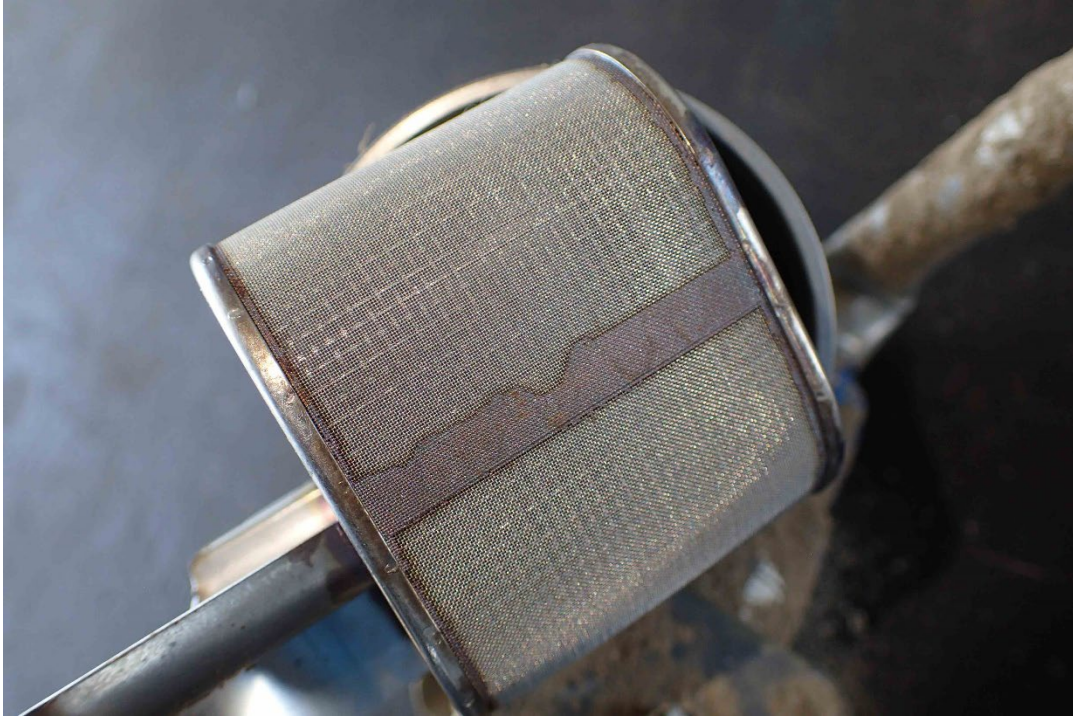
The fuel selector valve had pulled away from the cabin controls, and using low pressure air was determined to be in the "BOTH" tanks position. The fuel strainer was empty, and its screen was free of debris (figure 11).

**Figure 11 - Fuel strainer screen**

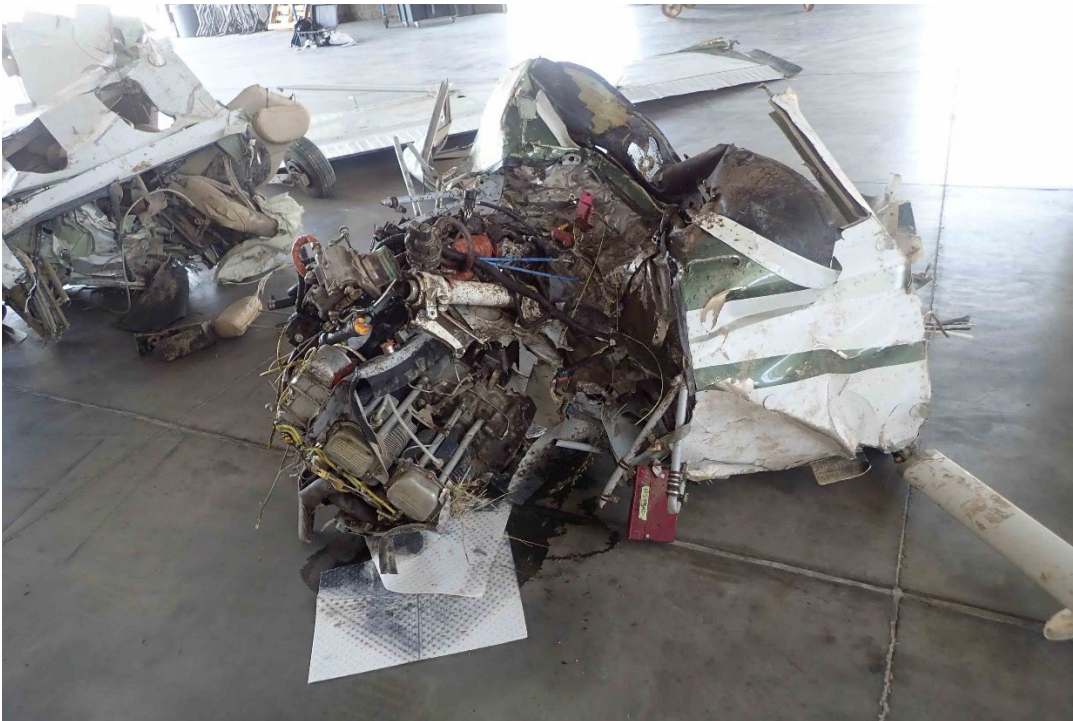
The engine remained attached to its mount, which was partially attached to the firewall (figure 12). The number 1 and 2 cylinders forward facing pushrods had bent aft with evidence of impact damage. There was no evidence of crankcase breach, and all cylinders were still attached. The exhaust muffler was crushed against oil sump; the inner surface of the muffler was coated in light grey deposits consistent with normal operation (figure 13).

**Figure 12 - Engine**

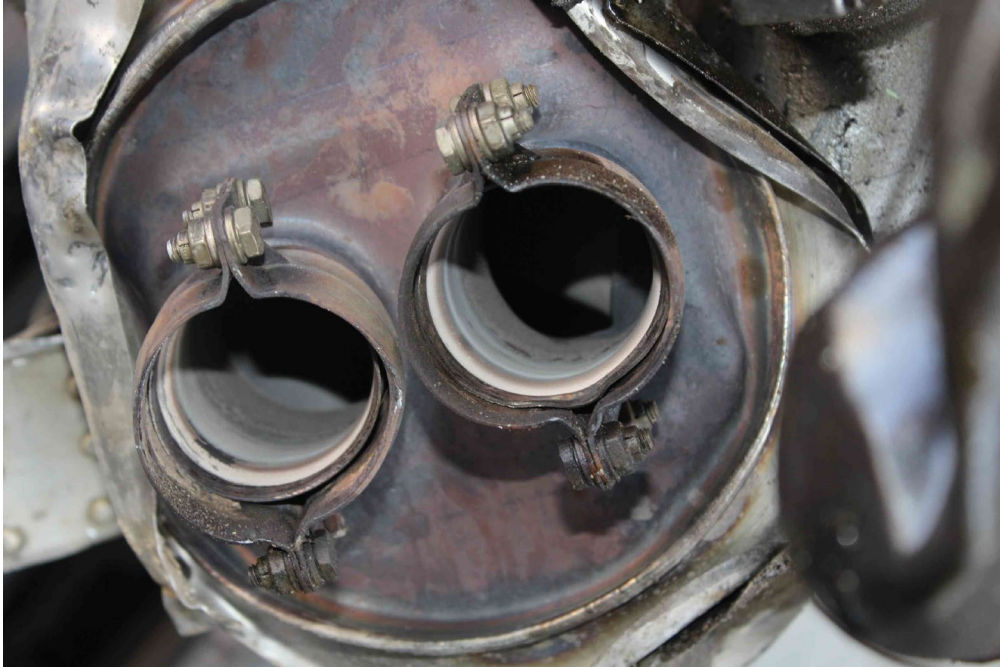
**Figure 13 - Exhaust pipe outlets**

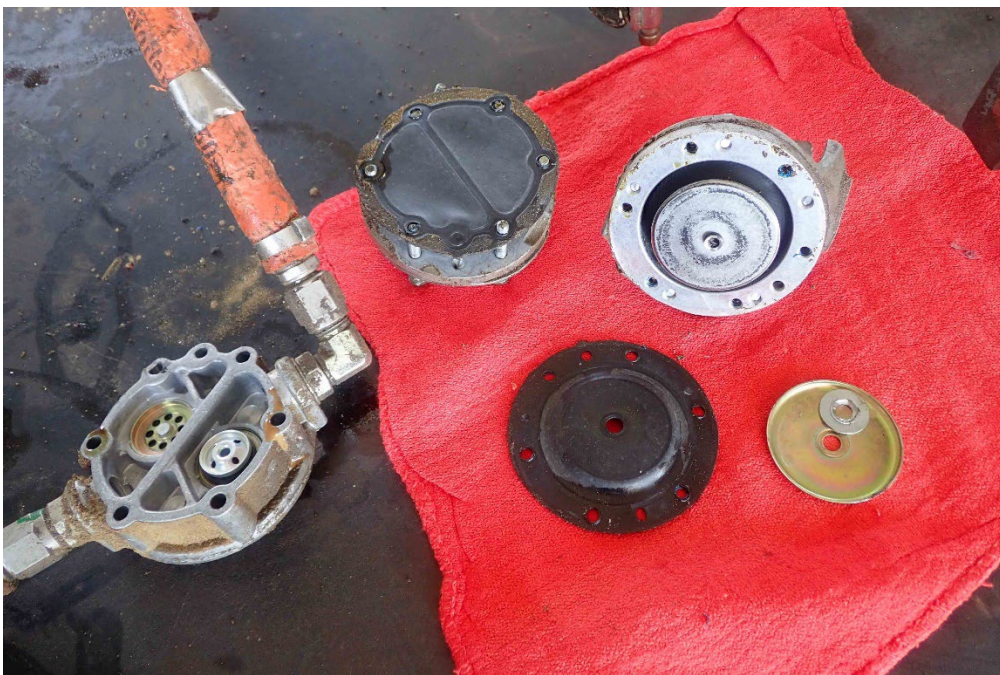
All fuel lines from the fuel strainer through to the fuel flow divider were intact, and their fittings were tight. From the flow divider, the fuel lines were continuous to each fuel injection nozzle, although the housing of nozzle number two exhibited impact damage and had broken away. The fuel servo had detached from the inlet at the oil sump, its mounting lugs and bolts remained attached at its pad. The fuel injection nozzles were removed and were all clear. The fuel pump was disassembled and examined. All internal valves were intact and appeared to be functional, and the diaphragm were pliable and free of cracks (figure 14).

**Figure 14 - Engine driven fuel pump components**

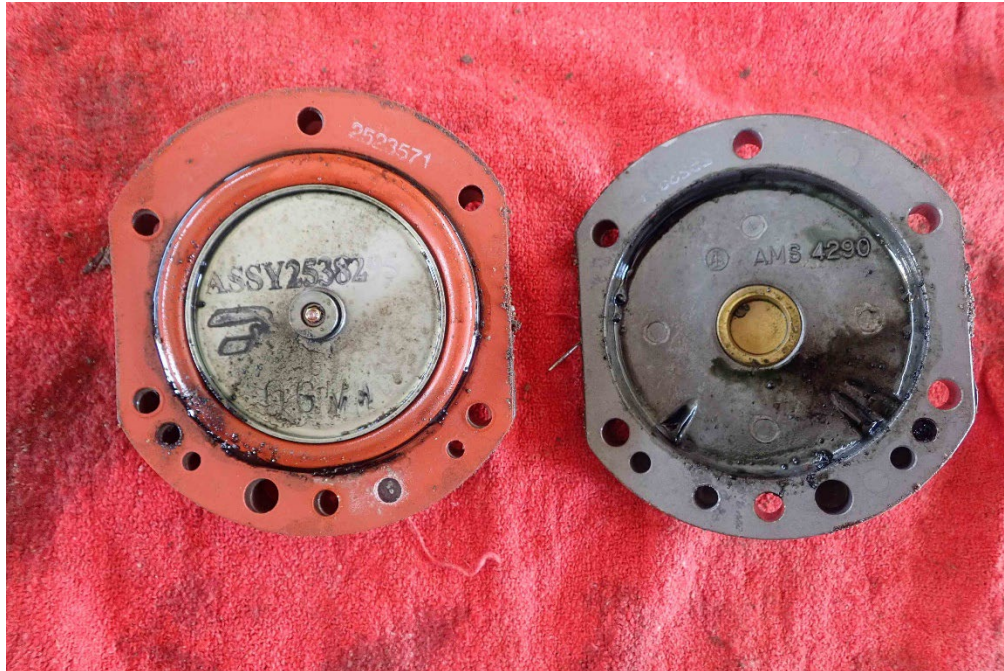
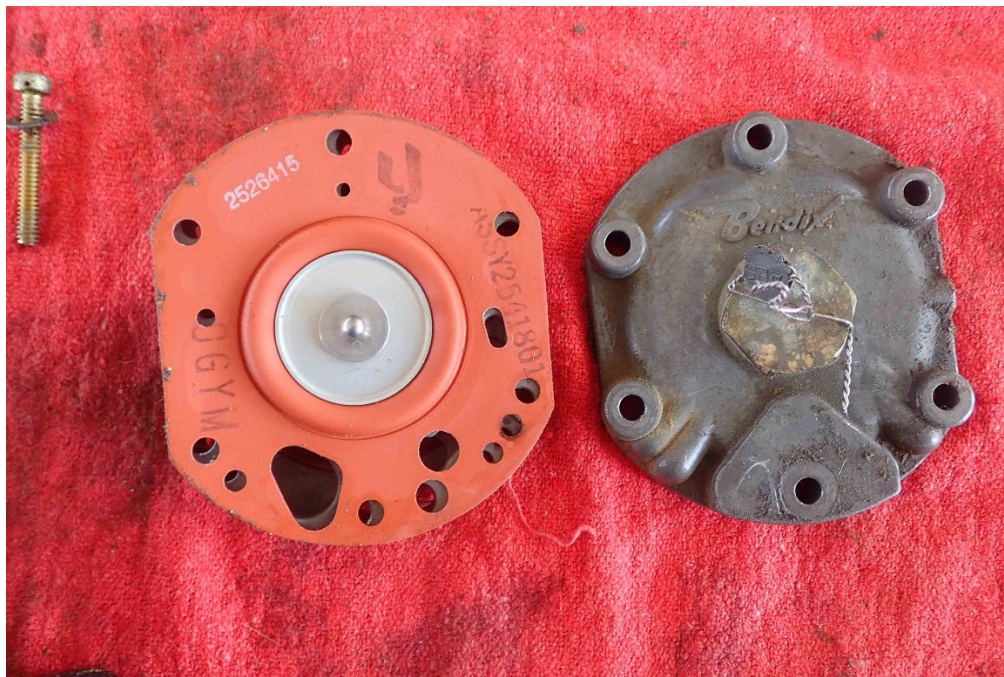
The fuel servo diaphragm assembly was disassembled, the effort spring was intact. Both diaphragms were orange in color, pliable, intact, and did not show any evidence of leak (figure 15, 16). The regulator seat was undamaged, along with the regulator

ball valve. A "G" had been stamped into the regulator hex plug, as required per FAA airworthiness directive (AD) 2009-02-03, and the applicable Precision Airmotive Service Letter RS-87.

**Figure 15 - Fuel servo diaphragm assembly**

**Figure 16 - Fuel servo diaphragm assembly with regulator hex plug**

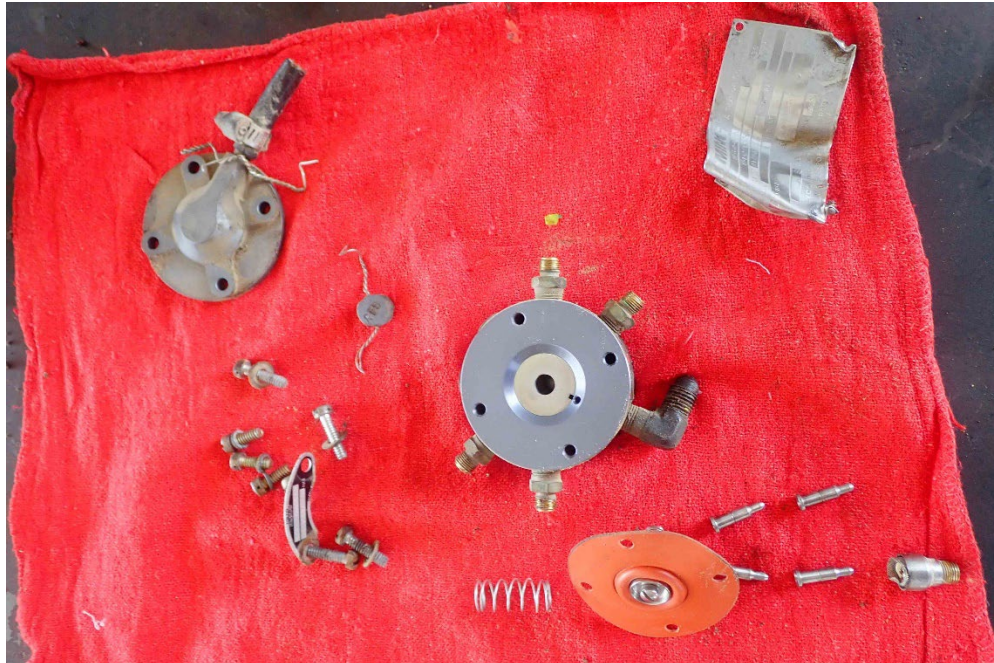
The fuel flow divider was disassembled, diaphragm assembly was intact, pliable and there was no indication of damage (figure 17).

**Figure 17 - Fuel flow divider components**

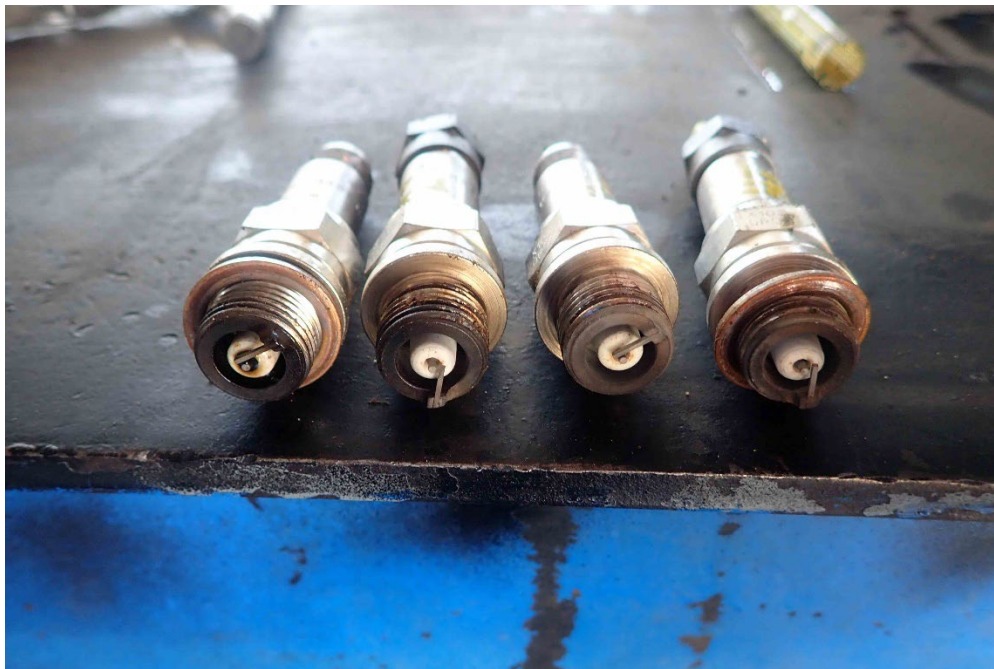
The top spark plugs were removed and were of the fine-wire type. The plug cases were bright, and the general condition appeared to indicate the plugs had sustained minimal use and were recently installed (figure 18).

**Figure 18 - Top spark plugs**

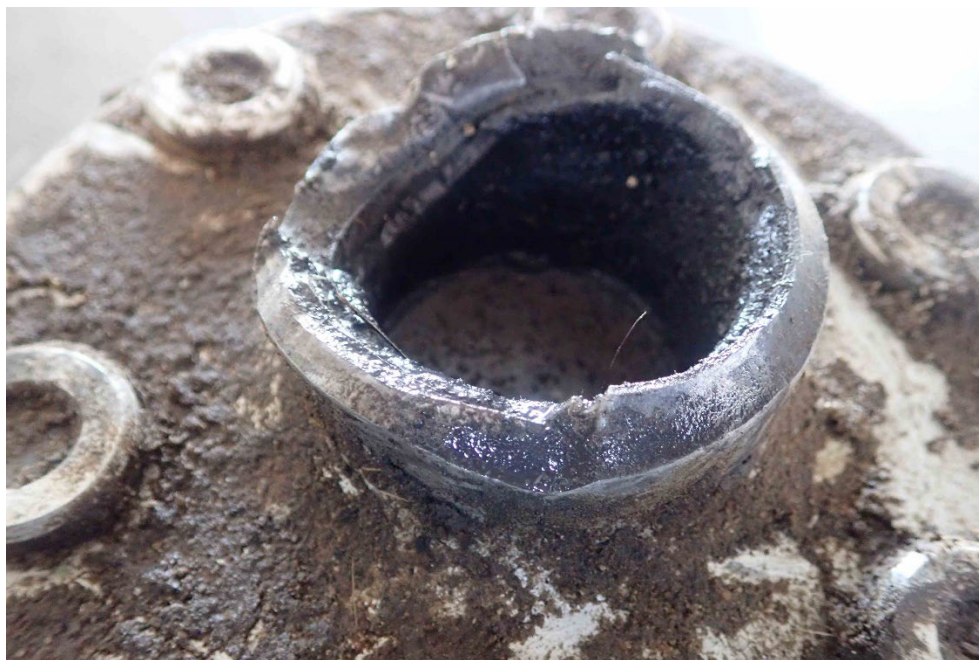
The propeller had broken away from the crankshaft, and 45° radial shear lips were present at the fracture surfaces (figure 19). Both blades exhibited leading edge polishing and paint removal, along with chordwise scratches. One blade exhibited about 90 ° of twist (figure 20), the other blade was largely intact (figure 21). The flywheel and ring gear had broken away from the crankshaft.

**Figure 19 - Propeller hub crankshaft flange**

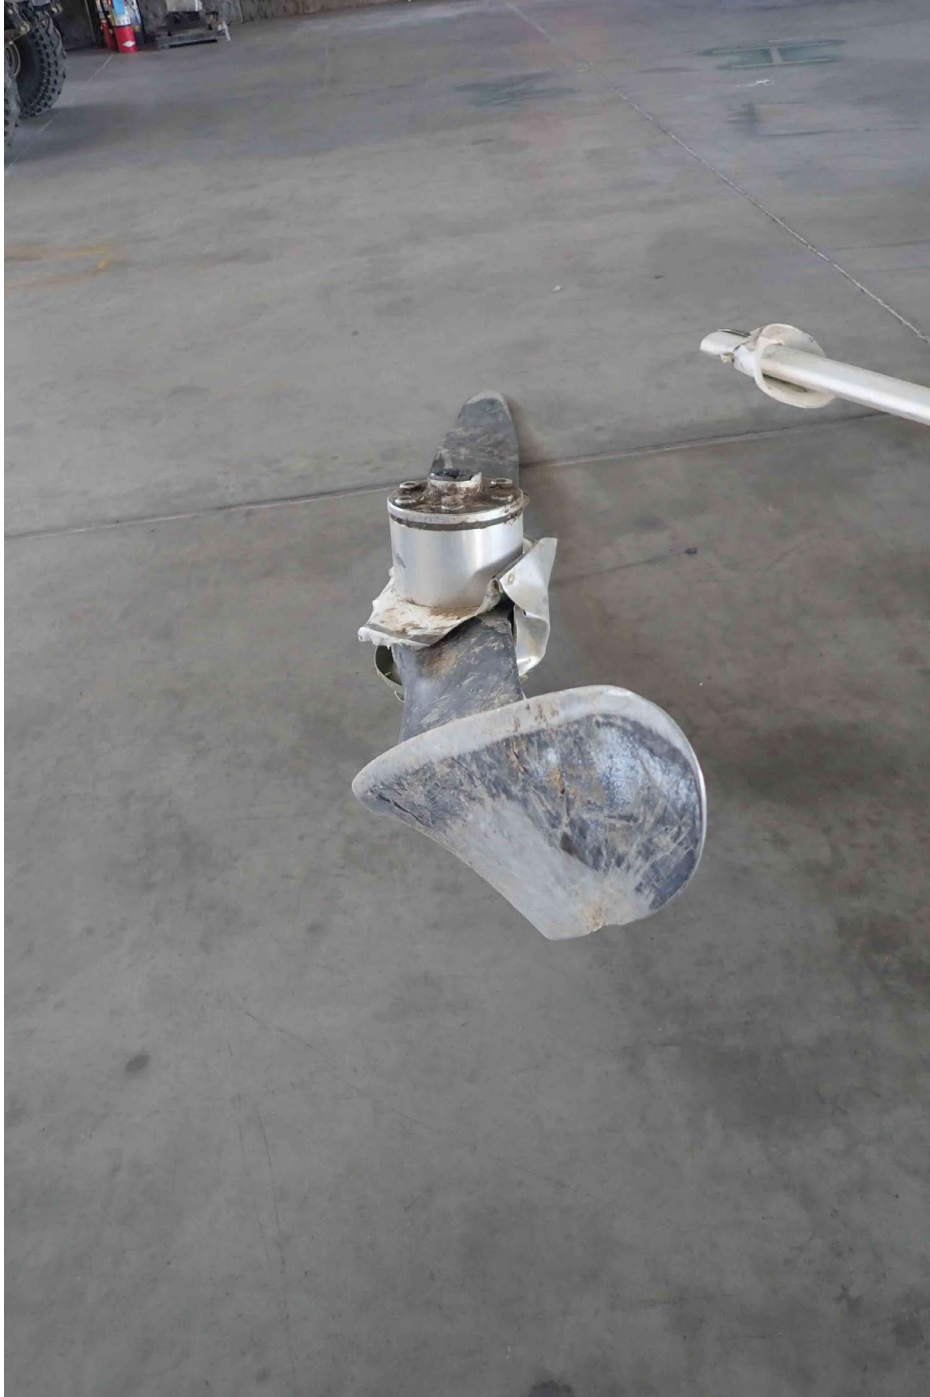
**Figure 20 - Propeller blade**

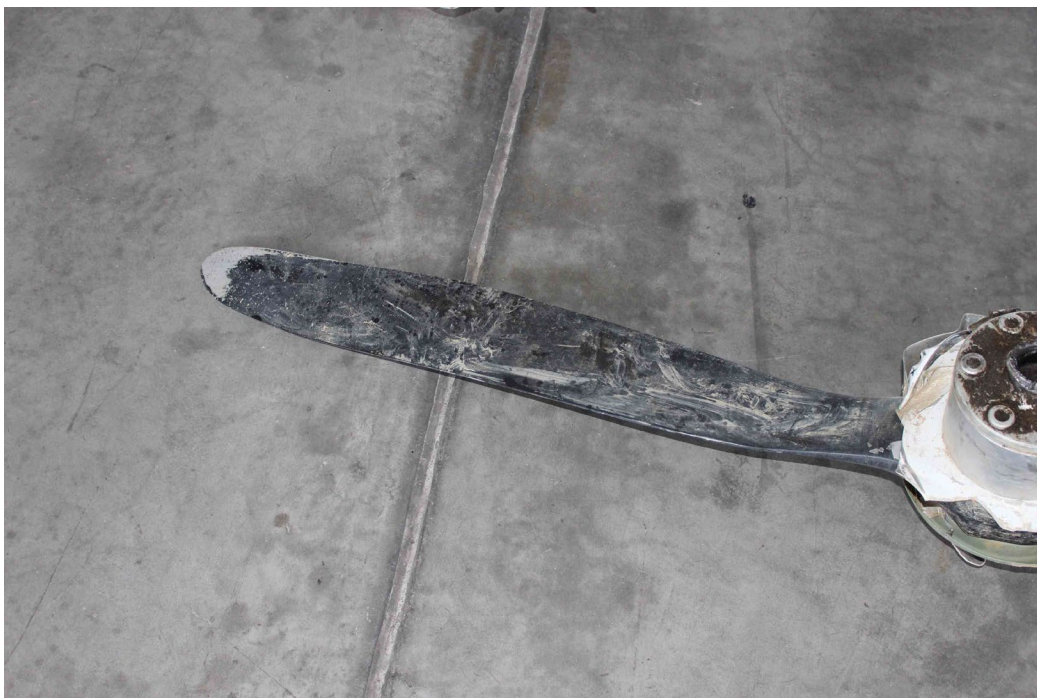
**Figure 21 - Propeller blade**
