**From:** Timothy Burtch  
**Sent:** Monday, November 6, 2023 2:22 PM  
**To:** Michael Hicks  
**Subject:** RE: WPR23FA173 Performance request

**WPR23FA173: Beech A36, N2038Y**  
**Big Bear City, CA**  
**5/1/2023**

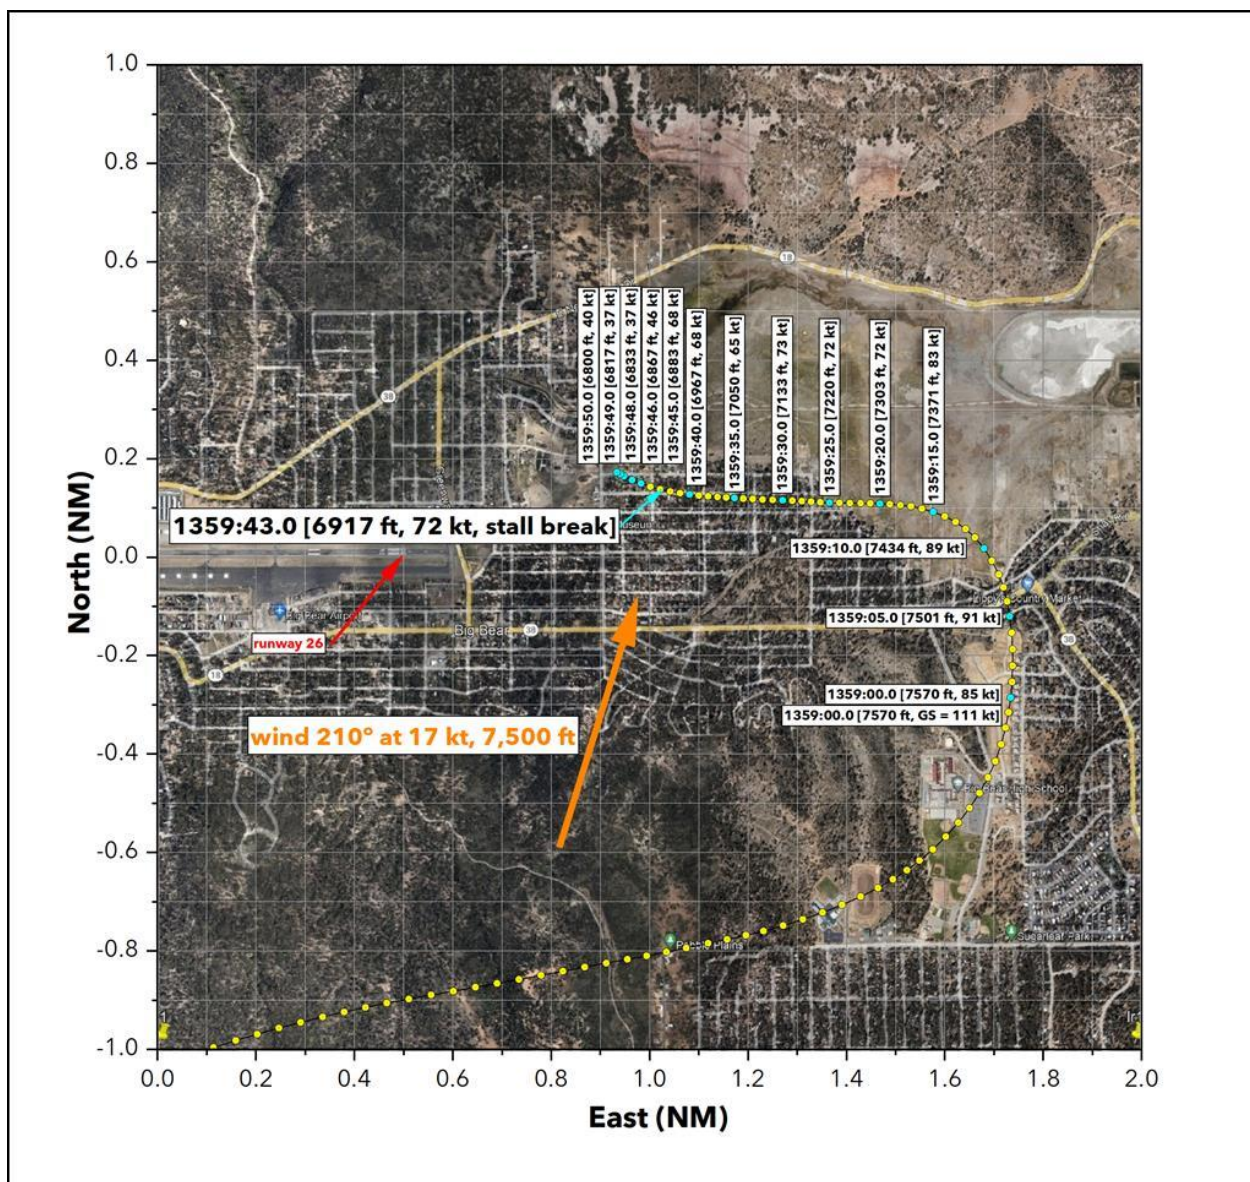
Here is an overlay of the left downwind, base, and final for runway 26 at Big Bear City (L35). It also includes altitude and estimated airspeed for select times on base and final (turquoise data points).

A 17 kt tail wind combined with the high airport elevation produced a ground speed that was much greater than the airspeed. See Figure 2. This may have deceived the pilot with the “illusion” of speed if he was not monitoring his instruments while flying close to the ground and resulted in an (overly) large power reduction. The high ground speed would also explain why the airplane overshot the extended runway centerline as shown in Figure 1.

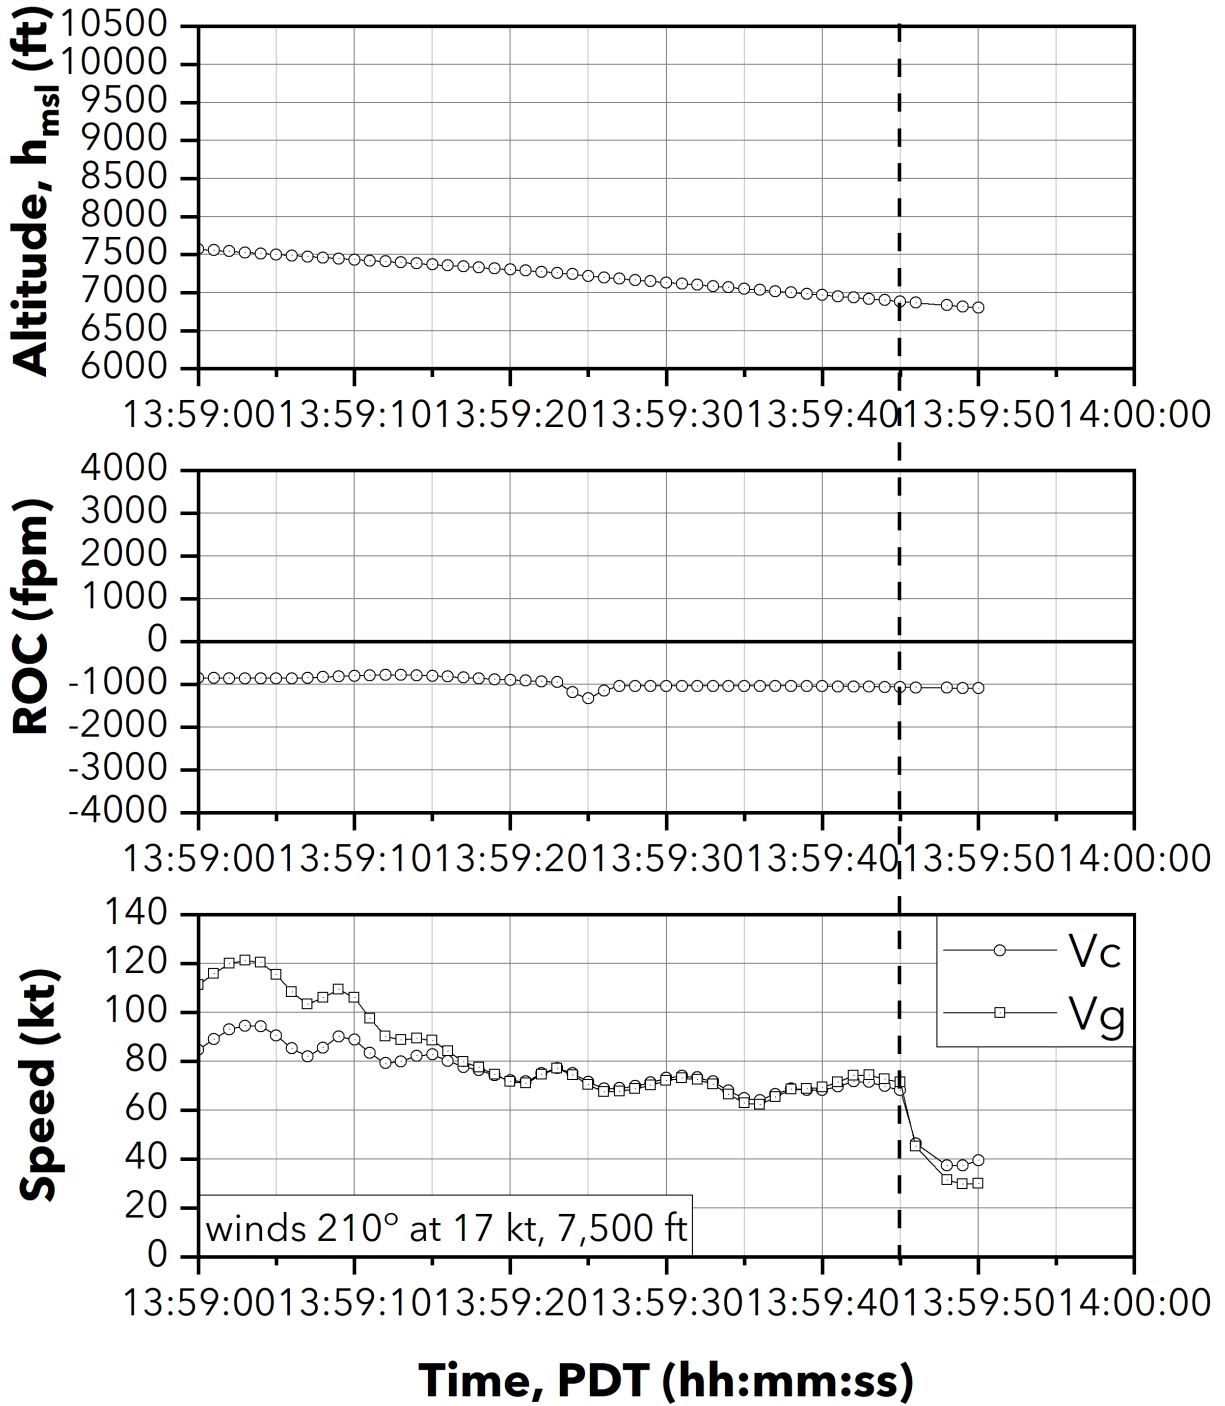
Figure 2: ADS-B Altitude, Rate of Climb, Ground Speed, and Estimated Airspeed

Notice how the airspeed and groundspeed come together at 1359:15 in Figure 2, when the airplane turns onto final. The ADS-B data indicate that the pilot did try to align the airplane with the runway with a 20 deg left turn on final. However, that's also when the airplane appeared to have stalled. The normal load factor likely increased, and the wing angle-of-attack exceeded the critical AOA. In addition, I suspect the right wing stalled first because of the deflected aileron as well as the heading change in the ADS-B data.
