# National Transportation Safety Board

WPR23FA173

## **N2038Y WRECKAGE AND EXAMINATION SUMMARY**

Location: Big Bear, California  
Date: May 1, 2023  
Time: 1359 PDT  
2059 UTC  
Airplane: N2038Y -1978 Beech A36 Bonanza

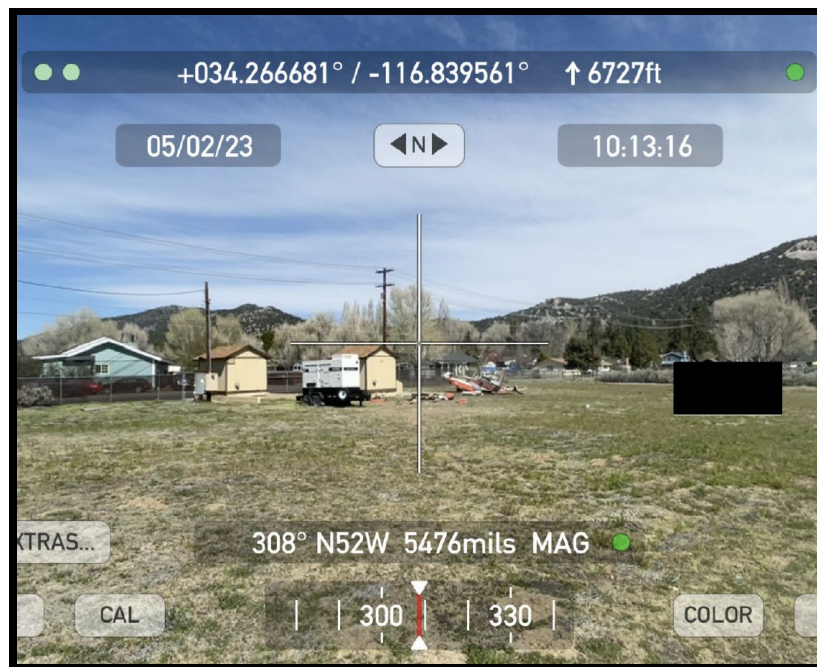
The airplane impacted the south side of a fenced in city owned facility yard and narrowly missed power line wires located just outside the western fence. The initial point of impact was identified by ground scars located at latitude: 34.2266689° longitude: -116.839562° and the ground elevation was 6,731 ft. The airplane impacted the ground in a nose down, right bank on a heading of 310° magnetic (see figure 1). The right wing struck the ground forming the initial point of impact, as confirmed by ground

scars that contained fragments of the green position light lens. The right wing created a ground scar that was about 45' long, and a subsequent ground scar was created by the nose of the airplane. The ground scars revealed a pivot point from the nose of the aircraft, followed by a cartwheel over to the left wing before the airplane came to rest in a near upright position.

**Figure 1:** View of airplane from initial point of impact

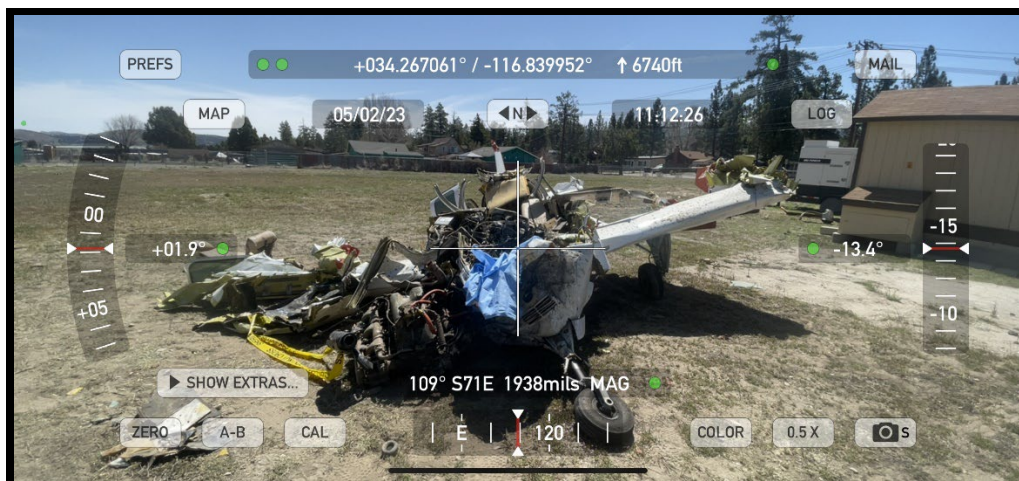
The spinner created a pivot point for the airplane to cartwheel and the propeller hub was liberated from the engine crank case. The left wing subsequently struck the ground, and the airplane came to rest upright with the nose of the airplane oriented on a heading of 329° magnetic (see figure 2).

**Figure 2:** View of airplane from nose to tail

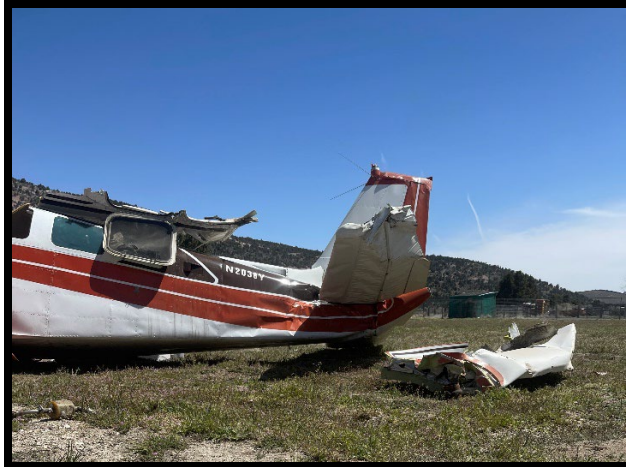
The empennage remained attached to the aft fuselage and minimal damage was sustained to the right side horizontal stabilator, elevator and trim tab. The left side horizontal stabilator, elevator and trim tab sustained impact damage which created an upward bow from the top of each surface control surface, that emanated from the outboard section to the fuselage (see figure 3). The aft left fuselage sustained impact damage identified by concave signatures resulting from horizontal stabilator and elevator ground impact (see figure 3). The vertical stabilizer sustained impact damage at its fuselage mating surface, and the rudder attachment points (see figure 4). The rudder revealed crushing signatures emanating from the top aft section which bent to the airfoil to the right, as indicated by the concave signatures at the top and midspan vertical stabilizer attachment points, when viewed from the right side (see figure 4).

**Figure 3:** View of empennage damage

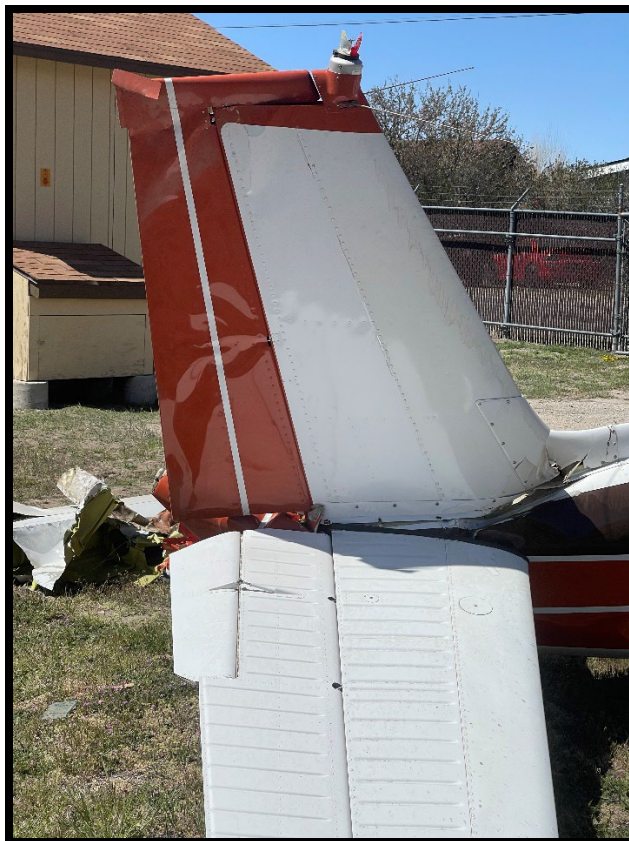
**Figure 4:** View of damage to horizontal stabilizer and rudder

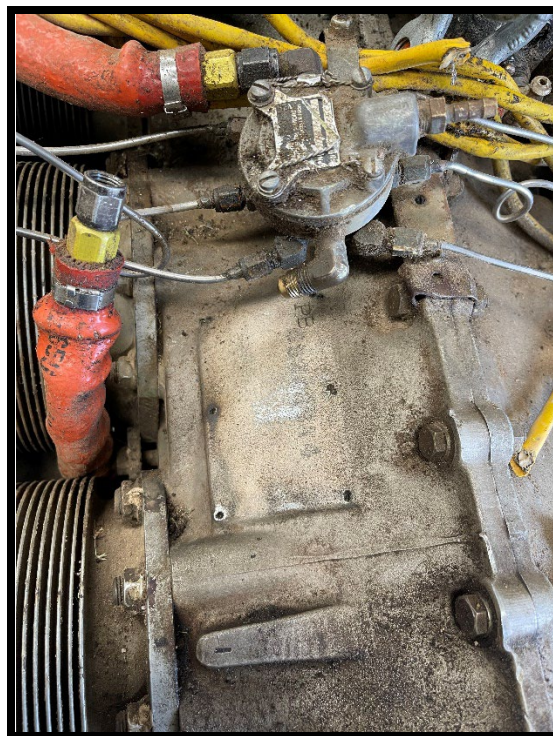
The airplane registration for the accident airplane indicated that it was equipped with a Continental IO-520 engine. However, the engine data plate was not attached to the engine case and did not appear that its absence was the result of impact damage. The letters PB were stamped into the engine case where the data plate should have been, along with several alpha numeric characters that were illegible. The engine logbook was not located in the wreckage.

**Figure 5:** View of missing engine data plate

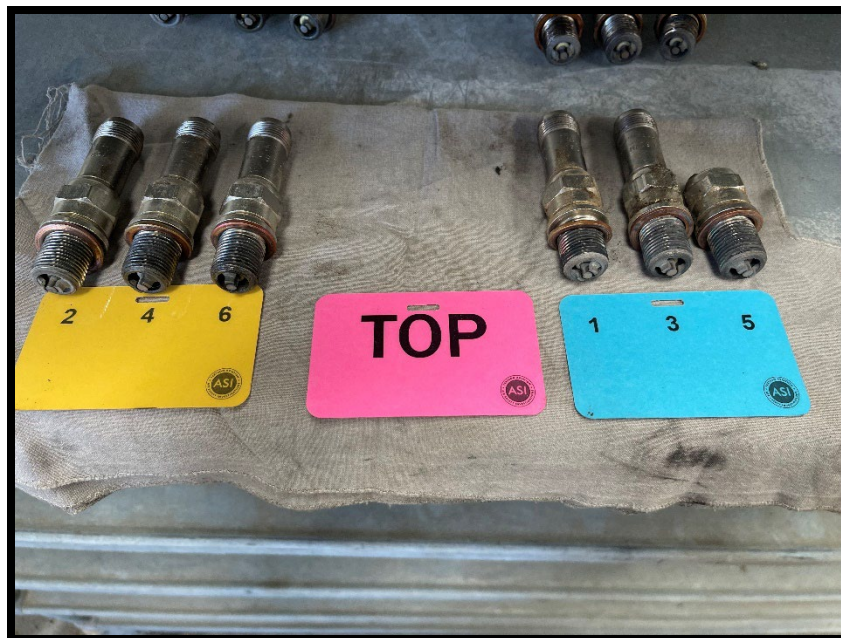
The left and right magnetos were removed and separated from the ignition harness, rotated by hand, and both produced a shower of sparks. The engine was rotated using a socket wrench and an M16 drive was inserted into the left magneto housing drive. The top spark plugs were removed, presented normal operational signatures and appeared to be new. The No. 5 spark top plug was impact damaged and separated in half (see figure 6). The bottom spark plugs were removed from each of the cylinders and thumb compression was obtained, albeit the No. 5 (impact damaged) cylinder compression was low. The bottom spark plugs presented normal operational signatures and appeared to be relatively new (see figure 7).

**Figure 6:** View of top spark plugs

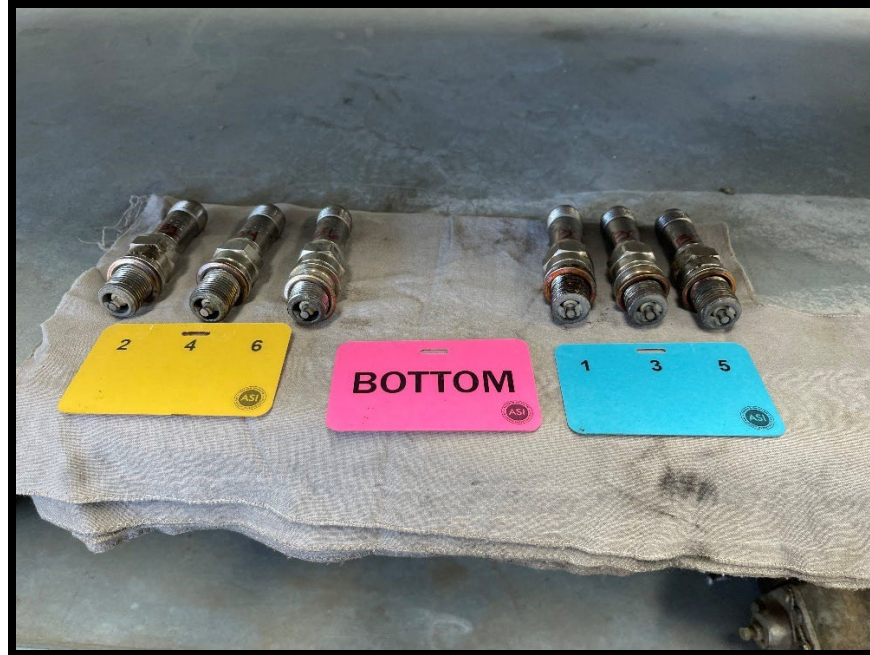
**Figure 7:** View of bottom spark plugs

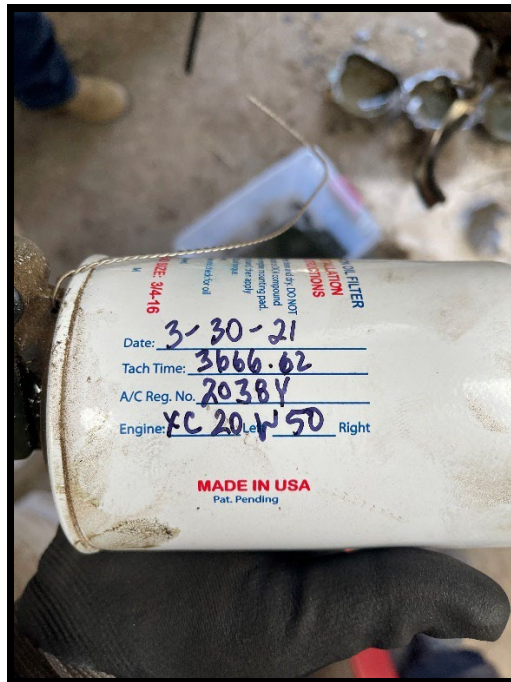
The oil filter remained attached to the oil filter adapter that was secure and attached to the accessory case. The date on the oil filter indicated March 03, 2021, with a tachometer time of 3,666.62 hours (see figure 8). The oil filter indicated that the aircraft registration number was N2038Y, the engine field was annotated with XC 20W50, which is the type of engine oil (see figure 8). The safety wire was removed, the filter was cut open and did not contain debris or visible contaminants. The oil appeared clean throughout the engine.

**Figure 5:** View of oil filter inscriptions

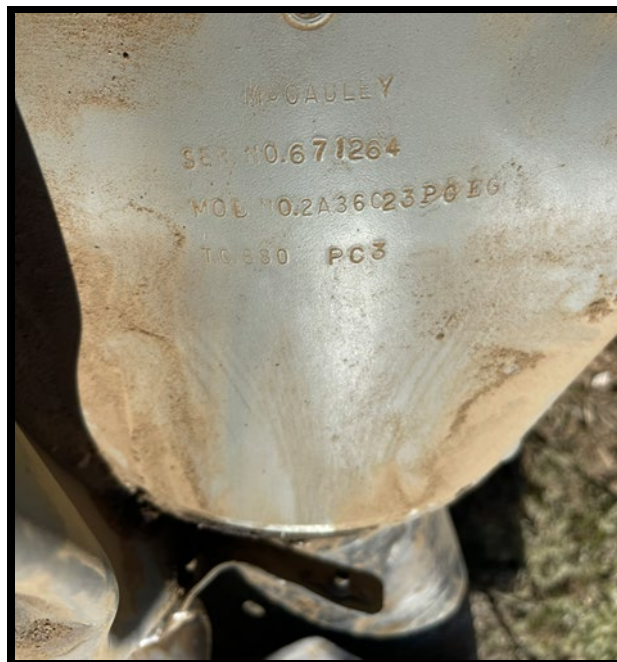
Model: 2A36C/23PCE6  
 Serial Number: 67126F  
 TCO: 880 PC3

**Figure 6:** View of propeller hub inscription

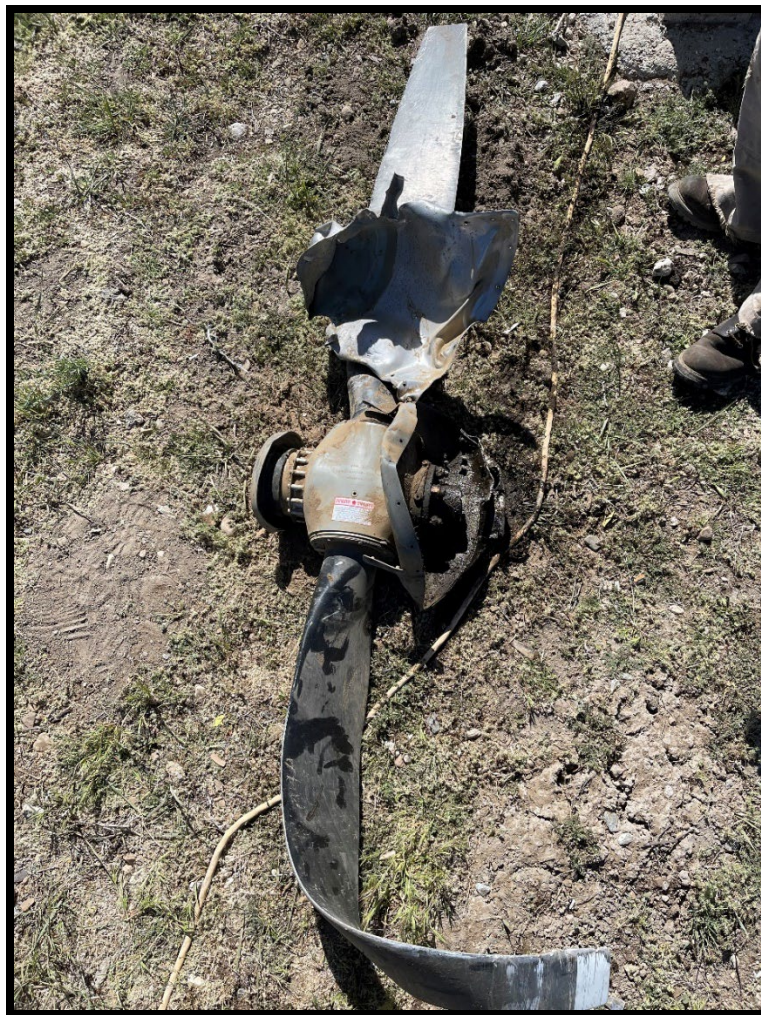
The propeller was observed separated from the engine about 1.5" aft of the propeller attachment flange (see figure 10). The spinner was observed deformed around the propeller hub with little rotational damage. The propeller blade marked "A" was observed in the No. 2 blade position of the hub, sustain rotational scoring along the length of the blade with leading-edge damage. The "A" blade was observed deformed towards the flat side, about mid-span. The propeller blade marked "B" was observed in the No. 1 blade position of the hub and was observed with rotational scoring and very little leading-edge damage. The blade was observed in a nearly straight condition.

**Figure 7:** View of propeller hub and blades
