# National Transportation Safety Board

WPR23FA185

## DEEC MICROCHIP EXAMINATION REPORT

WPR23FA185  
San Clemente Island, California  
May 10, 2023  
7:49 am PDT

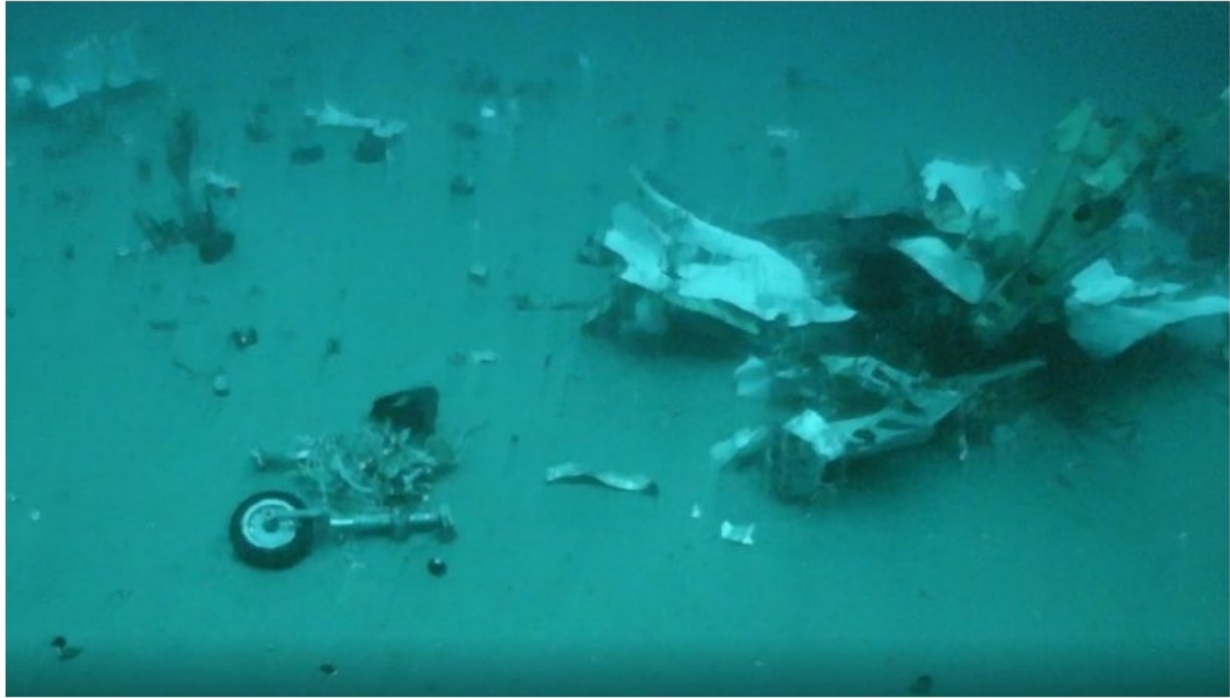
The airplane wreckage was located about 4 miles northwest of the last recorded ADS-B data point and one mile offshore in about 300 ft of water. A visual inspection of the wreckage was conducted using a remotely operated vehicle. The wreckage was highly fragmented (Figure 2) and evidence of a preimpact fire was visible on portions of the wreckage.

Figure 2 – N56PA Wreckage (LASD Video Extract)

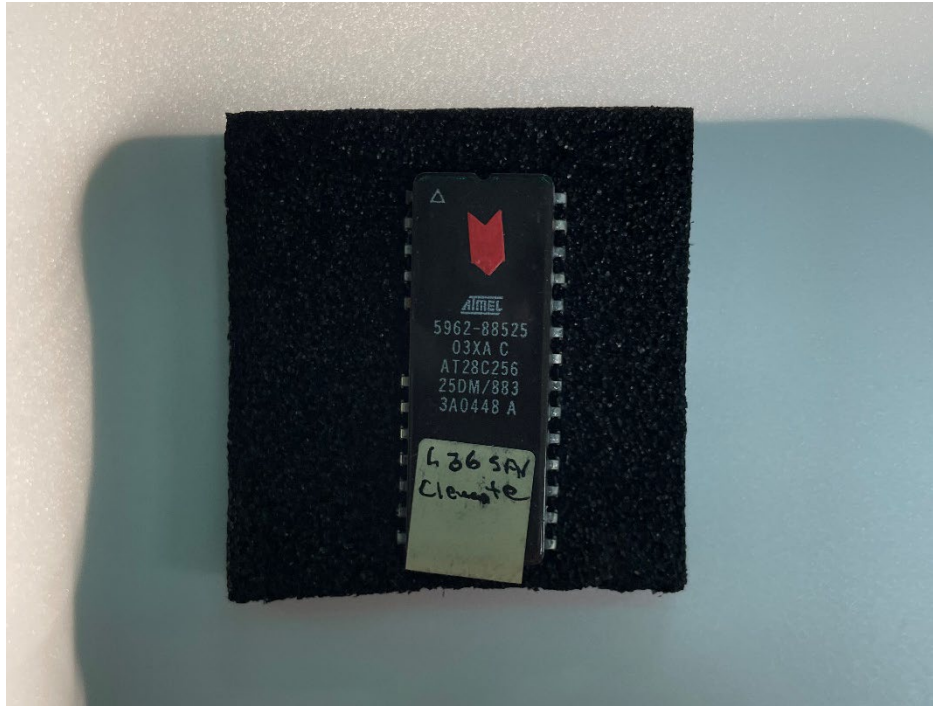
Photo 5, Accident Microchip

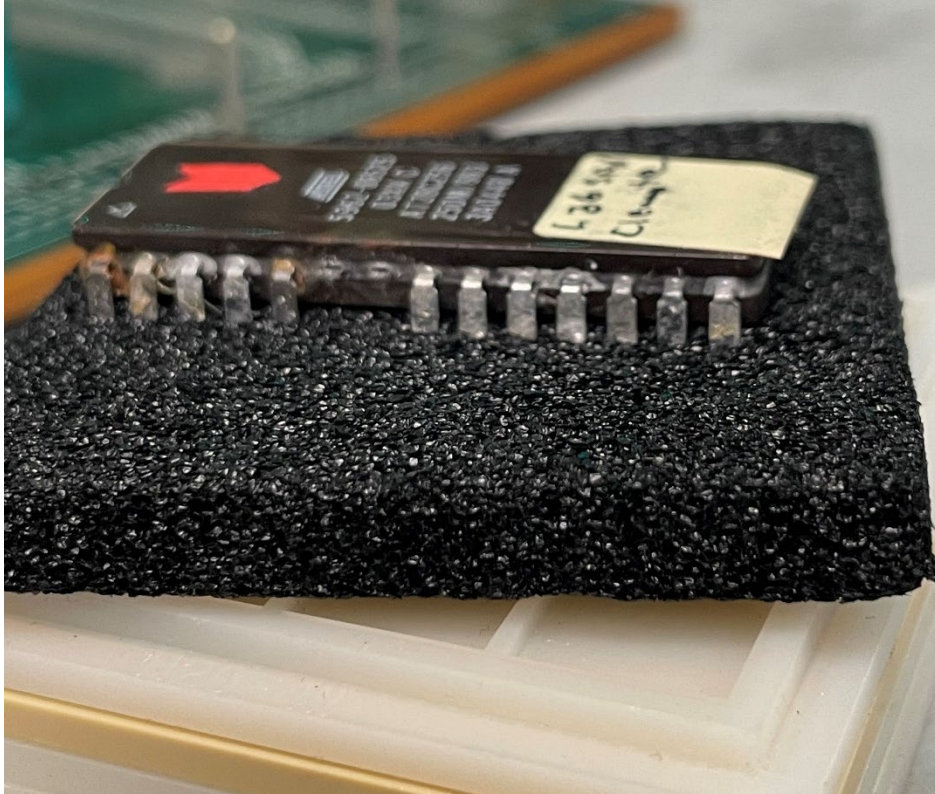
On initial examination, the accident microchip was intact, but two of the contact pins on the chip's right side were missing. A programmable curve tracer used to determine electrical continuity was used on the exemplar chip to form a foundation from which to compare the accident chip. If continuity is good, the display will show a line from the bottom of the screen along the Y-axis to the center and then the line should bend 90 degrees to the right along the X-axis indicating good continuity. Testing of the contact pins on the exemplar microchip showed good continuity.

Photo 6, Missing Contact Pins

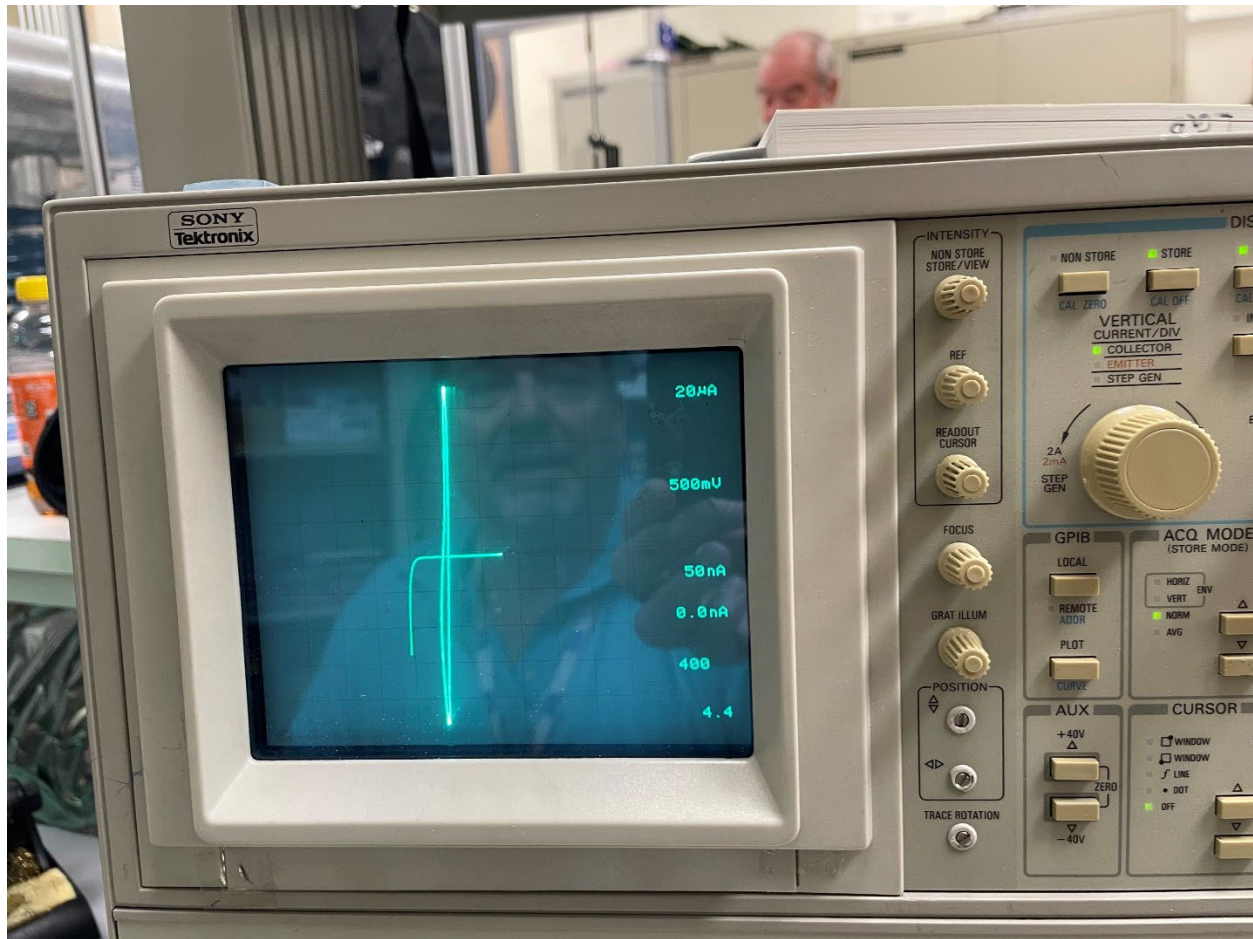
The accident microchip was then curve traced for continuity and failed to show normal readings. One channel showed a vertical loop on the Y-Axis.

Photo 8, Curve Tracer Display showing one channel (narrow vertical loop) on the Accident Chip (The proper continuity curve display is superimposed)

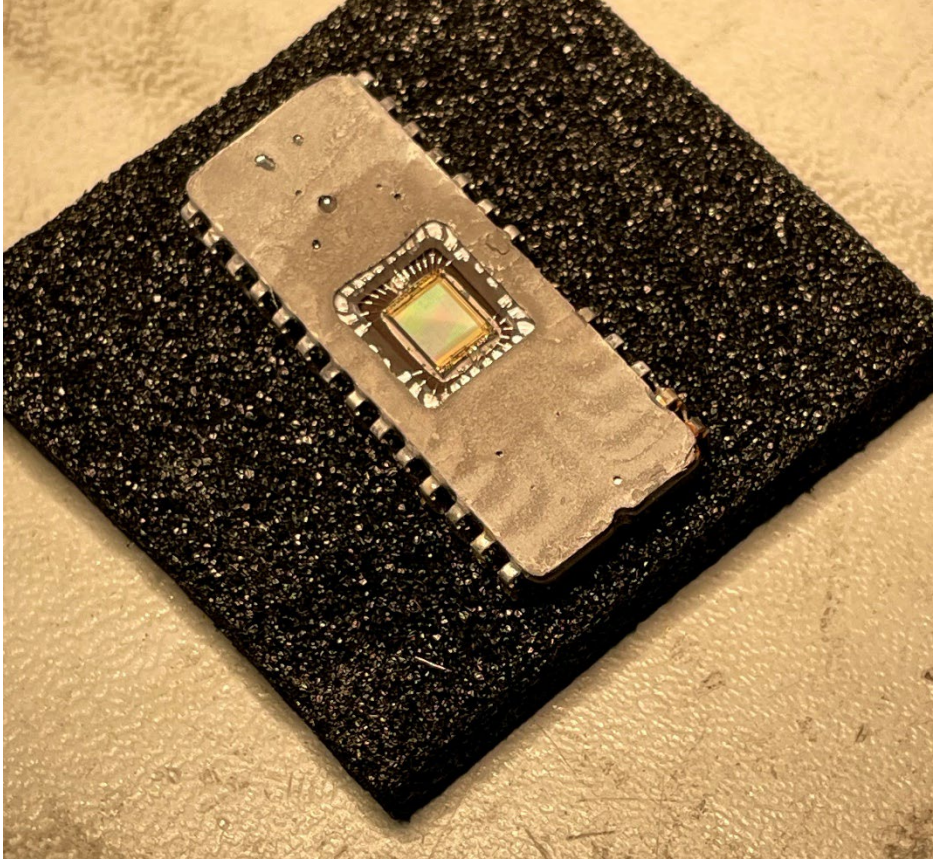
The microchip was then opened, and the microprocessor was examined under the microscope. Corrosion contamination was observed. The pad wires were removed, and the microprocessor was cleaned with acetone. The microprocessor was tested again and still showed erroneous curve tracing. The microprocessor was cleaned further and the pad metal at each of the 28 leads were either scraped or etched with a laser to assure better contact.

Photo 9, Opened Accident Microchip Showing the Microprocessor in the Center

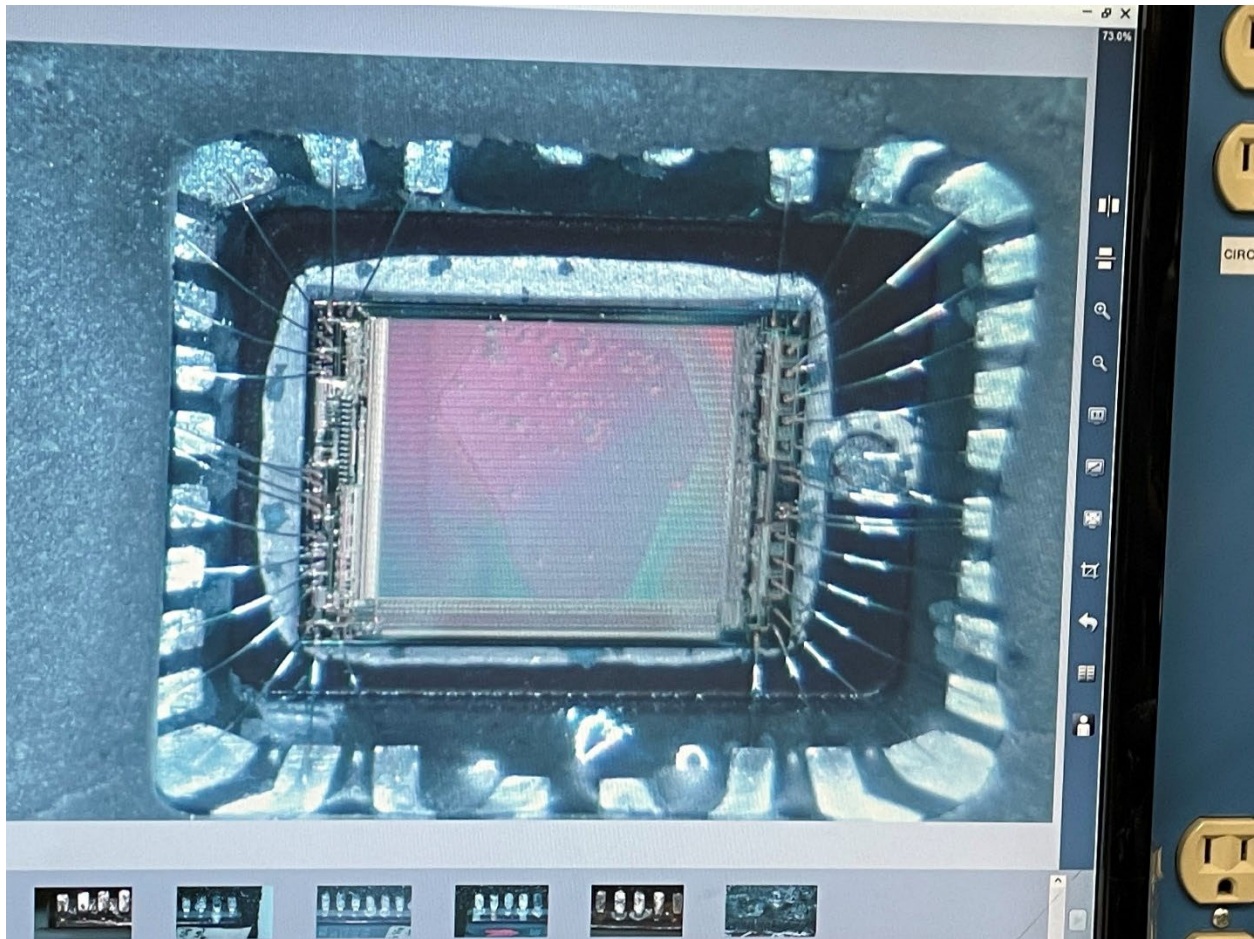
Photo 10, Accident Microprocessor, Close up View.

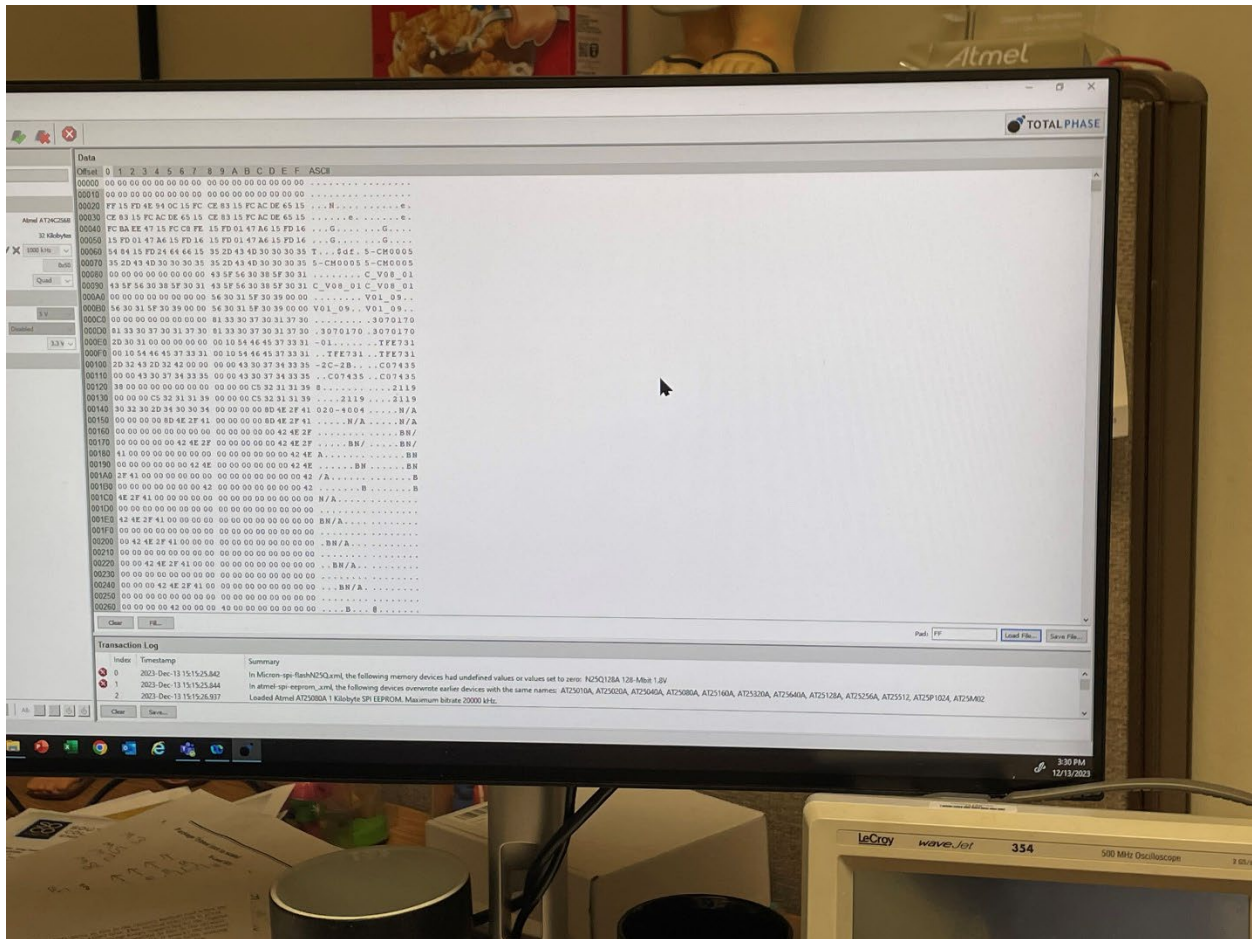
Photo 14, ASCII Text Display

Reviewing the ASCII text file, the data was found to be corrupt, repeating each of the data file lines at least three times and showing gaps in the lines. It was determined that the pathway between one of the leads from the microprocessor to the pads (narrowed to lead A3, pin 7) was not transmitting data. To move forward to clear this error would require additional probing to establish the pathway. This process would take addition setup time and equipment that was available but not yet in place. At that point, the team determined that they would reconvene at a later date to try and clear the error and re-download the data. However, what was determined from the ASCII text file was that the DEEC microchip was from the suspect left engine.
