# National Transportation Safety Board

WPR23FA185

## **MATERIALS LABORATORY**

Factual Report 24-090

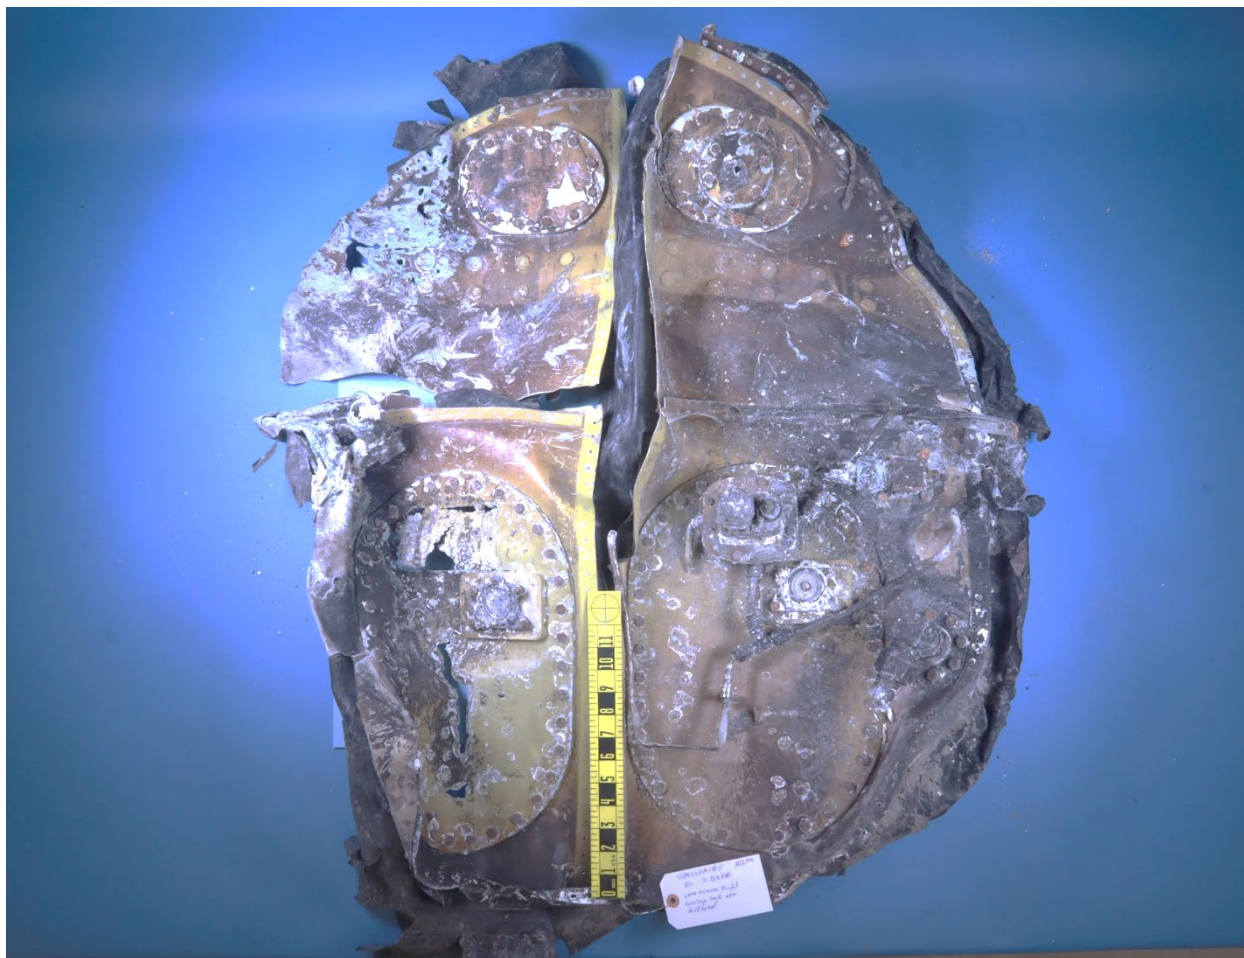
Portions of the fuselage fuel tank aft bulkhead (Figure 1). Fuel motive flow and hydraulic fluid return bulkhead fittings from left side aft engine mount carry through area (Figure 2).

**Figure 1.** Portions of fuselage fuel cell aft bulkhead (as Received)

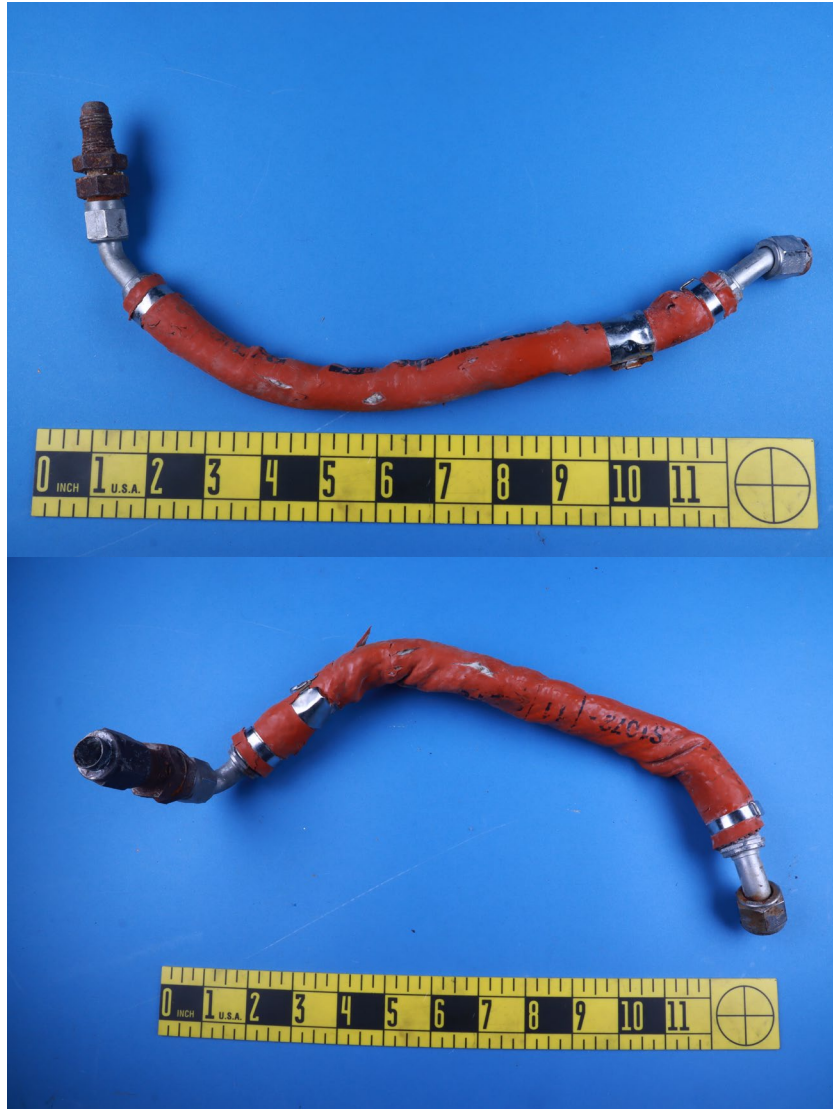
**Figure 2.** Motive flow fuel line with fittings (Top) Hydraulic fluid return line with fittings (Bottom) as received.

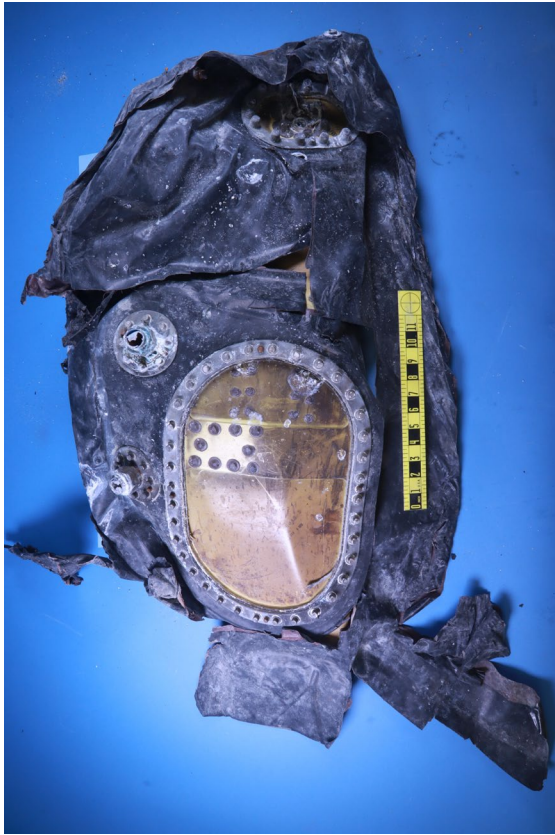
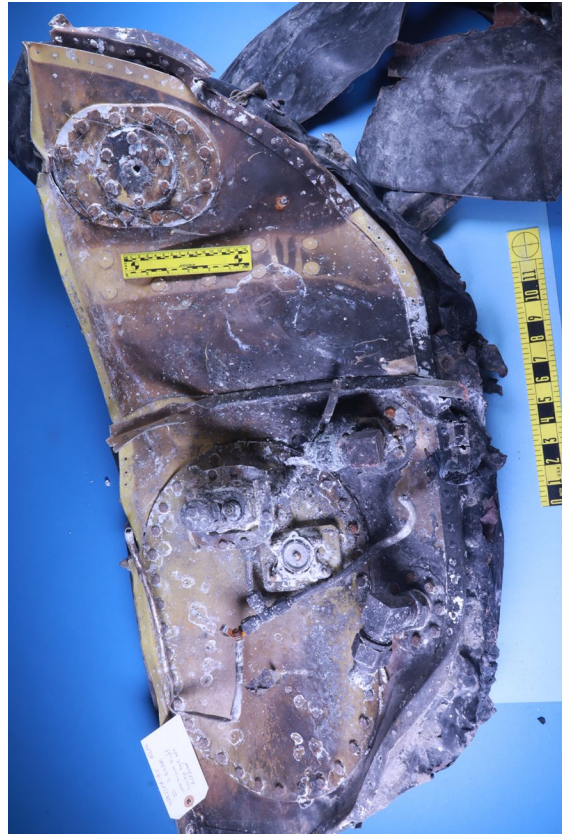
The right-side portion of the fuselage fuel tank aft bulkhead remained intact as one piece (Figure 3). Overall, on the aft-facing side the thermal discoloration was mostly uniform and diffuse. This side did not exhibit areas of sharp demarcation between thermally damaged and non-damaged areas. The upper half of this portion had some green colored debris adhering to the surface. This green debris resembled electrical wire fragments (Figure 9). The forward-facing side of this right-side portion of the fuselage fuel tank bulkhead exhibited fairly uniform and diffuse thermal discoloration of the primer.

**Figure 3.** Right side portion of the fuselage fuel tank aft bulkhead.

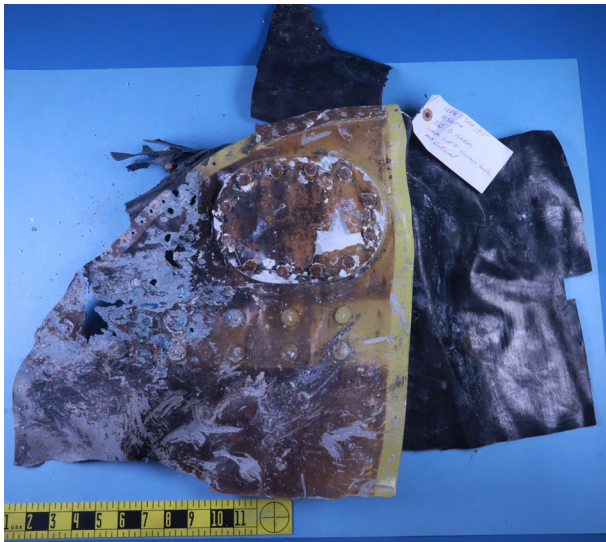
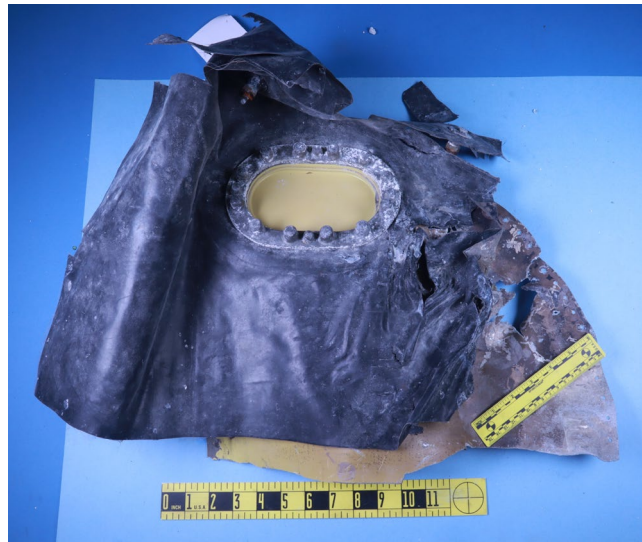
The aft bulkhead of the fuselage fuel tank was fractured into 3 pieces (Figures 3, 4, 5). The right side remained intact from top to bottom and the left side was fractured into approximately two equal portions. The aft facing side of the bulkhead would have been facing the interior of the aft equipment bay. This side of the bulkhead was painted with a green corrosion resistant primer. The forward face of the bulkhead was also painted with a green corrosion resistant primer. The forward face of the bulkhead panel would have been in direct contact with the rubber fuel bladder of the fuselage fuel tank.

**Figure 4.** Left side top portion of the fuselage fuel tank aft bulkhead.

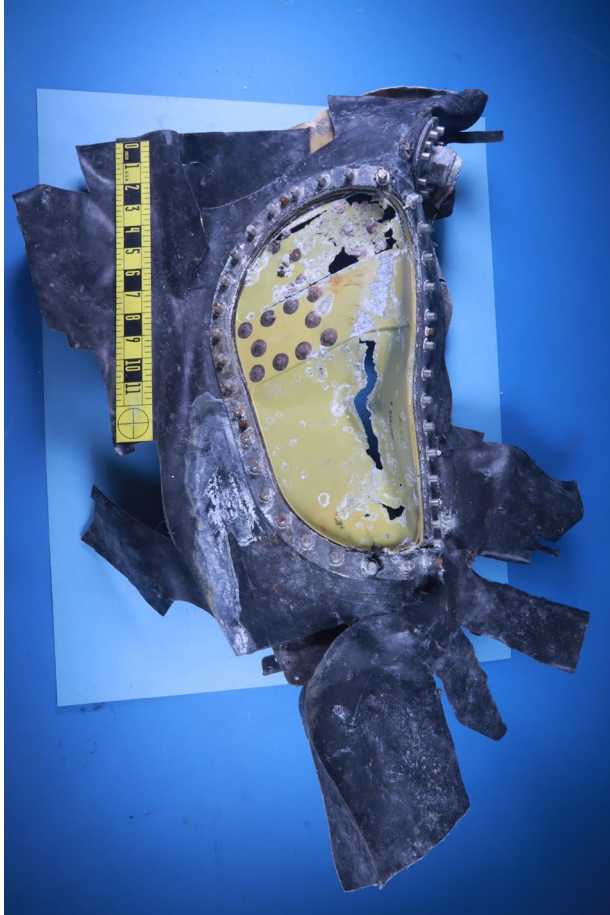
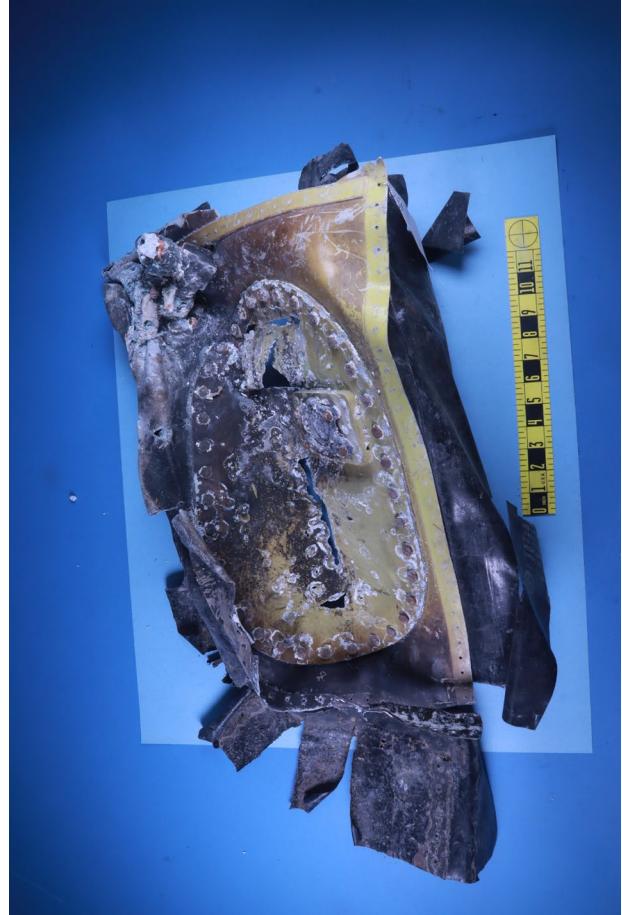
The aft-facing side of the lower portion of the left side fuselage fuel tank aft bulkhead exhibited an area along its upper outboard edge with similar characteristics as those observed in the eroded area of the upper portion of the bulkhead on the left side (Figure 5). This area of erosion and focused thermal damage was continuous across both portions of the bulkhead on the left side. Below this area the thermal damage became more diffuse. On the forward-facing side of this portion of the lower left bulkhead, the primer paint was less thermally discolored than on the aft-facing side.

**Figure 5.** Left side bottom portion of the fuselage fuel tank aft bulkhead.

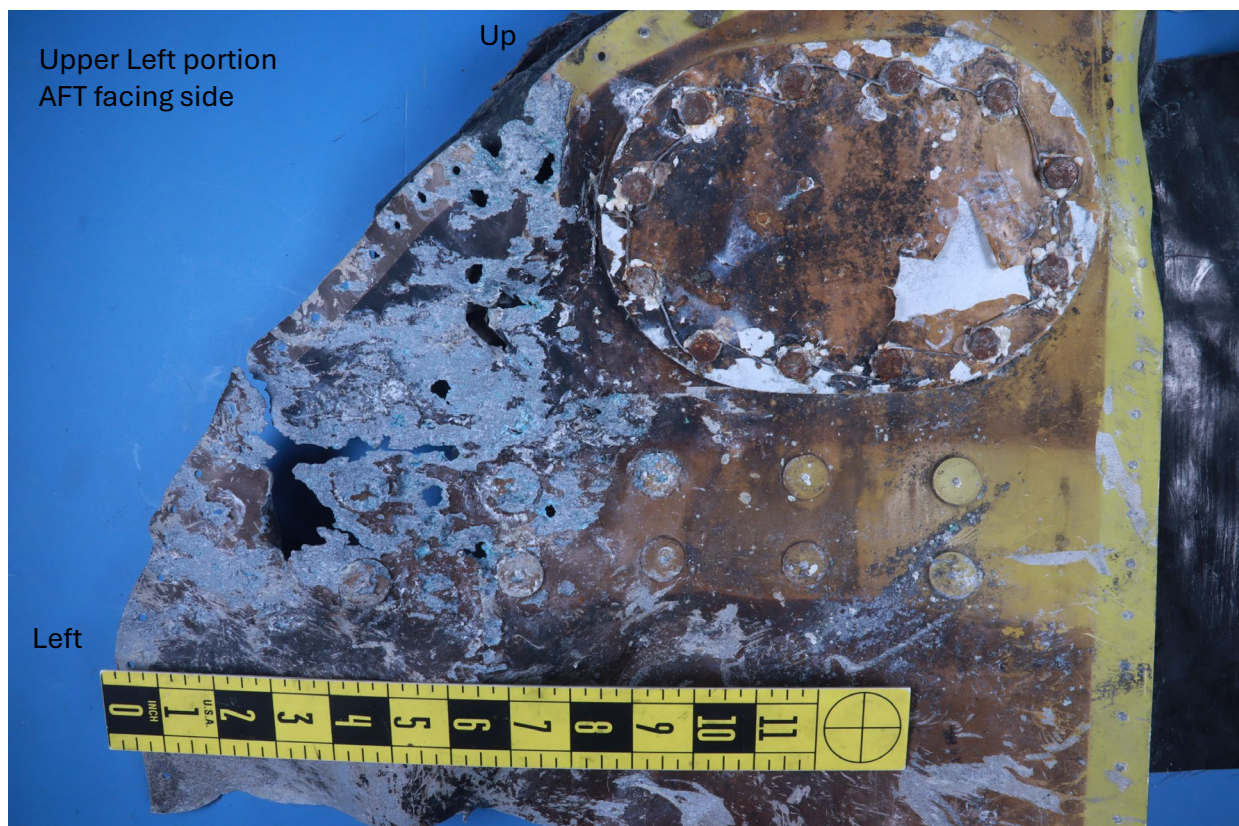
The aft-facing side of the upper portion of the left side of the fuselage fuel tank aft bulkhead exhibited a region of damage that was different than what was observed throughout the rest of the bulkhead (Figure 6). This region of damage was mostly devoid of any remaining charred primer paint and the aluminum substrate was eroded. In some areas within this region, the erosion was all the way through the thickness of the aluminum bulkhead panel. Other areas throughout the entire fuselage fuel tank aft bulkhead that exhibited charred, or missing paint did not exhibit the erosion. Additionally, the eroded area exhibited points of greenish coloration. A sample (Figure 7) was cut out of this area and examined using Energy Dispersive Spectroscopy (EDS). The EDS examination revealed copper oxides in the areas with the greenish coloration. The forward-facing side of this upper left-hand portion of the fuselage fuel tank aft bulkhead had some of the rubber fuel tank liner still attached (Figure 8). The rubber liner corresponding to the eroded area had shrunk and receded and could no longer overlap with the eroded area. The eroded area on the forward-facing side of this panel had more charred primer paint still adhering to the panel than the corresponding area on the aft facing side of the panel. Additionally, the gradient between charred primer and undamaged primer in this area was very sharp consistent with a focused heat source.

**Figure 6.** Upper left portion of the fuselage fuel tank aft bulkhead exhibiting a region of erosion of the aluminum panel.

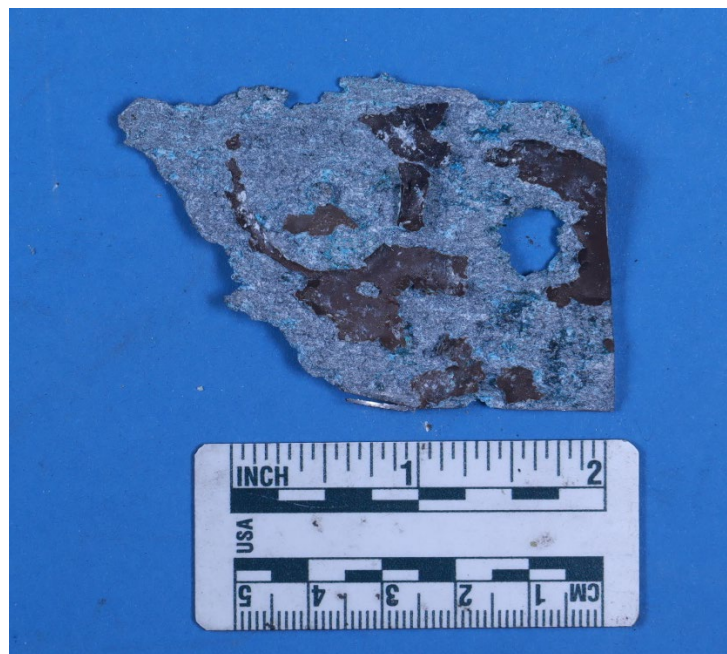
**Figure 7.** Sample removed from the erosion region of the upper left had portion of the fuselage fuel tank aft bulkhead.

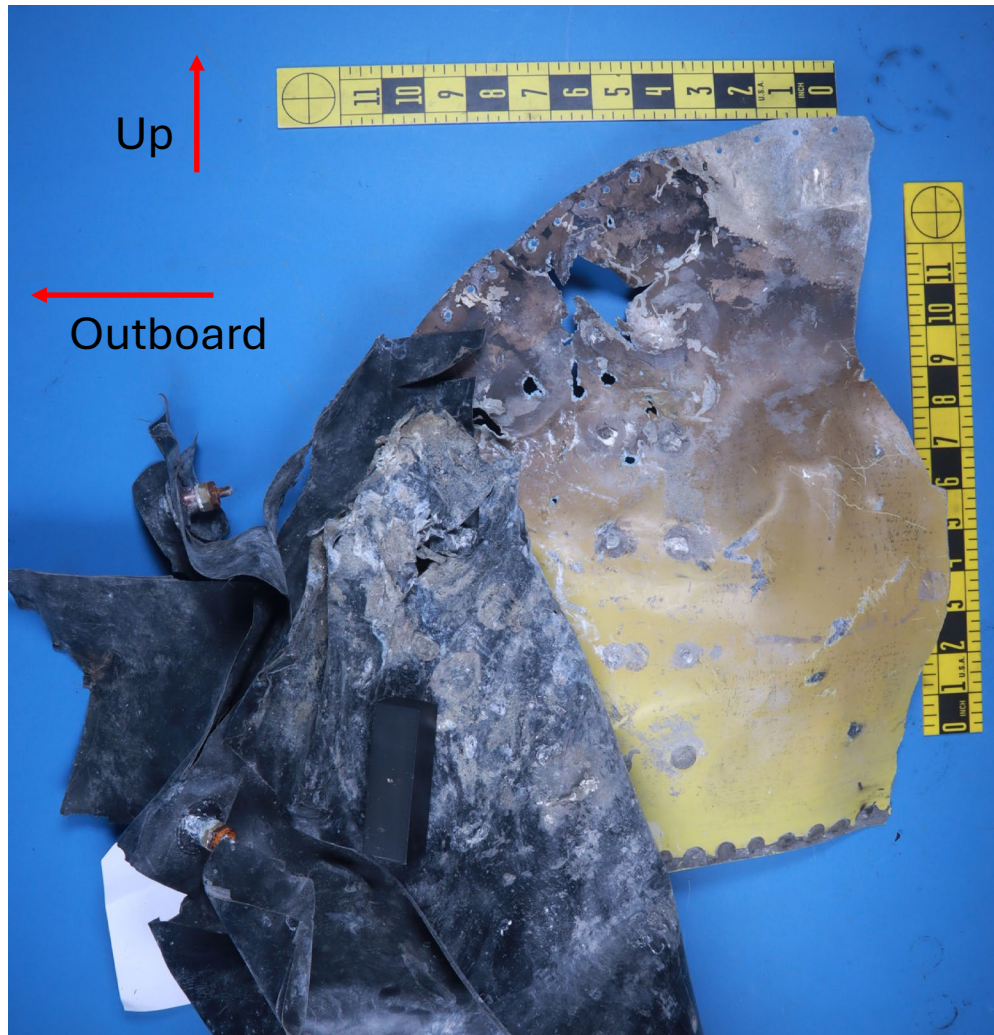
**Figure 8.** Forward-facing side of the upper left-hand portion of the fuselage fuel tank aft bulkhead.

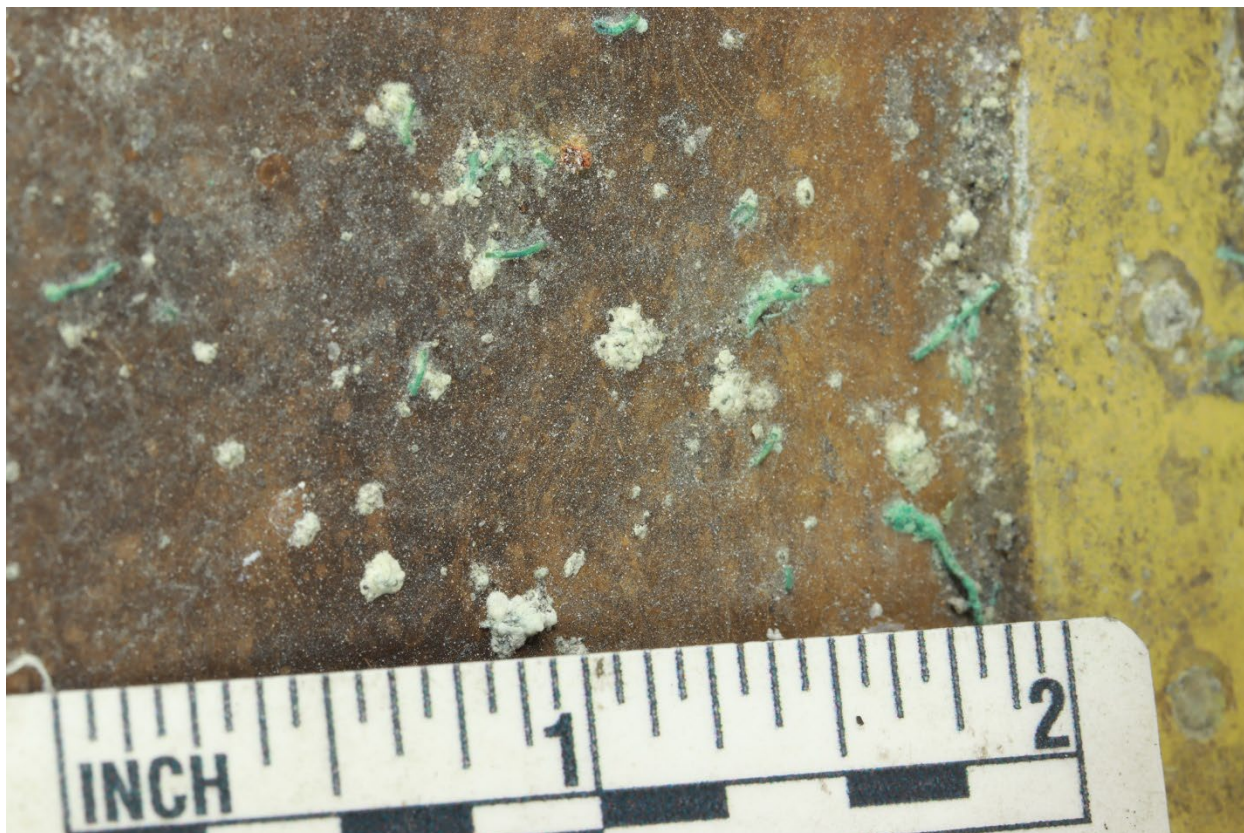
**Figure 9.** Green debris adhering to the aft-facing surface of the right-side portion of the fuselage fuel tank aft bulkhead.

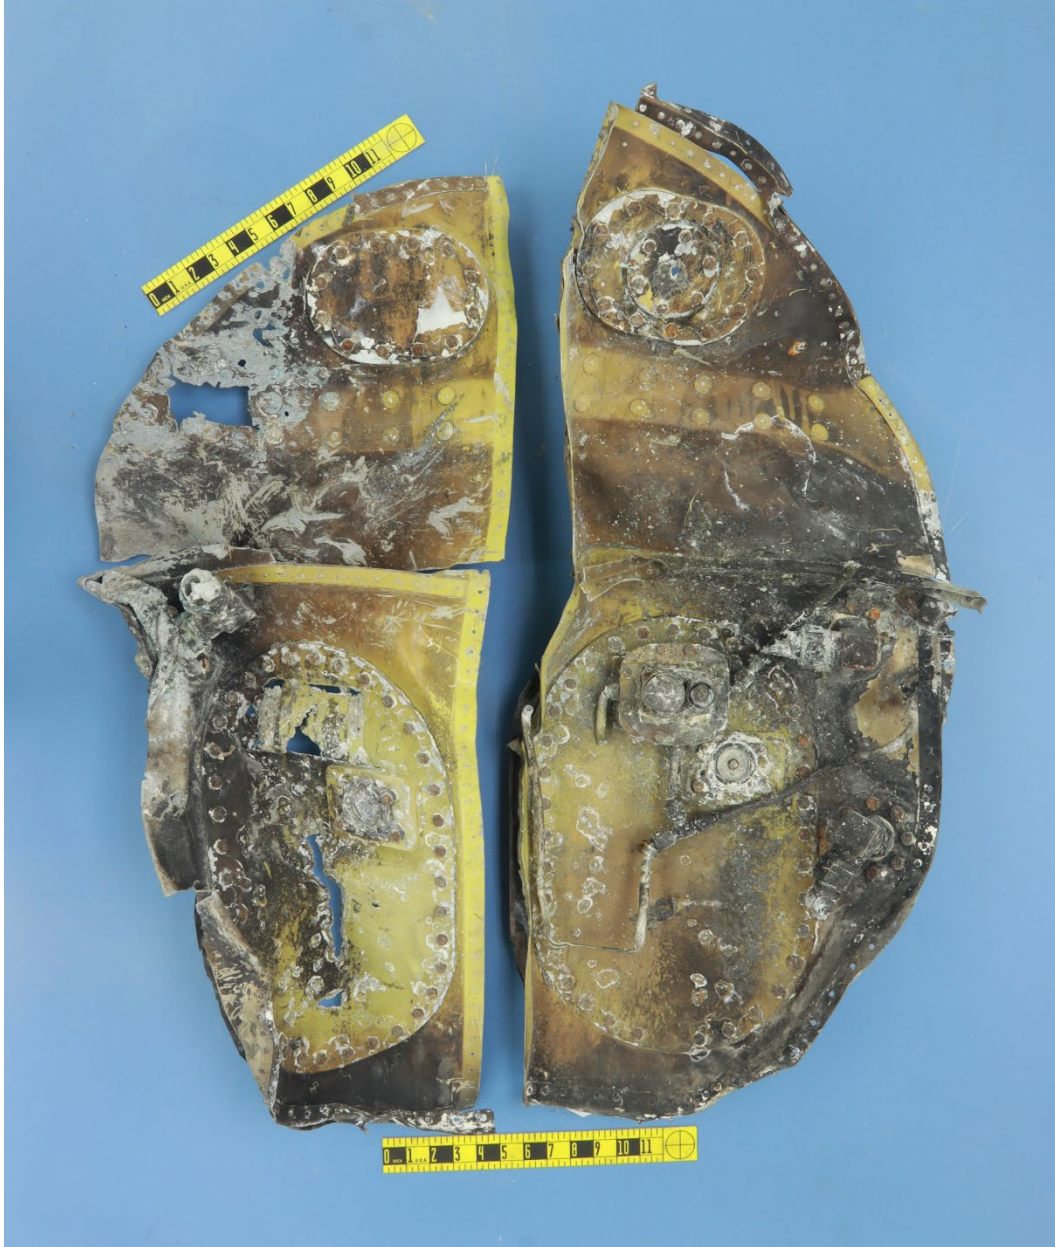
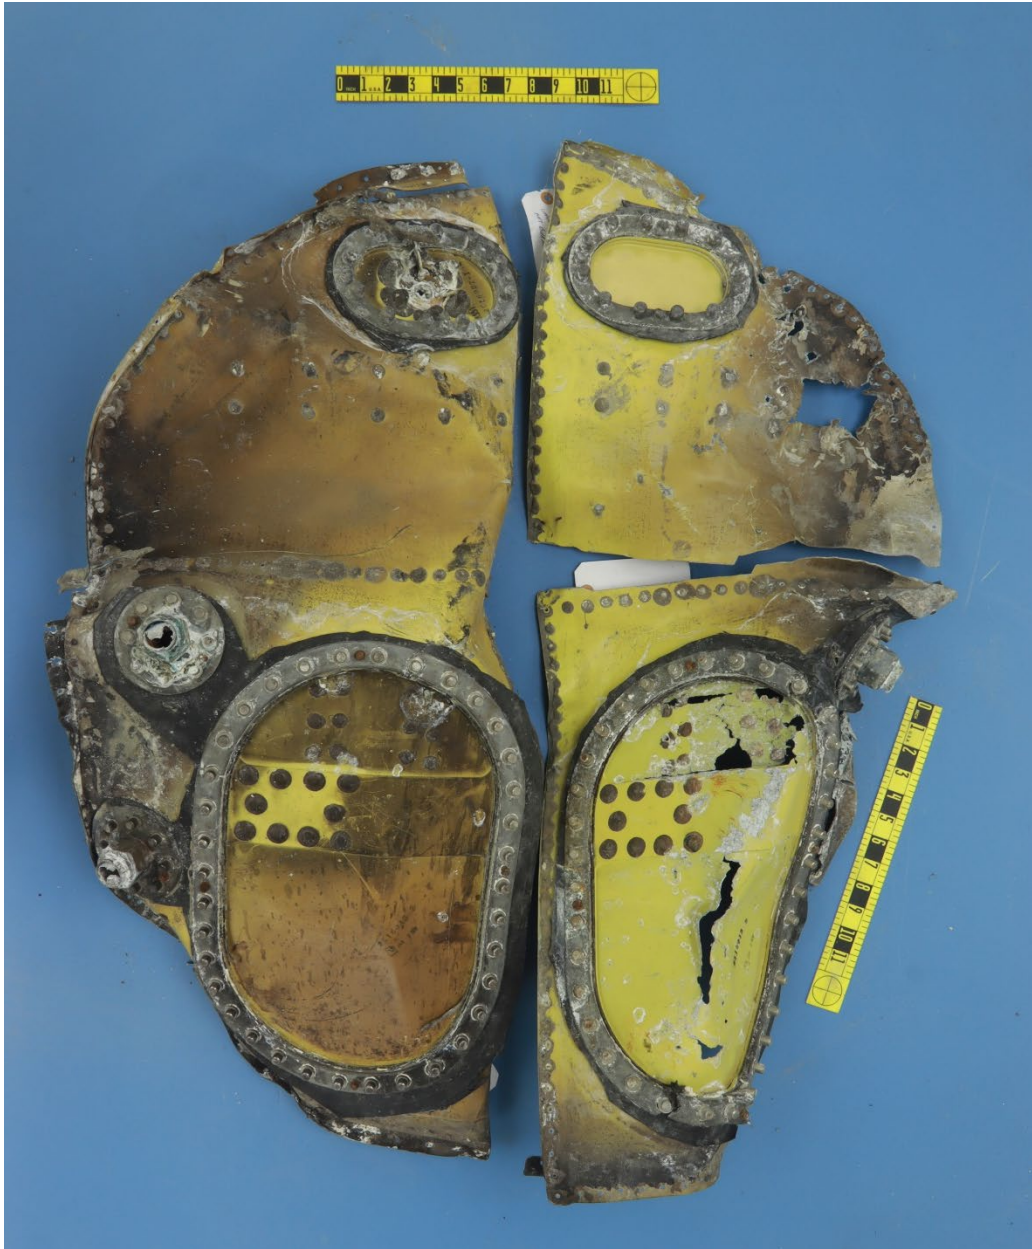
in its entirety (Figures 10, 11). This overall view revealed that on the aft-facing side the bulkhead exhibited a focused region of thermal damage extending from the 7 o'clock to the 10 o'clock position along the outboard edge of the bulkhead. While the rest of this aft facing side exhibited thermal damage that was more diffuse and less severe. The forward-facing side of the bulkhead (now with the rubble bladder removed) exhibited overall more thermal discoloration on the right-side half than on the left side with the exception of the focused region of thermal damage on the left side.

**Figure 10.** Aft-facing side of the fuselage fuel tank aft bulkhead.

**Figure 11.** Forward-facing side of the fuselage fuel tank aft bulkhead with the rubber fuel tank liner removed.

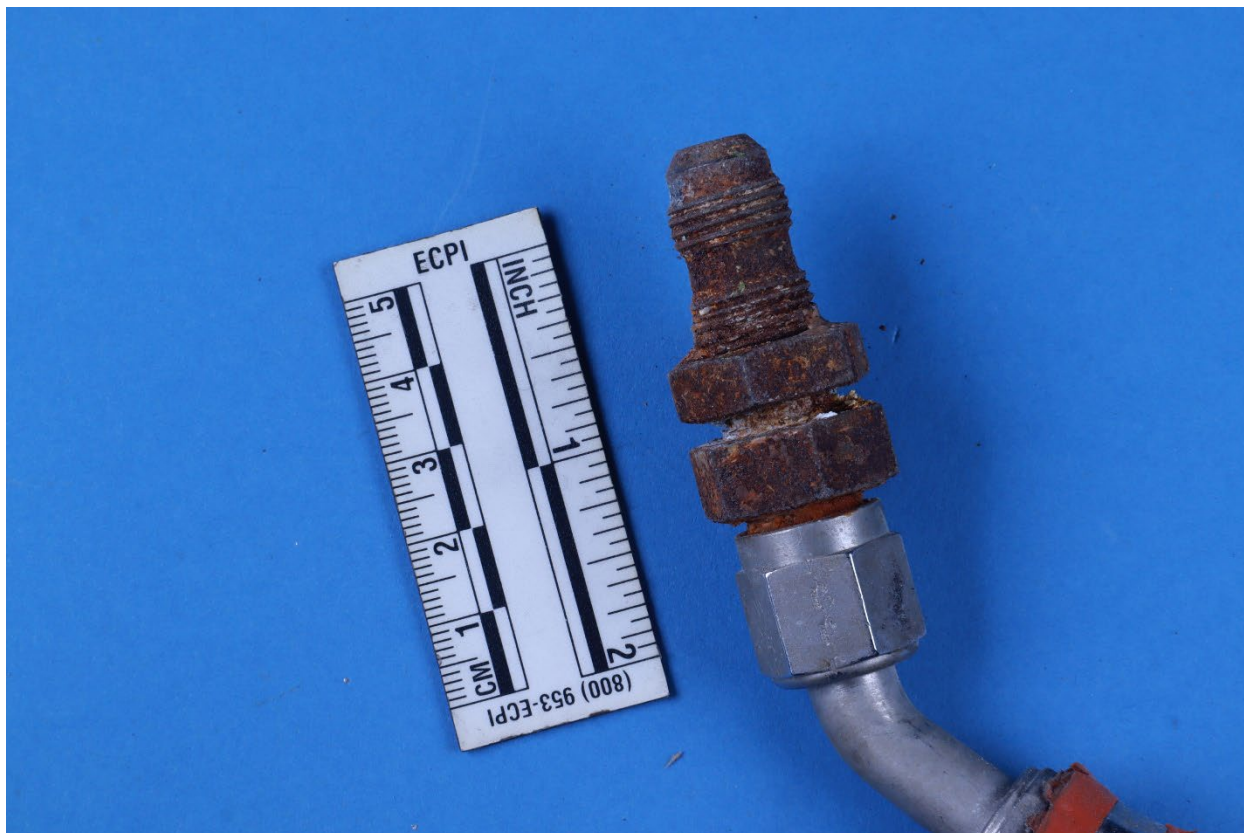
The motive flow fuel fitting (Figure 12) and the hydraulic fluid return fitting (Figure 13) were bulkhead type fittings that penetrated the fuselage near the aft left engine mount. These fittings were made out of steel and were located a couple inches from each other. Both of the fittings exhibited red rust colored corrosion. On the outboard side, both of these fittings had stainless steel nuts attached and tubing with fire resistant sleeves (Figure 2). No thermal damage was observed on the outboard nuts and attached portions of tubing. On the inboard side, the motive flow fuel fitting was missing the nut and tubing. The missing nut and tubing on the inboard side would have been made out of aluminum. Examination of the threads on the inboard side of the motive flow fuel fitting using a stereo microscope did not reveal evidence of thread stripping. On the inboard side, the hydraulic fluid return fitting still had the nut attached but was missing the tubing. The nut and tubing for this fitting were also constructed of aluminum. After removal of the nut, examination of the threads did not reveal any anomalies. Comparison between the two fittings (motive flow fuel, hydraulic fluid return) did not reveal any physical differences to explain why one remained with the nut attached and the other did not (Figure 14).

**Figure 12.** Motive flow fuel line bulkhead fitting.

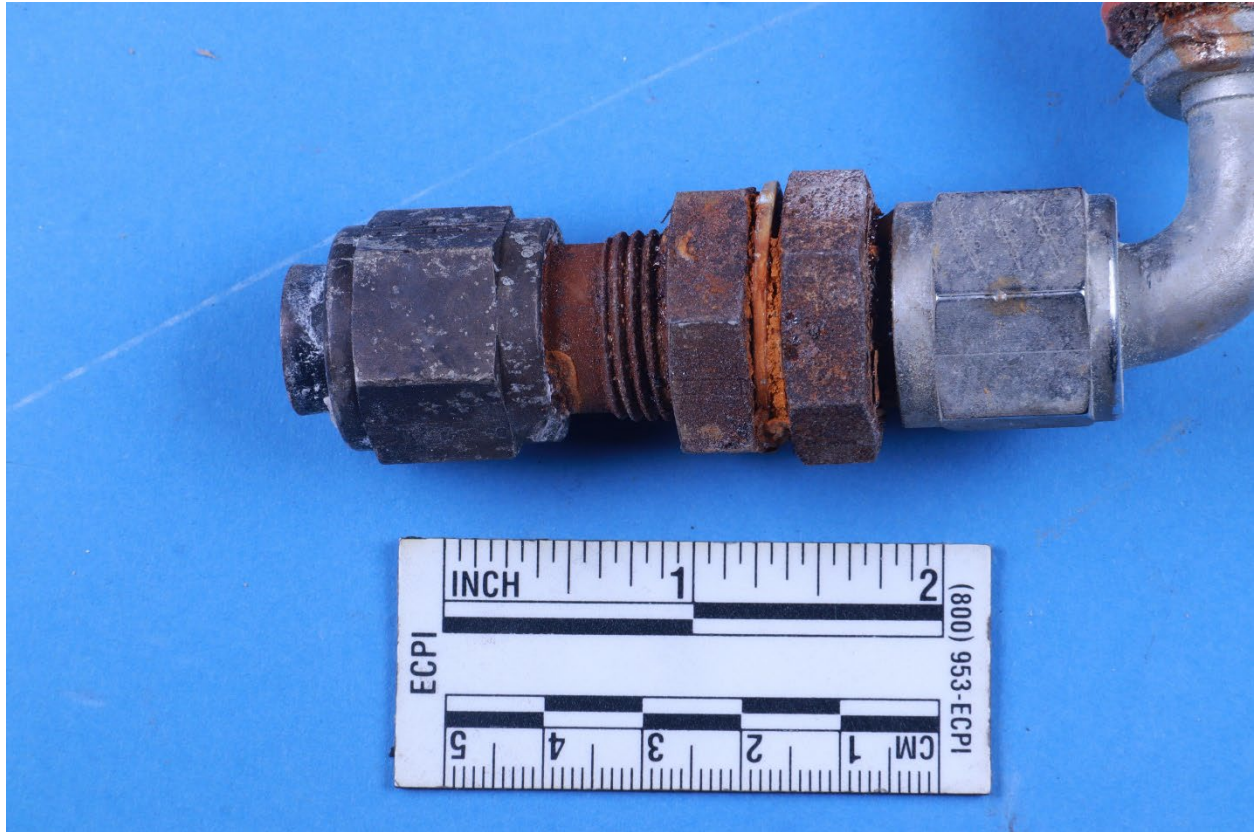
**Figure 13.** Hydraulic fluid return line bulkhead fitting.

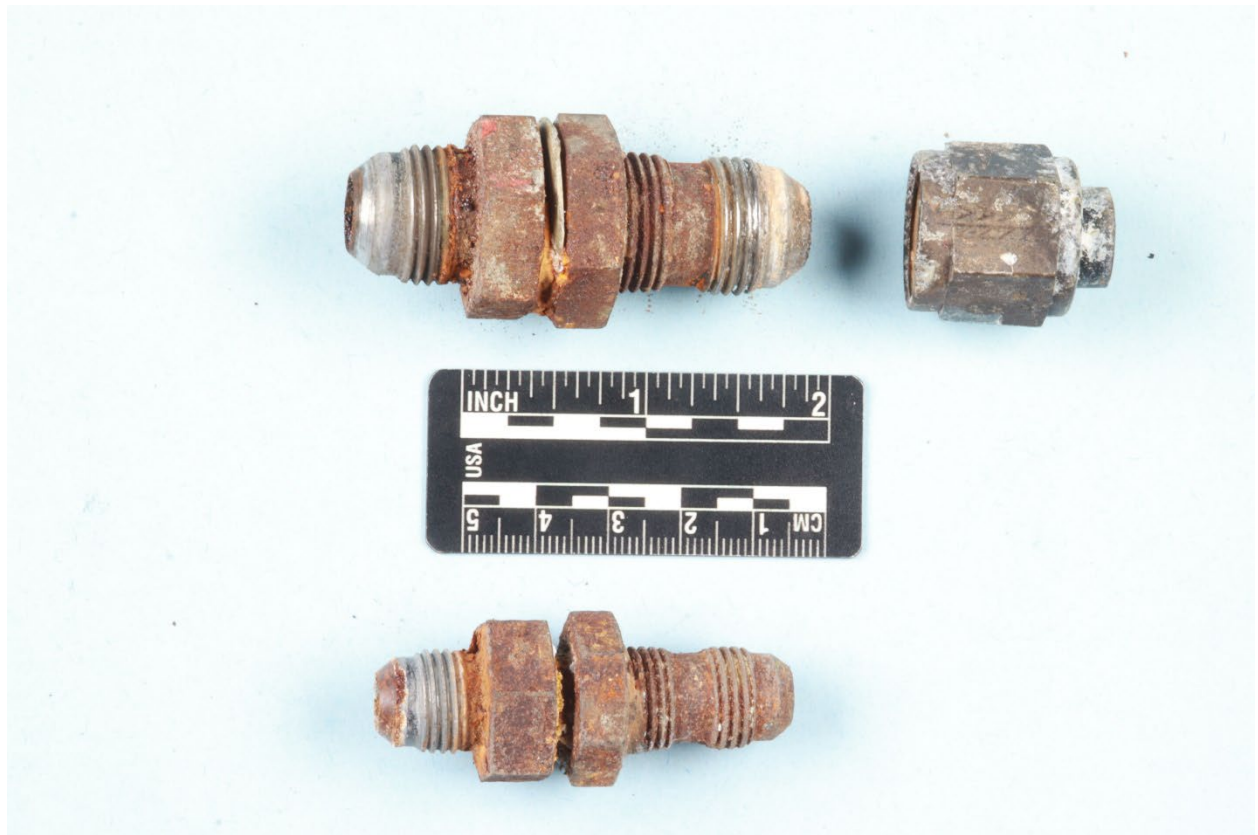
**Figure 14.** Hydraulic fluid return (top) and motion flow fuel fitting (Bottom).
