# National Transportation Safety Board

WPR23FA185

## **AIRWORTHINESS**

Group Chairman's Factual Report

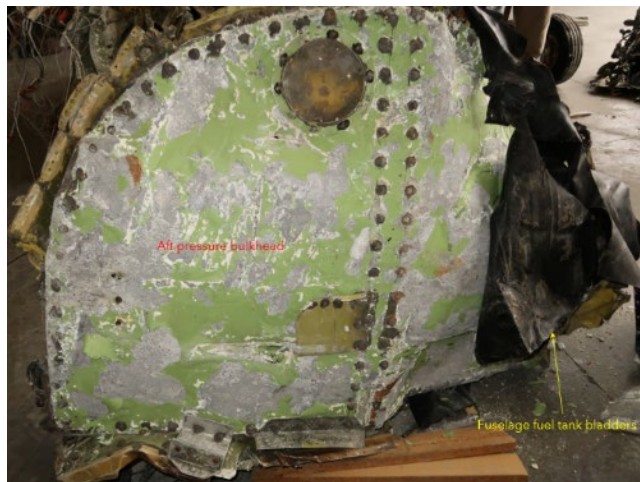
**Figure 4.** Aft pressure bulkhead.

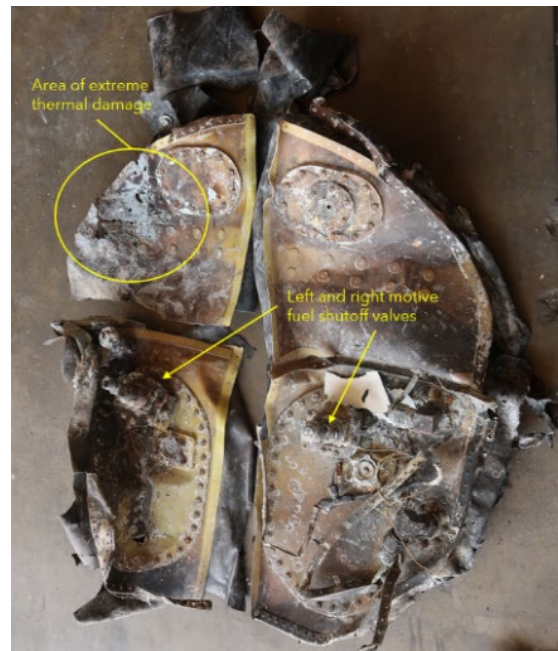
**Figure 5.** Fuselage fuel tank aft bulkhead.

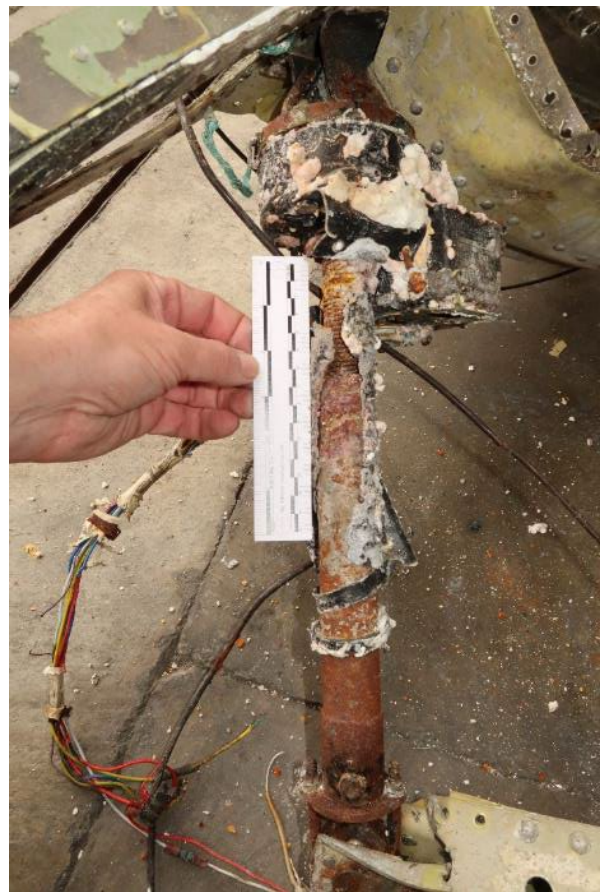
<sup>7</sup> Bombardier 5/14/2024 email to the NTSB: "The screw attaches to the stab forward of the pivot point, so when it's fully extended, the stab is leading edge full up, which would be full nose down trim."

**Figure 8.** Elevator trim jack screw.

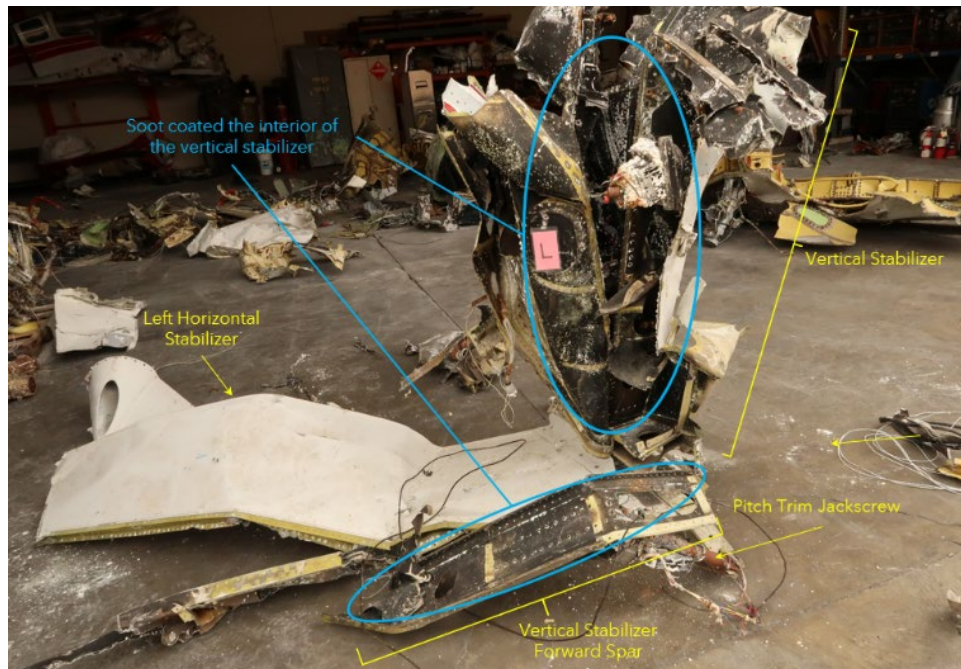
The aft equipment bay (tailcone) right side fuselage structure had heat/fire damage, the left side of the equipment bay was not present, and the entire fuselage structure aft of the avionics bay was not present. The aft half of the right-side engine mount fairing remained attached to fuselage skin. A 6-foot vertical center section of the vertical stabilizer was present, the left horizontal stabilizer remained partially attached to the vertical stabilizer, the right horizontal stabilizer and both elevators were missing (Figure 7). The horizontal stabilizer trim jack screw was attached to the vertical stabilizer structure and the leading edge portion of the horizontal stabilizer. The trim jack screw was extended centimeters (2.76 inches) measured from the end of the cylinder to the center of the screw rod end eye (Figure 8). The measurement is consistent with full nose down trim<sup>7</sup>. The interior of the vertical stabilizer was coated in black soot (Figure 9).

**Figure 9.** Airplane wreckage tail section (upside down).

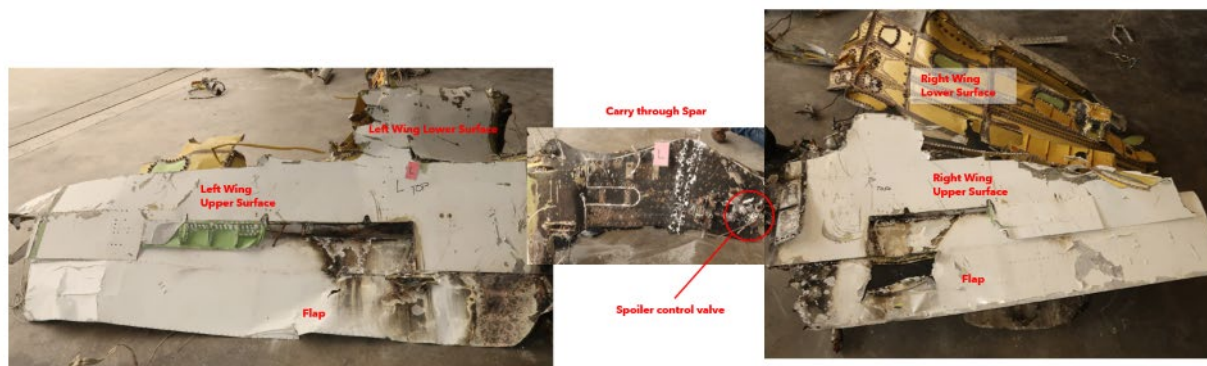
Both left and right wings sections from the wing root to the outboard end of each flap, and the wing spar carry-through were examined. Both wing structures outboard of the flaps were not present. Both flaps were retracted into the wing flap channel and appeared to have been in the retracted position at the time of wing fragmentation. Soot and thermal heat damage was observed on the inboard root sections of both wings and on the wing spar carry-through. Thermal heat damage and soot deposition existed on the inboard half of each wing flap. Thermal heat damage and extensive soot deposition was evident on the keel beam section and the inboard landing gear doors (Figure 10).

**Figure 10.** Composite image of both wing sections joined by the wing spar carry through.

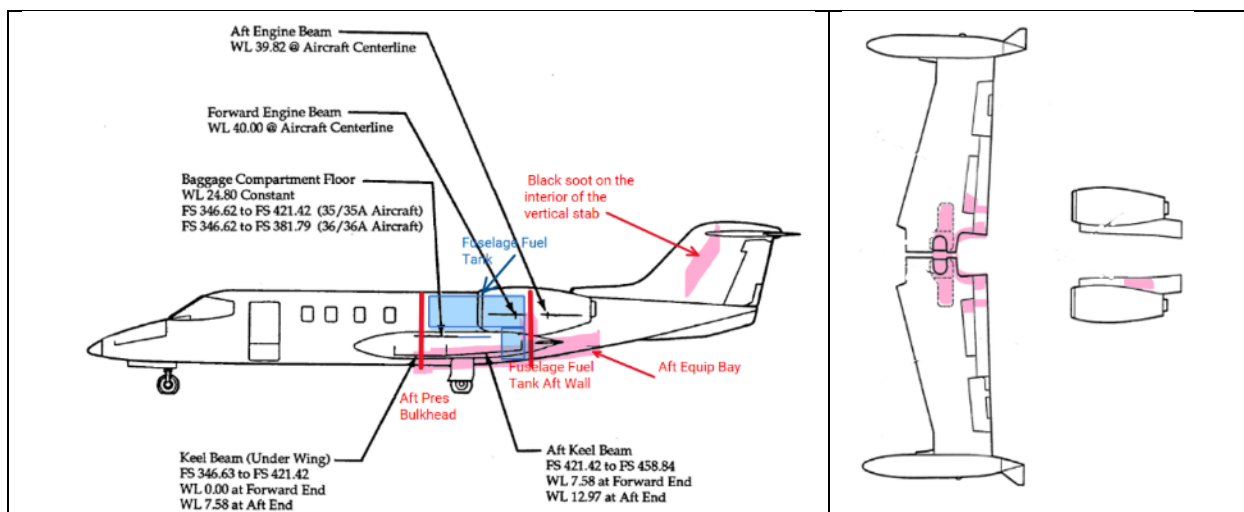
Fire and heat damage was concentrated in the vicinity of the aft equipment bay (tailcone), aft portion of the fuselage fuel tank, both wheel well areas and the inboard section of both flaps (Figure 11).

**Figure 11.** Diagram showing areas of fire/heat damage. (Diagram source: Learjet 20/30 Series Structural Repair Manual)

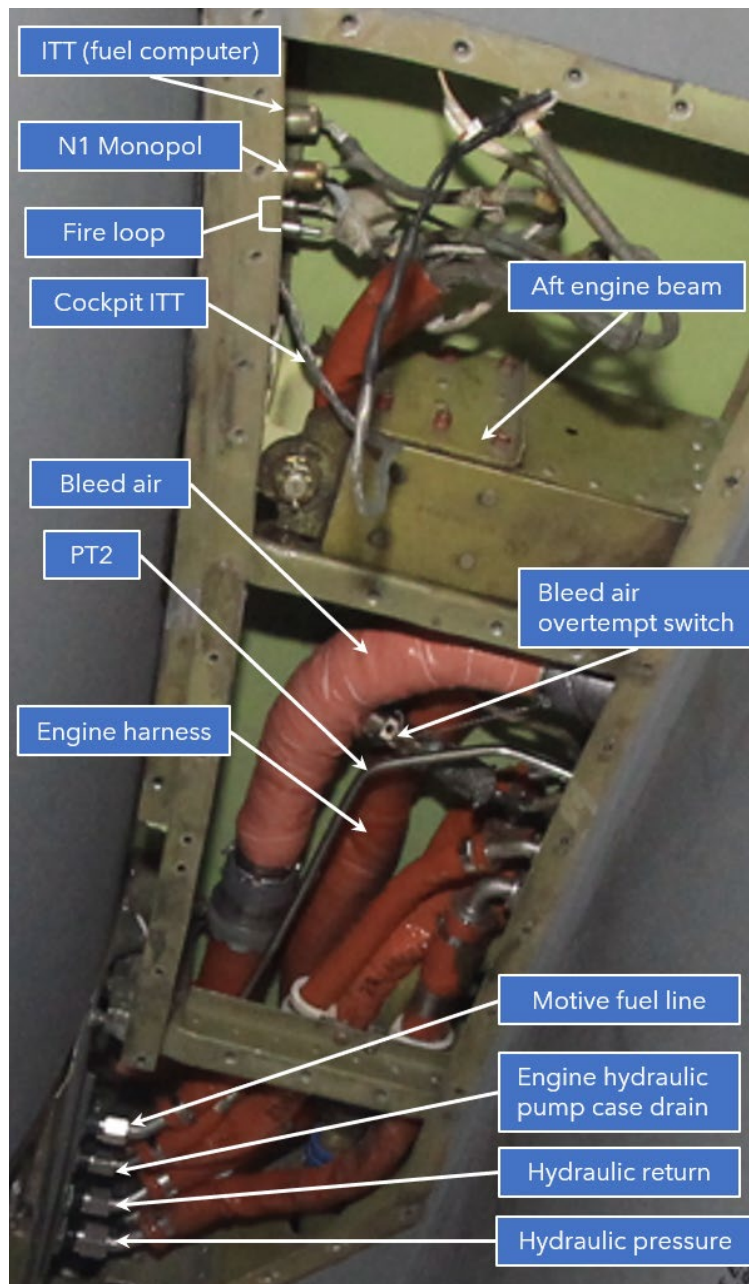
**Figure 13.** Left pylon engine service connections.

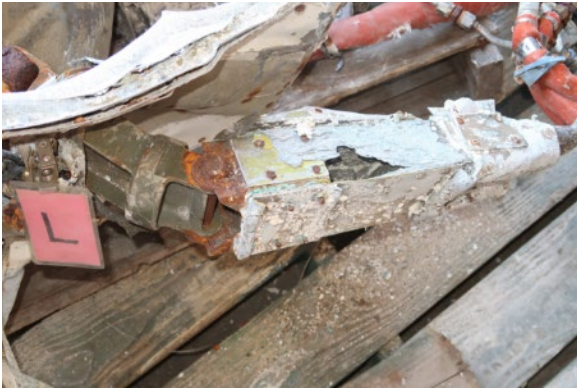
Examination of the left and right rear engine beams showed an asymmetric material condition between the two. The left engine beam exhibited beam deformation, extreme thinning of the upper beam plate, moderate thinning of the forward plate, and unpainted surfaces with corrosive deposits (Figure 14). The thinning of the left engine beam plates presented an eroded appearance with similar characteristics as to what was observed on the upper left portion of the fuselage fuel tank aft bulkhead.

**Figure 14.** Left rear engine mount beam.

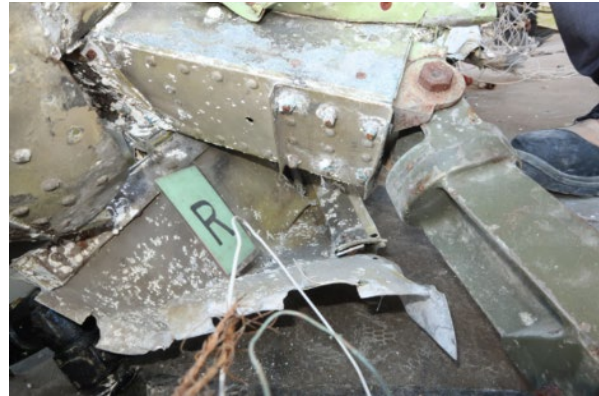
The right engine beam retained its box structure, paint was present on all beam surfaces with minor amounts of corrosive deposits (Figure 15)

**Figure 15.** Right rear engine mount beam.

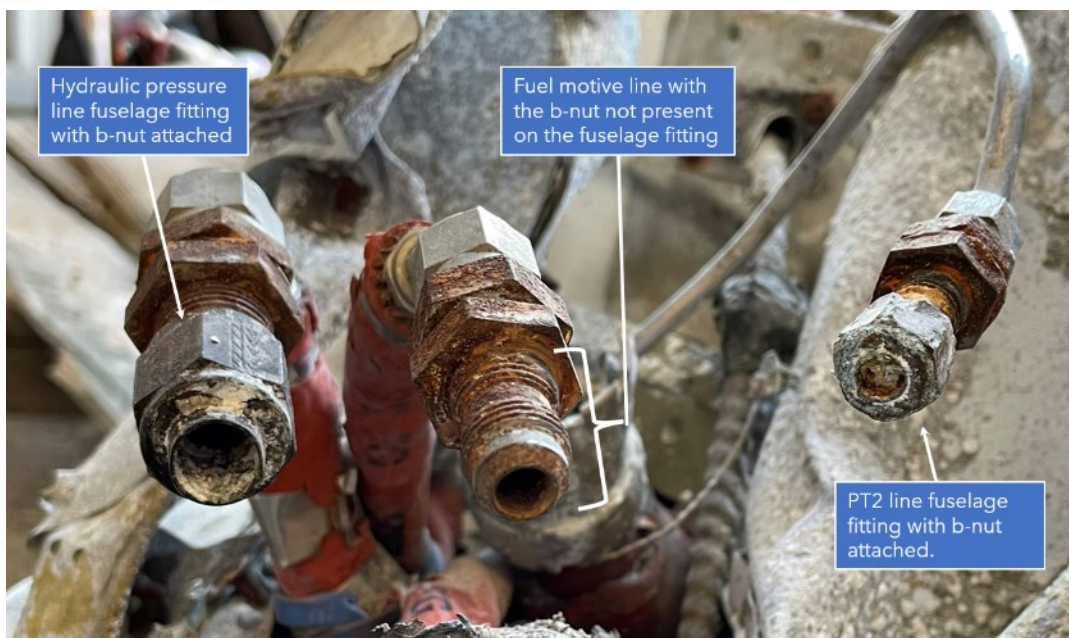
The fuel motive flow line was traced from the engine fuel pump to the fuselage fitting. The line enters the aircraft fuselage in the upper left quadrant of the aft equipment bay (tailcone). The fuel line was intact and covered with fire protective sleeve up to the fuselage skin and attached to the fuselage fitting. The fuselage fitting on the aft equipment bay (tailcone) side did not have a b-nut attached nor the line that should extend to the motive flow valve (Figure 16).

**Figure 16.** Left engine service connections and fuselage fittings.

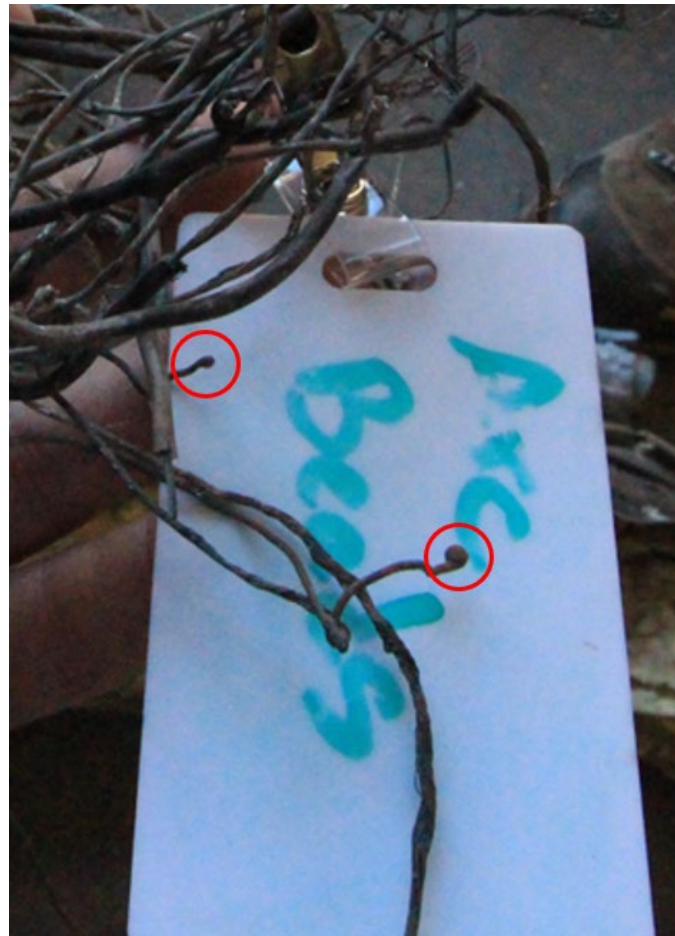
Engine wire circuitry associated with the left engine pylon was found to have a few wires that exhibited beads of resolidified molten copper. No such beads were found on other wiring (Figure 17).

**Figure 17.** Resolidified molten copper beads circled in red.

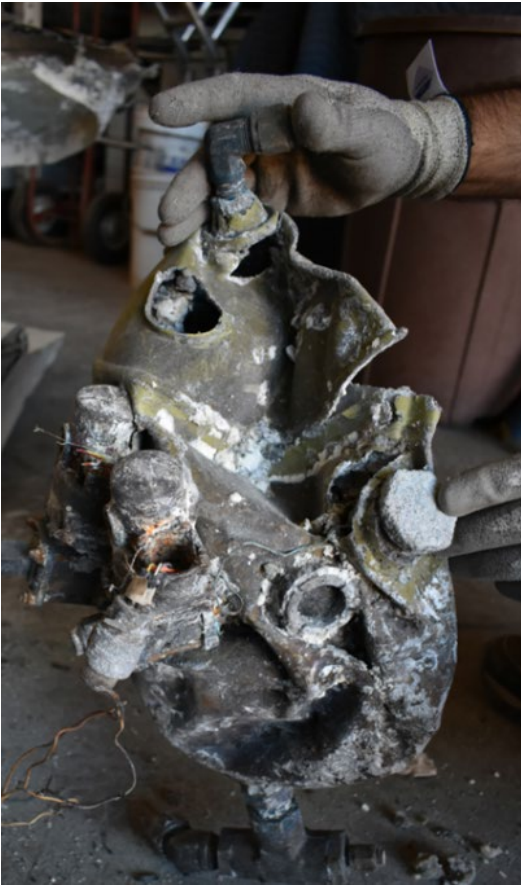
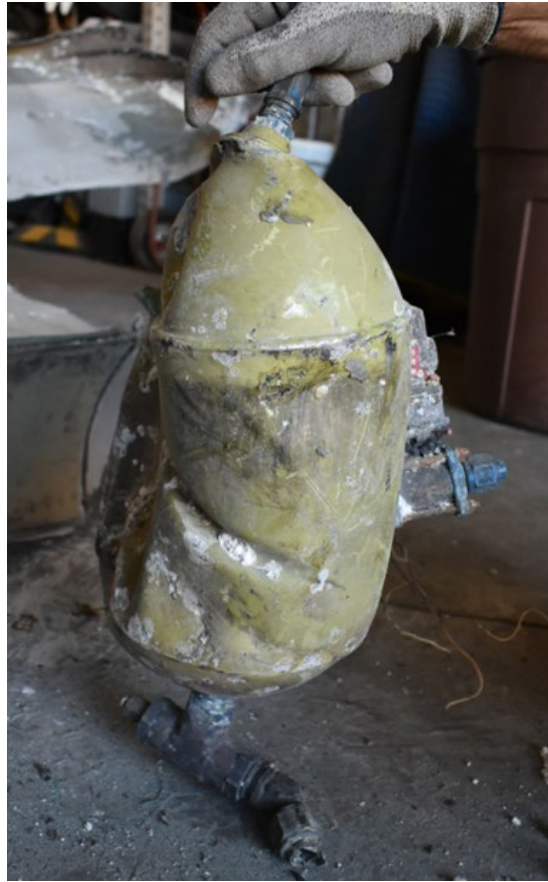
The main hydraulic system components were examined. The components consisted of the hydraulic reservoir, accumulator, pressure filter, return filter, and auxiliary hydraulic pump (Figure 21). Both the pressure filter and return filter elements were disassembled and examined for metallic particles. Both filters were clear of debris when examined visually. The input ports of both left and right hydraulic shut off valves that were attached to the hydraulic reservoir were probed and found that the left valve was in the closed position and the right valve was in the open position. The reservoir tank was deformed inwards (crushed). The quadrant of the tank that faced inward to the equipment bay compartment exhibited substantial heat damage, while the half that was up against the fuselage and the quadrant that faced aft was undamaged by heat (Figures 19 and 20).

**Figure 19.** Hydraulic reservoir, inward facing quadrant.

**Figure 20.** Hydraulic reservoir outboard and aft facing quadrants.

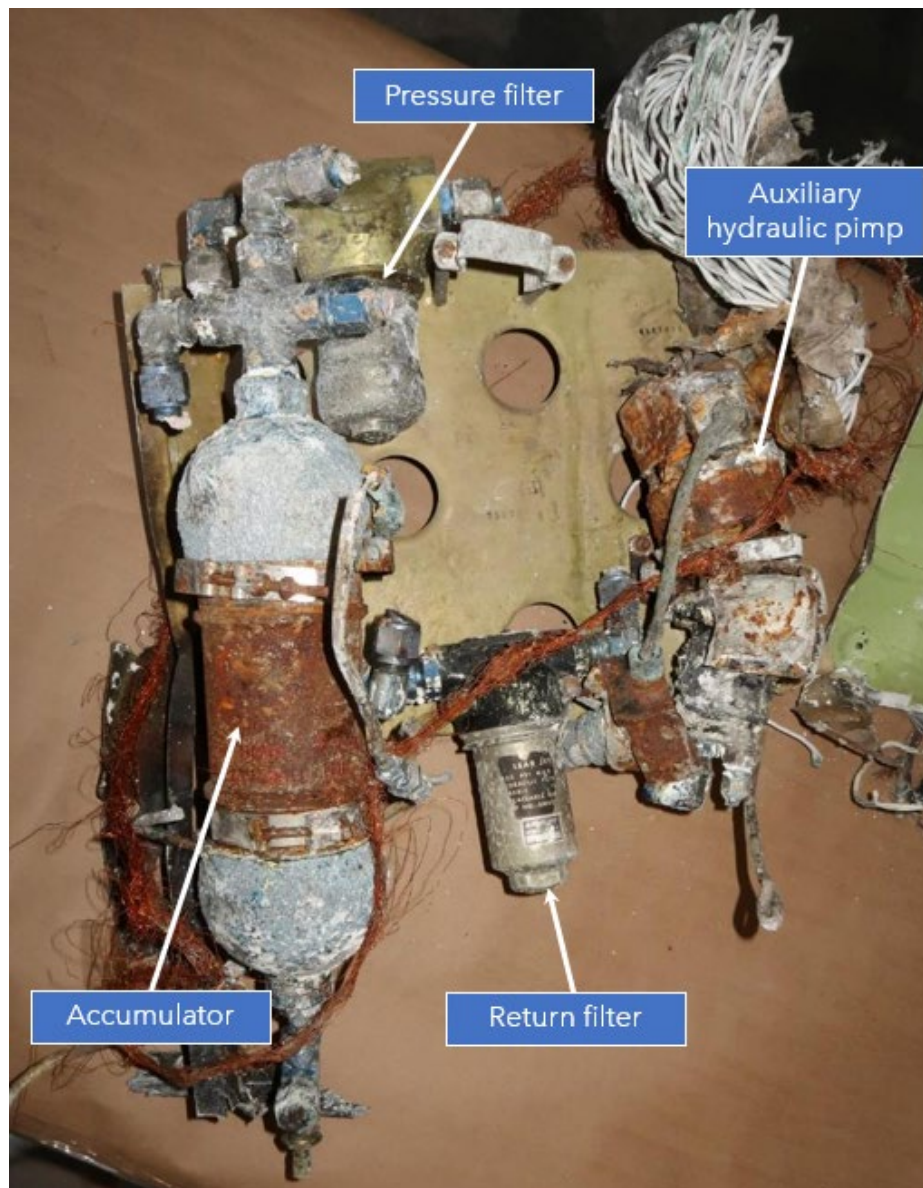
**Figure 21.** Hydraulic system accumulator, pressure filter, return filter, and auxiliary hydraulic pump.

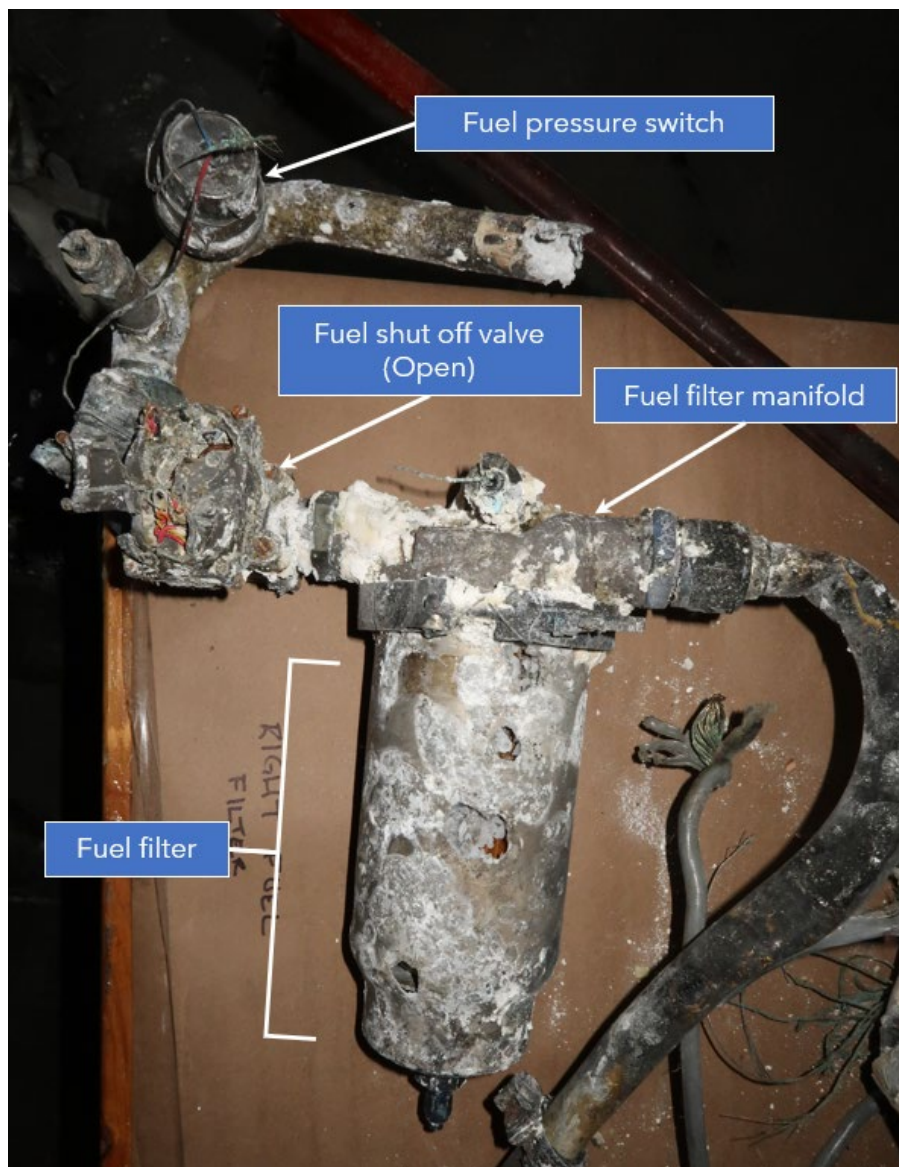
The right-side fuel filter (Figure 24) with attached fuel lines was recovered with the wreckage, the input fuel line was sooted. The soot stopped at the connection to the fuel filter manifold. The fuel shutoff valve on the other side of the filter was impact damaged but did not appear to have heat or soot damage, and the valve was in the open position. The left side fuel filter and shutoff valve were not found.

**Figure 24.** Right side fuel filter and shutoff valve.

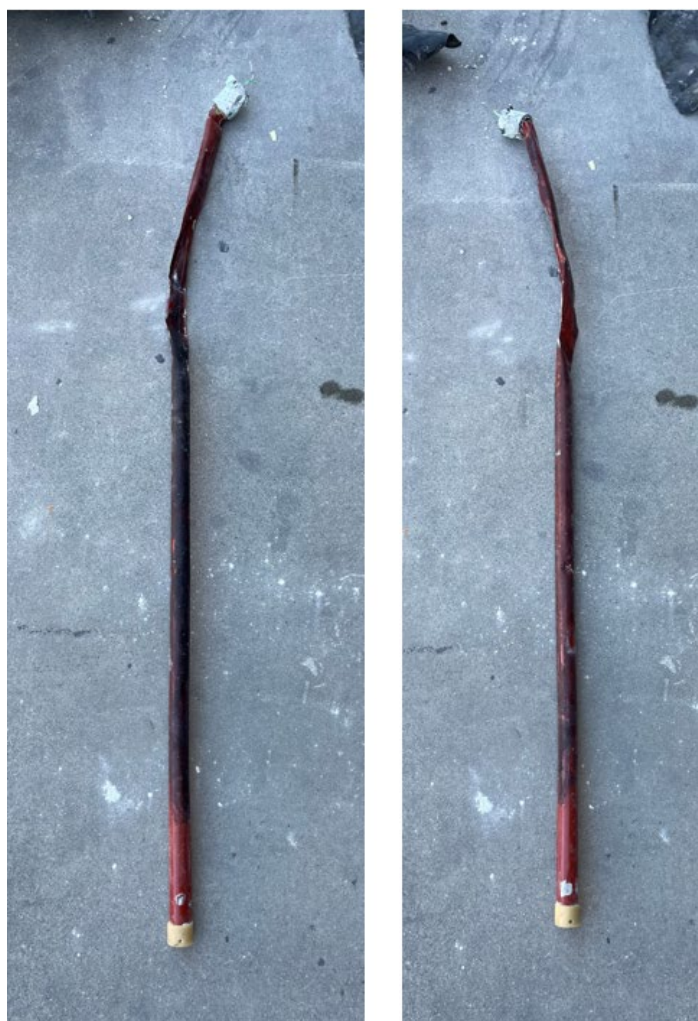
The fuselage fuel tank fuel quantity indicator tube was found to have soot deposits on it (Figure 25).

**Figure 25.** View of both sides of the fuselage fuel tank fuel quantity indicator tube.

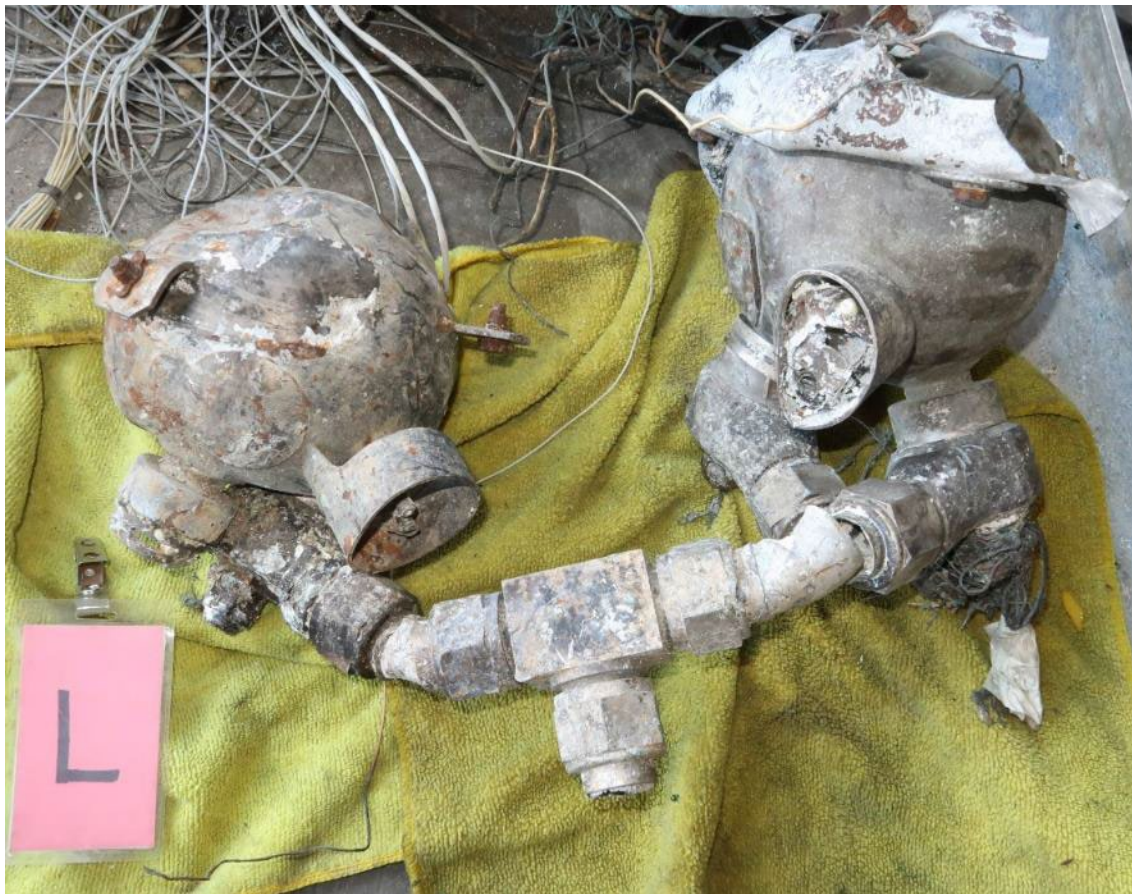
**Figure 31.** Fire extinguishing bottles.

Both extinguishing agent bottles (Figure 31) were located within the wreckage. Both bottles were empty of contents, the pressure gages were damaged and unreadable, and both had some extent of mechanical deformation (crushing). When comparing the two bottles the left bottle appeared to have more extensive heat damage than the right bottle. Other components of the extinguishing system were not located or identified.

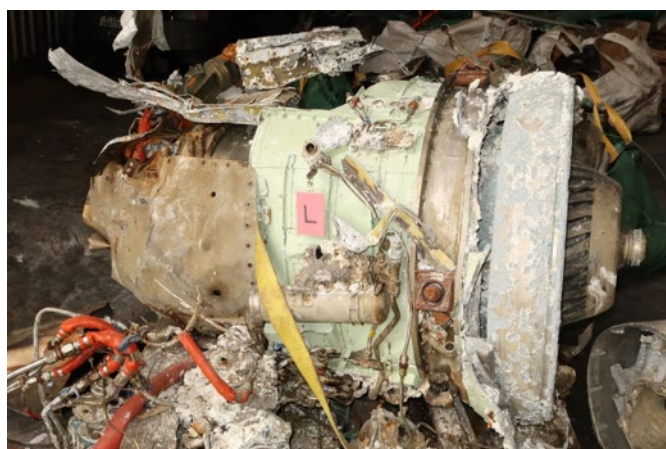
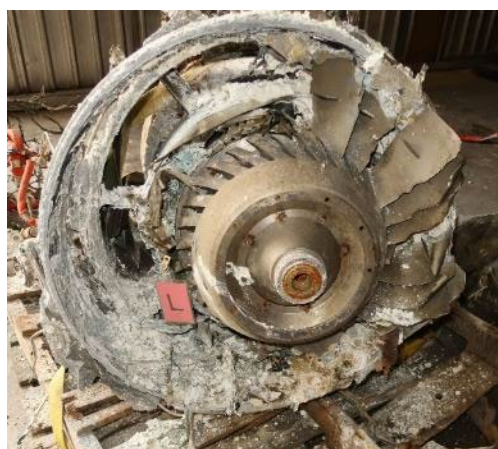
**Figure 32.** Left engine side view

**Figure 33.** Left engine front view.

No evidence of fire damage was found. Several fan blades had separated at the blade root, while others had shifted aft in the fan disk. At least half of the fan blades were missing, and those present were bent in the opposite direction of rotation, with damage visible on the leading edges. Multiple slots in the fan disk were also damaged. The spinner and bypass vanes were missing. The compressor inlet vanes were damaged, with some sections entirely missing.

A borescope inspection of the first-stage compressor revealed leading-edge damage and bending of the blades opposite to the direction of rotation, along with the presence of earthen debris. The containment ring was deformed and detached from the front frame, no punctures or penetrations were identified. The front frame itself was fractured, with most of its material missing, and it had separated from the mount ring. The mount ring was deformed, with a 45°- arc separated from its flanges.

The bypass duct was severed aft of the forward flange, with half of its circumference missing. The air/oil cooler was intact and appeared undamaged, though covered in earthen debris. The aircraft engine mount points had separated from the aircraft mount structure and showed signs of corrosion. Portions of the aircraft mount structure, including a section of the engine beam, were detached from the engine but loosely connected by cables.

The airframe exhaust was crushed and deformed. During the wreckage examination, it was partially removed and cut to allow observation of the third-stage turbine and a section of the fuel manifold. The fuel manifold appeared intact and undamaged in the visible areas, though the fuel nozzles showed signs of corrosion. The third-stage low-pressure turbine (LPT) stator and rotor were intact and undamaged, though earthen debris was present. The turbine could not be manually rotated. The turbine housing remained intact but showed evidence of corrosion.

The accessory gearbox was not present. The fuel control and fuel pump remained assembled as a unit. The accessory housings were cracked and covered in earthen debris.

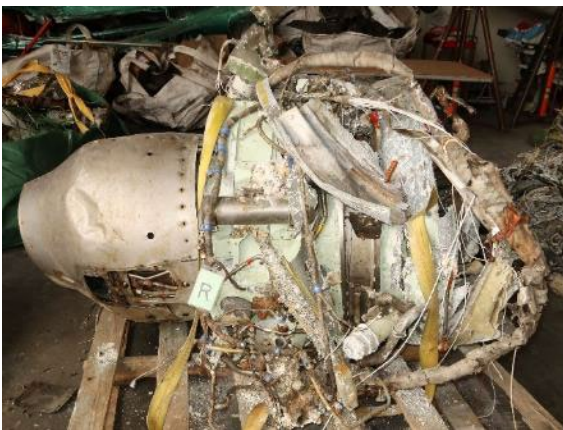
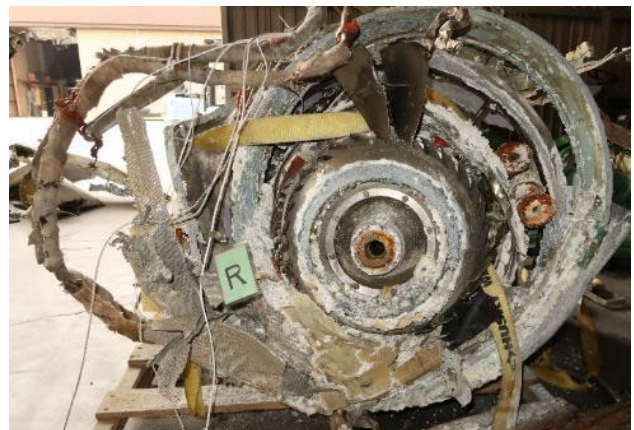
**Figure 34.** Right engine side view.

**Figure 35.** Right engine front view.

Two fan blades remained installed but were bent in the opposite direction of rotation and showed leading-edge damage. Several fan blades had separated at the blade root, and most were missing. Some fan blade dovetails had shifted aft in the disk, and multiple fan disk slots were damaged. The spinner had separated

The compressor inlet vanes were crushed and deformed, with about 180° arc absent. Debris was present in the compressor. A borescope inspection of the first-stage compressor revealed the blades were damaged, with leading-edge wear and bending opposite the direction of rotation. Earthen debris was also observed. The containment ring was deformed and detached from the front frame, which was fractured, with most of its material missing.

The bypass duct had a circumferential crack over about 180°, just aft of the forward flange, and material was missing over approximately 120° near the aft flange. The aft flange itself was separated. The air/oil cooler was intact and appeared undamaged, though it was covered in earthen debris.

The aircraft engine mount points had separated from the aircraft mount structure and showed signs of corrosion. The mount structure remained attached to the fuselage. The airframe exhaust was crushed and deformed. During the wreckage review, it was partially removed and cut to facilitate observation of the third-stage turbine and a section of the fuel manifold. The fuel manifold appeared intact and undamaged in the visible portions, though the fuel nozzles showed signs of corrosion.

The third-stage LPT stator and rotor were intact and appeared undamaged, though earthen debris was present. The turbine could not be rotated manually, but the turbine housing remained intact. The bleed duct was crushed. The accessory gearbox was missing. However, the fuel control and fuel pump were still assembled and located in the aft fuselage section.
