**Summary of Download and Analysis of  
One N1 Digital Electronic Engine  
Control from  
San Clemente, CA  
Learjet 36A Accident Aircraft  
Registration N56PA**

Phoenix Air Group Inc, Learjet 36A, N56PA  
San Clemente CA, May 10, 2023  
1-5120 Seconds of Data

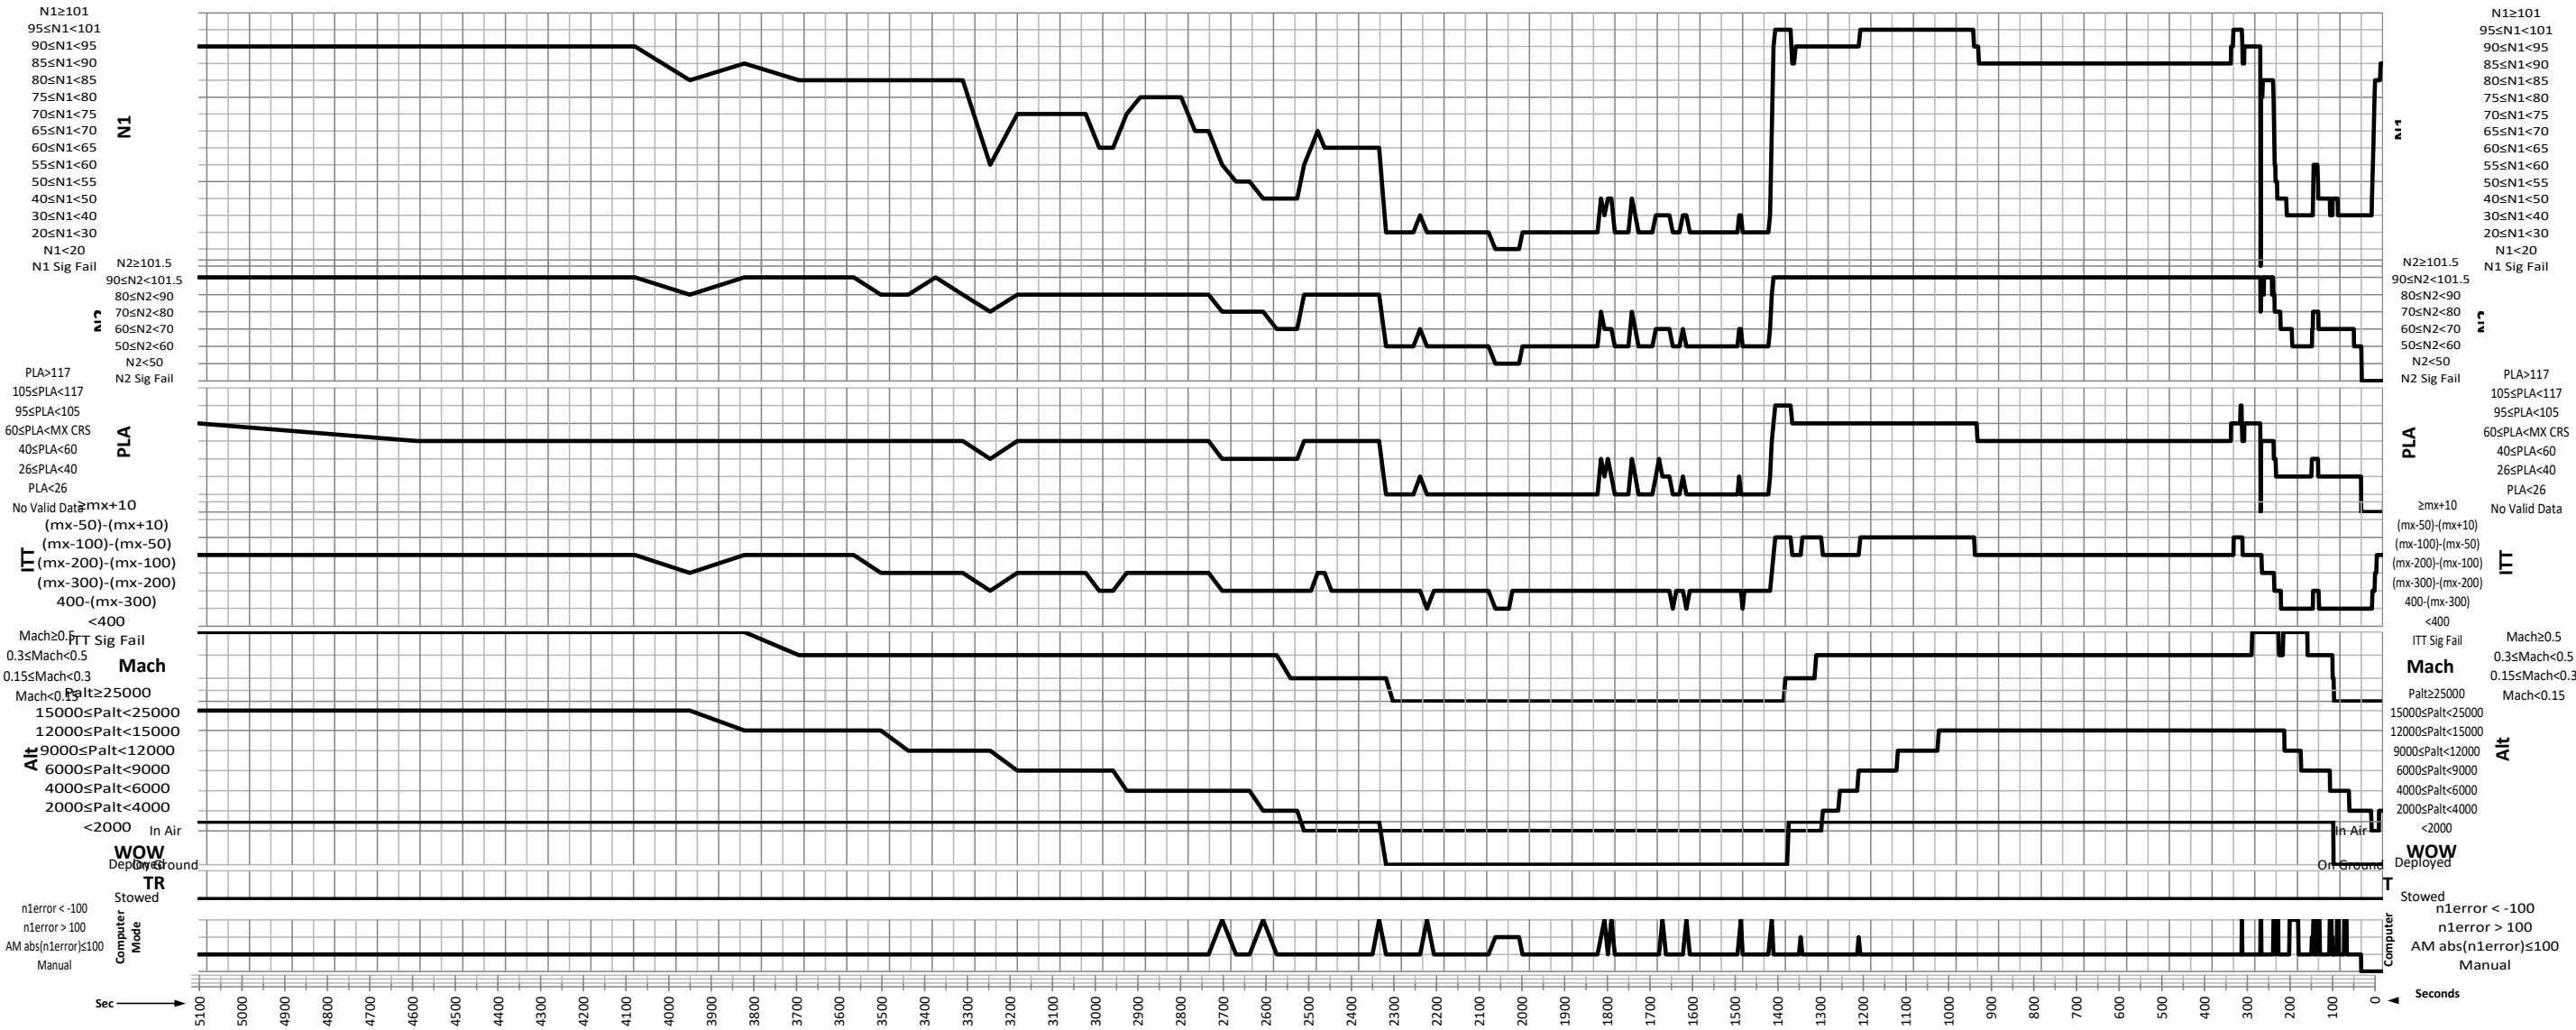
- Throughout the accident flight, until the FCU PLA Circuit Failure Fault (at approximately time stamp<sup>2</sup> 50 seconds), the engine appears to be operating and correctly responding to Power Lever (PLA) movements.
- At time stamp 50 seconds through the remainder of the dataset, the N2 and PLA parameters indicate N2 Signal Fail and No Valid Data,

respectively. This coincides with faults indicating a failure of the FCU PLA circuit and the N2 Monopole Circuit being open or shorted.

- The recorded ITT datapoints are consistent with the expected ITT values for the recorded N1 speeds. The PLA and N2 data are consistent with the expected values for the recorded N1 speeds up until the final twenty seconds of data, consistent with the introduction of circuit faults.

- The DEEC records data when the engine is operating, which is defined as when N2 exceeds a minimum threshold and ITT exceeds a specified value. The DEEC continues to record data as long as power is applied. The recording will end when power to the DEEC is removed or when WOW = 1 (on ground), engine shutdown has occurred, and five minutes has elapsed. As the data does not capture an N1 decrease consistent with engine shutdown, it is unknown if the end of the dataset corresponds with loss of DEEC power prior to or corresponding to aircraft impact.
