# National Transportation Safety Board

WPR23FA188

## **AIRFRAME AND ENGINE EXAMINATION REPORT**

Location: Albany, Wyoming  
Date: May 14, 2023  
Time: 1135 Mountain daylight time  
Airplane: N665B, Cessna T182T

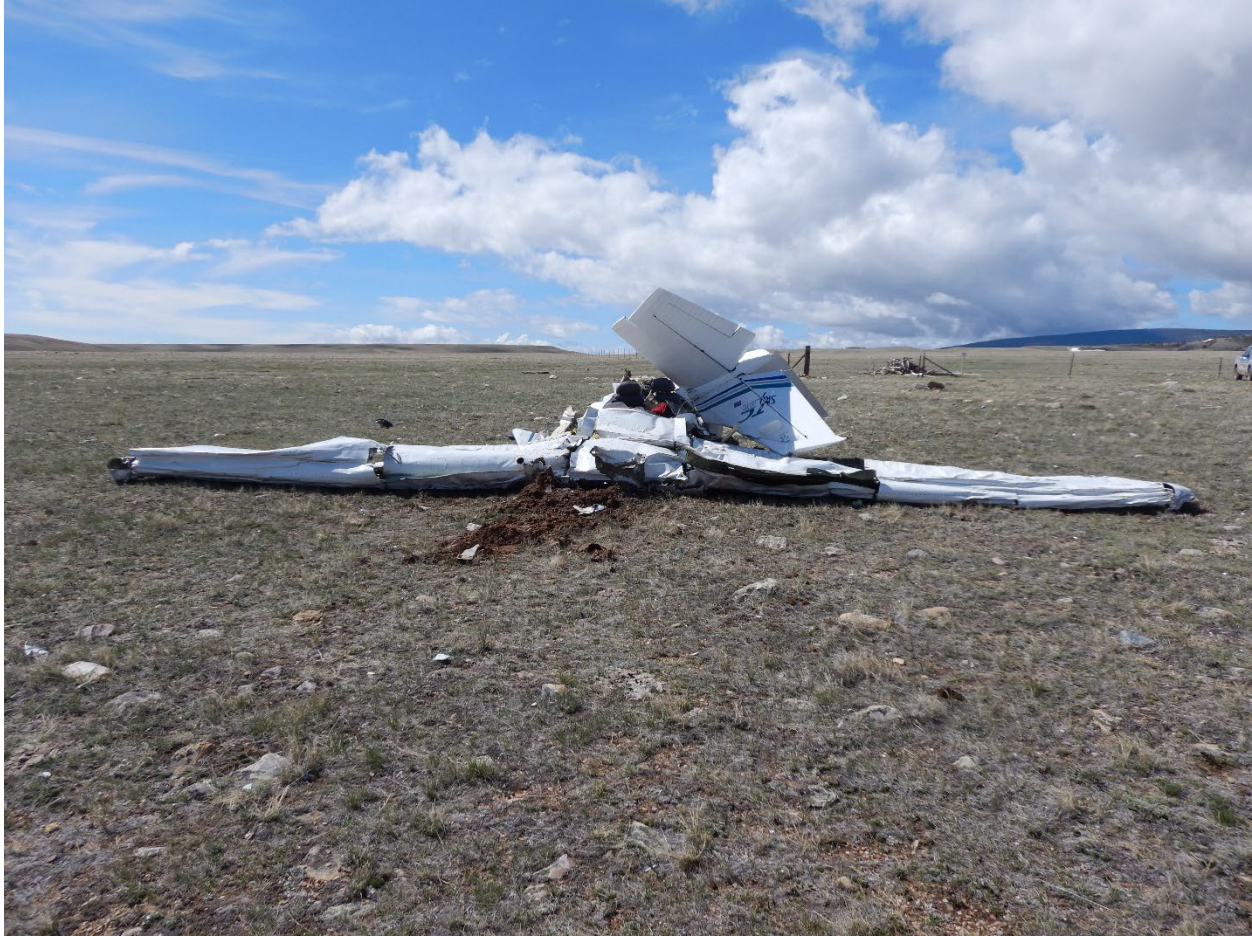
All four corners of the airplane remained attached to the fuselage at the accident site. The fuselage exhibited substantial crushing, and deformation throughout. The nose structure and engine were crushed aft into the cockpit instrument panel. The cockpit bottom skin structure was crushed aft to the landing gear bulkhead assembly. The top cockpit and cabin/baggage skin structure shifted forward where the rear cabin window was in the cockpit. Part of the tail section was displaced forward and canted to the left tearing and opening the tail bottom skin structure from about F.S. 172.00 to F.S. 199.00. The tail cone remained attached to tail section. The empennage remained attached to the tail section. Both cabin doors and the baggage door exhibited aft crushing.

Figure 1.N665B front view. while at the accident site front.

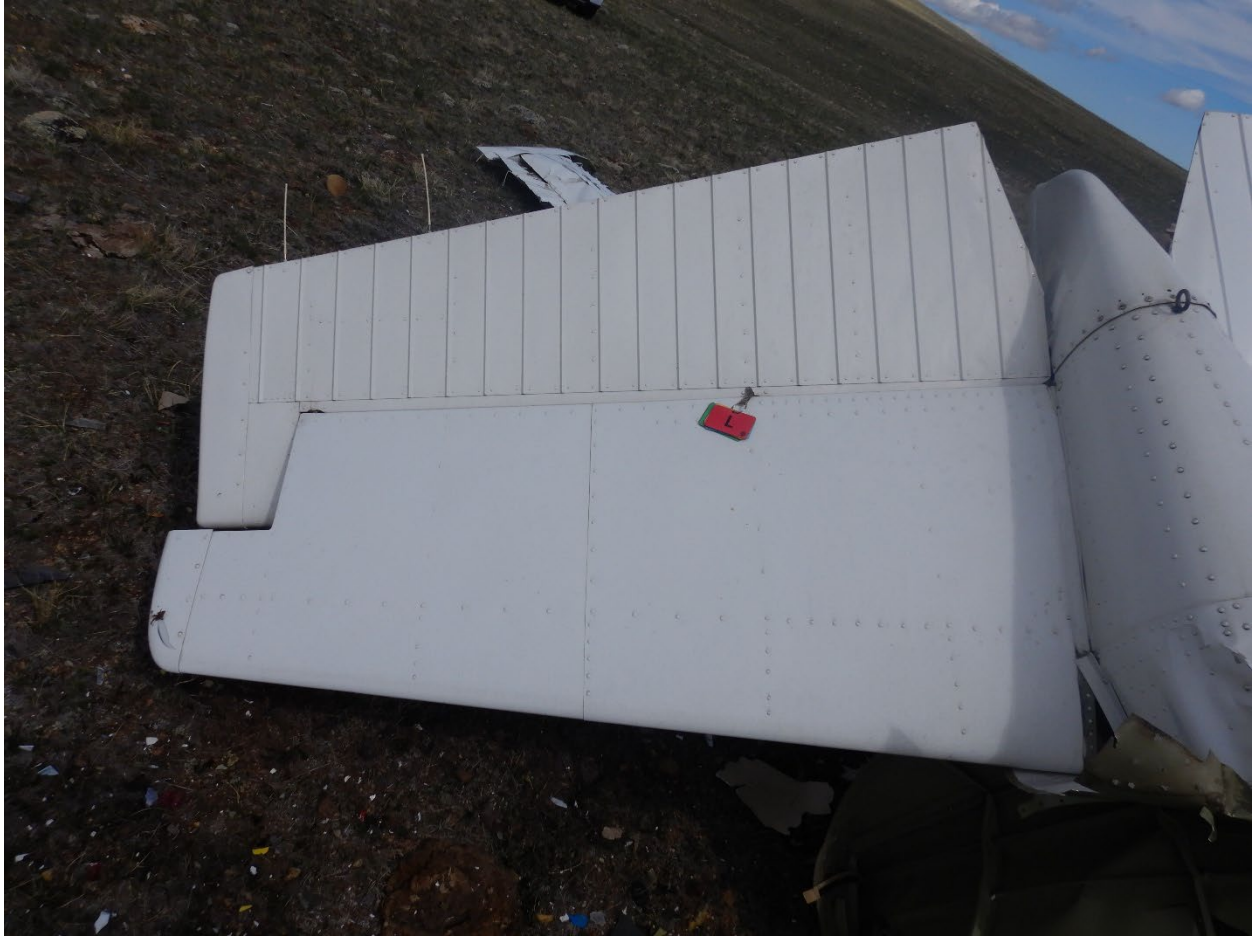
The empennage was displaced and canted to the forward left. The horizontal stabilizers remained attached to the fuselage and exhibited minor damage. The elevators remained attached to their respective stabilizers and exhibited minor damage. The vertical stabilizer remained attached to the tail structure and displayed dents to the leading edge. The rudder remained attached to the vertical stabilizer and exhibited minor damage. The rudder flight control cable continuity was established from the aft bell crank to the cockpit. Cable continuity at the left and right rudder bar assembly could not be confirmed due to the cockpit damage.

Figure 2. Underside view of the left horizontal stabilizer and elevator. Source Textron.

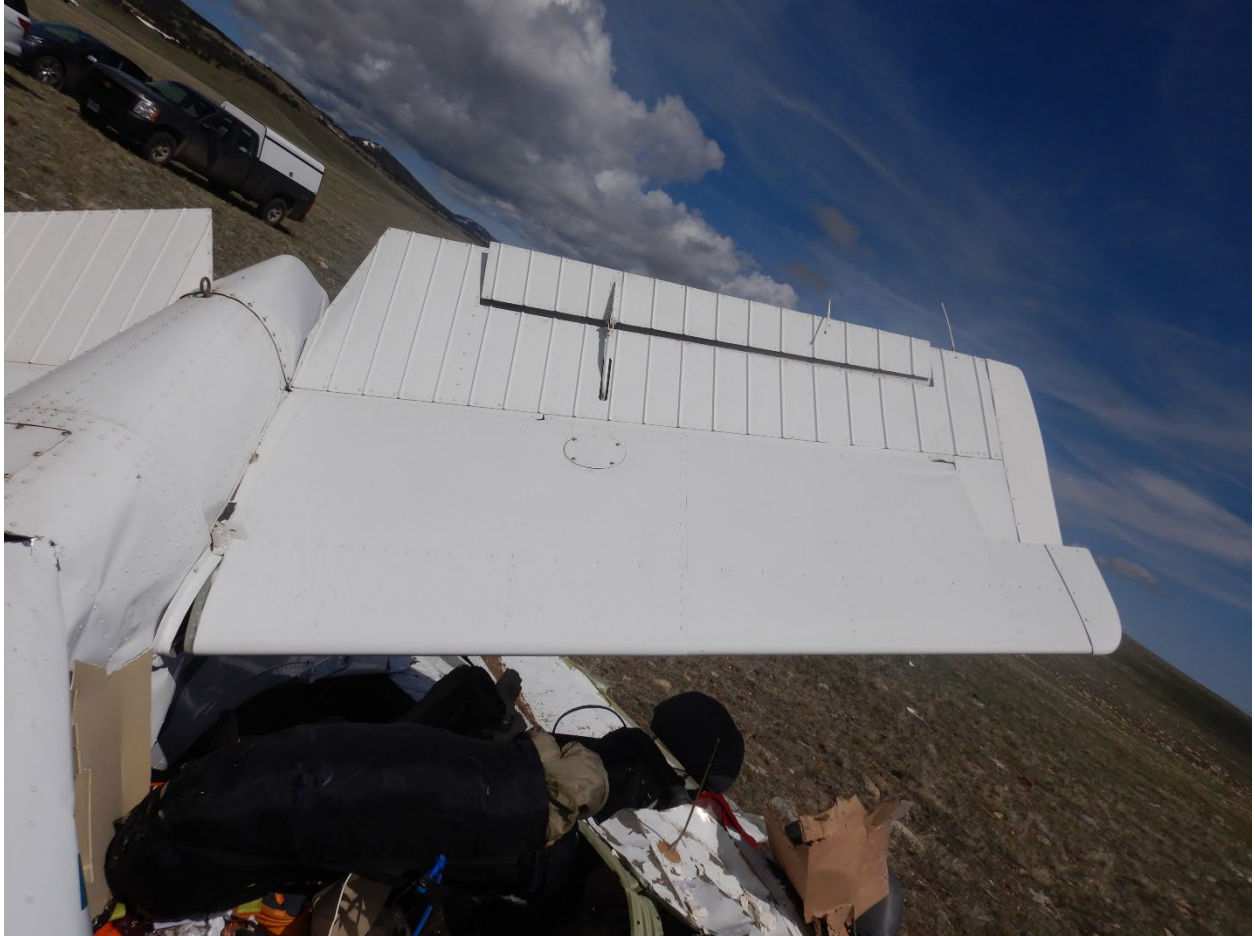
Figure 3. Underside view of the right horizontal stabilizer, elevator, and trim. Source Textron.

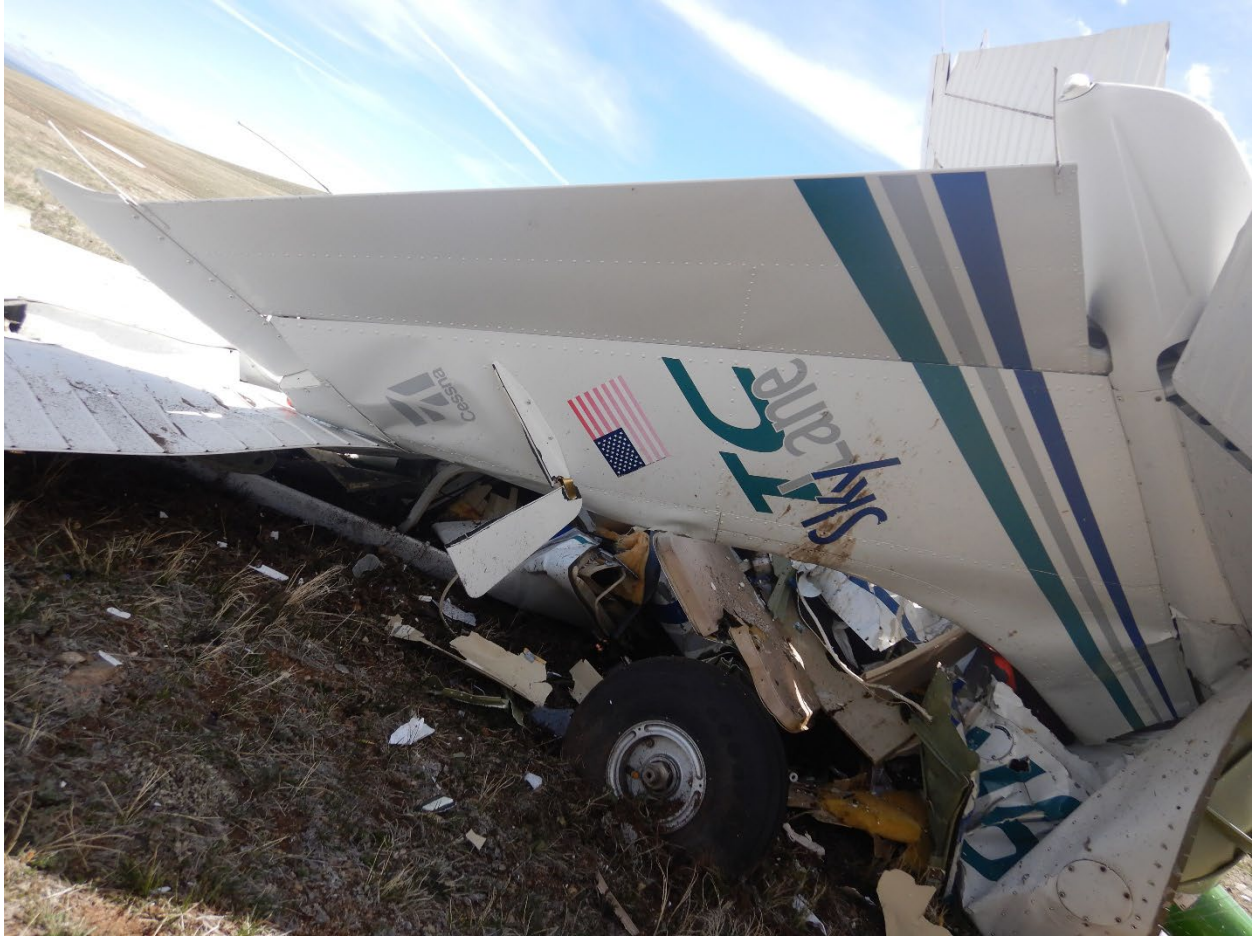
Figure 4. Right side view of the vertical stabilizer and rudder. Source Textron.

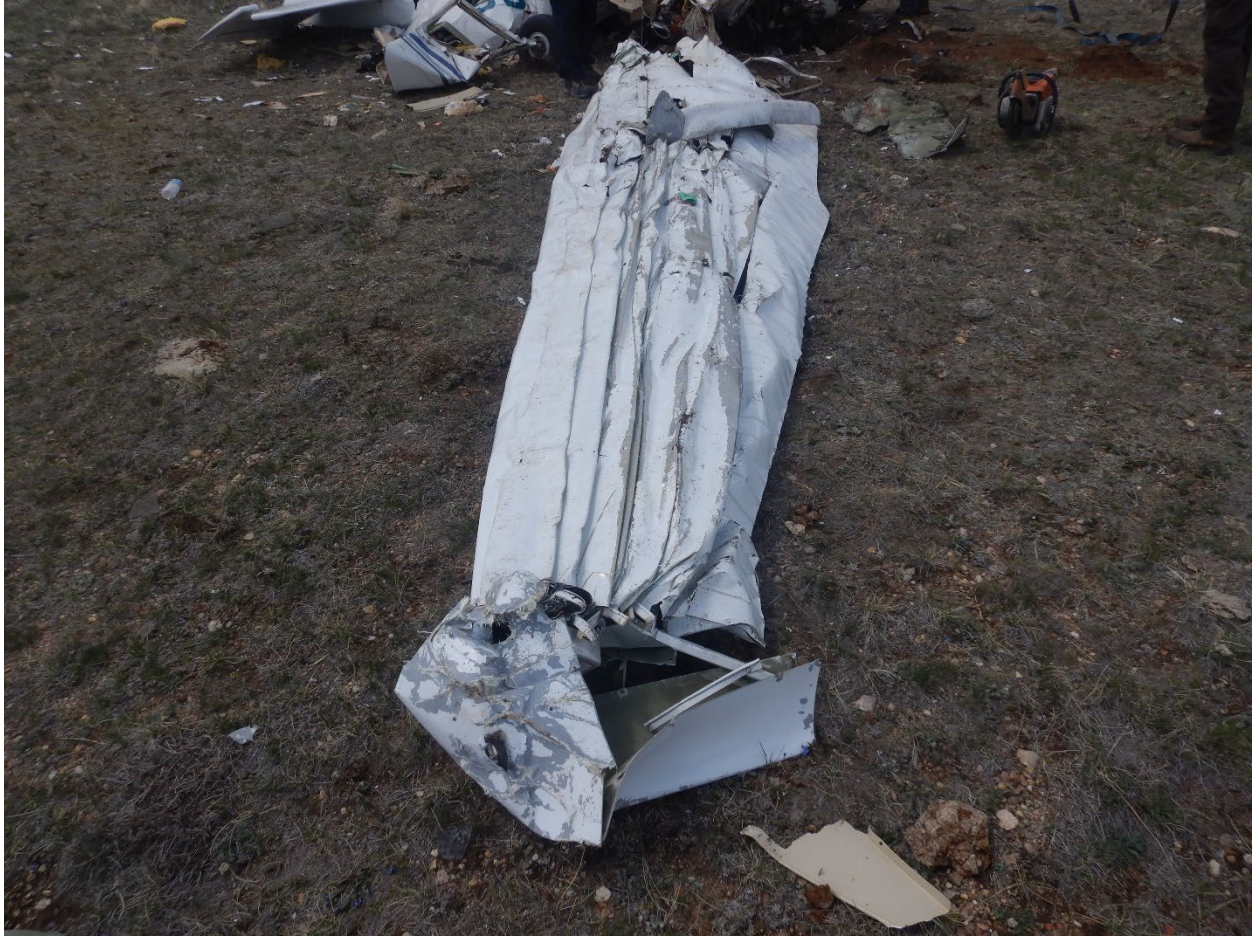
Figure 5. Underside view of the right wing. Source Textron.

The right wing exhibited hydraulic deformation consistent with fuel in the tank. The right-wing fuel cap separated from the wing and was found near the wing. The left wing exhibited some hydraulic deformation, and an automotive-style fuel cap was found installed. The cap was loosely attached. Both bottom wing leading edges exhibited aft buckling, while the top surface skin displaced forward. The right-wing front spar was found face down. Both wings remained attached at their respective attachment points. Both ailerons remained attached to the wings at their respective attachment points. Both flaps remained attached to the wings at their respective attachment points. The right-wing strut separated from the airplane about mid-span. The left-wing strut remained attached to the fuselage and wing at the attachment points.

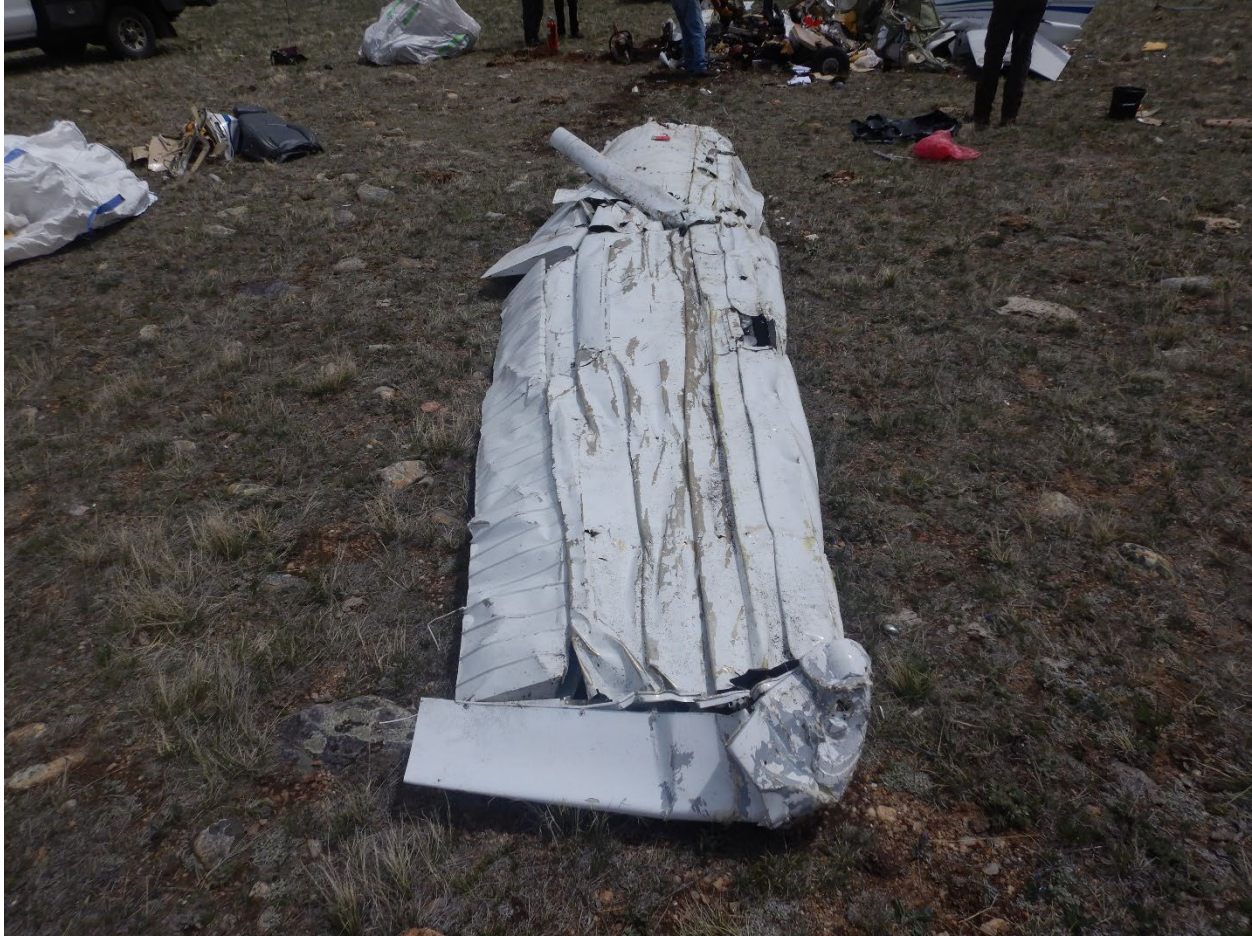
Figure 6. Underside view of the left wing. Source Textron.

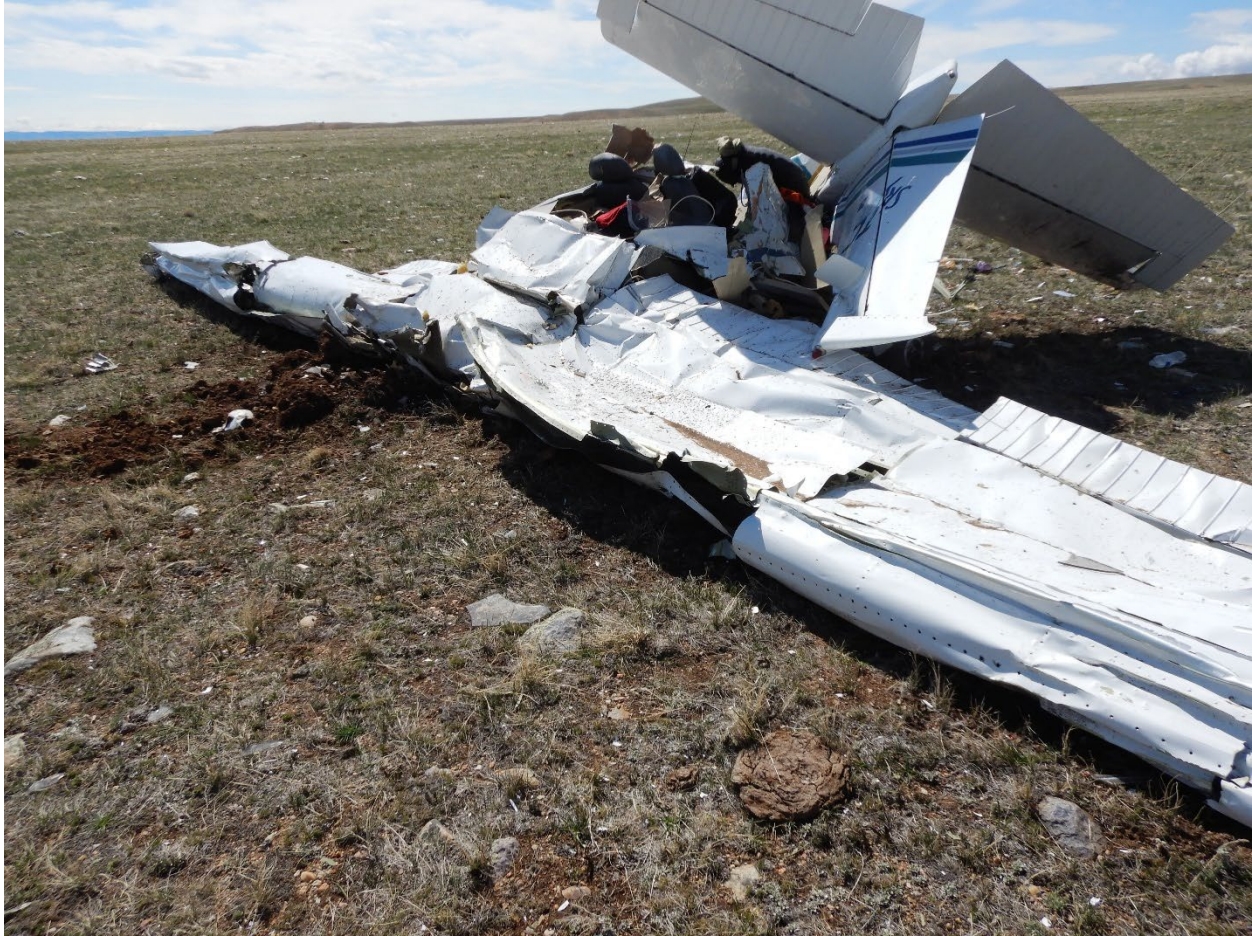
Figure 7. Top view of the left and right wings and empennage. Source NTSB.

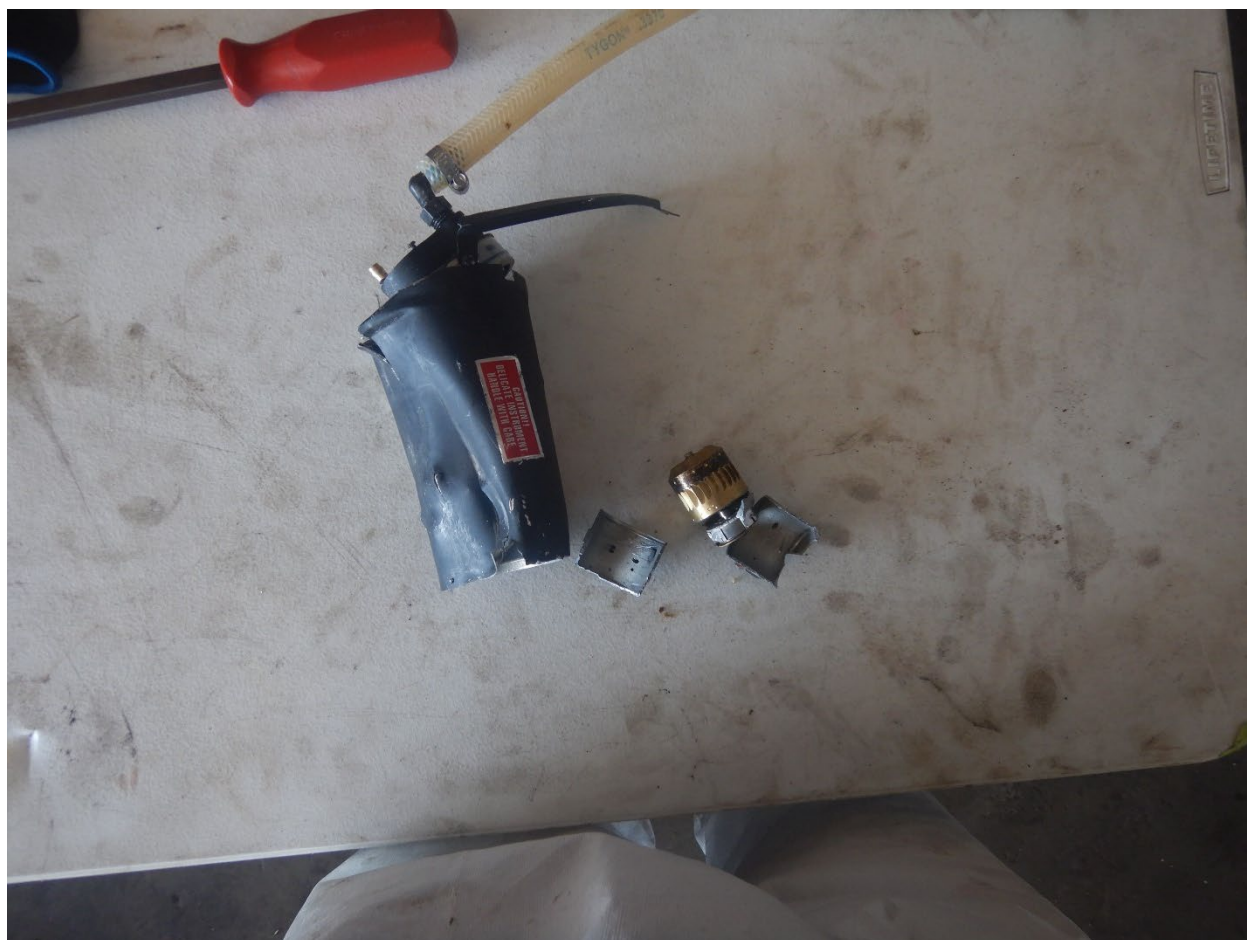
The attitude indicator exhibited impact damage. After the recovery, the internal components had fallen out of the indicator case. The gyro case was fractured into two halves. One of the case halves exhibited a gouge mark on the inner section.

Figure 8. Case for the attitude indicator and the remaining internal components. Source Textron.

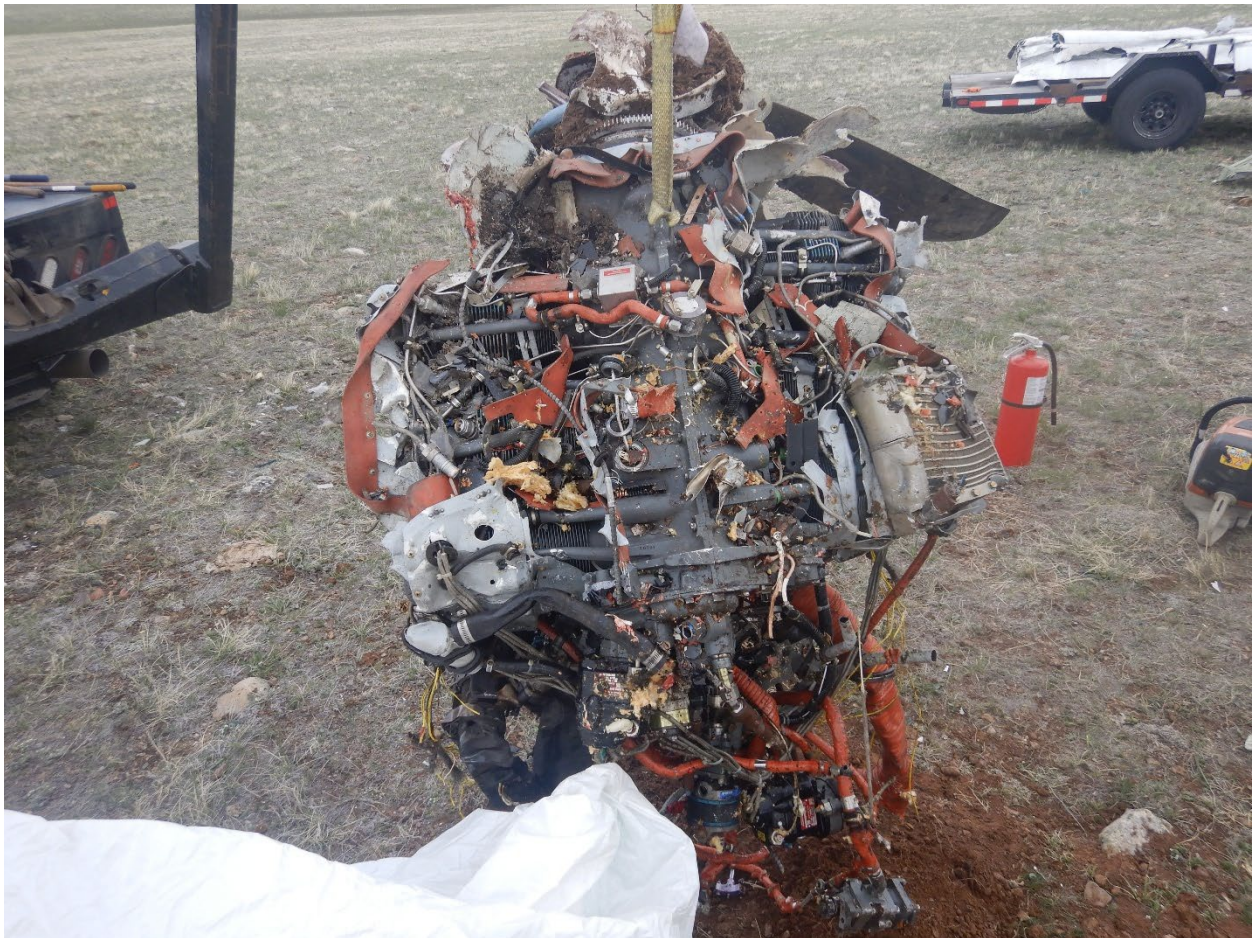
A visual inspection conducted at the accident site revealed that the engine was displaced aft into the cockpit. The engine was relocated to a secure facility where the following observations were made.

Figure 9. Engine after removal from airframe. Source Textron.

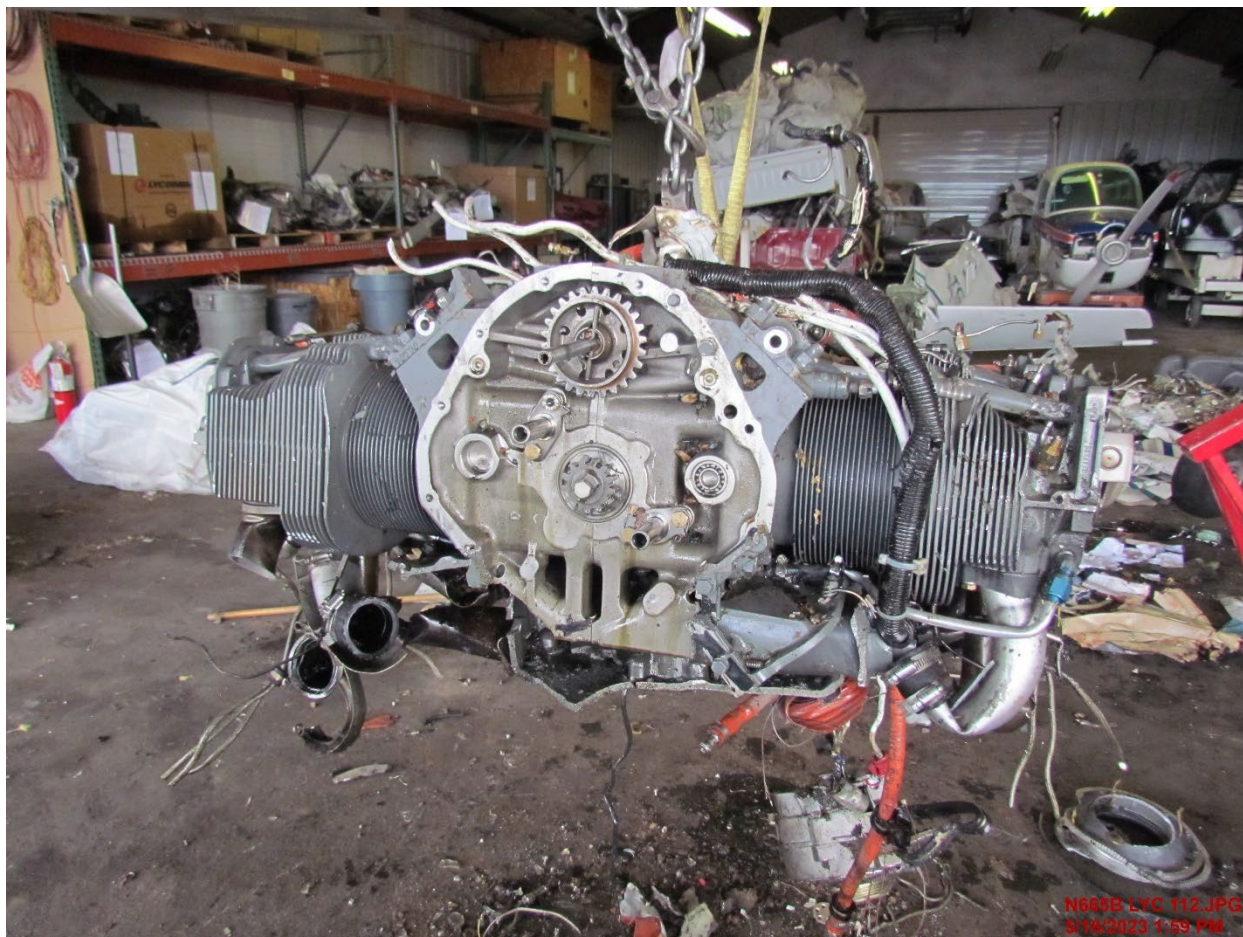
Figure 10. Engine examination while at secure facility. Source NTSB.

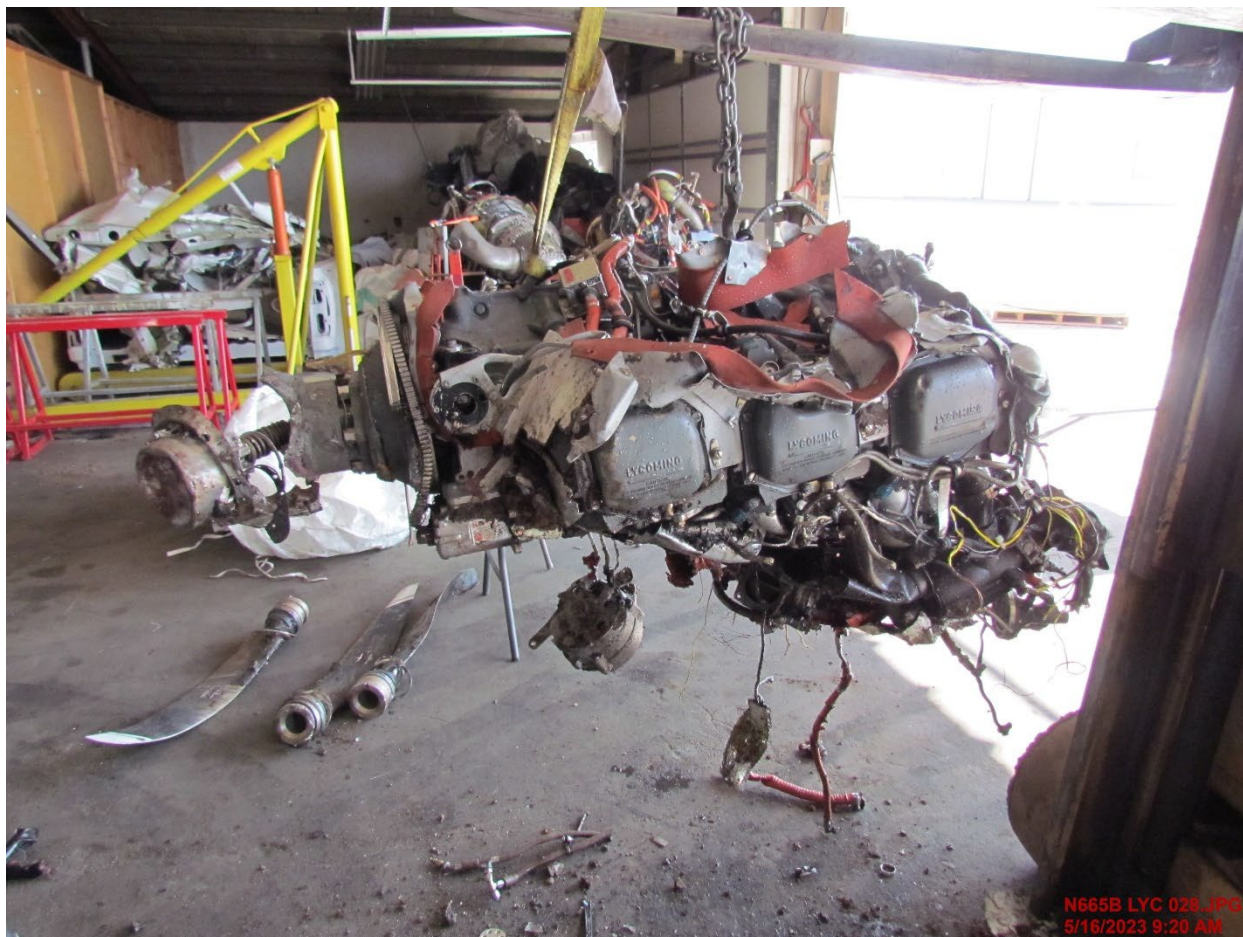
Figure 11. Left-side view of engine and the propeller blades. Source NTSB.

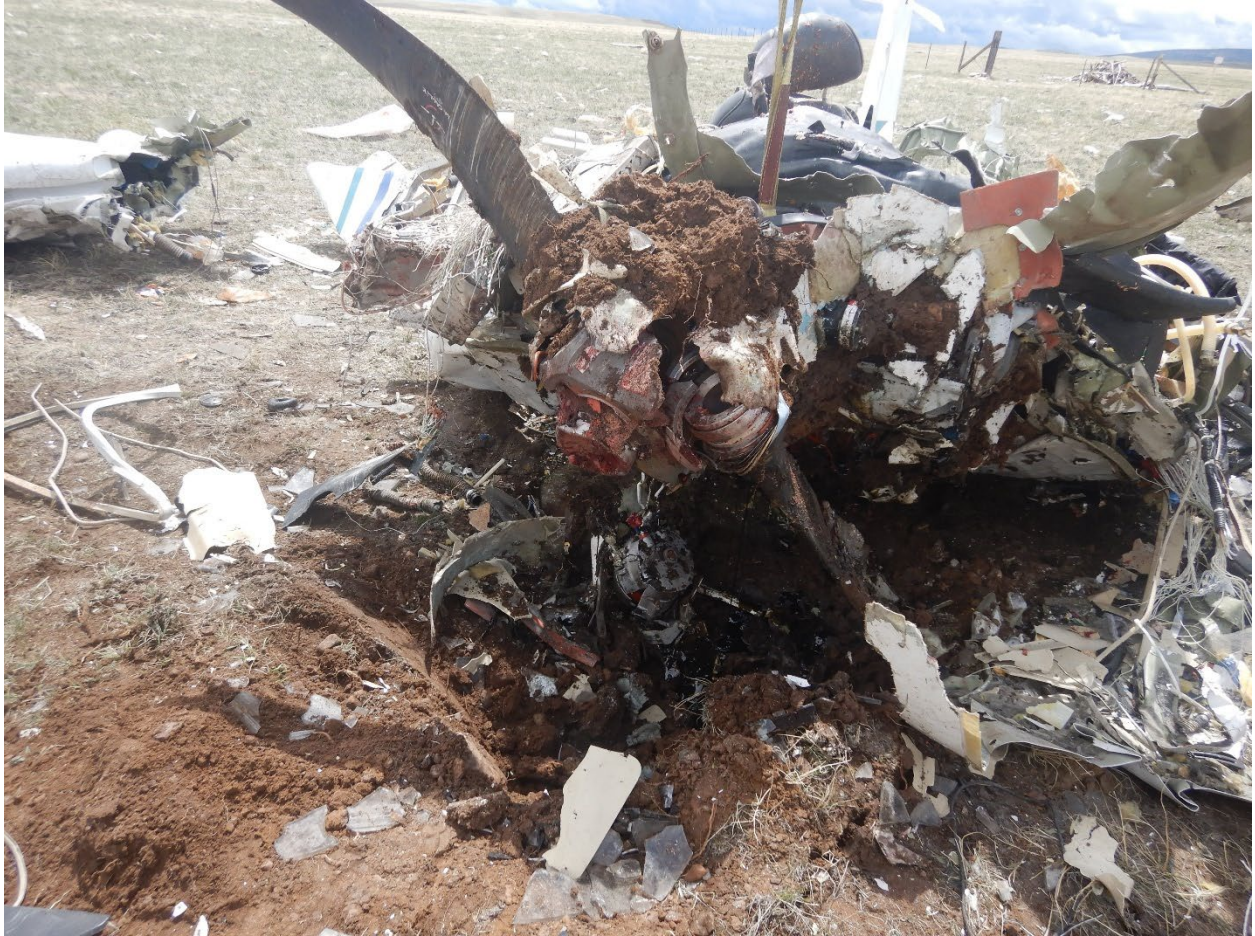
The propeller hub was fragmented but remained attached to the engine crankshaft propeller flange. One propeller blade exhibited leading edge gouging, and chordwise striations. a second propeller blade exhibited chord-wise striations and the tip exhibited minor damage. A third propeller blade exhibited leading edge gouging, and chordwise striations, and tip curling. The spinner was fragmented and impact damaged.

Figure 12. Propeller blades while at the accident site. Source NTSB.

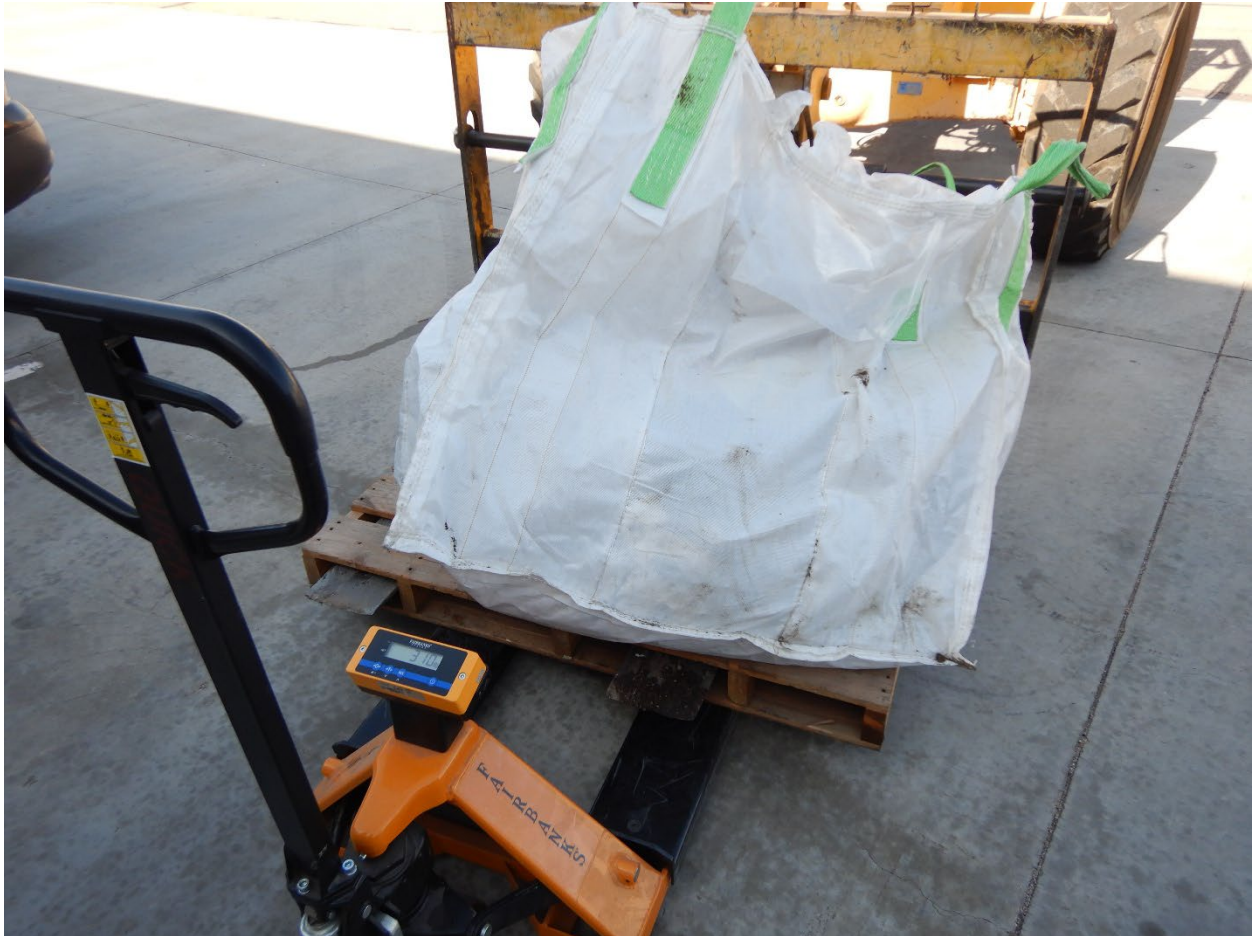
The contents of the airplane were collected and weighed. The total weight of the cargo was 310 pounds, as shown in figure 13.

Figure 13. Cargo from the accident flight. The scale indicates 310 pounds. Source NTSB.
