# National Transportation Safety Board

WPR23FA208

## **MATERIALS LABORATORY**

Factual Report 23-062

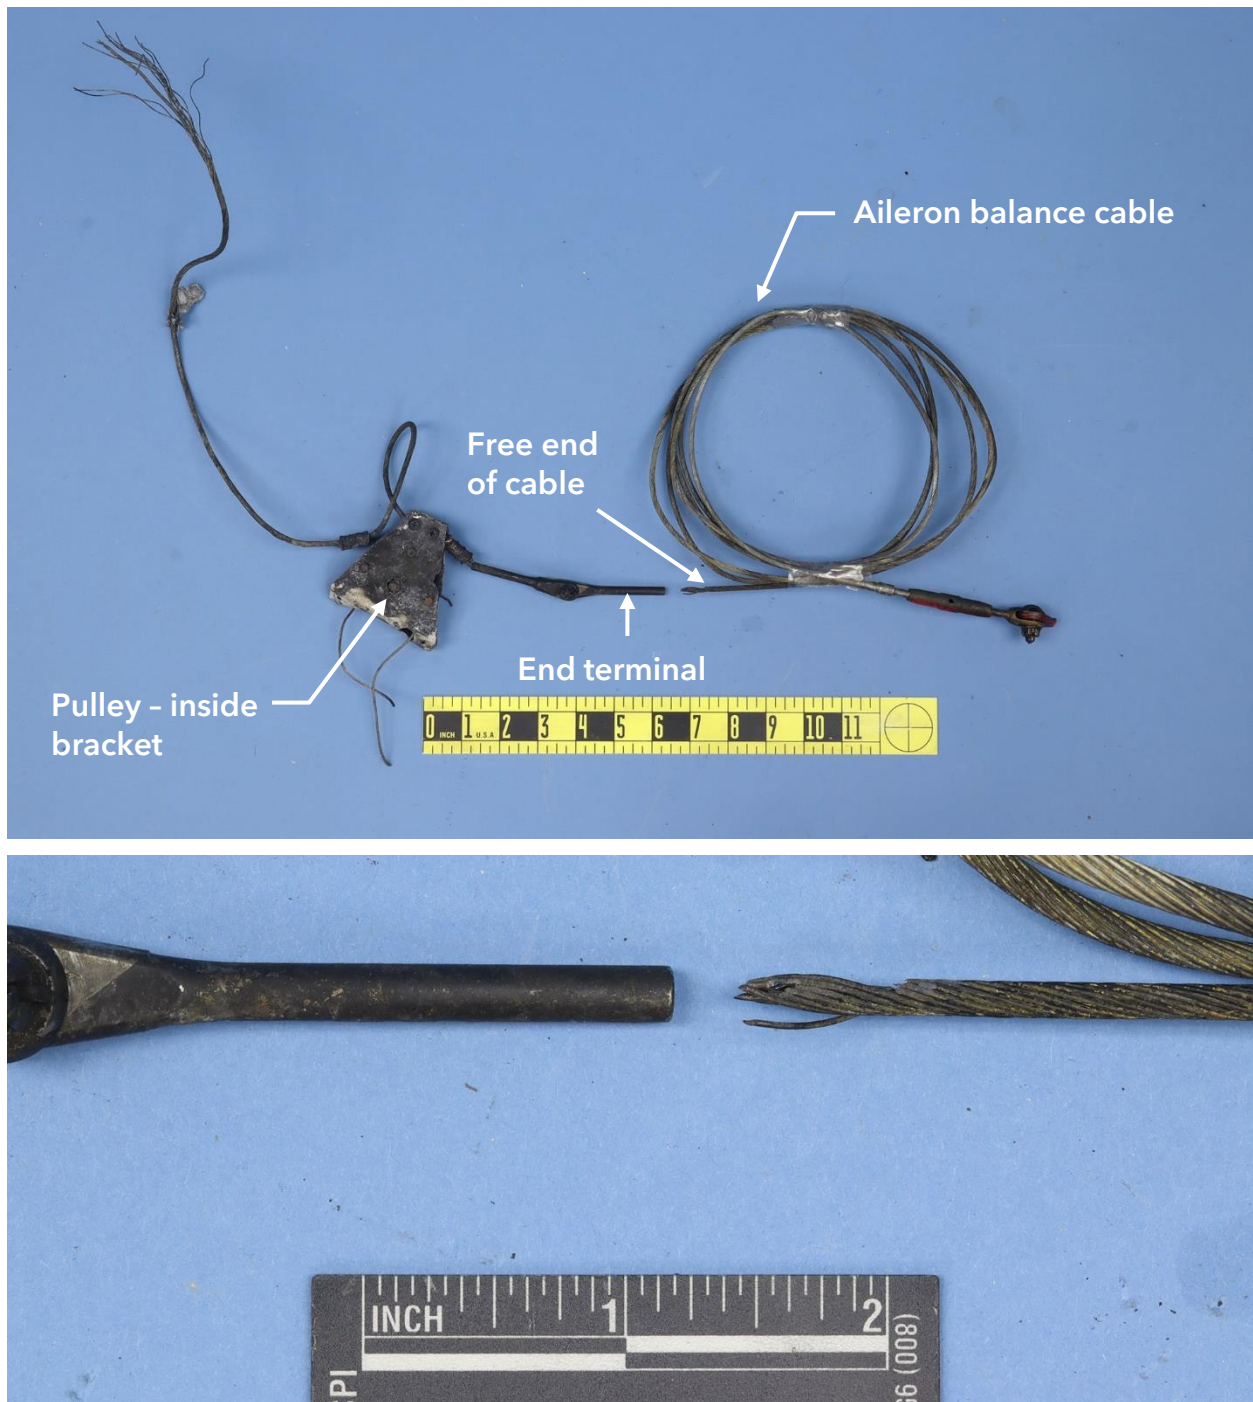
An aileron balance cable that had separated from its root end terminal fitting was submitted to the NTSB Materials Laboratory for examination, as shown in figure 1. As part of the original cable manufacturing process, the cable and end terminal are joined by swaging. The cable end is inserted fully into the terminal socket and the terminal is swaged (plastically deformed) around the cable, mechanically interlocking the two components. The cable was found separated from its terminal.

**Figure 1.** Top image: Aileron balance cable and end terminal as received. Bottom image: closer view of terminal end and free end of balance cable.

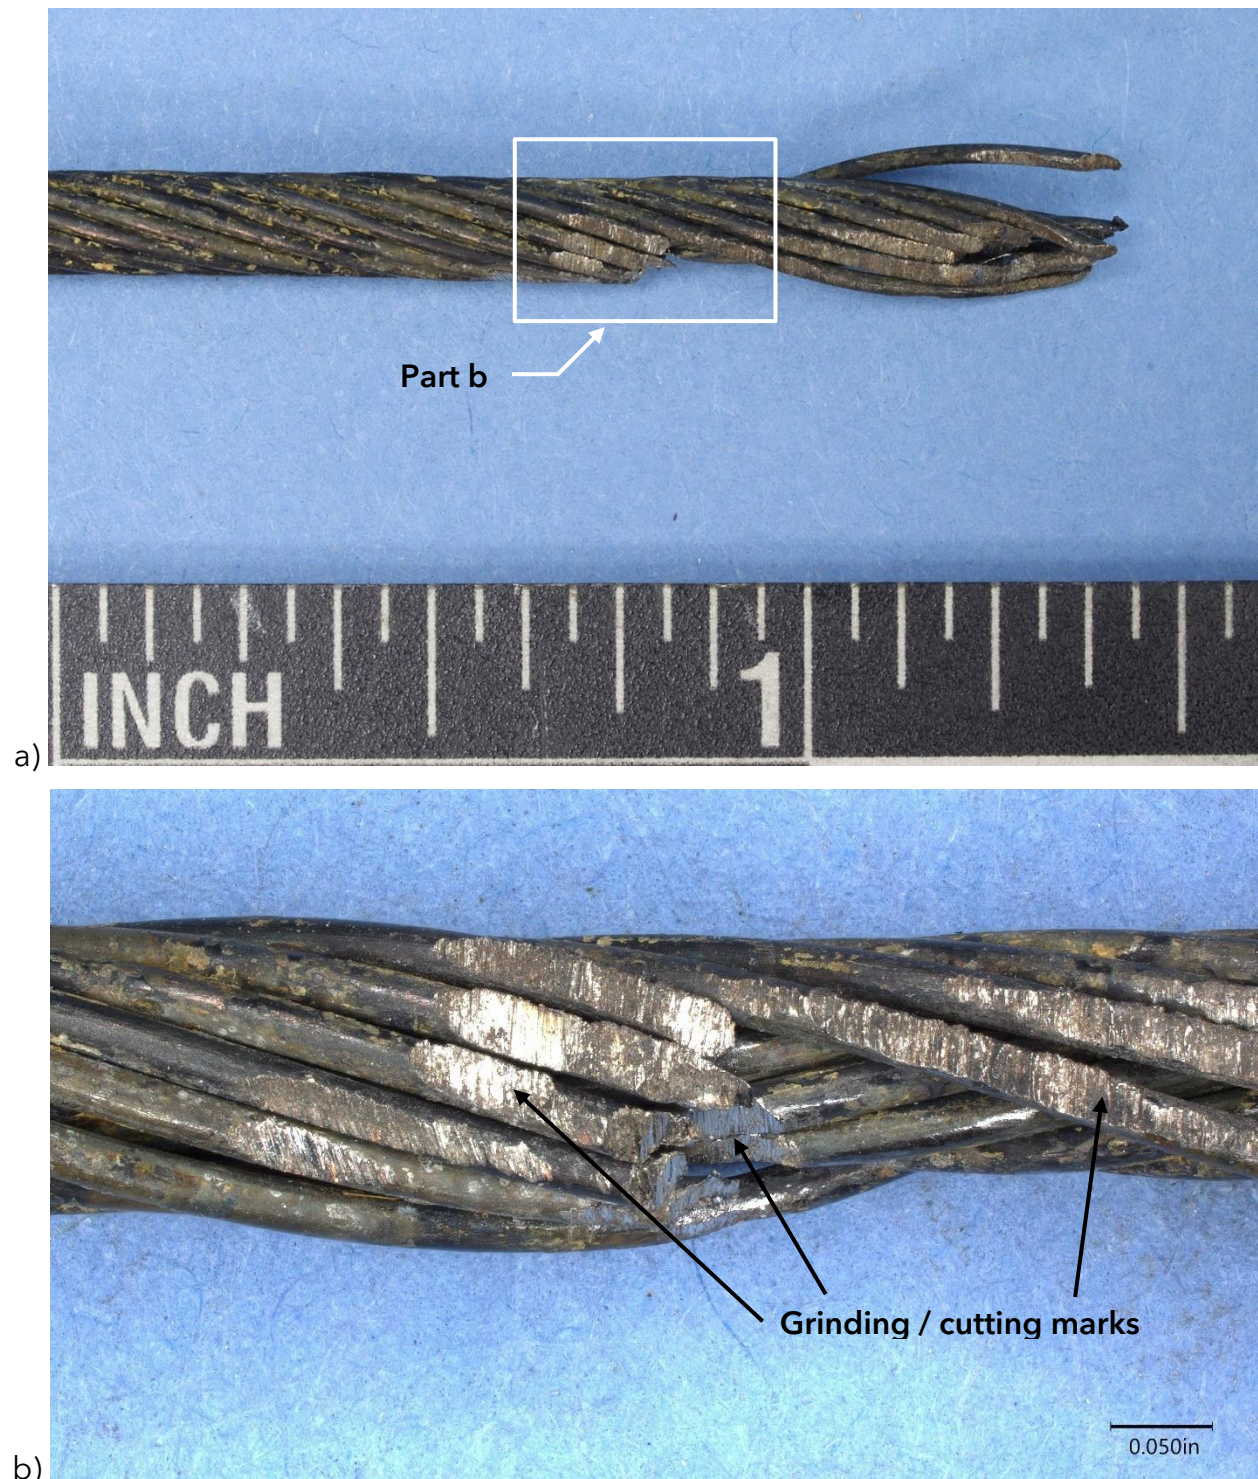
The free end of the cable exhibited grinding and cutting features. Figure 2a shows an overview image of the free end. Figure 2b shows a higher magnification image of the same end. Multiple regions exhibited superficial grinding marks. One region exhibited a U-shaped channel cut with grinding marks, metal burrs along one edge, and several cut wires. The cut and abraded surfaces had a shiny metallic appearance as opposed to the dark and oxidized appearance observed across the rest of the cable, terminal, and pulley assembly. The cable assembly length was approximately 142 inch, which was between 30 inch and 36 inch short of the nominal assembly length, according to the manufacturer's assembly drawing. The features and measurements were consistent with the cable having been cut.

**Figure 2.** Images of the aileron balance cable's free end - a) Overview image showing orientation of cable and b) closer view of free end showing grinding and cutting marks.
