# National Transportation Safety Board

WPR23FA208

## **AUTOMATIC DEPENDENT SURVEILLANCE- BROADCAST (ADS-B) STUDY**

Location: Tupelo, Mississippi  
Date: June 3, 2023  
Time: 08:11 central daylight time (CDT)  
Airplane: Piper PA-31-325, N4077W

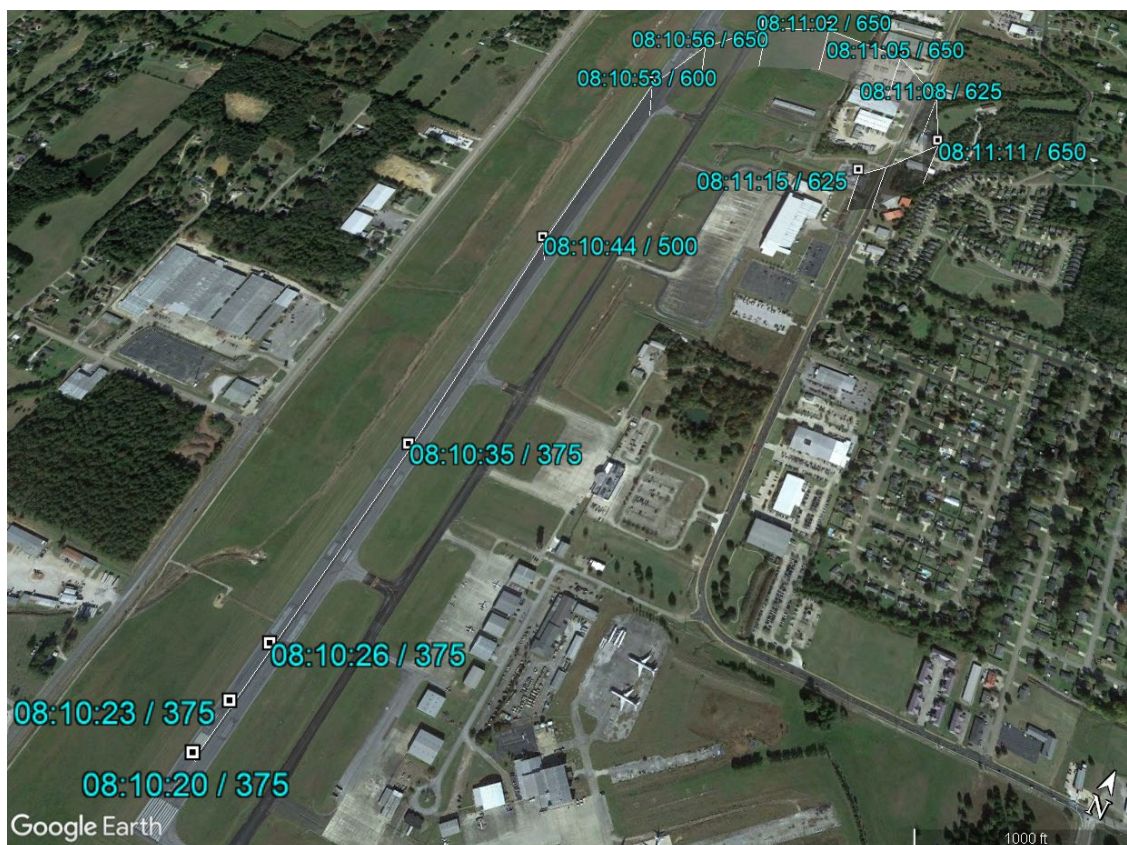
Figure 2 shows the airplane's takeoff roll and flight with altitude in MSL. Figure 3 shows the altitude as height above ground and calculated groundspeed, calibrated airspeed, and true airspeed. The atmospheric conditions at the time of the accident meant that the calibrated airspeed was within one to two kts of the true airspeed. The airplane began a right turn about 08:10:53 as it climbed through 600 ft MSL, 250 ft above ground level (AGL). Its speed was 100 kts and slowing. The Sound Spectrum Study [1] determined that at least one engine was functioning normally throughout the flight. The wreckage exam found the flaps to be at 15°.

**Figure 2.** ADS-B flight path with times and altitudes in MSL noted.

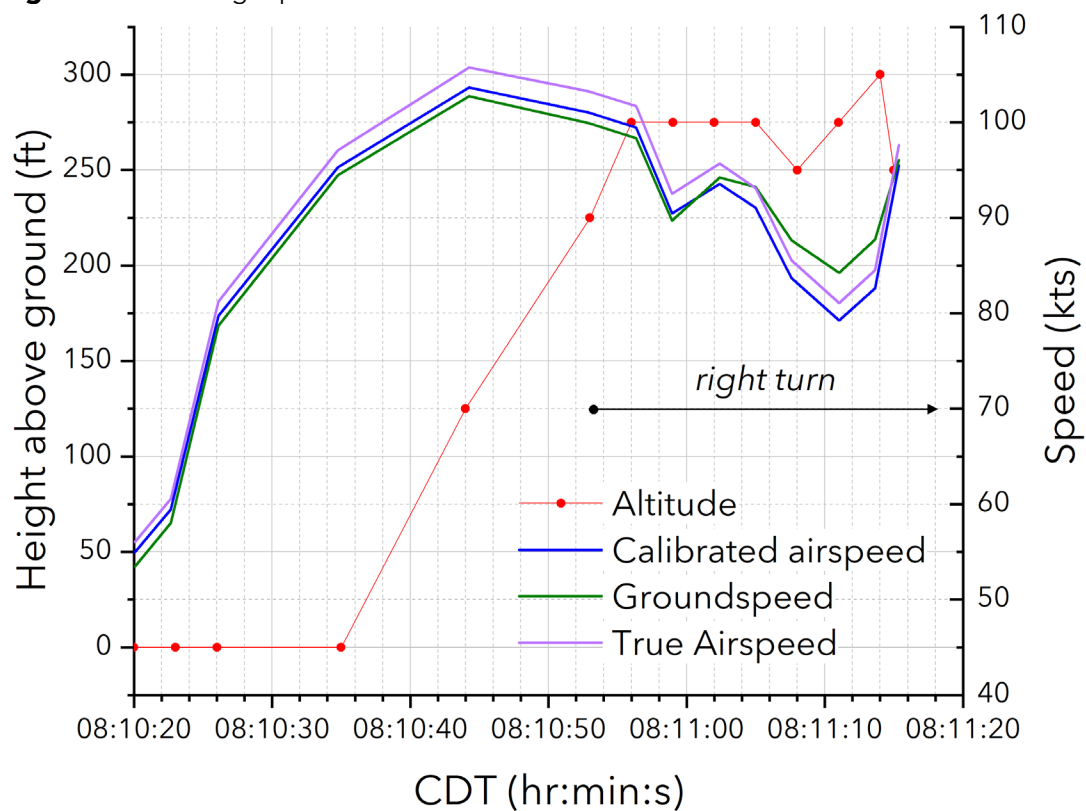
**Figure 3.** Height above ground with calculated calibrated airspeed and groundspeed.

As the airplane turned right, its speed slowed to below 90 kts calibrated airspeed. The airplane's listed calibrated stall speeds for flaps 15°, gear extended, 6,500 lbs is 66 kts and for 4,750 lbs it is 56 kts [2]. However, during a turn, the stall speed will rise with square root of the load factor,  $N$ , according to

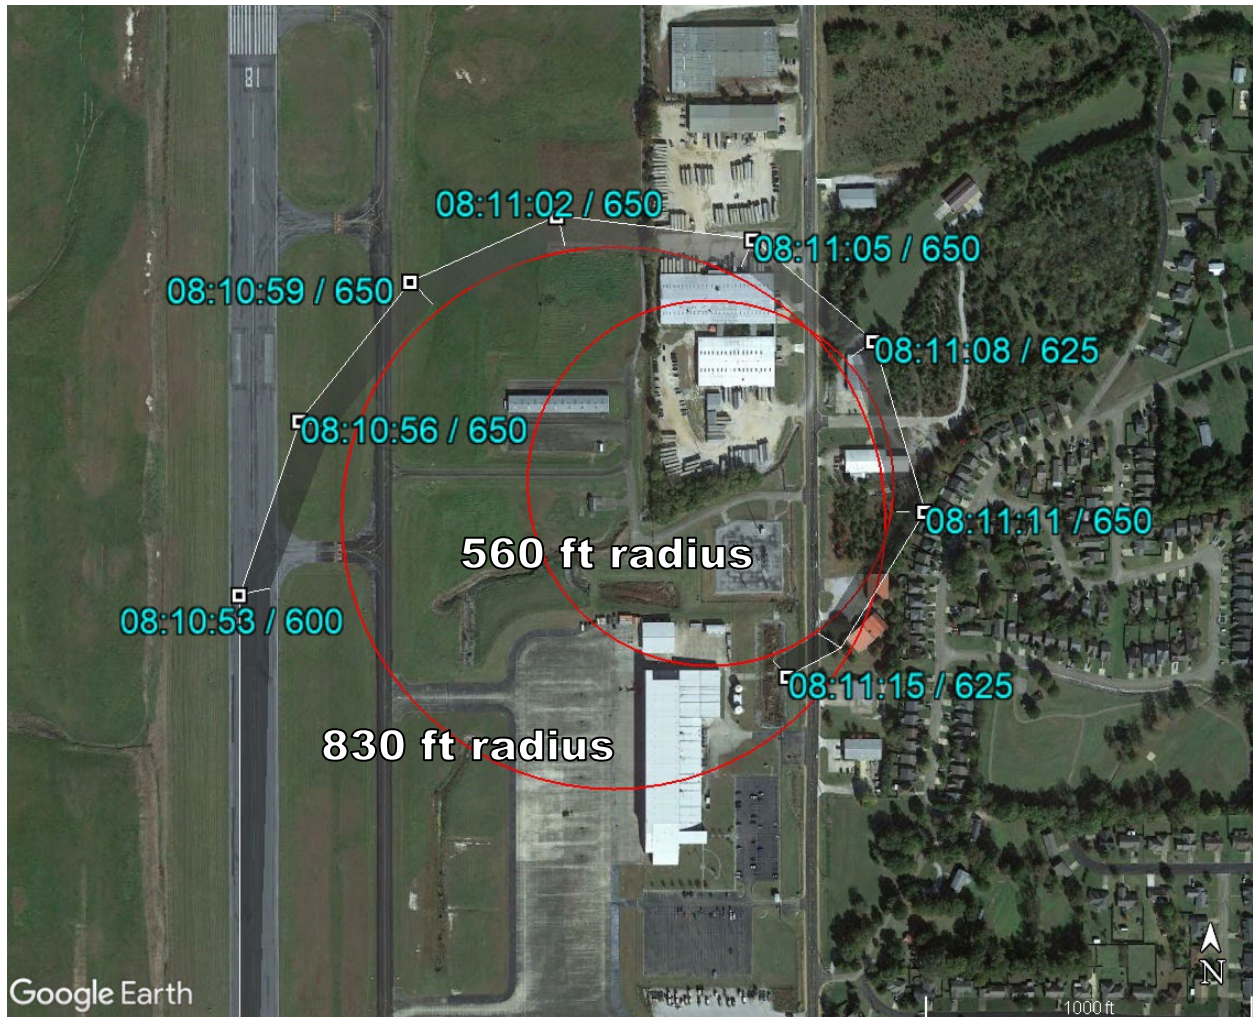
where  $\varphi$  is the bank angle and  $g$  the acceleration due to gravity. The final right turn tightened from an 830 ft radius turn at 93 kts true airspeed at 08:11:05 to a 560 ft radius turn at 81 kts true airspeed at 08:11:11 (Figure 4). Table 1 shows the resulting banked stall speeds for each part of the turn. As the turn tightened the flaps 15, heavy stall speed increased to be within 2 kts of the calculated true airspeed.

**Figure 4.** ADS-B flight path and altitude.

The airplane took off between 08:10:35 and 08:10:44. As it climbed through 250 ft AGL it began a tightening right turn. As the turn tightened, the airplane's speed slowed towards its banked stall speed.
