# National Transportation Safety Board

WPR23FA208

## **SOUND SPECTRUM STUDY**

Location: Tupelo, Mississippi  
Date: June 3, 2023  
Time: 0811 central daylight time (CDT)  
Aircraft: Piper PA-31-325, N4077W

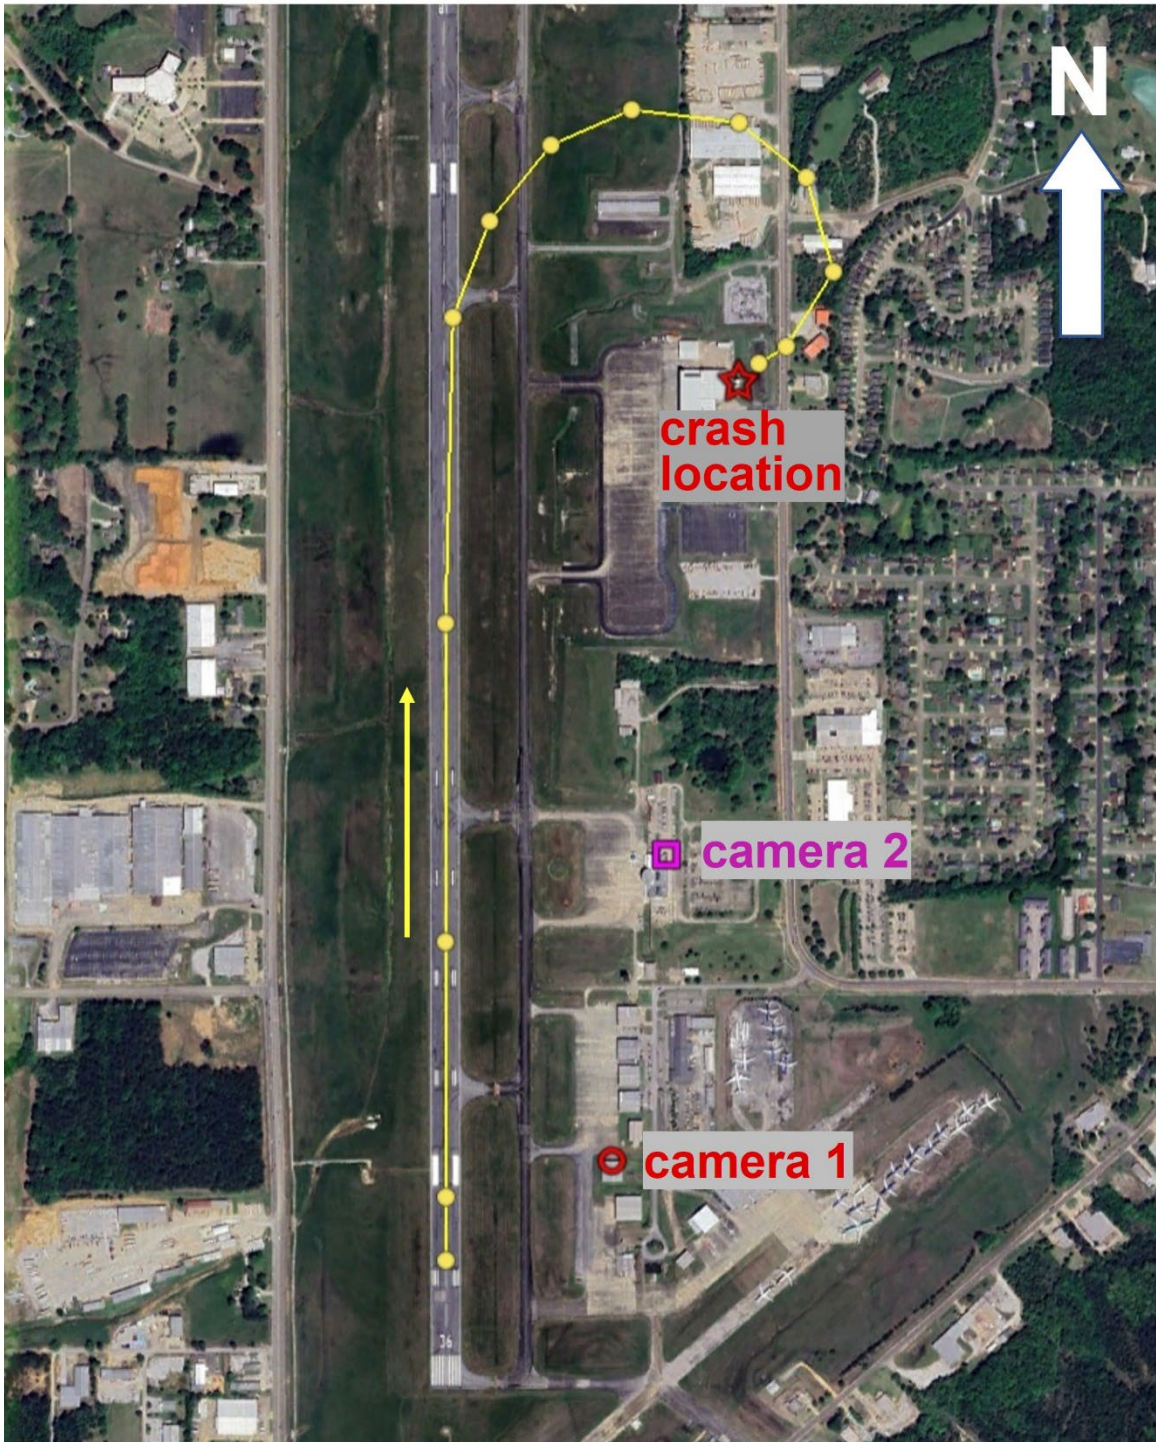
**Figure 1.** Aerial view of the accident area

Figure 1 is an aerial view of the accident area. The figure shows the locations of the two cameras, the ADS-B ground track of the airplane, and the crash location. The ground track shows that the airplane was initially approaching the cameras, resulting

in the sound frequencies recorded by the cameras being higher than the frequencies emitted by the airplane due to the Doppler effect. Then the airplane was flying away from the cameras, resulting in the sound frequencies recorded by the cameras being lower than the frequencies emitted by the airplane. During the final segment of the flight, the airplane was again flying toward the cameras.

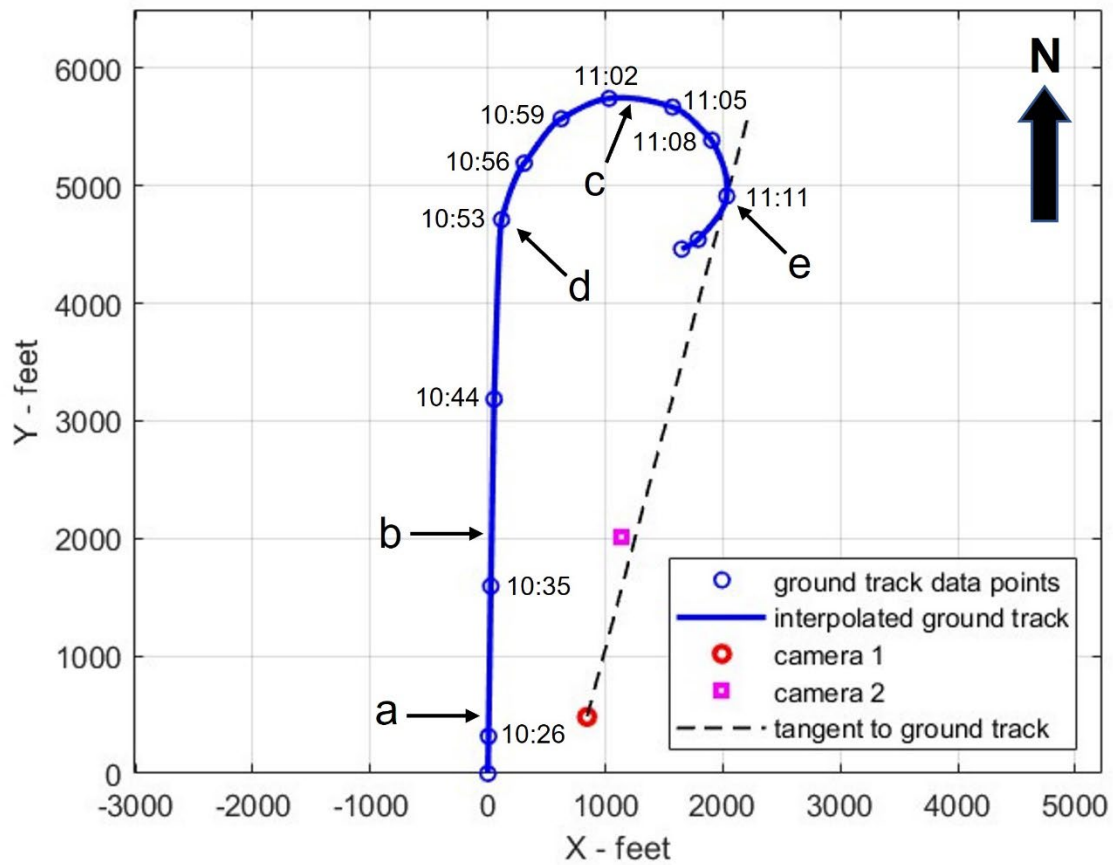
**Figure 2.** Geometry of the accident area. Times are shown as MM:SS past 8:00:00.

There were two airplane locations for each camera where there was no Doppler effect. At these locations, the frequencies recorded by the cameras were equal to the frequencies emitted by the airplane. Figure 2 shows the geometry of the accident area and the times, in format MM:SS past 8 AM, when the airplane was at the marked locations. When the airplane was at location a, marked in Figure 2, the sound recorded by camera 1 was not affected by the Doppler effect because the airplane was moving perpendicularly to the line from camera 1 to the airplane.

When the airplane was at location b, the sound recorded by camera 2 was not affected by the Doppler effect because the airplane was moving perpendicularly to the line from camera 2 to the airplane. When the airplane was near location c, the sound recorded by both cameras was not affected by the Doppler effect because the airplane was moving perpendicularly to the lines from the cameras to the airplane.

There was a need to locate the times in the two videos when the airplane was at locations a, b and c. The video times corresponding to locations a and b were assumed to be the times when the recorded sound intensities were highest. The video times corresponding to location c were estimated as follows. Figure 2 shows a line originating at the camera 1 location and passing tangentially to the ground track. The line touches the ground track at point e, corresponding to ADS-B time 8:11:11. A line originating at the camera 2 location and passing tangentially to the ground track also touches the ground track at the point corresponding to time 8:11:11.

Figure 2 shows that just before time 8:11:11, the airplane had a small speed component toward the east and just past time 8:11:11 it had a small speed component toward the west. Frame-by-frame inspection of the videos made it possible to identify the frames and the corresponding video times when the east-west speed component was zero.

Figure 2 shows that the zero Doppler effect was expected at point c, when the time was about 8:11:03. Consequently, the video times when the airplane was at location c could be estimated as the video times  $11-3=8$  seconds before the video times corresponding to the airplane location at ADS-B time 8:11:11 when the east-west speed component was zero.

Two more airplane locations were of interest in the investigation. Point d shown in Figure 2 is at a location where the airplane was just past the start of its right turn. Point e is at a time shortly past which the airplane started its rapid descent toward ground. At point d, the airplane was flying away from the cameras and, therefore, the recorded frequencies were lower than the frequencies emitted by the airplane. At point e, the airplane was flying toward the cameras and, therefore, the recorded frequencies were higher than the frequencies emitted by the airplane. A Doppler

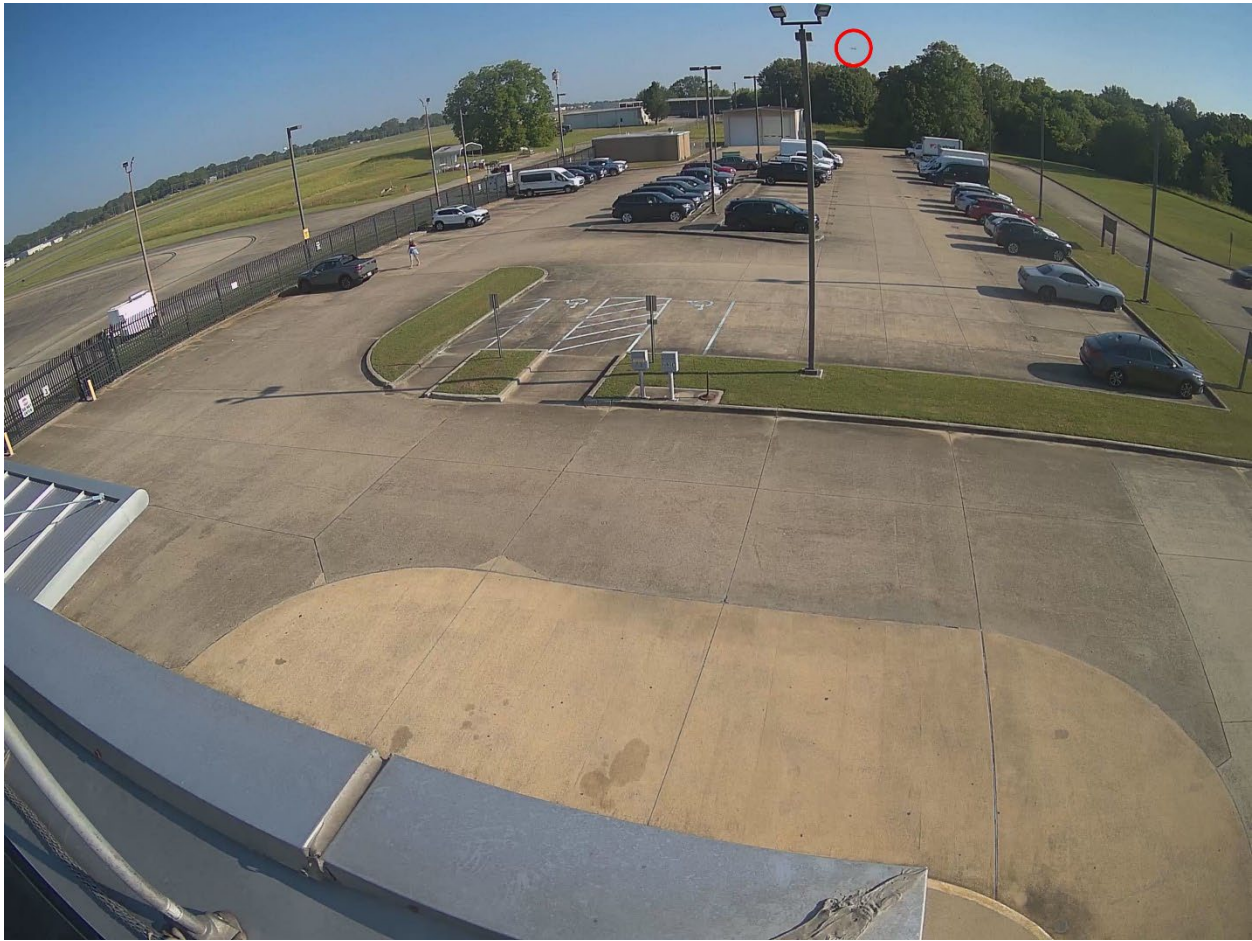
**Figure 3.** Video frame recorded by camera 2 at time 8:11:03

Figure 3 is a frame from the video recorded by camera 2 when the airplane was at point c marked in Figure 2. The image of the airplane, located inside the red circle, is small because it was located about 3750 feet from the camera.

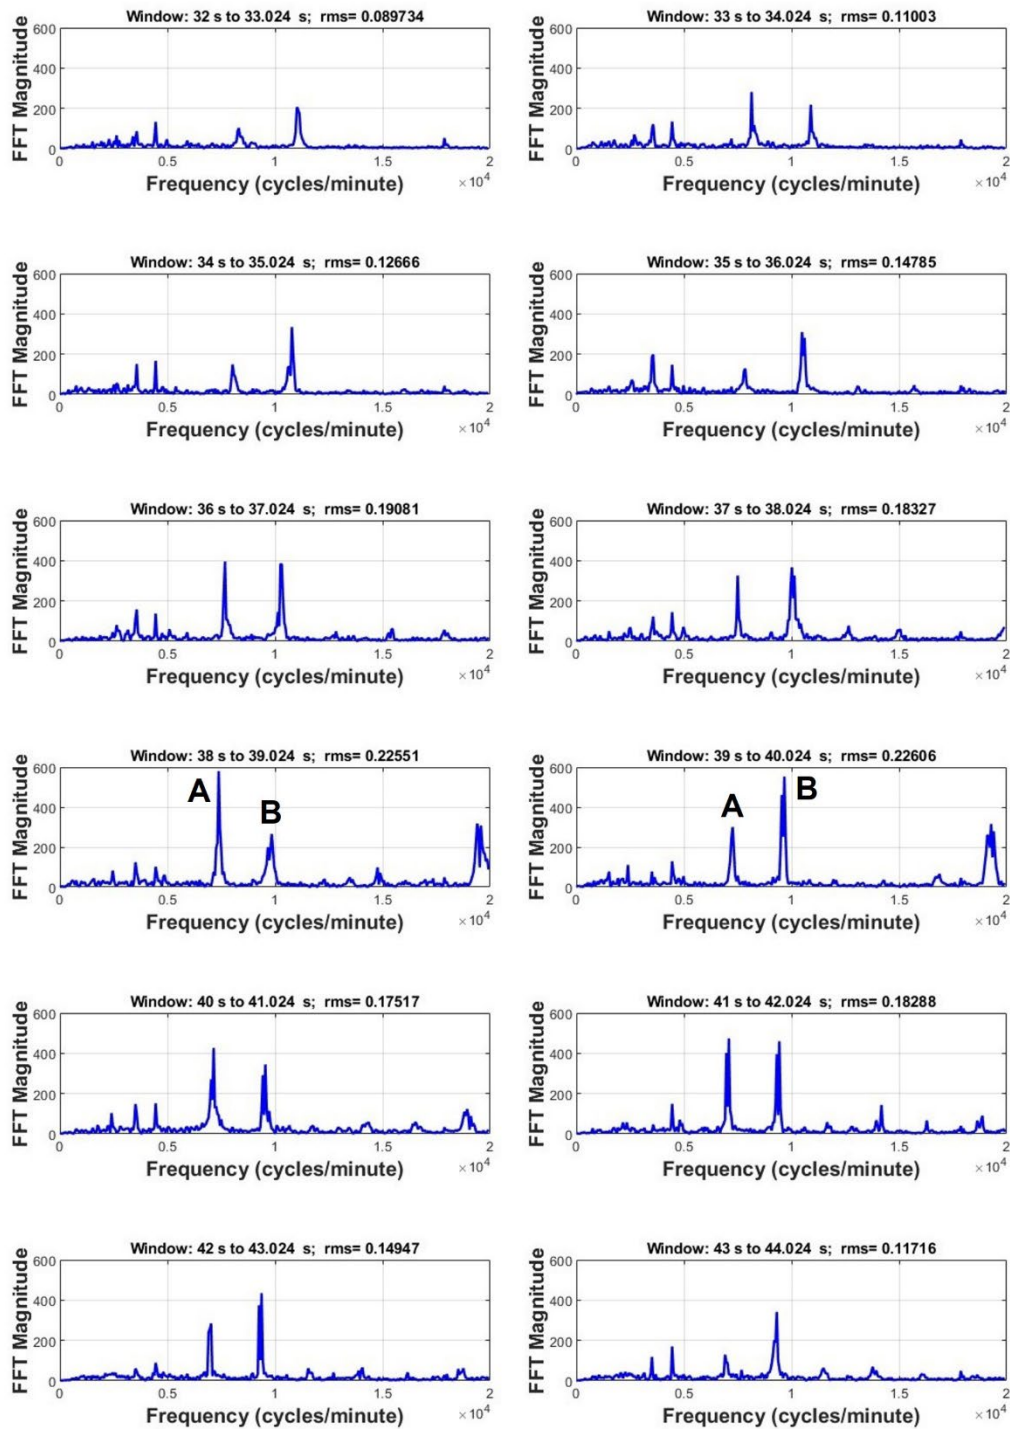
**Figure 4.** Sound spectra in windows starting at time 32 seconds (camera 2)

Once the video times corresponding to airplane locations a, b and c were estimated, it was possible to estimate the engine speed at these Doppler-effect-free locations. The spectrum of the sound recorded by the cameras was analyzed with the Fast Fourier Transform (FFT). Camera 2 recorded sound at the rate of 8000 samples per second. The FFT algorithm used 8192-point windows, resulting in windows that were 1.024 seconds wide. The frequency resolution was 58.6 cycles per minute (cpm). Figure 4 shows the FFT intensity in twelve windows with starting times from 32 seconds to 43 seconds. The airplane was near location b, marked in Figure 2, at video time 39 seconds.

Figure 4 shows that the highest rms value of the sound signal was in the window starting at time 38 seconds and in the window starting at 39 seconds. Two spectral peaks, A and B, are marked in the figure in these two FFT intensity plots. The frequencies of the A peaks are 7383 cpm and 7265 cpm in windows starting at 38 seconds and 39 seconds, respectively. These are the blade passage frequencies (BPF). The frequencies of the B peaks are 9844 cpm and 9668 cpm. The average values of these spectral peaks are:  $(7383+7265)/2=7324$  cpm and  $(9844+9668)/2=9756$  cpm. Since the airplane propellers had three blades, the estimated engine speed of the airplane when it was at location b is  $7324/3=2441$  rpm. Since  $9756/7324=1.33$ , spectral peak B is believed to be the sum of the blade passage frequency (BPF) of 7324 cpm and either the engine 2441 rpm or the second harmonic of the engine firing order.
