# National Transportation Safety Board

WPR23FA208

## **ON-SCENE AND WRECKAGE EXAMINATION FACTUAL SUMMARY**

Location: Tupelo, MS  
Date: 6/4/2023  
Time: 8:16  
1316 UTC  
Airplane: Piper PA-31-325; N4077W

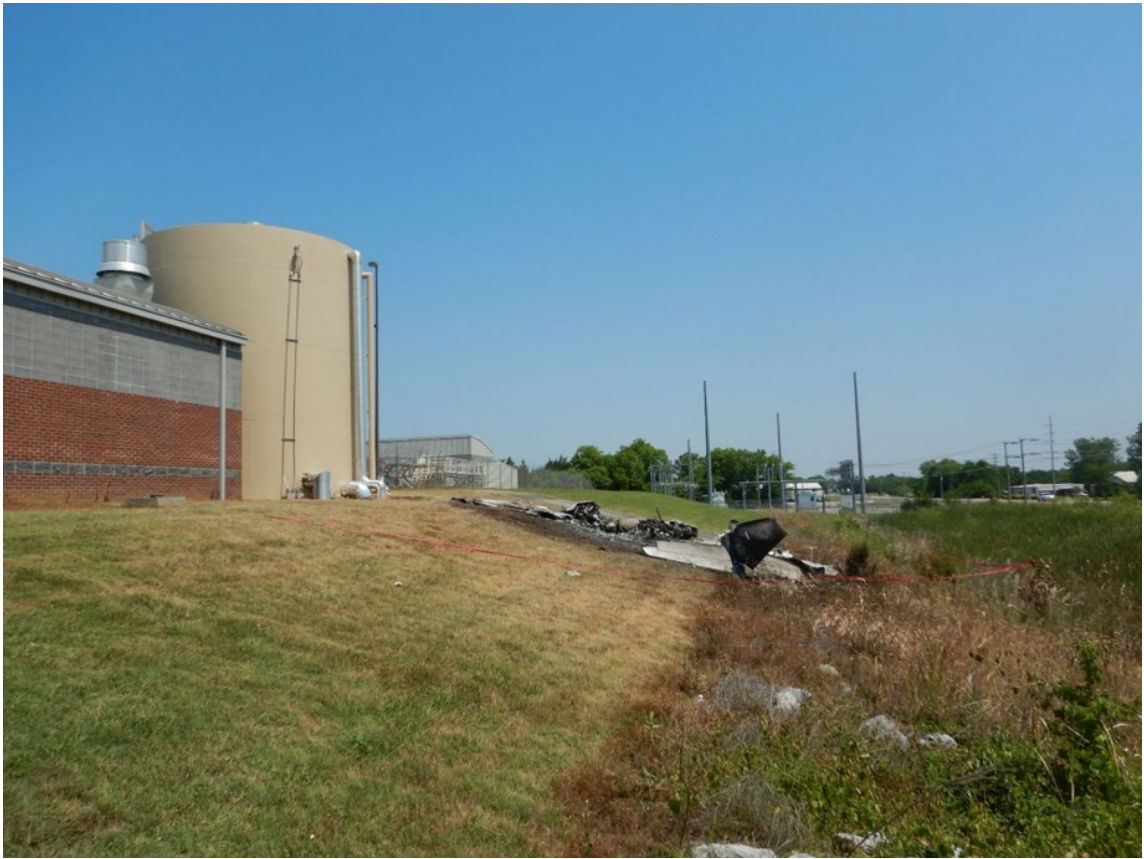
The airplane impacted on a grassy 25° sloped hill side which led to a drainage area with an elevation of 330 feet mean sea level, (msl). The first identified point of contact (FIPC) was an area of disturbed dirt about 1,524 ft east of the centerline of runway 36, east of two large fire suppression water tanks. Two additional impact craters, consistent with both engines, were located at the FIPC and the right crater was about 3 ft northeast of the FIPC. The left main gear was embedded within the terrain and the right above ground in the burned fuselage. The debris pattern remained within 70 feet of the FIPC and mostly consisted of windshield fragments that were scattered in a rotating impact pattern north and south of the impact site.

**Figure 1: View of accident site north view**

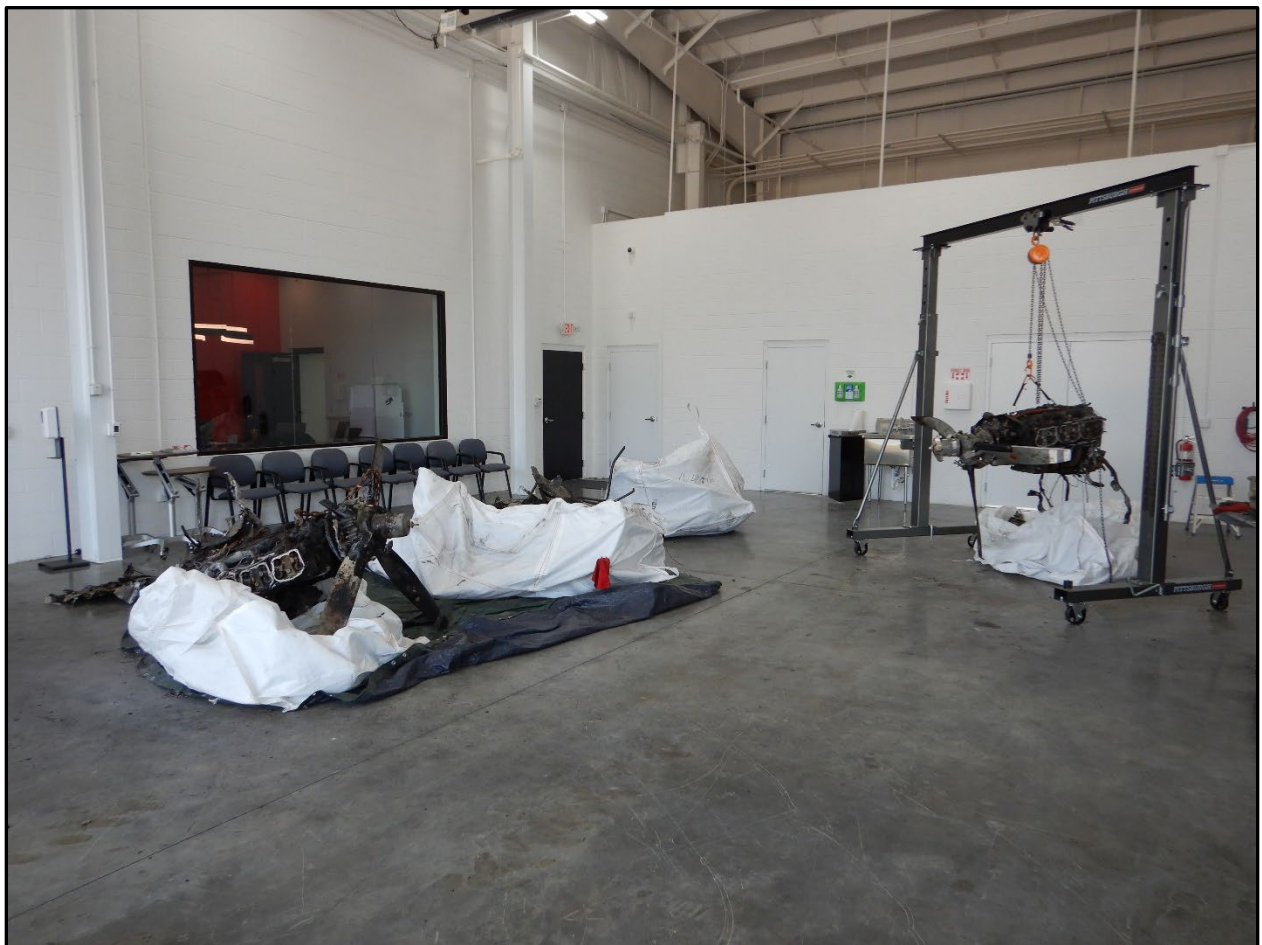
**Figure 2: View of both engine during the examinations**
