# National Transportation Safety Board

WPR23FA219

## INVESTIGATION MATERIALS SUPPLEMENT

Location: Rio Vista, California  
Date: 06/08/2023  
Time: 1124 Pacific daylight time  
Airplane: Steen Skybolt

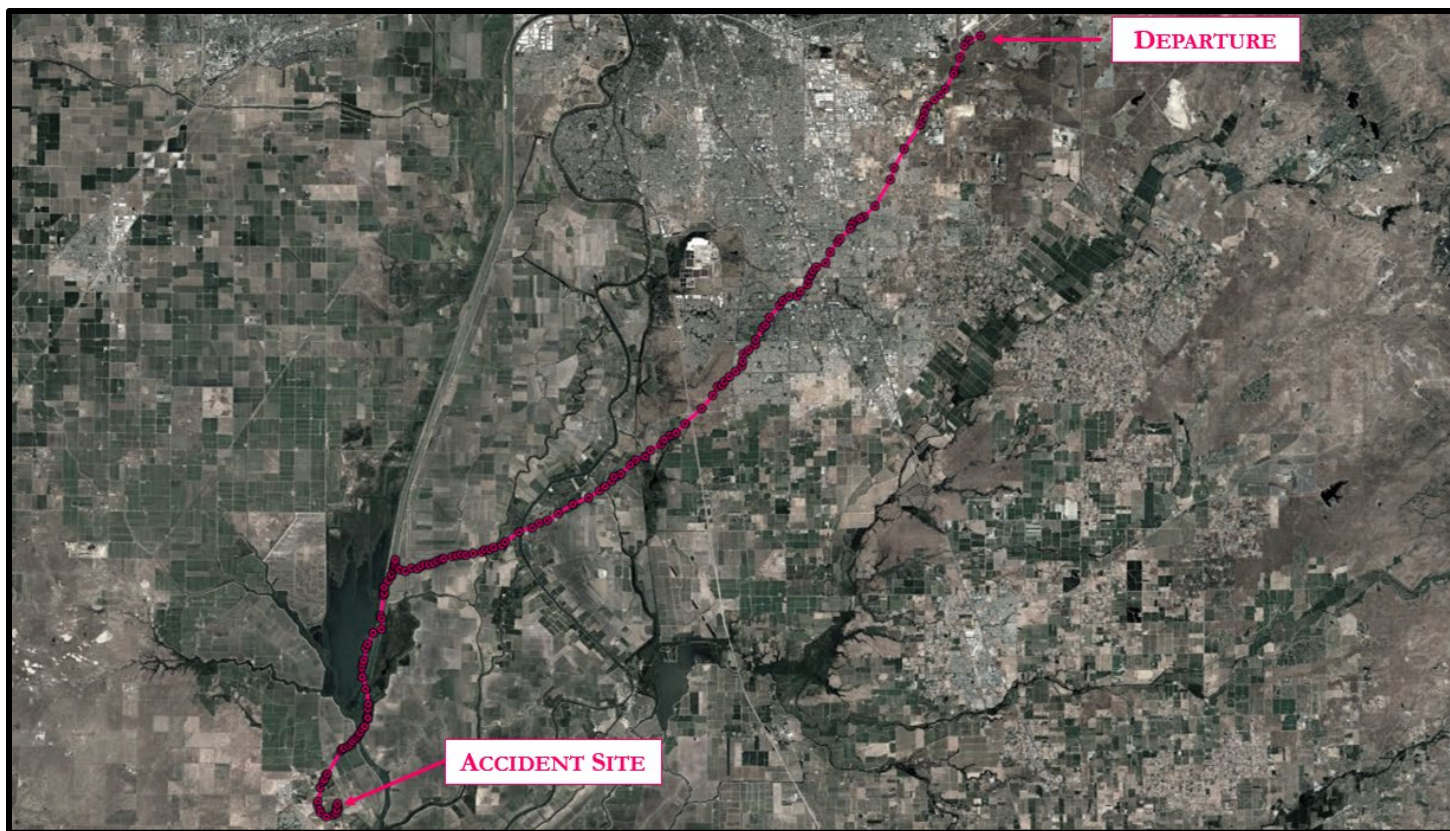
Figure 2: Flight track

Recorded radar data was obtained and reviewed by a National Transportation Safety Board investigator. Recorded radar data covering the area of the accident was examined for the time frame, and a primary beacon code target was observed that terminated near the accident site and started near the airplane's known departure. The radar data consisted of about 25 minutes of returns from 1059:09 to 1124:20. The returns were consistent with the airplane flying in a southwesterly direction. At 1115:30, the returns are clumped together, consistent with the airplane making a 360° turn or maneuvering. At 1116:15, the returns begin to follow a more southerly path along the Sacramento River Deep Water Ship Channel. The returns then became sparse and continued on a flight path over the middle of the airport. The returns make a left bank consistent with adjoining the downwind and then the left base leg of the traffic pattern to runway 25. The returns then make a left hook-shape at the end of the track, consistent with a spiral.

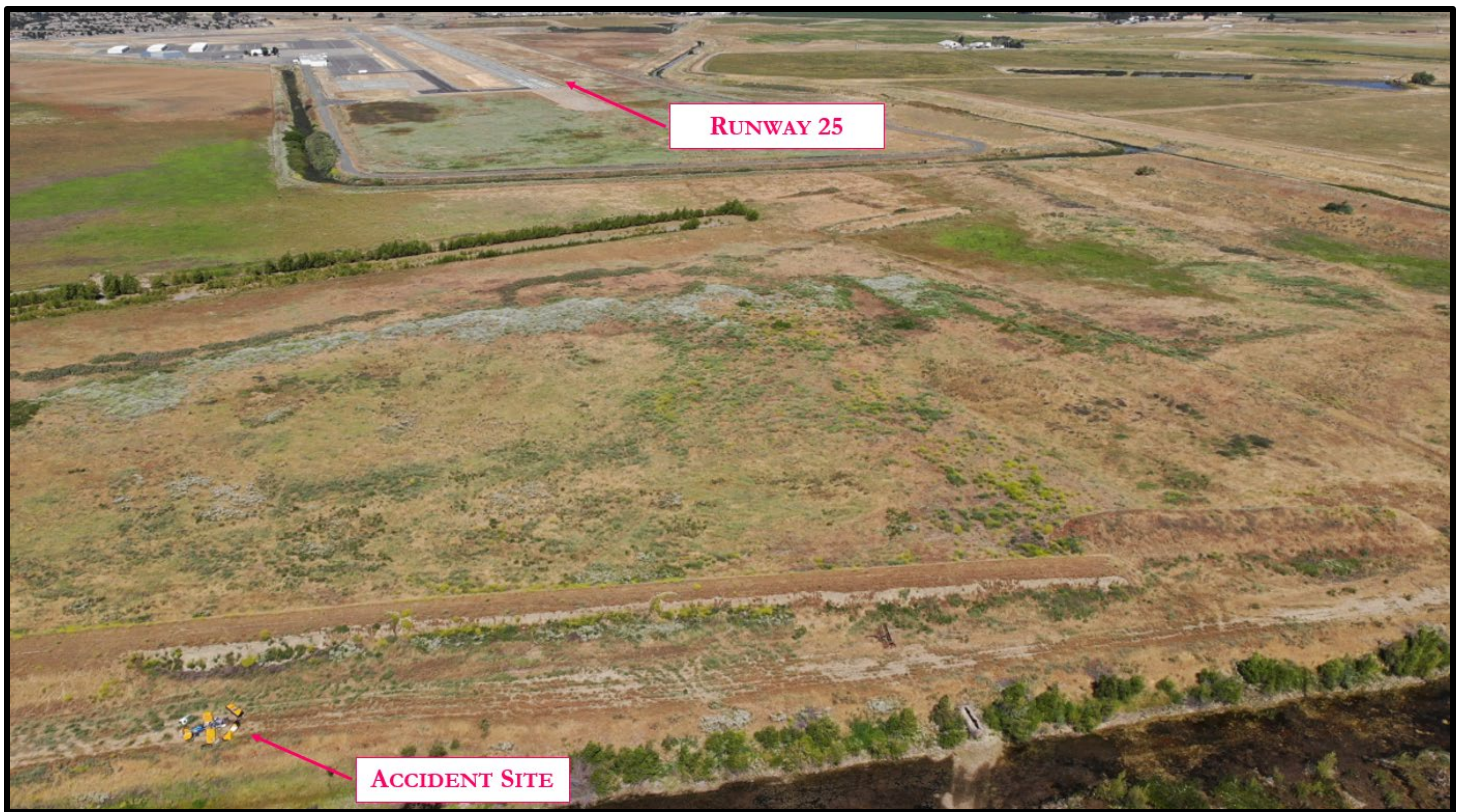
*Figure 8: Accident site in reference to the runway*

The accident site was located about 2,615 feet from the beginning of runway 25 at the following coordinates: 38.1928796, -121.6860844. The wreckage was found distributed over about 45-feet on a true heading of 350°. The nose was pointed on a median true heading of about 20°. The first identified piece of debris was paint chips and air scoop from the lift side fuselage.

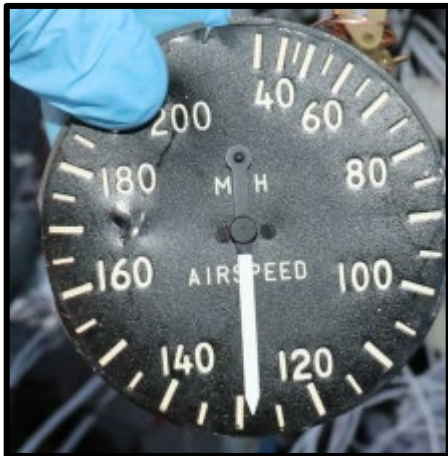
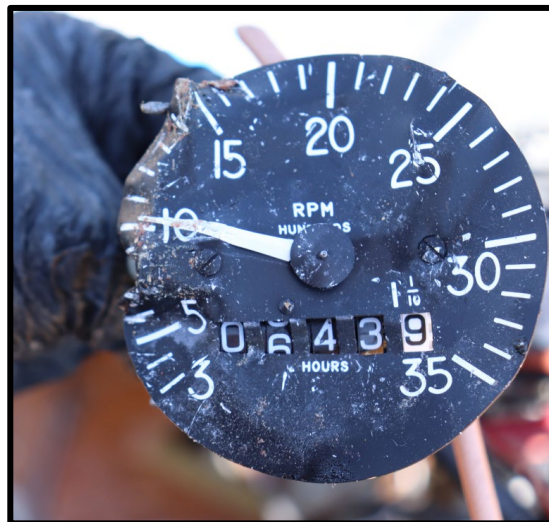
*Figure 10: Cockpit gauges*

Acceleration unit -1.2 and pegged out at +10, with a current reading at +5.4.

Altitude was set at 29.90

The airspeed was pegged at 128 mph

The vertical speed indicator was pegged at a climb of about 1,200

The oil pressure, CHT, oil temp all showed zero.

The fuel gauge was pegged just over half (which said 20 gallons total on the gauge).

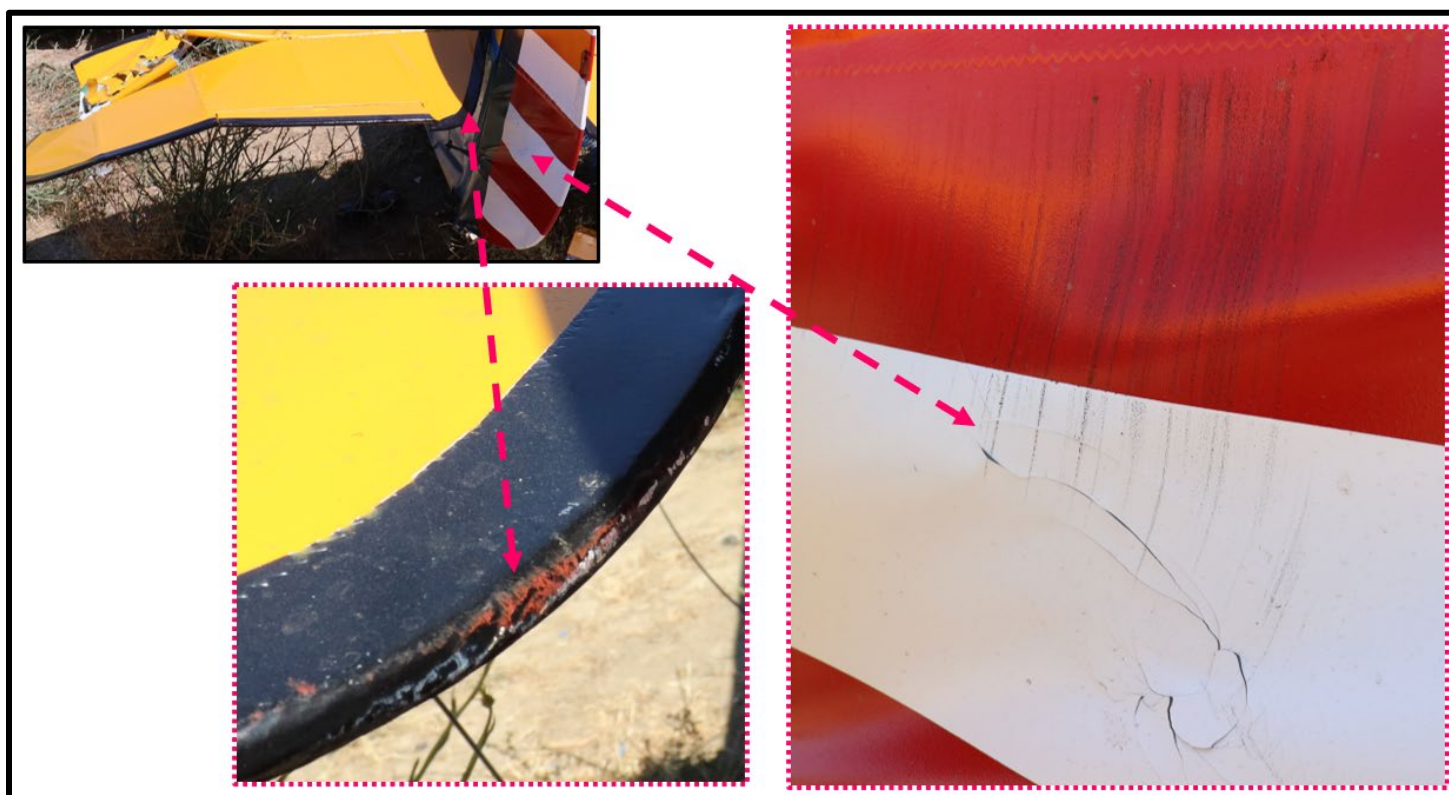
*Figure 11: Rudder control*

The rudder and elevator control cables were continuous from the cockpit to their respective attach fittings. The rudder control horn moved freely, and its stops showed no damage. The elevator would not move freely, presumably due to severe aft deformation in the forward structure. The rudder's left side fabric displayed slight rubbing, and a corresponding rub mark was found on the adjacent left elevator, indicating contact between the two surfaces.

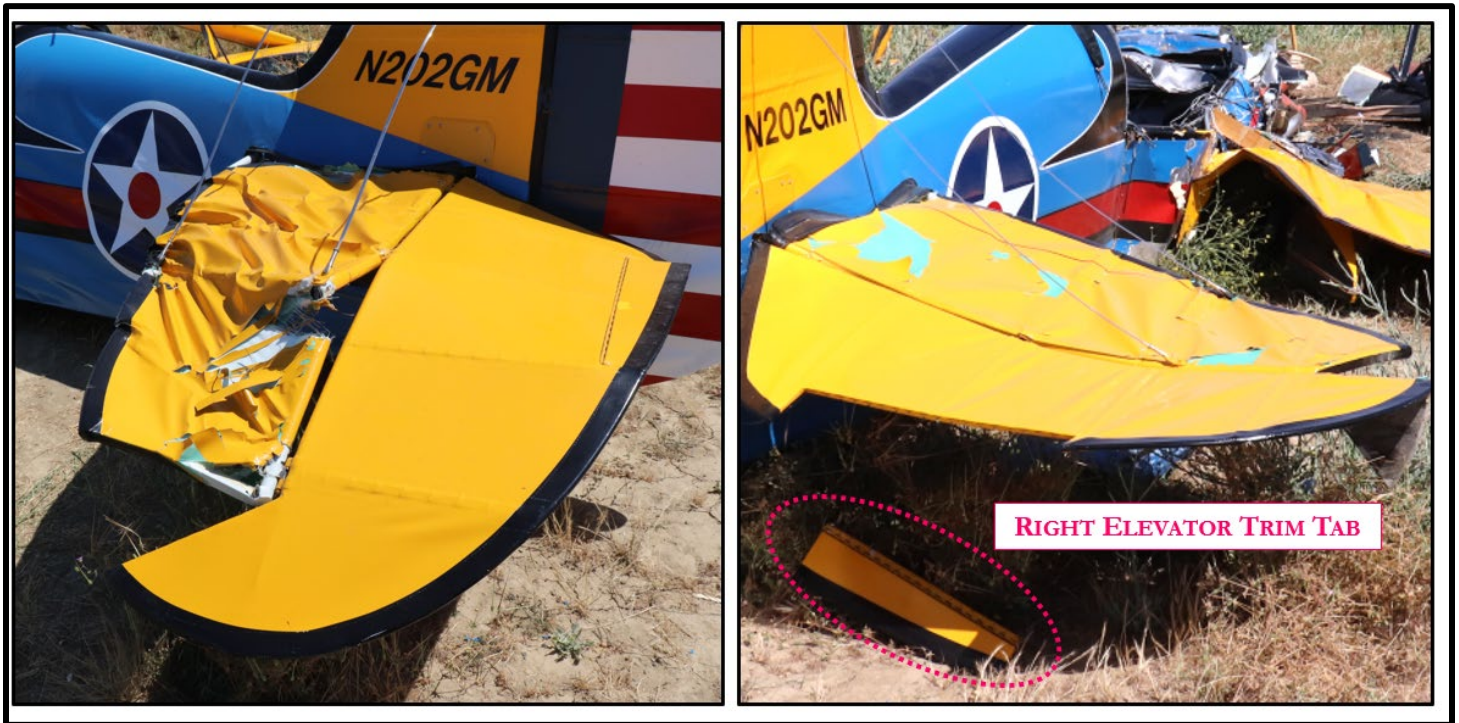
Figure 12: Trim tabs

The left trim tab stayed attached at its surfaces, and the control rod was continuous from the fuselage bellcrank. The right trim tab sheared off the piano hinge and lay under the elevator yet remained connected to the bellcranks and continuous to the fuselage bellcrank. Neither trim tab moved freely. The cockpit trim control, folded into the cabin, was still attached to the deformed frame, with its selector found in the neutral position. Moving the control to nose-down shifted the surface upward, but the control would not move toward nose-up, indicating binding. When attempting to move the control aft, the wires remained continuous to the aft bellcrank; however, a sleeve on the end attachment floated loosely and caused additional binding.

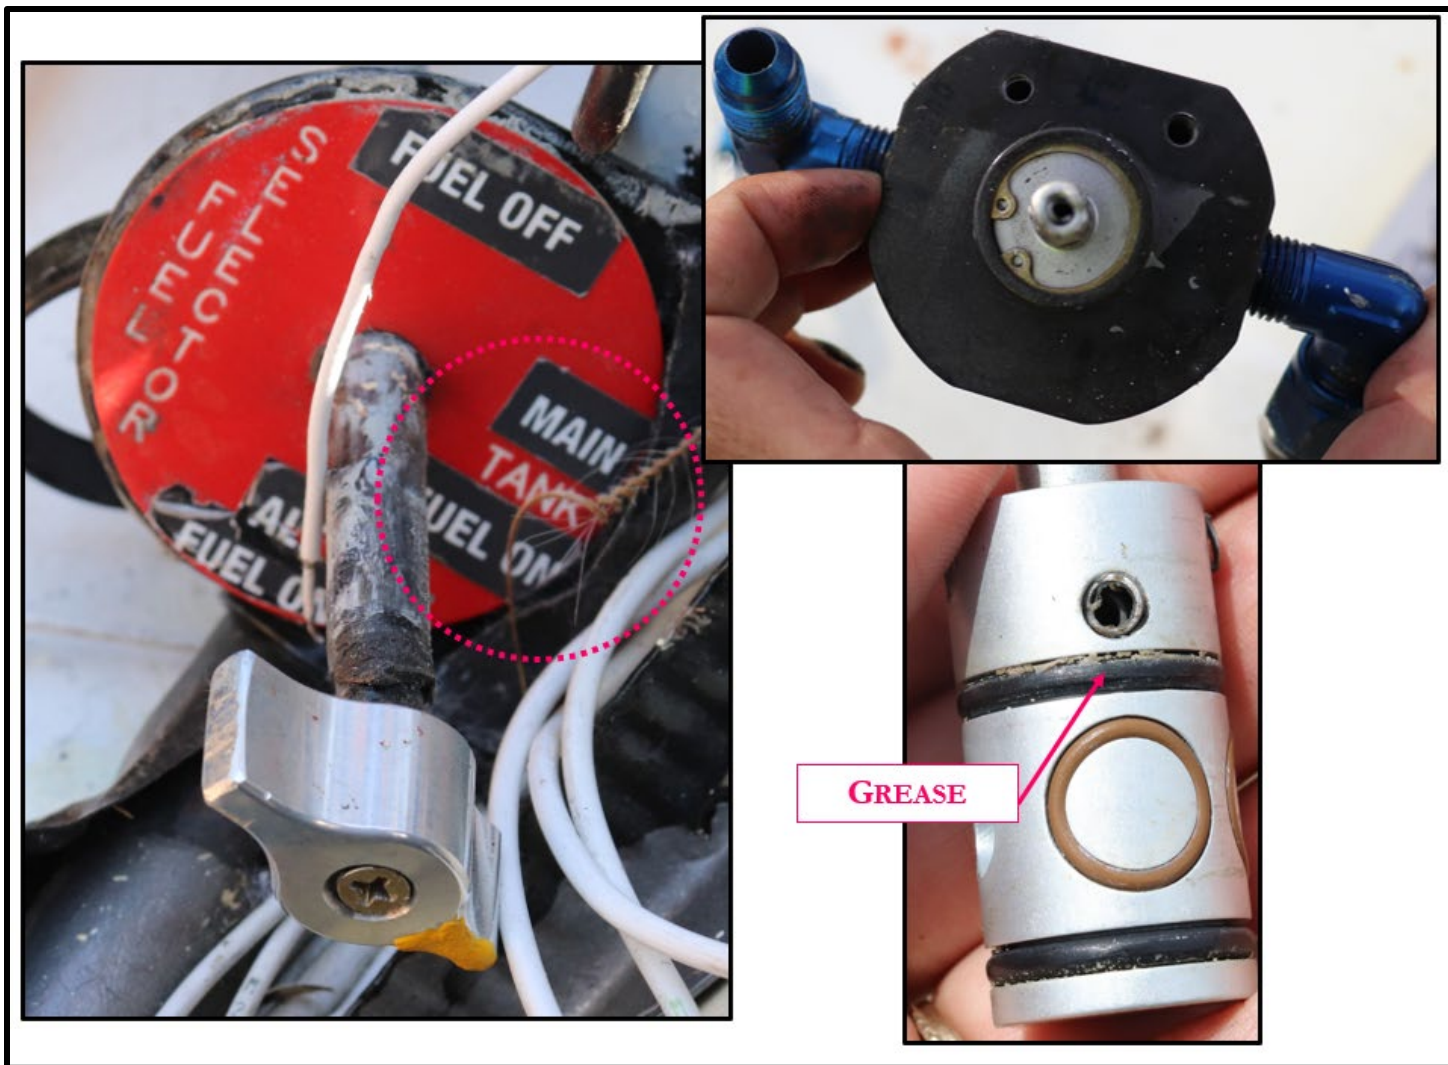
Figure 15: Fuel selector

The fuel selector was positioned on the main fuel tank position. There was no fuel found in the upper tank. Upon removing the fuel selector there was trace amount of fluid that came out of the lines. The blue liquid was consistent in odor with that of 100LL Avgas. A water detection paste showed there was no water in the liquid.

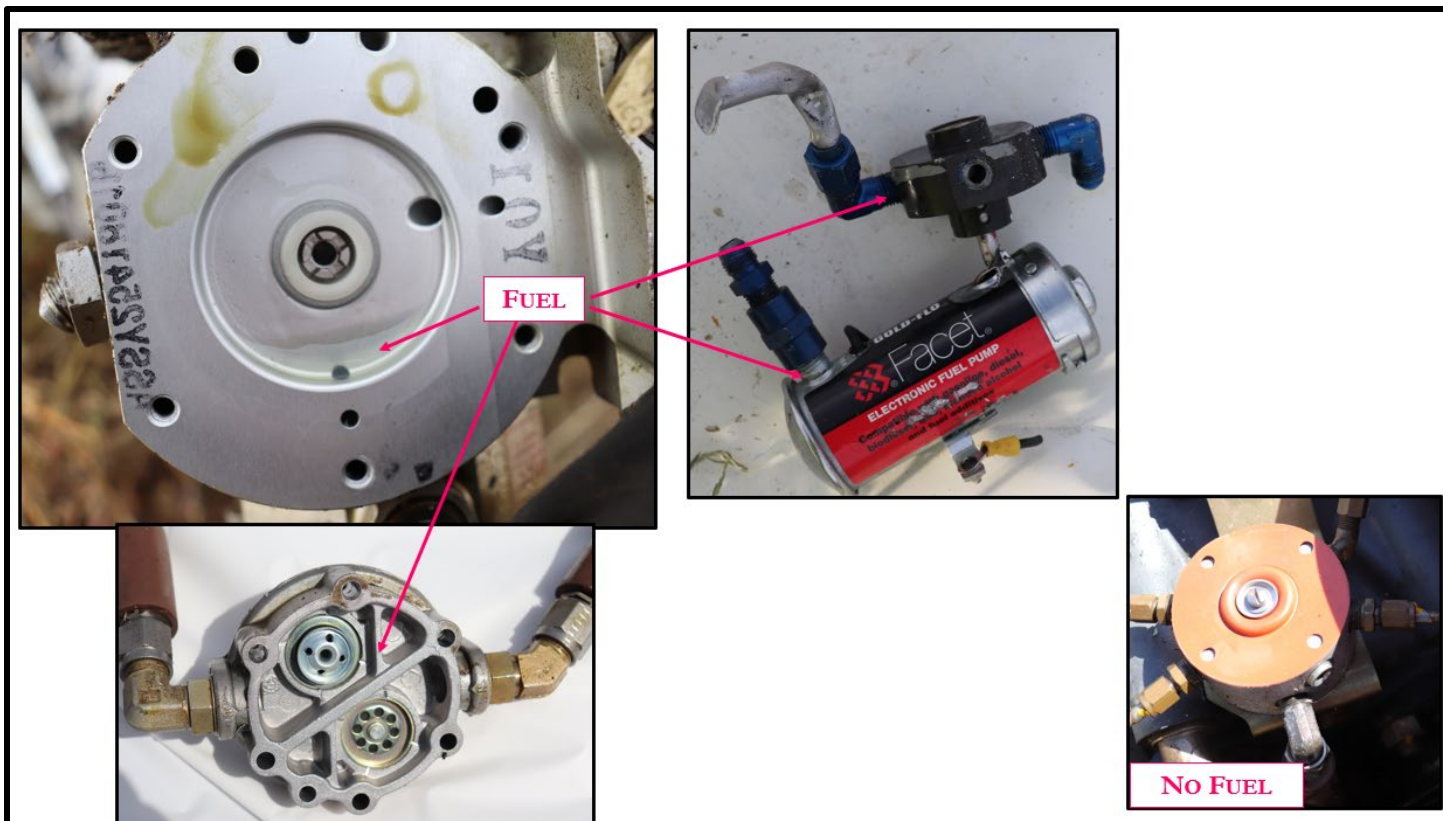
Figure 16: Fuel found in the fuel system

Removal of the faucet electrical fuel pump revealed there was fuel between the pump and gascolator. A battery was hooked up to the pump and it could be felt puffing out air and the motor could be heard. The gascolator was crushed open; the screen was clean of debris. The mechanical fuel pump was broken at the plunger. The cavity contained blue liquid and trace amounts of fine debris.

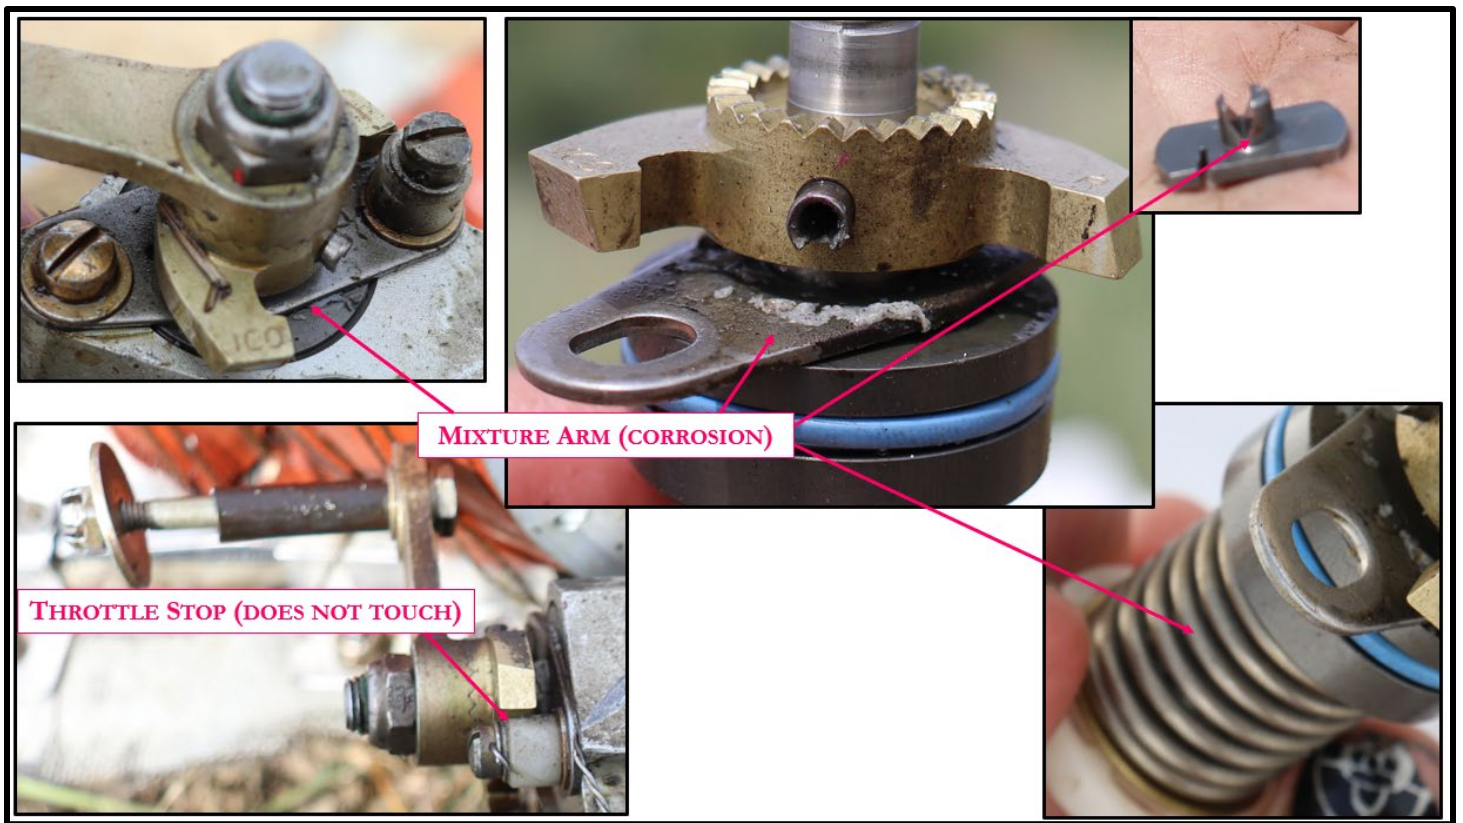
Figure 17: Fuel servo throttle and mixture arms

The fuel servo, Precision EX-5VA2, was crushed up into the engine and fuel line was broken off. The throttle and mixture cables remained attached. The throttle did not move stop-to-stop and would slightly bind at the stop. The mixture was difficult to turn throughout the rotation. There was a white residue and debris at the base. Removal of the arm revealed that the spring and grommet were intact; the shaft appeared slightly bent. Disassembly revealed the diaphragm were intact. Trace amounts of fuel with small debris. There was corrosion in the servo.

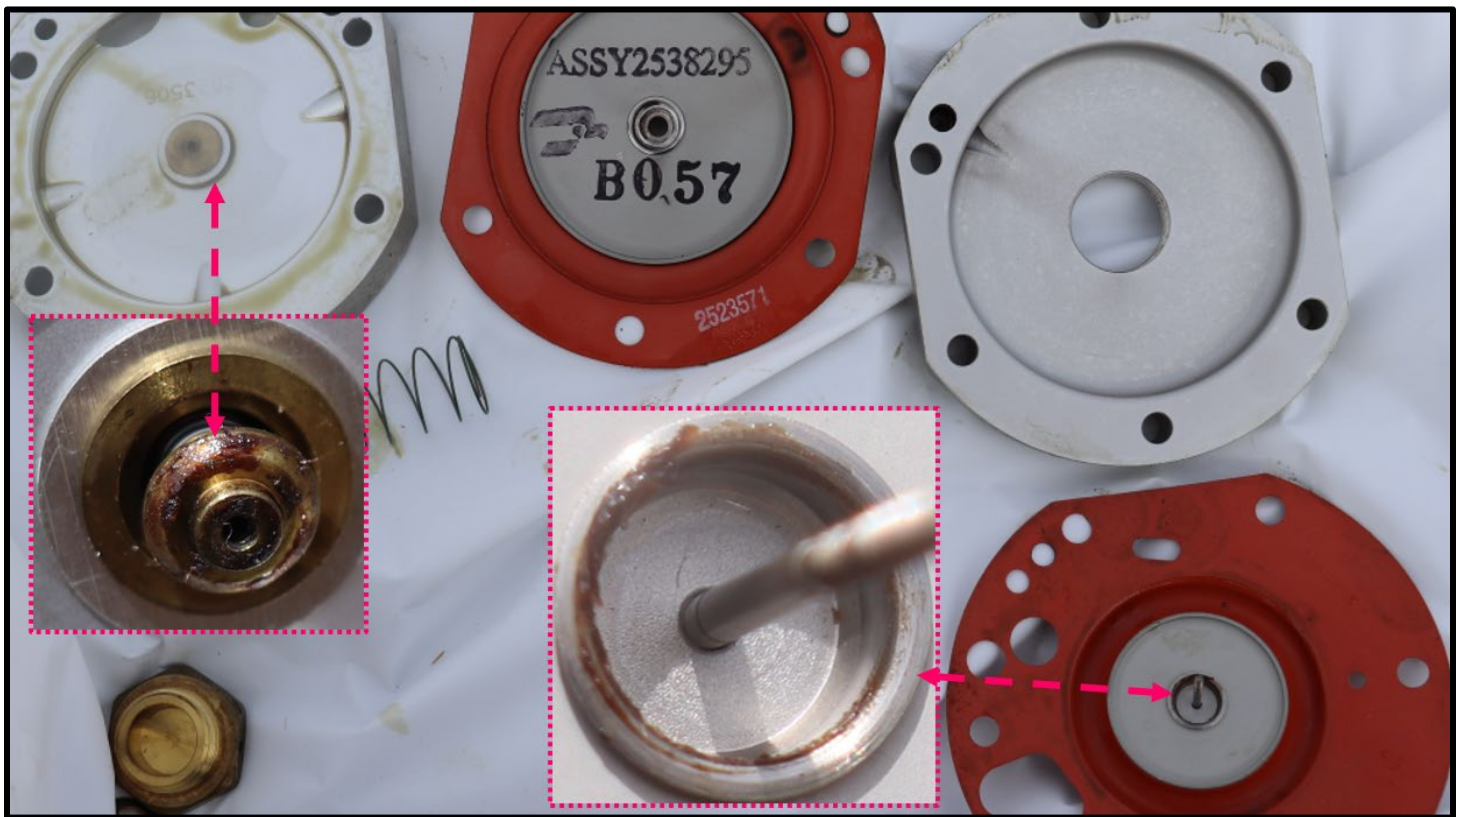
Figure 18: Air cavity of fuel servo

There was no fuel in the spider; the diaphragm was pliable and free of tears. There was a trace amount of sandy/greasy debris in the bottom air-only cavity as well as an oily substance around it..

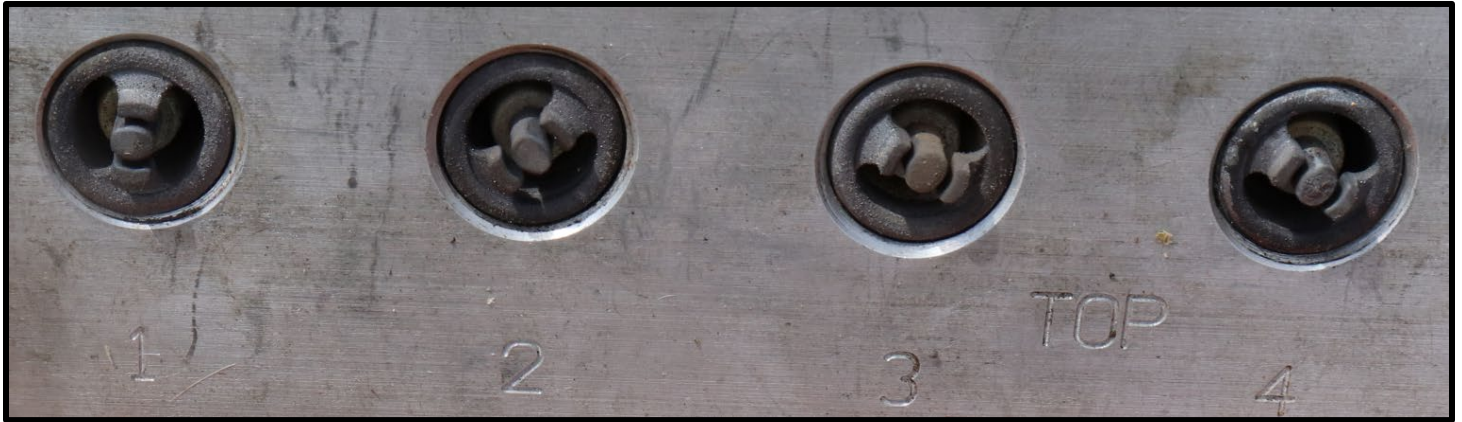
*Figure 19: Top spark plugs*

An external examination revealed multiple fractures in the crankcase, with the oil sump and intake manifold broken apart. Investigators removed and examined the top spark plugs. The spark plug electrodes were undamaged, and, according to the Champion Spark Plugs Check-A-Plug chart AV-27, were consistent with normal operation but in worn condition.

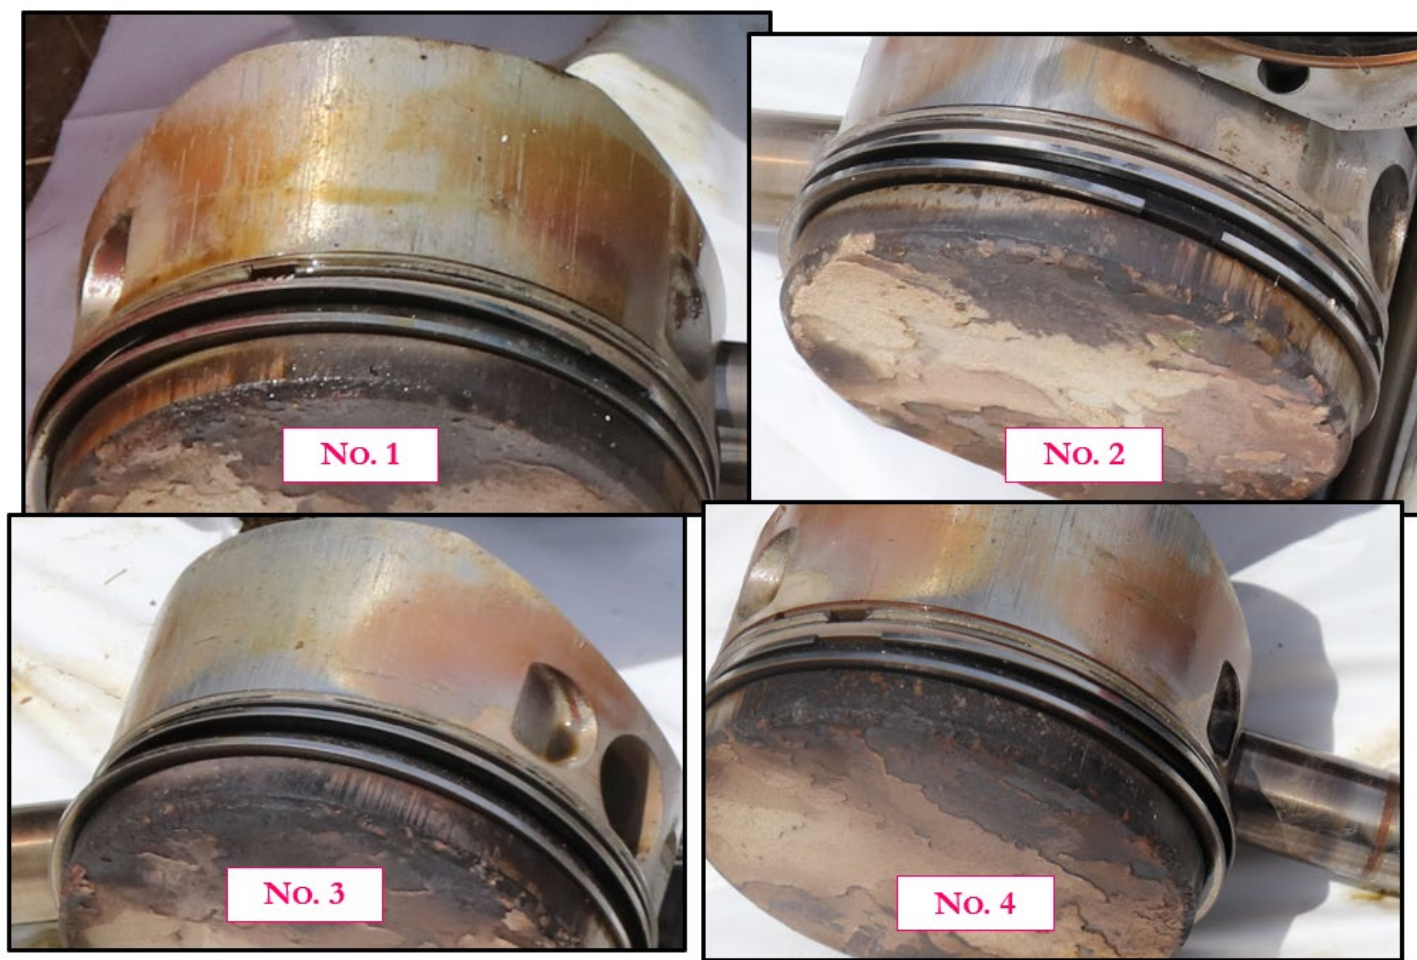
*Figure 20: Pistons skirts*

There was no evidence of valve-to-piston face contact observed. The pistons and their respective rings were intact. The piston skirts were dark in color and had numerous scuffs/grooves.

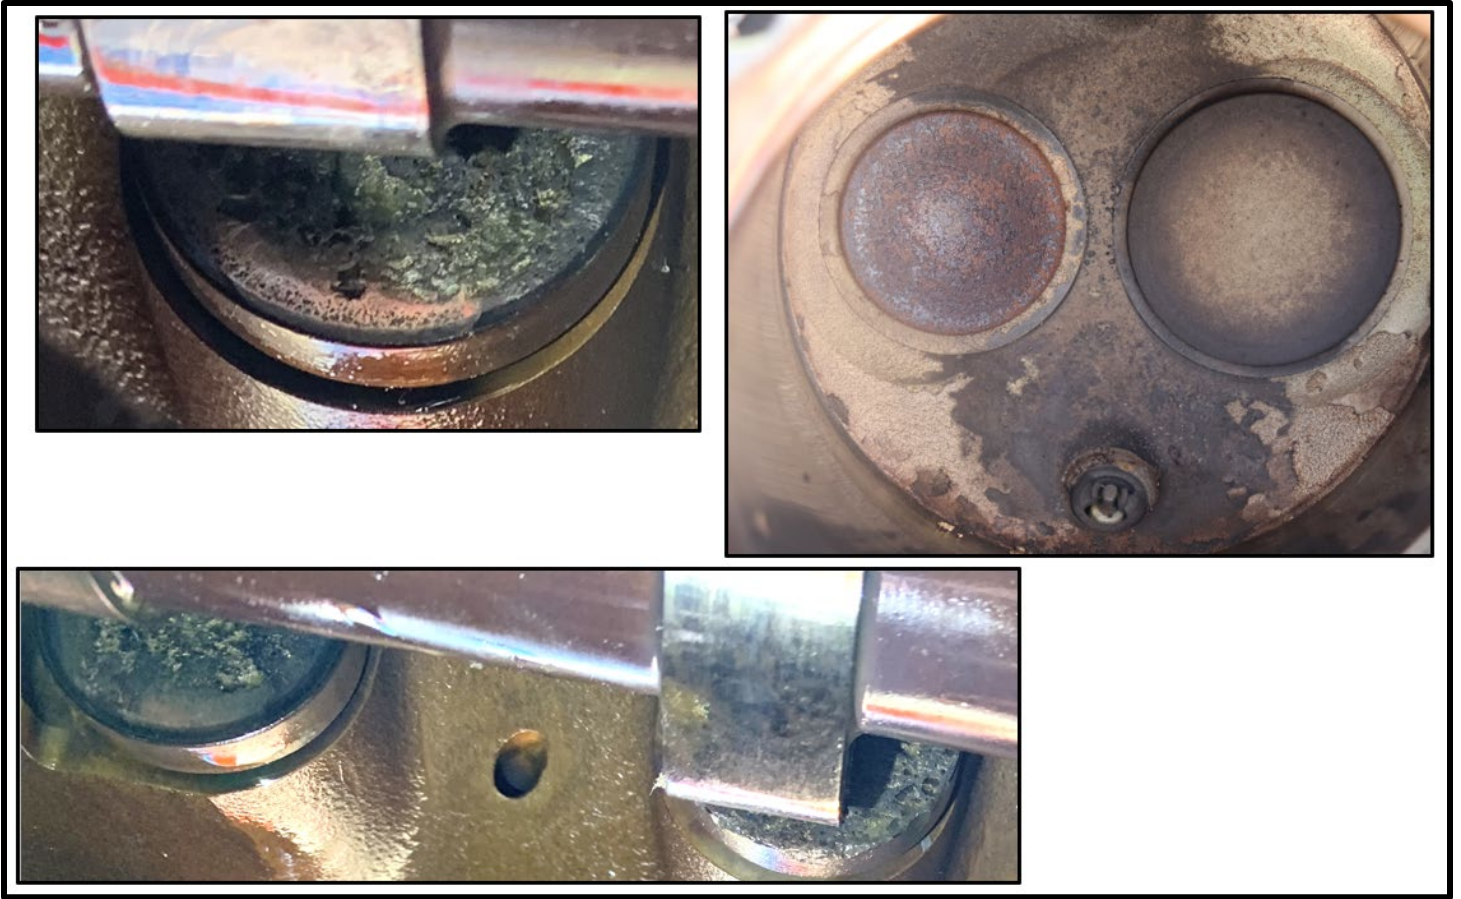
*Figure 21: Lifter faces and lobes showing #3 cylinder*

Removal of the pistons revealed that the cam lobes and lifter faces showed evidence of wear. There was severe spalling on the faces of all the intake lifters and several exhaust lifters; there was also evidence of galling noted. The camshaft lobes did not appear rounded and no material deformation was observed on the lobes.

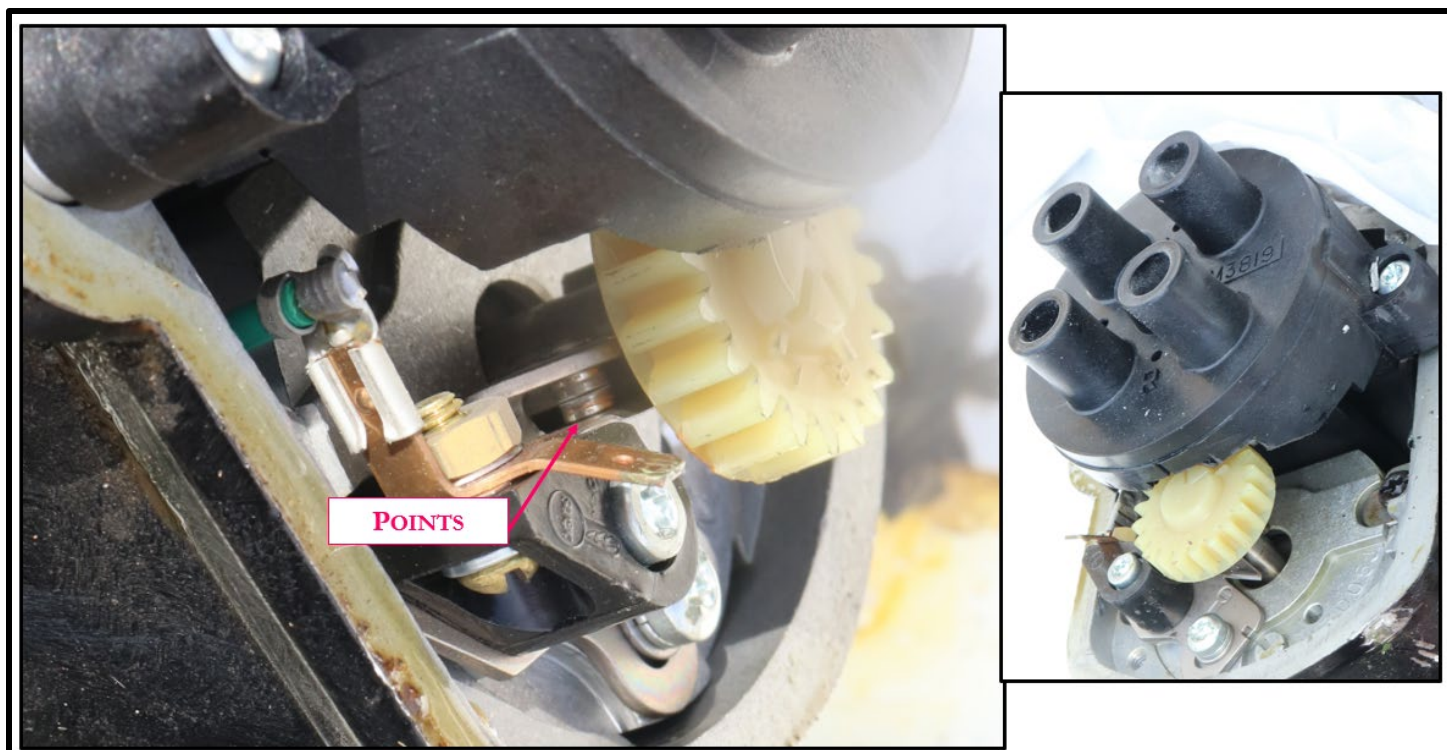
*Figure 22: Magneto*

Both magnetos were broken away from the engine and timing could not be ascertained. The magneto lead on the No. 3 cylinder was severed at the spark plug. Both produced spark upon rotation.

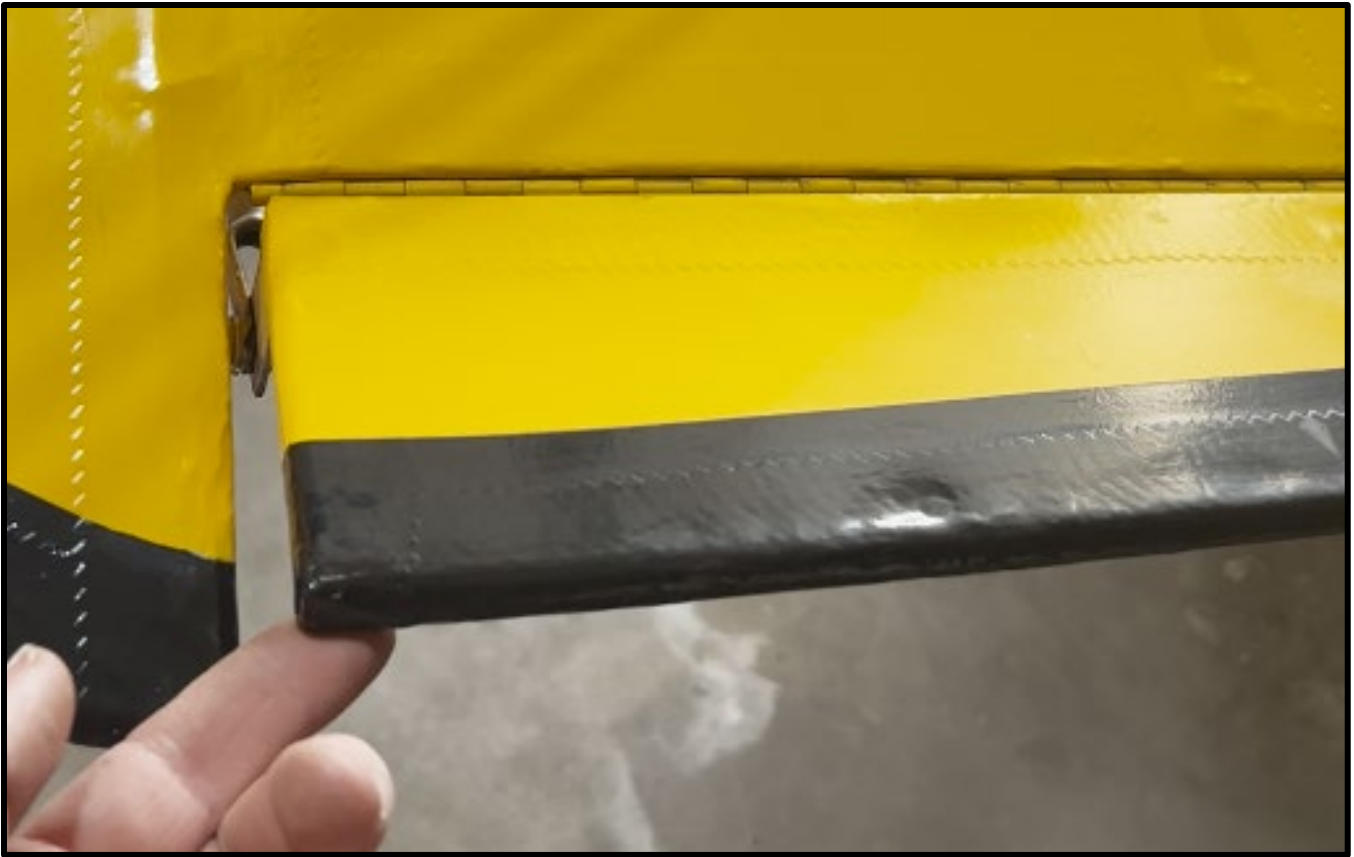
A 40-seconds video was located on the pilot's iPad that showed the pilot talking to the prior owner/builder about the airplane. The video was taken January 18, 2023. During the video, he narrates to the prior owner "here is what we found" and moves the right trim tab up and down. While moving it he says "see how much that moves."

*Figure 24: Excerpt of video showing the slack in the left trim*

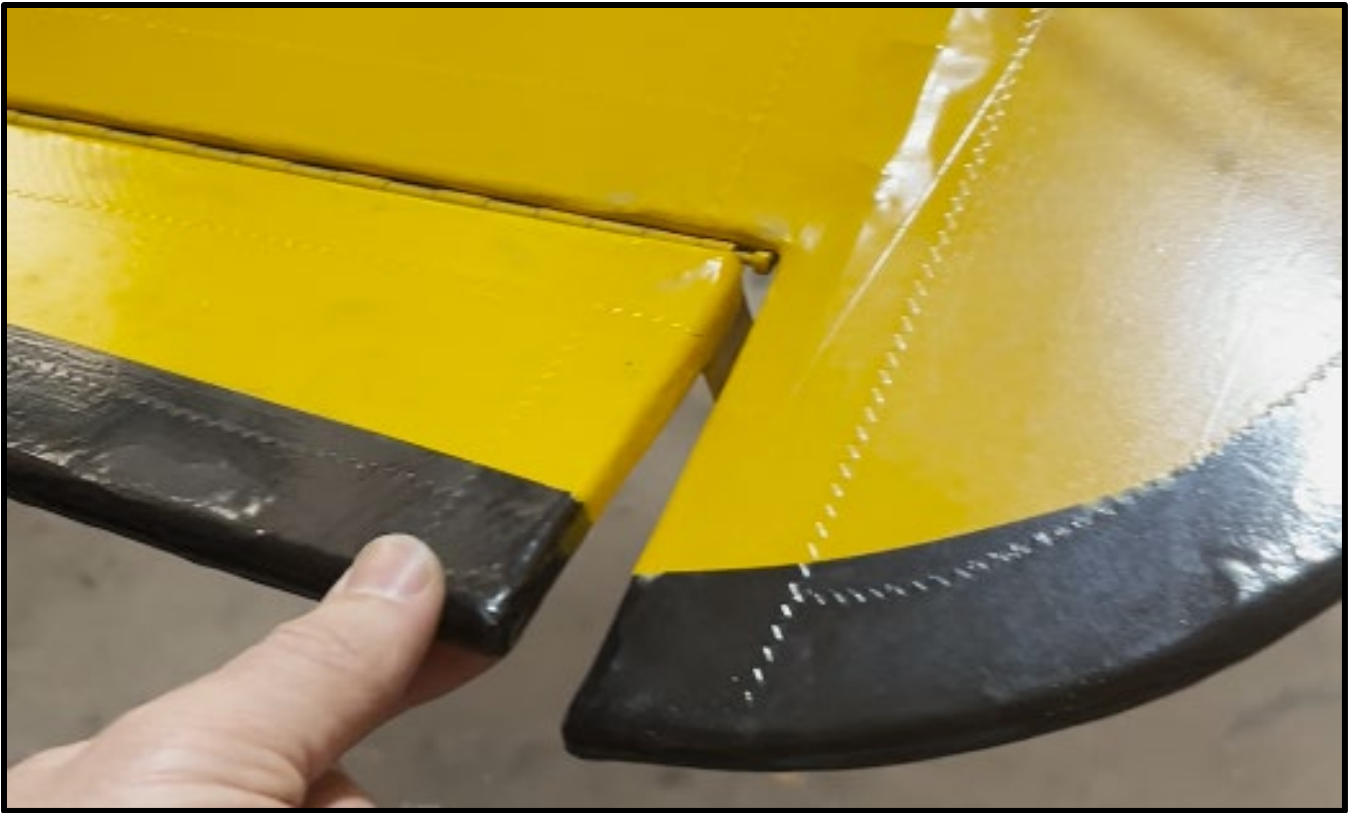
He then goes to the left trim tab and moves it in the same up and down manner and says “that’s stiff.” Then he goes back to the right trim tab and moves it again while saying that he believes that is “what the problem was... it just started oscillating” and “throwing the elevator up and down.” He then concludes that he found the problem and was going to fix it.

*Figure 25: Excerpt of video showing the left trim tab*
