ZOË KELIHER  
Sr. Air Safety Investigator  
Office of Aviation Safety – Western Pacific Region

The following is a summary of conversation:

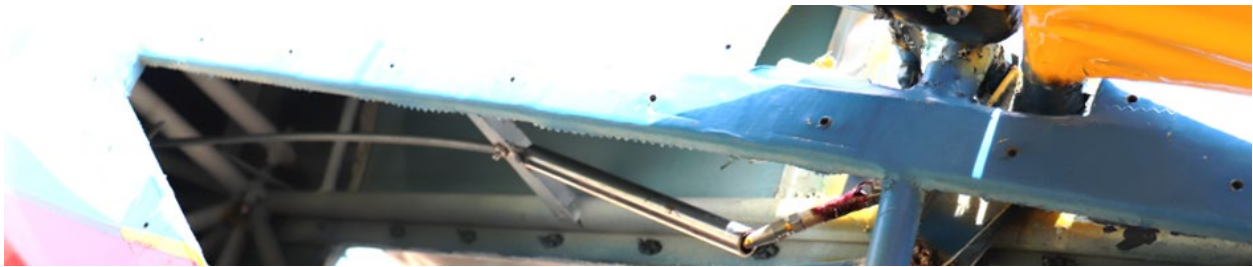
This is not what I installed. No tube, and no red grease. When talking with Jesse and Ben they did not bring up this modification. Very odd. I remember a conversation very early upon their getting it home in Nov. when they told me of breaking the canopy latch that they also backed the plane into something but did not elaborate as I recall.....perhaps they hit one of the trim tabs and pushed it down so hard as to bow or bend this section of cable and instead of replacing the cable the tube was put on to keep it from bowing.....(?).

Complete speculation here: Perhaps the 'backing in the hangar' damage resulted in a bent or kinked elevator trim control rod, and instead of replacing the control rod they put a tube over it and put red grease on where the end may have slid into the tube.

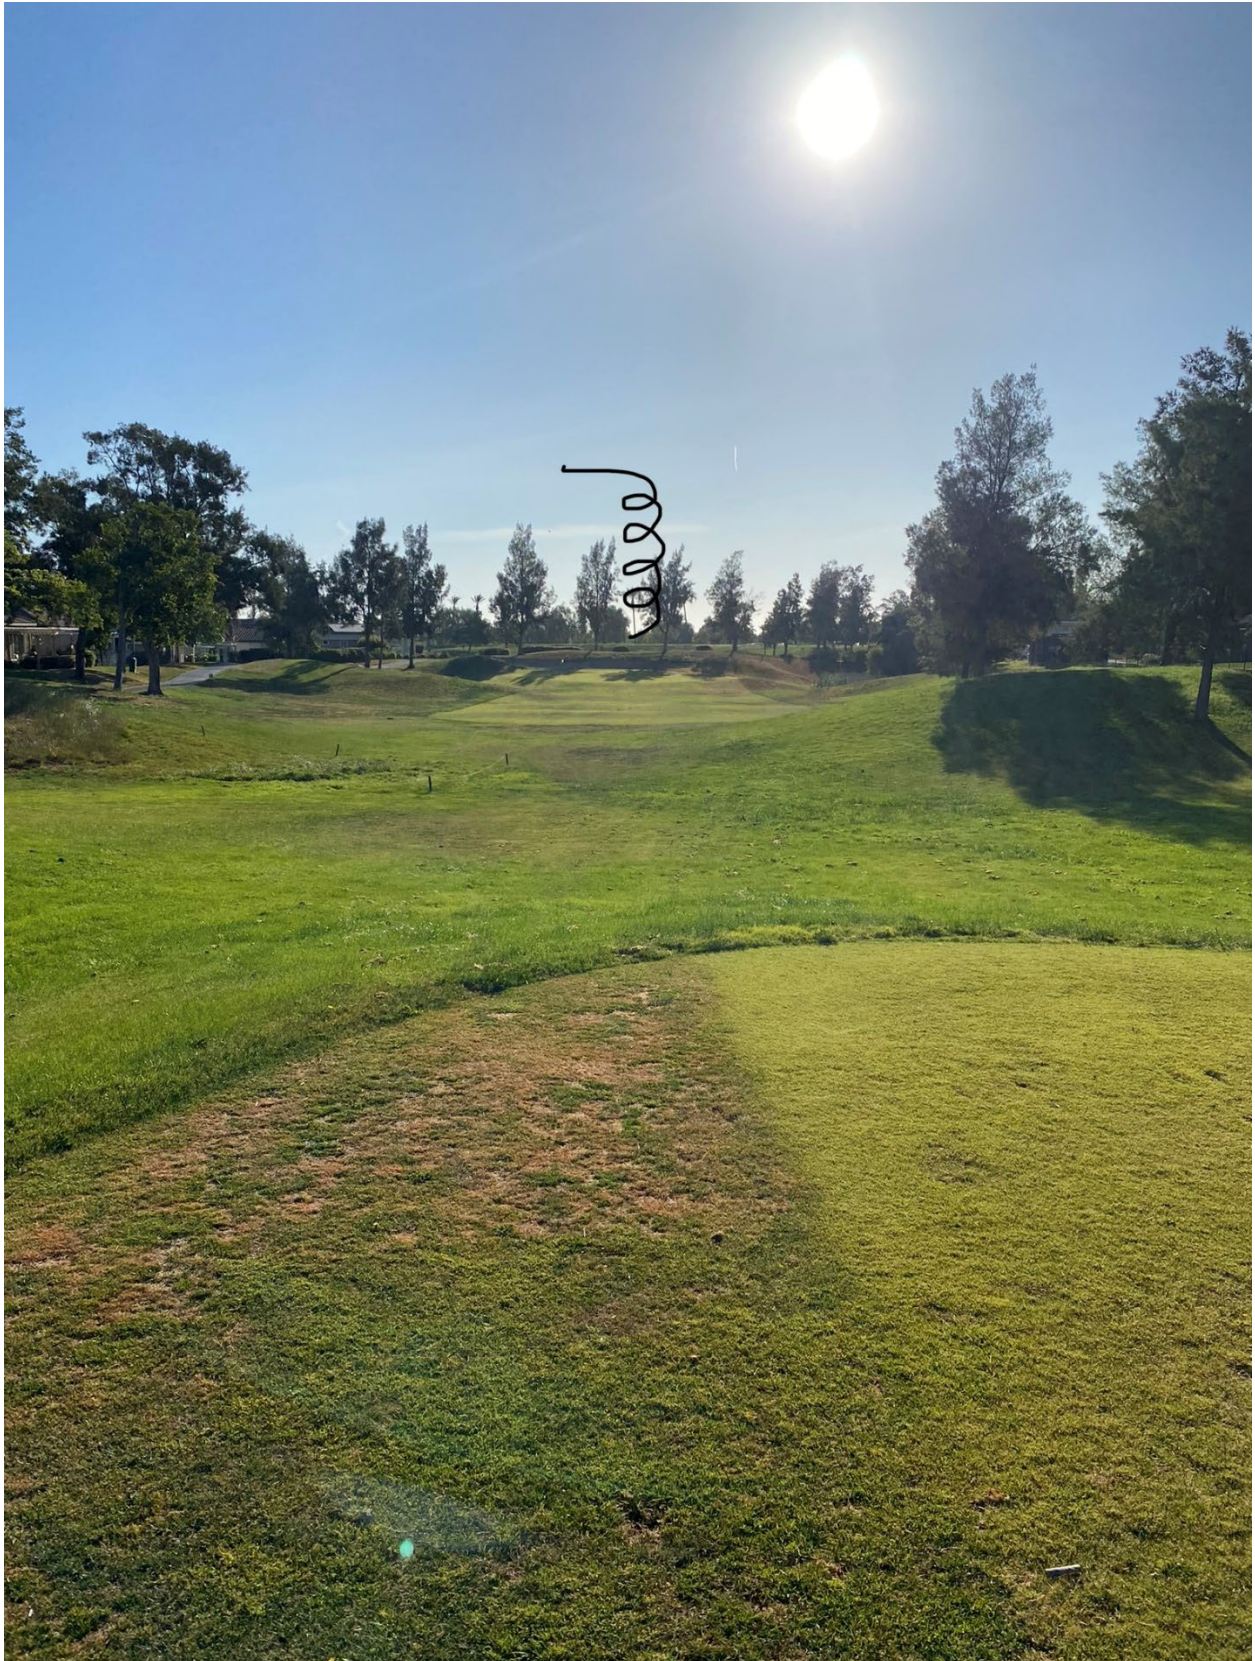
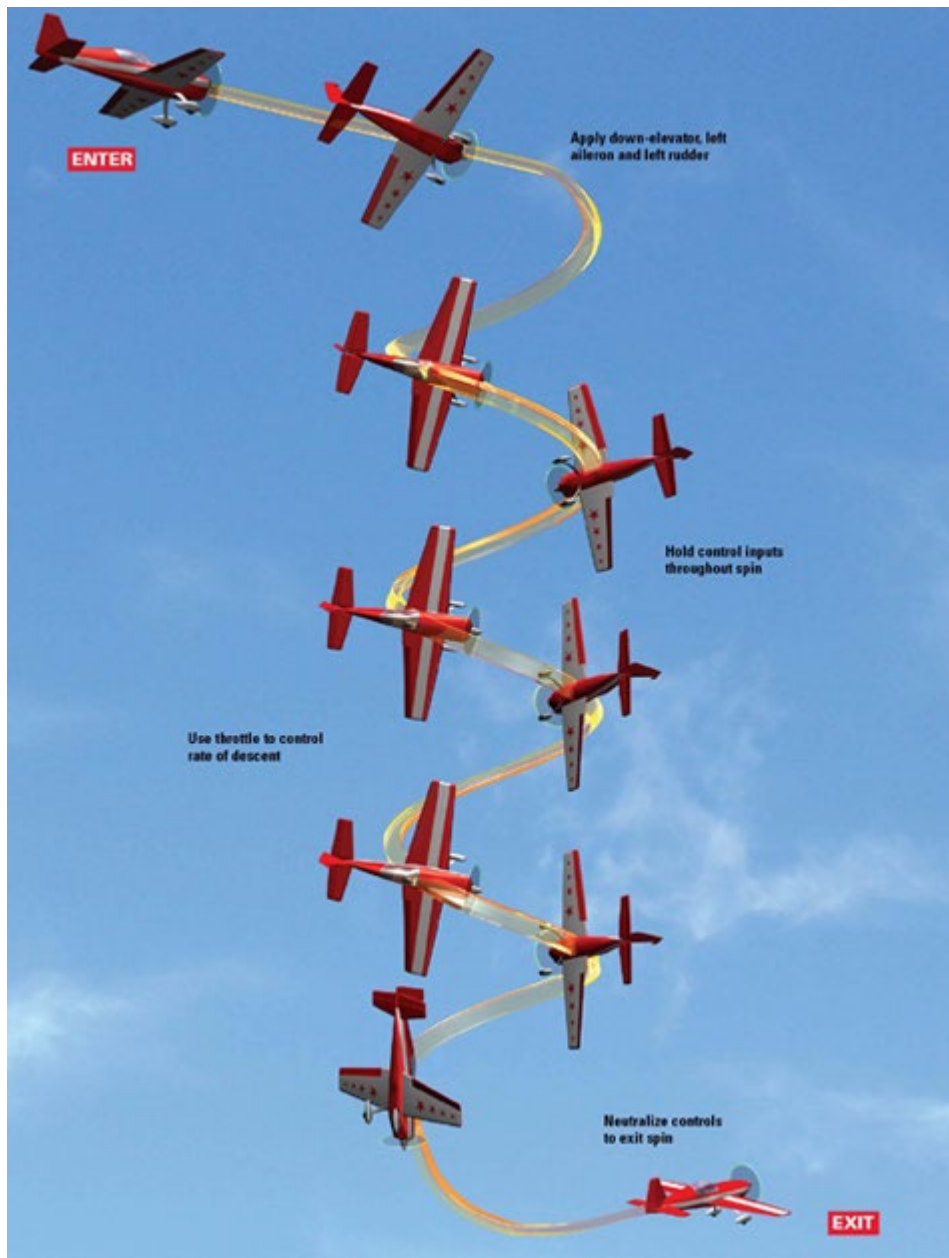
Attached are photos from where I was standing on the eighth hole and the best descriptive drawing according to what I saw, lined up directly with the trees in the palm trees in the distance

For which wing was down , the plane was traveling left to right and then the right wing started to go into a clockwise spiral .
