# National Transportation Safety Board

WPR23FA223

## **AIRWORTHINESS**

Location: Apache Junction, Arizona  
Date: June 10, 2023  
Time: 0751 Mountain Standard Time  
1451 UTC  
Airplane: COMPAGNIE DAHER, TB 30 EPSILON, N759F

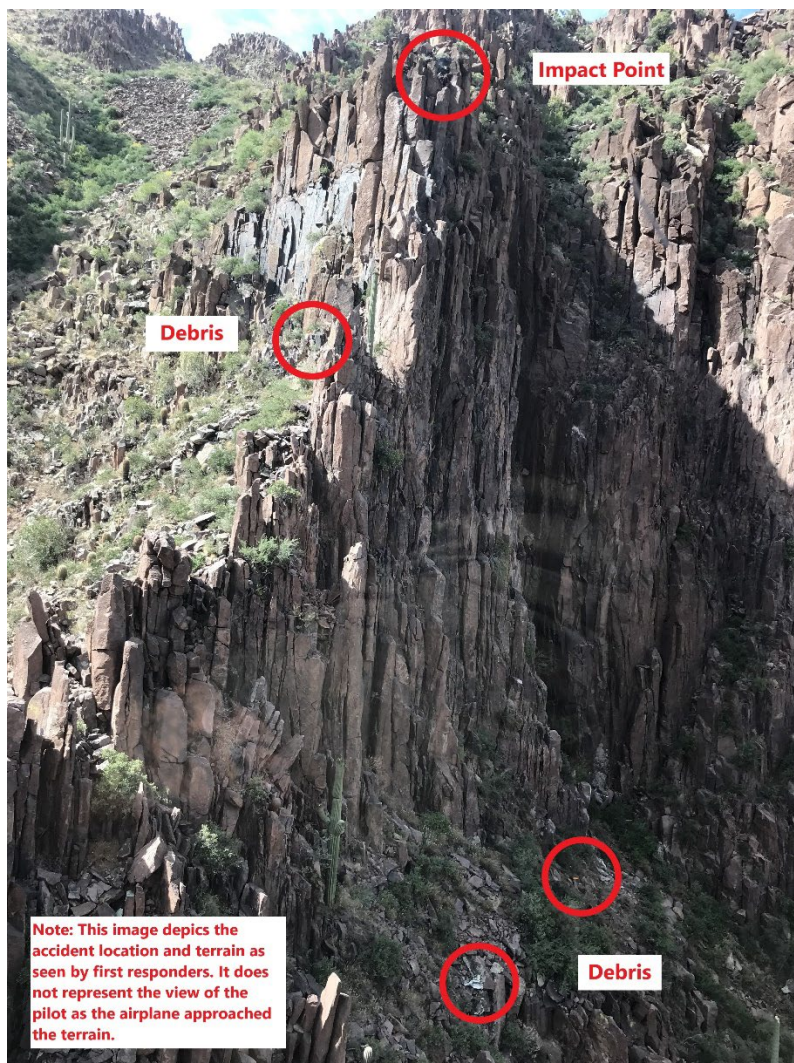
Figure 1 - Accident Site (Courtesy of Pinal County)

The accident site was not accessible by investigators due to rugged terrain. An aerial assessment of the accident site by a National Transportation Safety Board investigator the day of the accident revealed that the airplane impacted near vertical terrain about 200-400 ft below a ridgeline. The debris field extended about 200 ft downslope from the initial point of impact (figure 1).

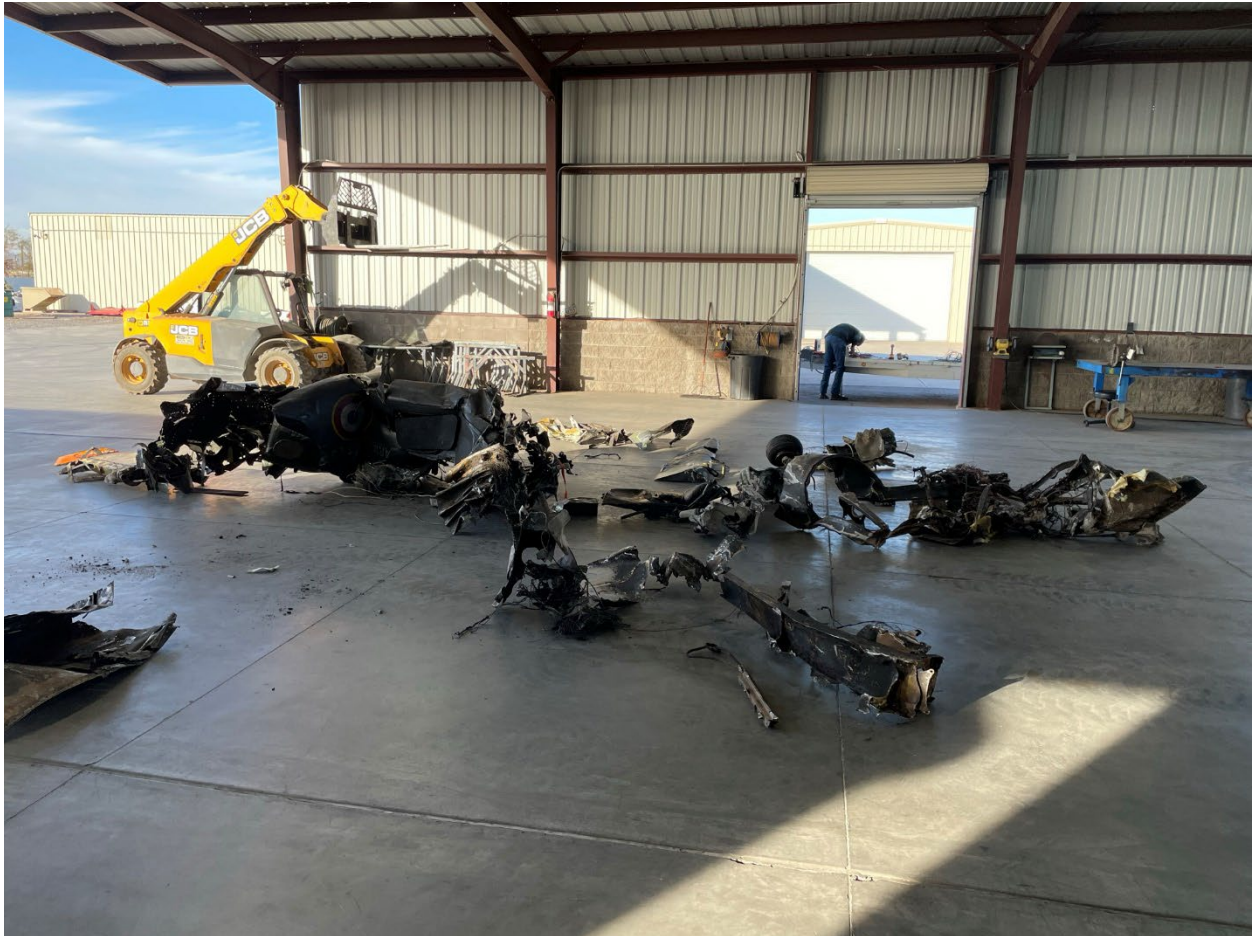
Figure 2 - Airplane Wreckage (Right Side)

The wreckage was identifiable as that from N759F. The wreckage was highly fragmented. The identifiable components included portions of the cockpit, the tail section from the wing spar aft to the vertical stabilizer, the left wing flap fragments from both wings, the left, right, and nose gear assemblies. The main landing gear appeared to be in the stowed position. The nose gear assembly was separated from the fuselage. Impact damage prevented determination of flight control continuity.

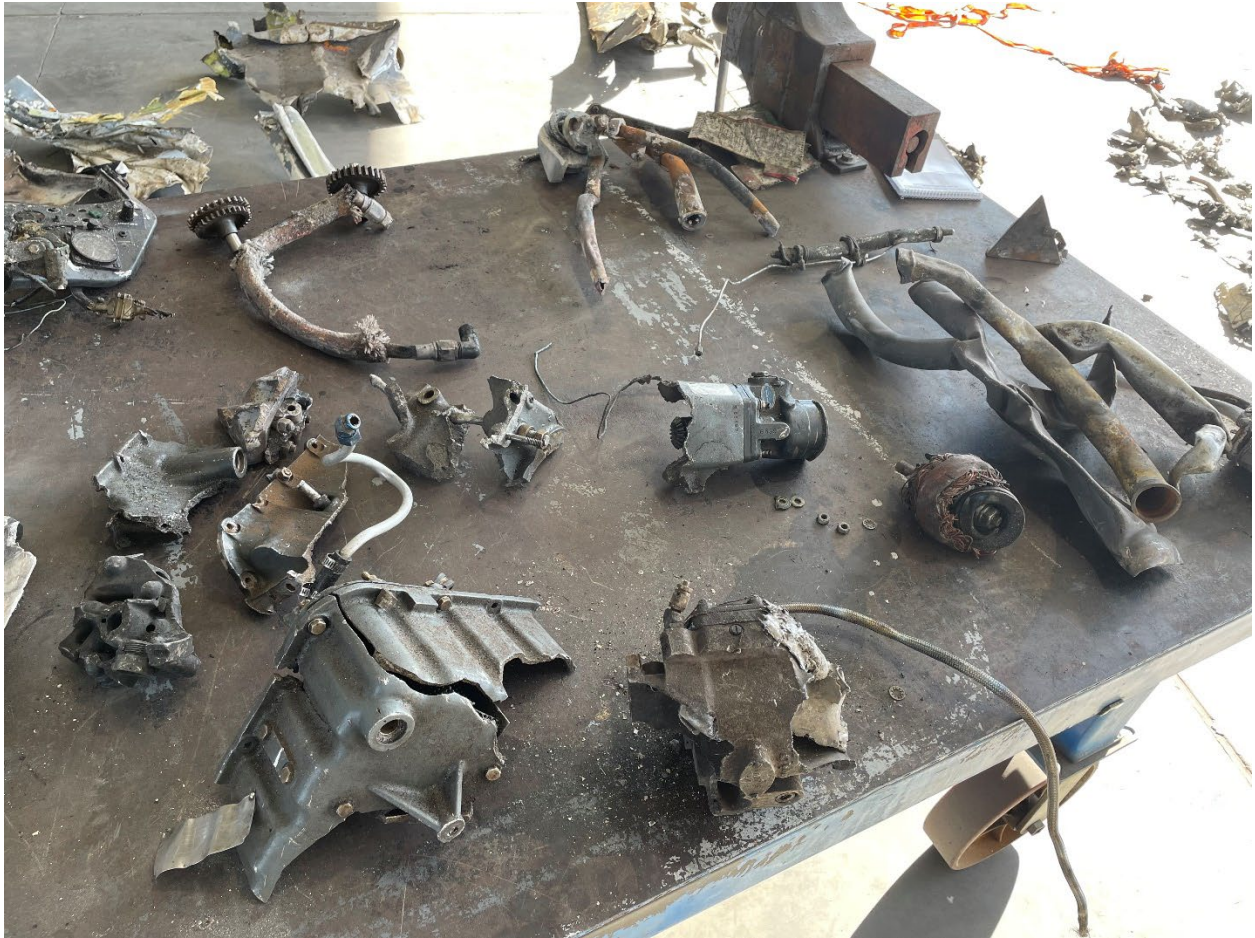
Figure 6 - Identified Engine Components

The engine was highly fragmented. Portions of the engine case, some accessories, and exhaust tubes were identifiable.

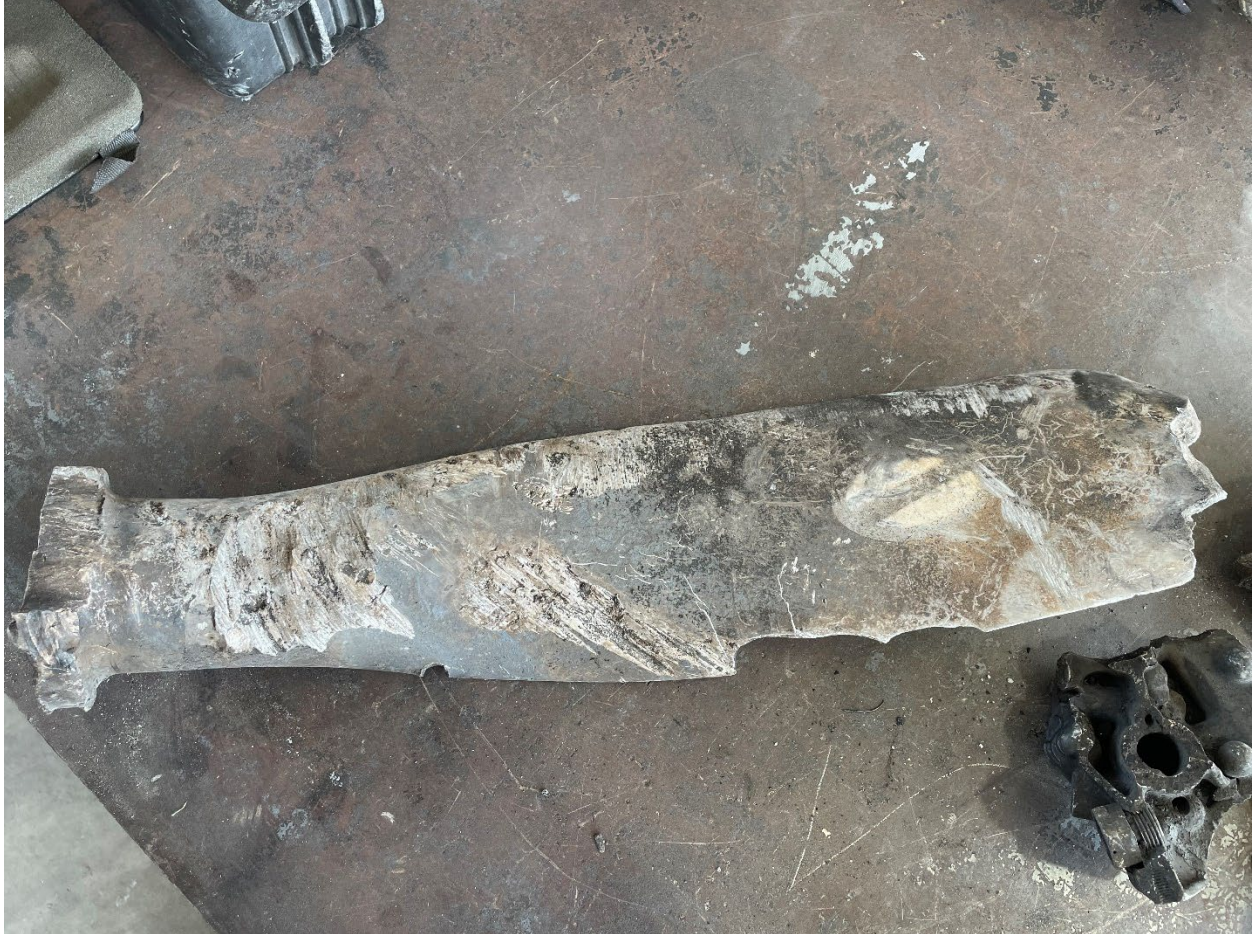
Figure 8 - Propeller Blade (front)

One propeller blade was identified. About 24 inches of the blade remained. Chordwise, leading and trailing edge scratches and gouging was evident on the blade.
