# National Transportation Safety Board

WPR23FA225

## **AIRFRAME AND ENGINE EXAMINATION**

Location: McCall, Idaho  
Date: June 12, 2023  
Time: 10:29 mountain daylight time  
Airplane: N3138C, Cessna R182

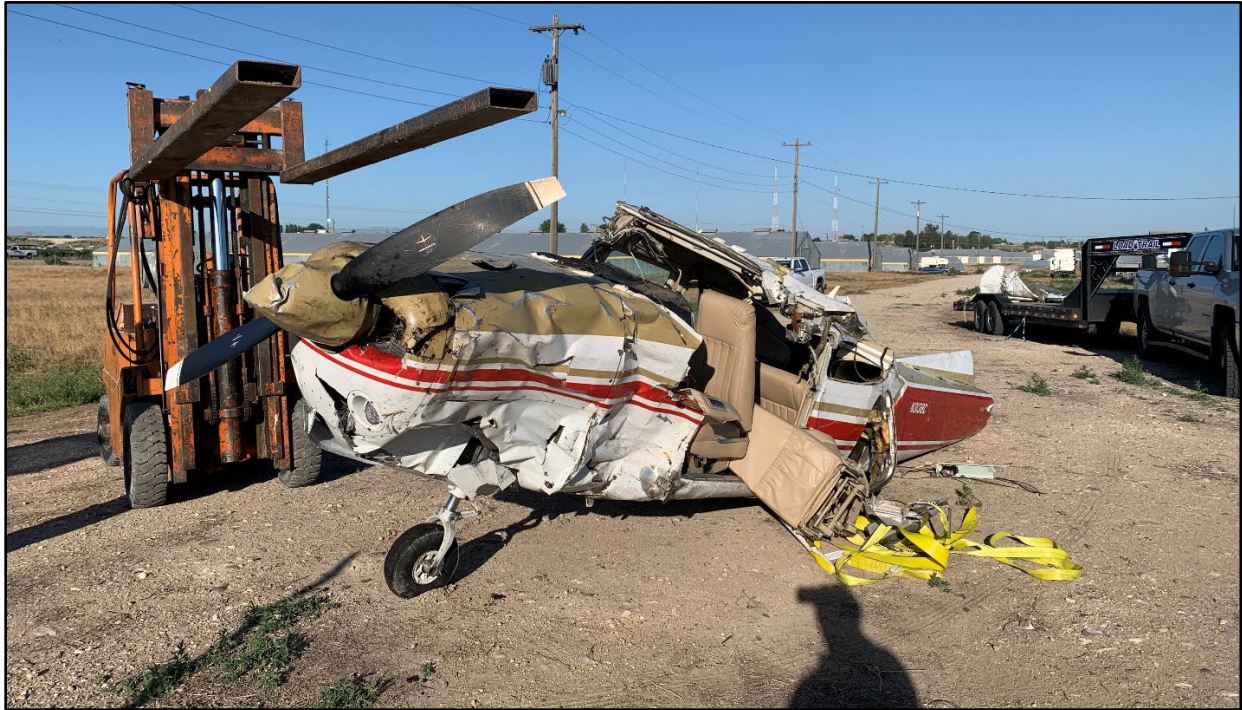
Examination of the recovered airframe revealed that both wings and empennage were separated from the airframe. The fuselage was mostly intact. The engine cowlings, engine and propeller remained attached. Crushing and bending was observed throughout the cowlings, consistent with impact damage. The forward left

section of the fuselage was impact damaged and displaced to the left. The landing gear remained attached via the fuselage mounts and was extended. The left main landing gear was fracture separated near the tire.

The forward section of the cockpit was impact damaged. The instrument panel was impact damaged with multiple instruments displaced.

**Figure 1: View of accident airplane during examination**

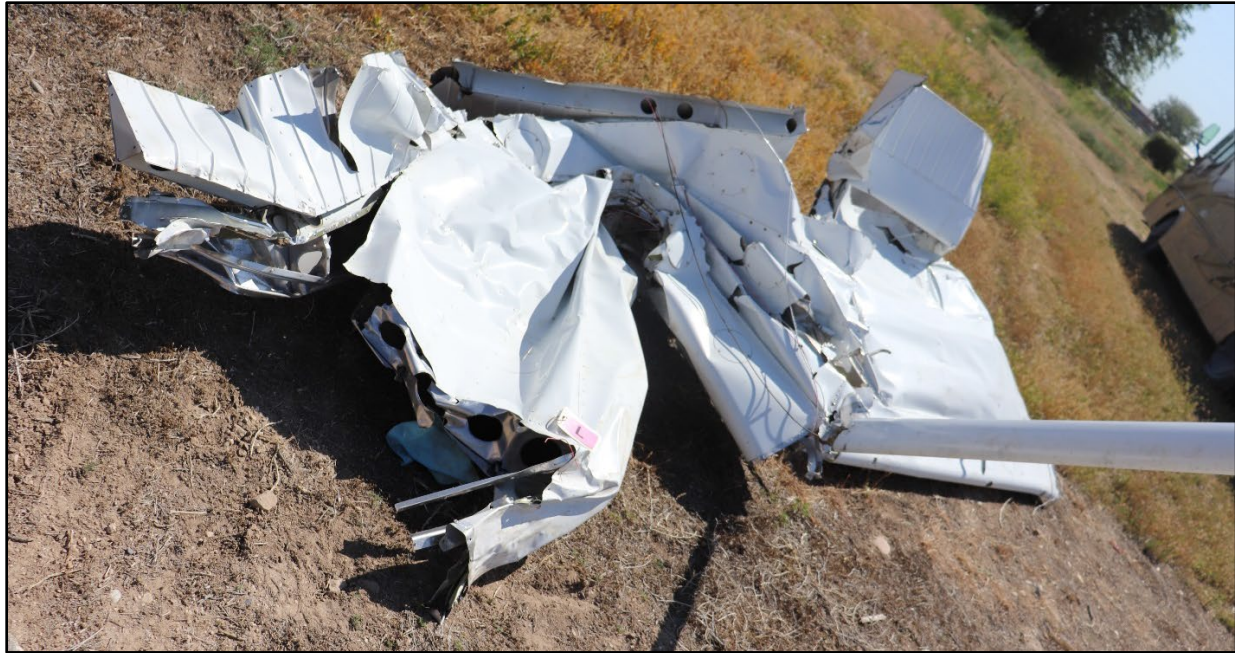
The left and right wings exhibited impact damage. The airplane was equipped with bladder fuel tanks. The left wing fragmented into numerous sections, left flap remained attached via its mounts and partially extended. The outboard section of the left wing was bent in a semi-circular shape. The aileron remained attached via its mounts. Crushing and bending was observed throughout the outboard wing section. The fuel cap was separated and not observed with the wreckage.

**Figure 2: view of left wing**

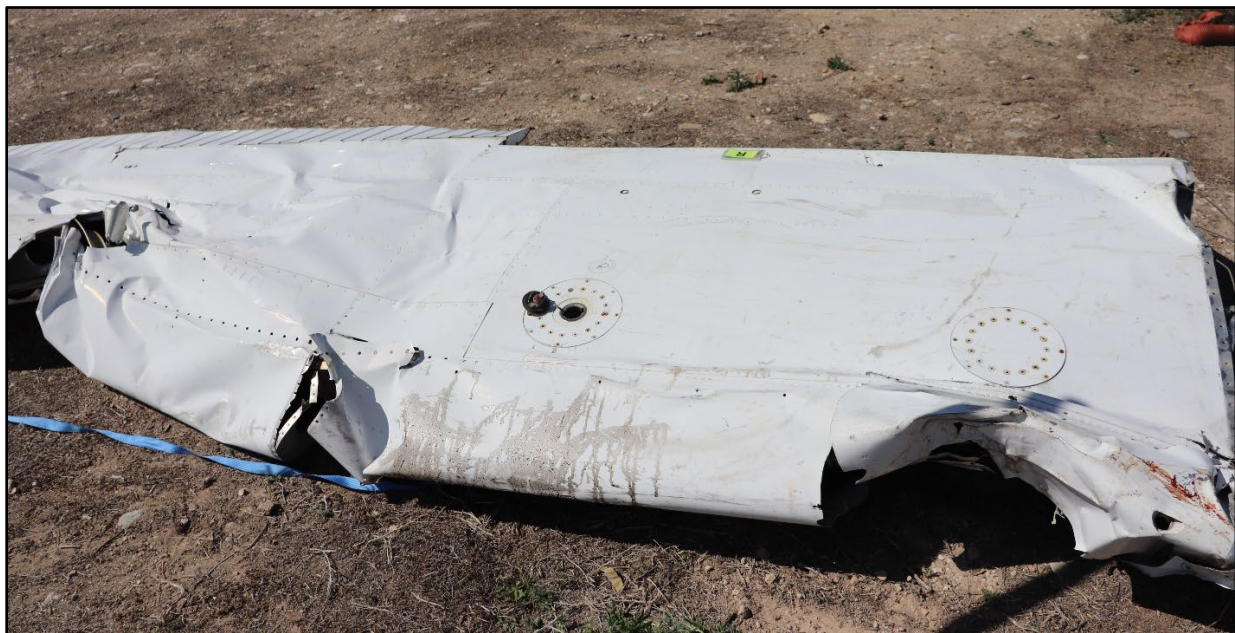
The right wing separated from fuselage at the wing root, crushing and bending was observed throughout the wing span. The right flap and aileron remained attached via their mounts. The flap was observed partially extended. The right main fuel tank fuel cap was observed in place and secure. Visual inspection of the right fuel cap revealed that the rubber seal appeared normal and unremarkable. Both wing fuel filler ports were normal and unremarkable.

**Figure 3: view of right wing**

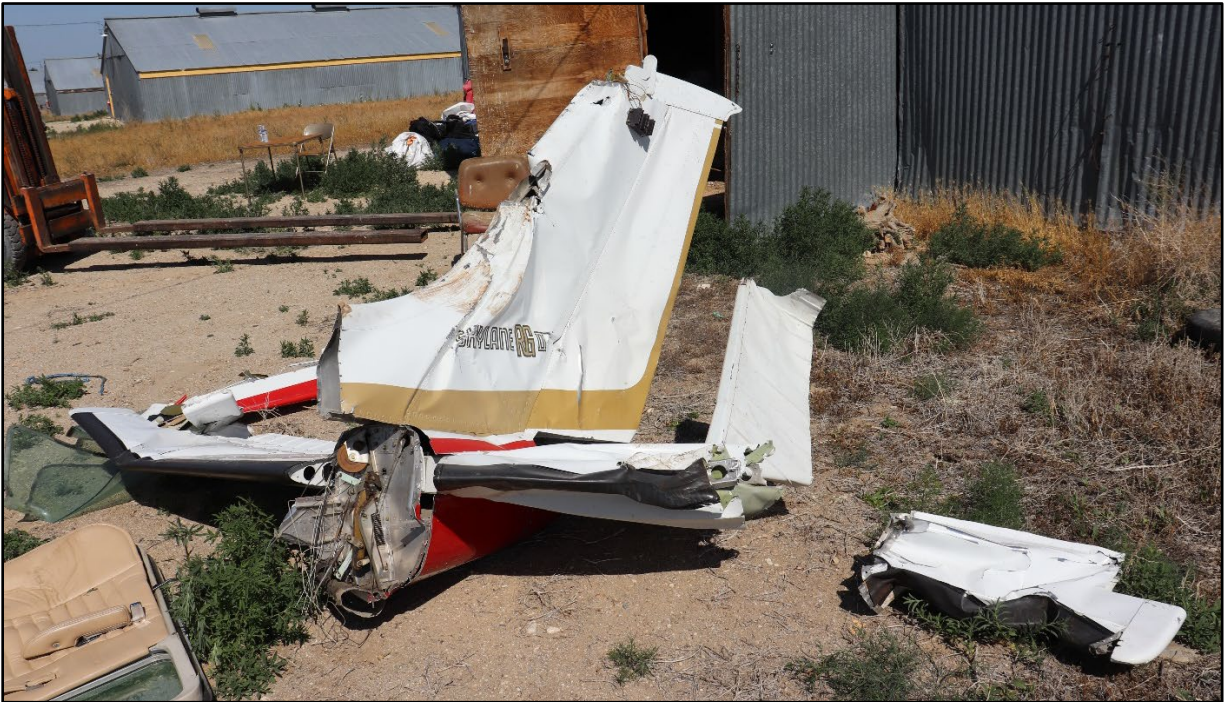
The empennage was separated from the fuselage, near the leading edge of the horizontal stabilizer. The vertical stabilizer, rudder, horizontal stabilizers, elevator, and elevator trim tabs remained attached and secure to their respective mounts. Both elevator and rudder flight control cables remained attached to their respective mounts. Crushing and bending was observed throughout the empennage.

**Figure 4: view of empennage**

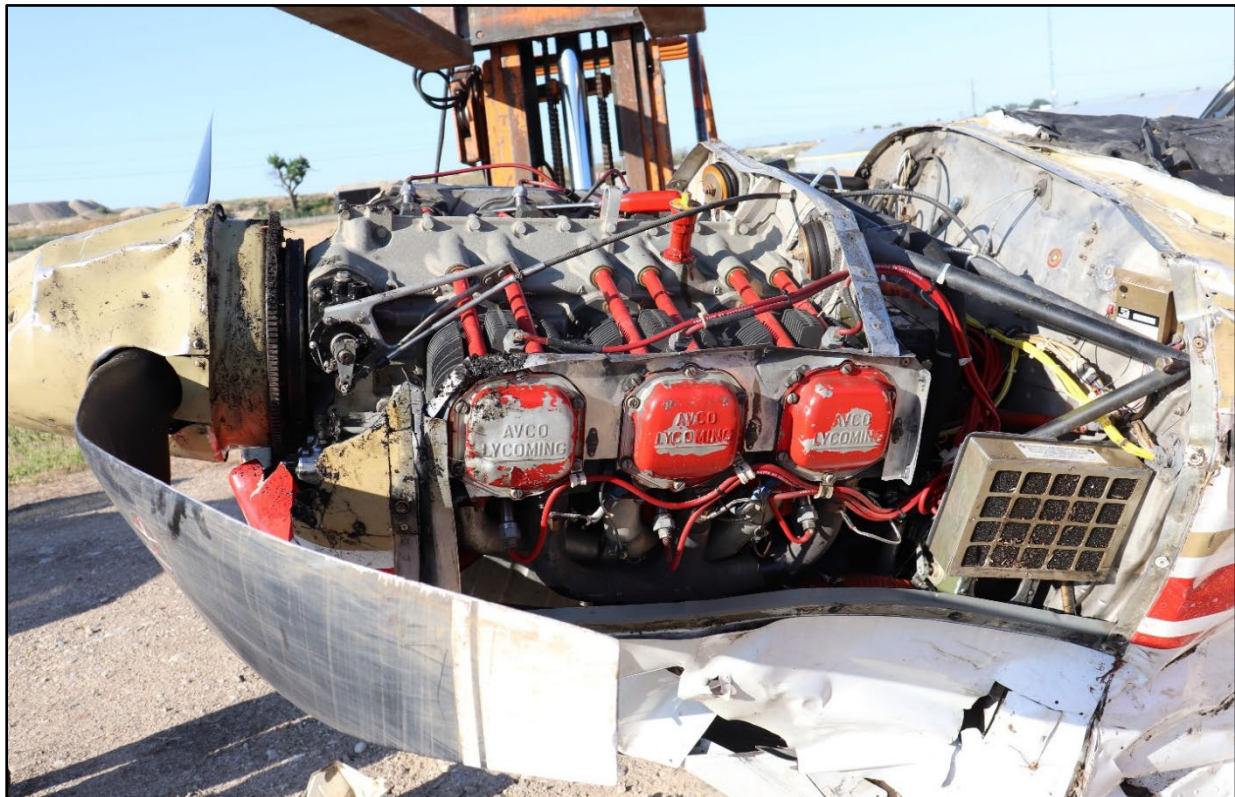
Examination of the recovered engine revealed that engine remained attached to the engine mount. All six cylinders and all engine accessories remained attached. All fuel and oil lines that were removed were tight. The number 1 and 2 cylinder rocker box covers exhibited impact damage. No evidence of any mechanical damage was observed to the engine crankcase.

**Figure 5: view of engine during examination**

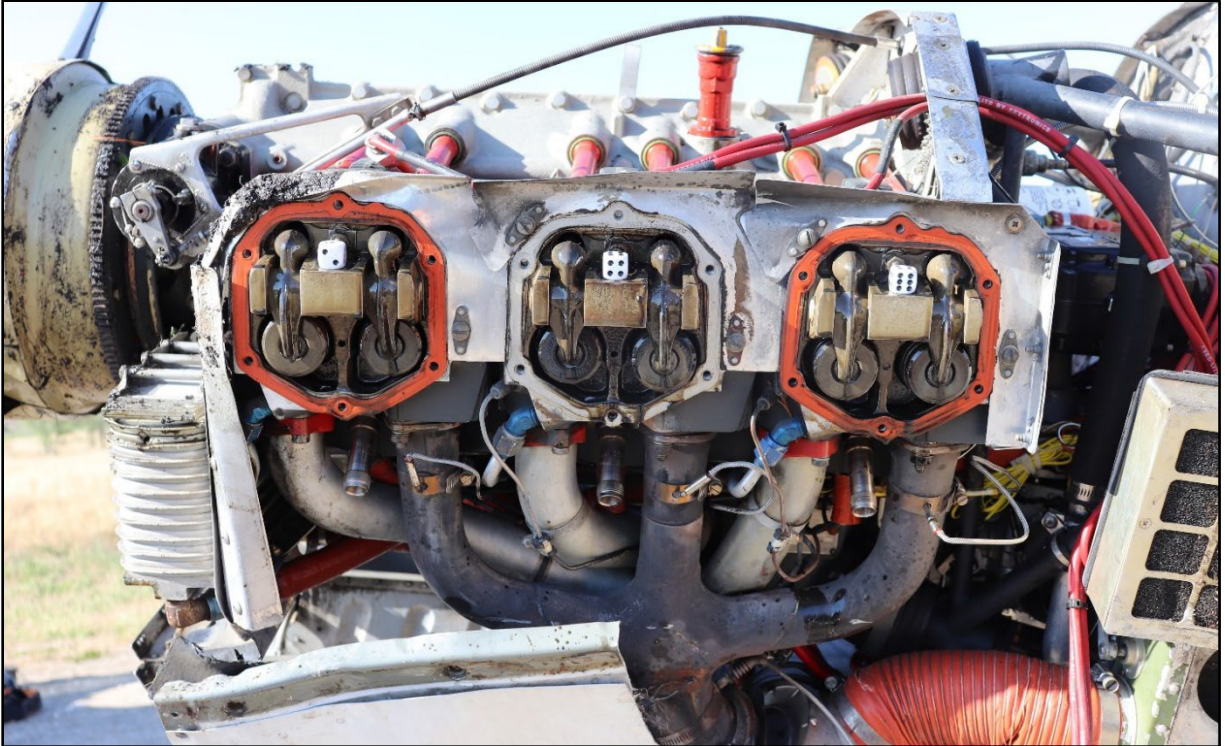
The rocker box covers were removed. The intake and exhaust rocker arms were intact, and oil coated on all cylinders. All intake and exhaust valve springs were in place and visually appeared to be undamaged. The upper spark plugs were removed, and all six cylinders were examined internally using a lighted borescope. A normal amount of combustion deposits was observed within the combustion dome of each cylinder and piston face. All of the intake and exhaust valves were unremarkable. The crankshaft was rotated by hand using the propeller. Rotational continuity was established throughout the engine and valve train. Thumb compression and suction was obtained on all six cylinders.

**Figure 7: view of left side intake and exhaust rocker arms**

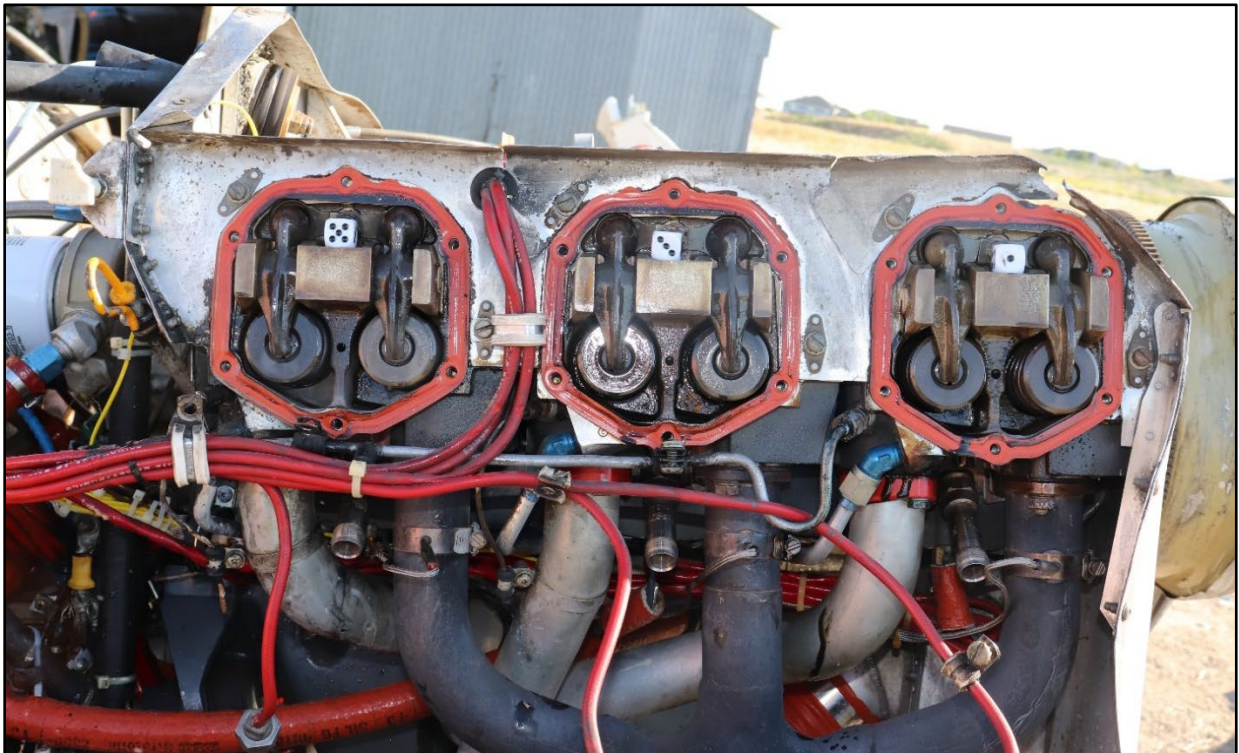
**Figure 8: view of right side intake and exhaust rocker arms**

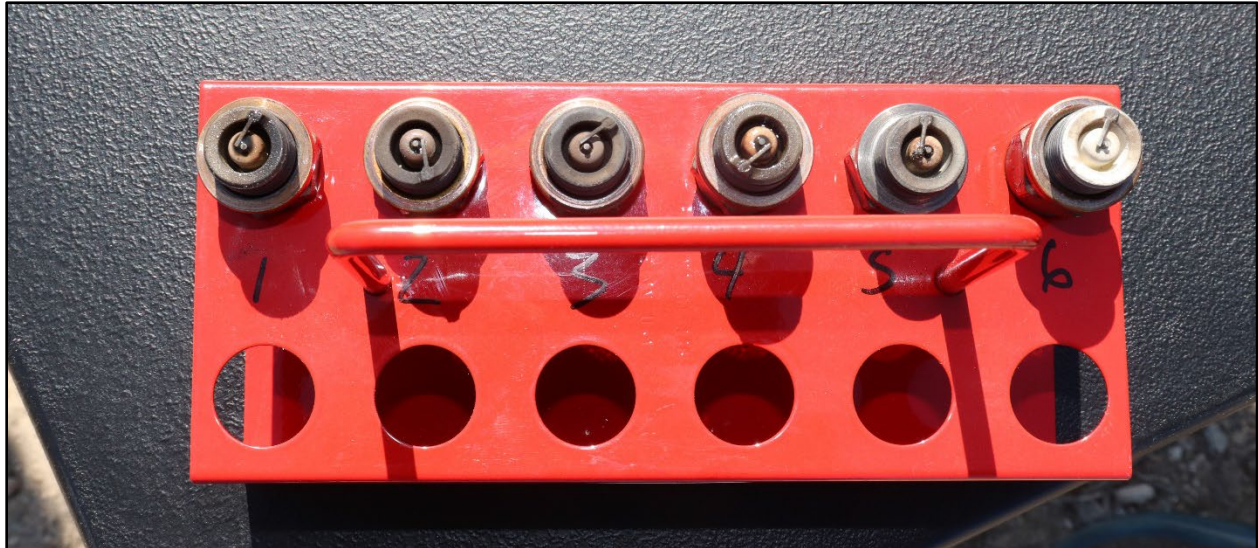
The top engine spark plugs were removed from the engine, and they were the fine-wire electrode type. The number 1 and 4 cylinder spark plugs were oil coated. The

number 2, 3 and 5 cylinder spark plugs exhibited gray deposits within the electrode area. The number 6 cylinder spark plug exhibited light gray deposits within the electrode area. The spark plugs exhibited signatures consistent with WORN NORMAL when compared to the Champion Check-A-Plug comparison chart.

**Figure 9: view of top spark plugs**

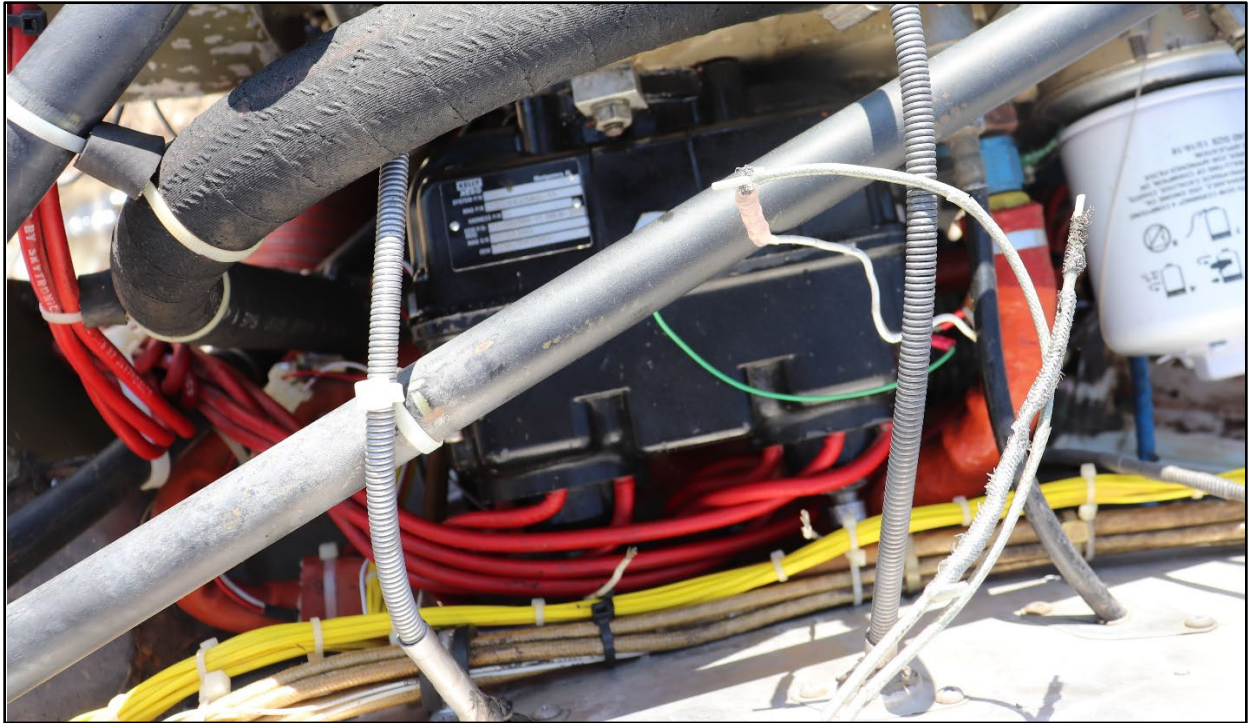
The single drive, dual magneto remained attached to the engine accessory case but not secured to the mounting pad, which allowed for movement between the mounting pad and the magneto. The dual magneto rotated, left and right with minimal resistance. The upper magneto retaining hardware was loose and the lower retaining hardware was loose and backed off, about 1/8 in from the magneto. The dual magneto timing was found to be at about 18° before top dead center. When the engine crankshaft was rotated by hand using the propeller, spark was produced on all twelve ignition leads and the impulse coupling engagement was heard.

**Figure 10: View of magneto from above**

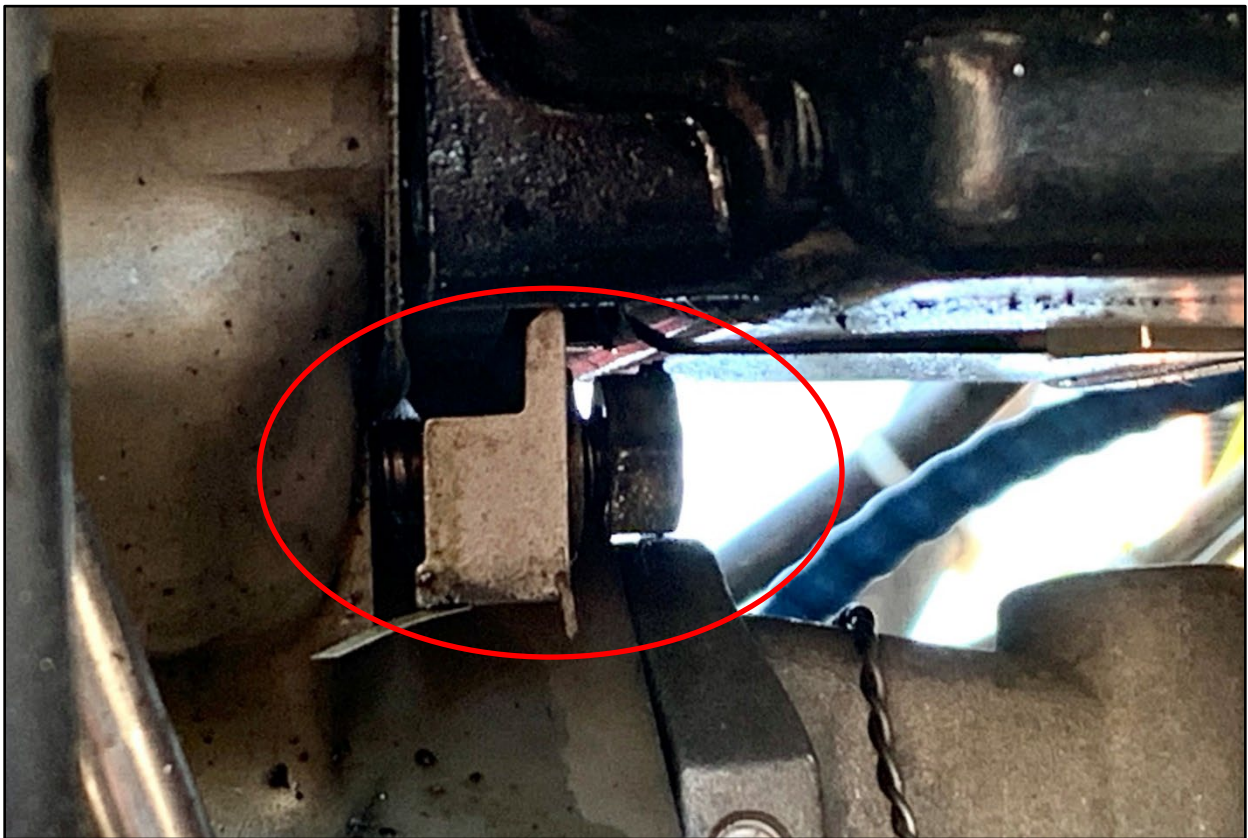
**Figure 11: view of loose magneto retaining hardware**

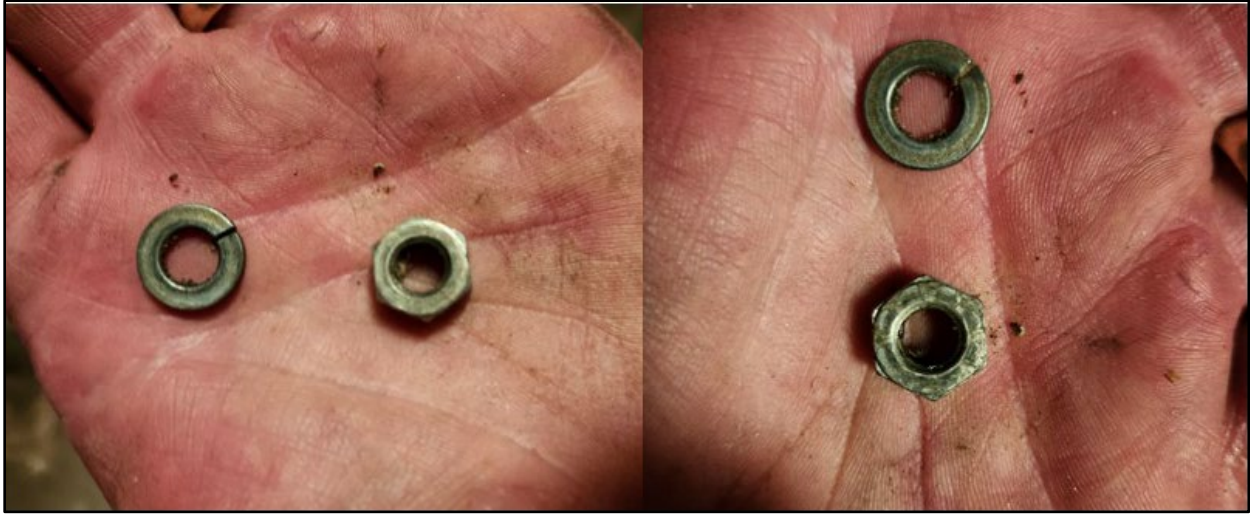
**Figure 12: view of magneto retaining hardware**

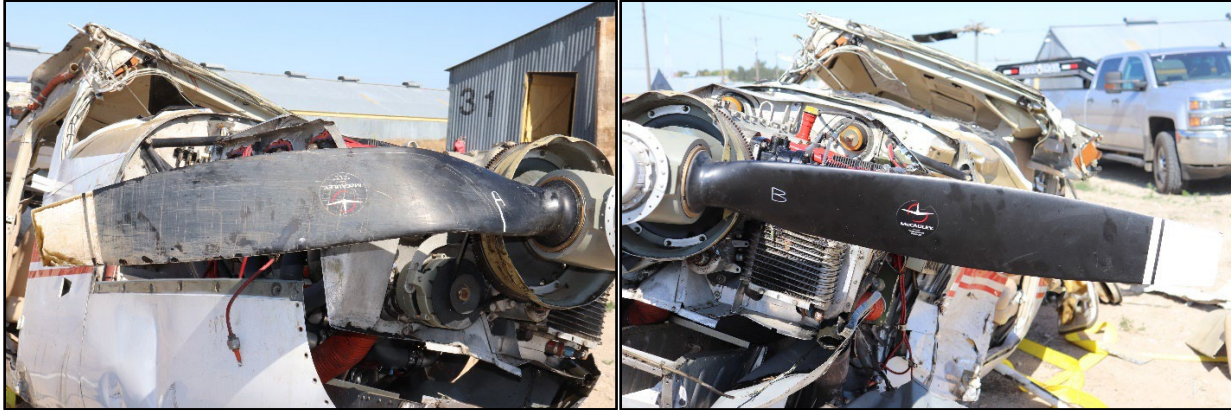
The airplane was equipped with a two blade McCauley propeller. The propeller and propeller hub remained attached to the engine. Propeller blade A exhibited aft bending about mid span, with unidirectional striations on the cambered side of the blade and polishing along the leading edge. Propeller blade B exhibited polishing along the leading edge.

**Figure 13: view of propeller**
